Preliminary Geotechnical Assessment

Ladies Mile Masterplan Area,
Queenstown

December 2020

GeoSolve Ref: 200353

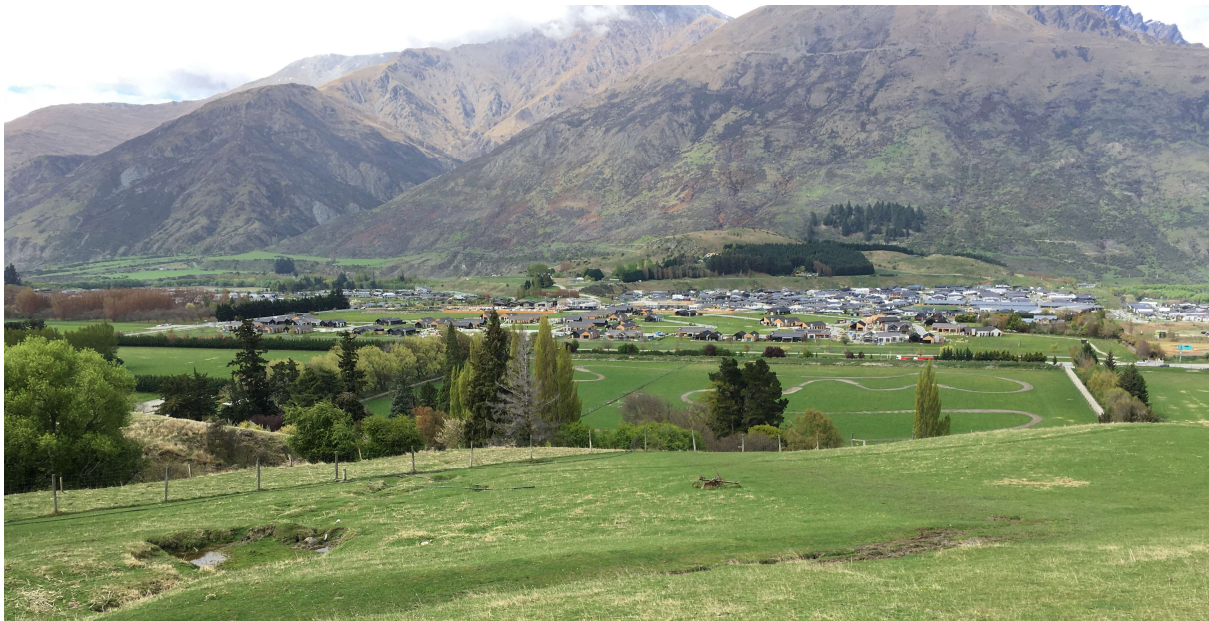
Photograph 1a – Site photo taken on the hills east of the site, looking south across the masterplan area.

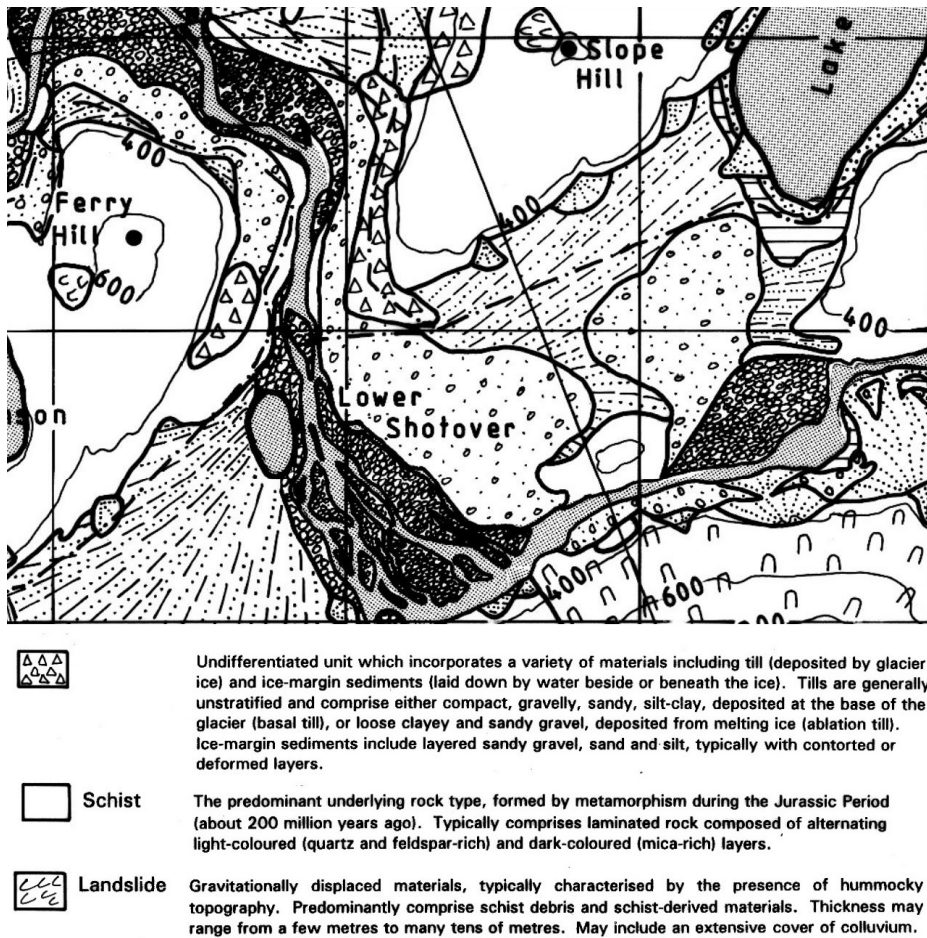
Figure 3: Excerpt from IGNS Map Surficial Geology of the Wakatipu Basin, October 1994

The QLDC hazard maps show a landslide area in the north-western part of the masterplan area, see Figure 9, Appendix A. The landslide is identified as 'non verified.' The source of the landslide is noted as the IGNS QMAP 1:50,000 compilation sheets. This map and the accompanying overview report 'Surficial geology of the Wakatipu Basin, Central Otago, New Zealand, reference 94/39,1994' have been reviewed. An excerpt from the map showing the site location is provided below in Figure 3.

From Figure 3 above it can be seen that there is no landslide feature shown. The site area is shown to be underlain by glacial deposits in lower areas and schist bedrock in upper areas.

- The lower area of the landslide is characterised by historic river terrace and terrace riser landforms typical of those found around this area of the Shotover River.
- Schist bedrock, dipping west-southwest at 25°, was observed in the lower landslide area. This is characteristic of in-situ schist and untypical of a landslide.
- The upper areas are gently sloping and do not show the typical landforms expected of a landslide.
- In general, there are no distinctive landslide features present in the area.

Based on the above assessment it is considered likely that the landslide feature shown on the QLDC data results from an error whilst compiling the hazard maps.

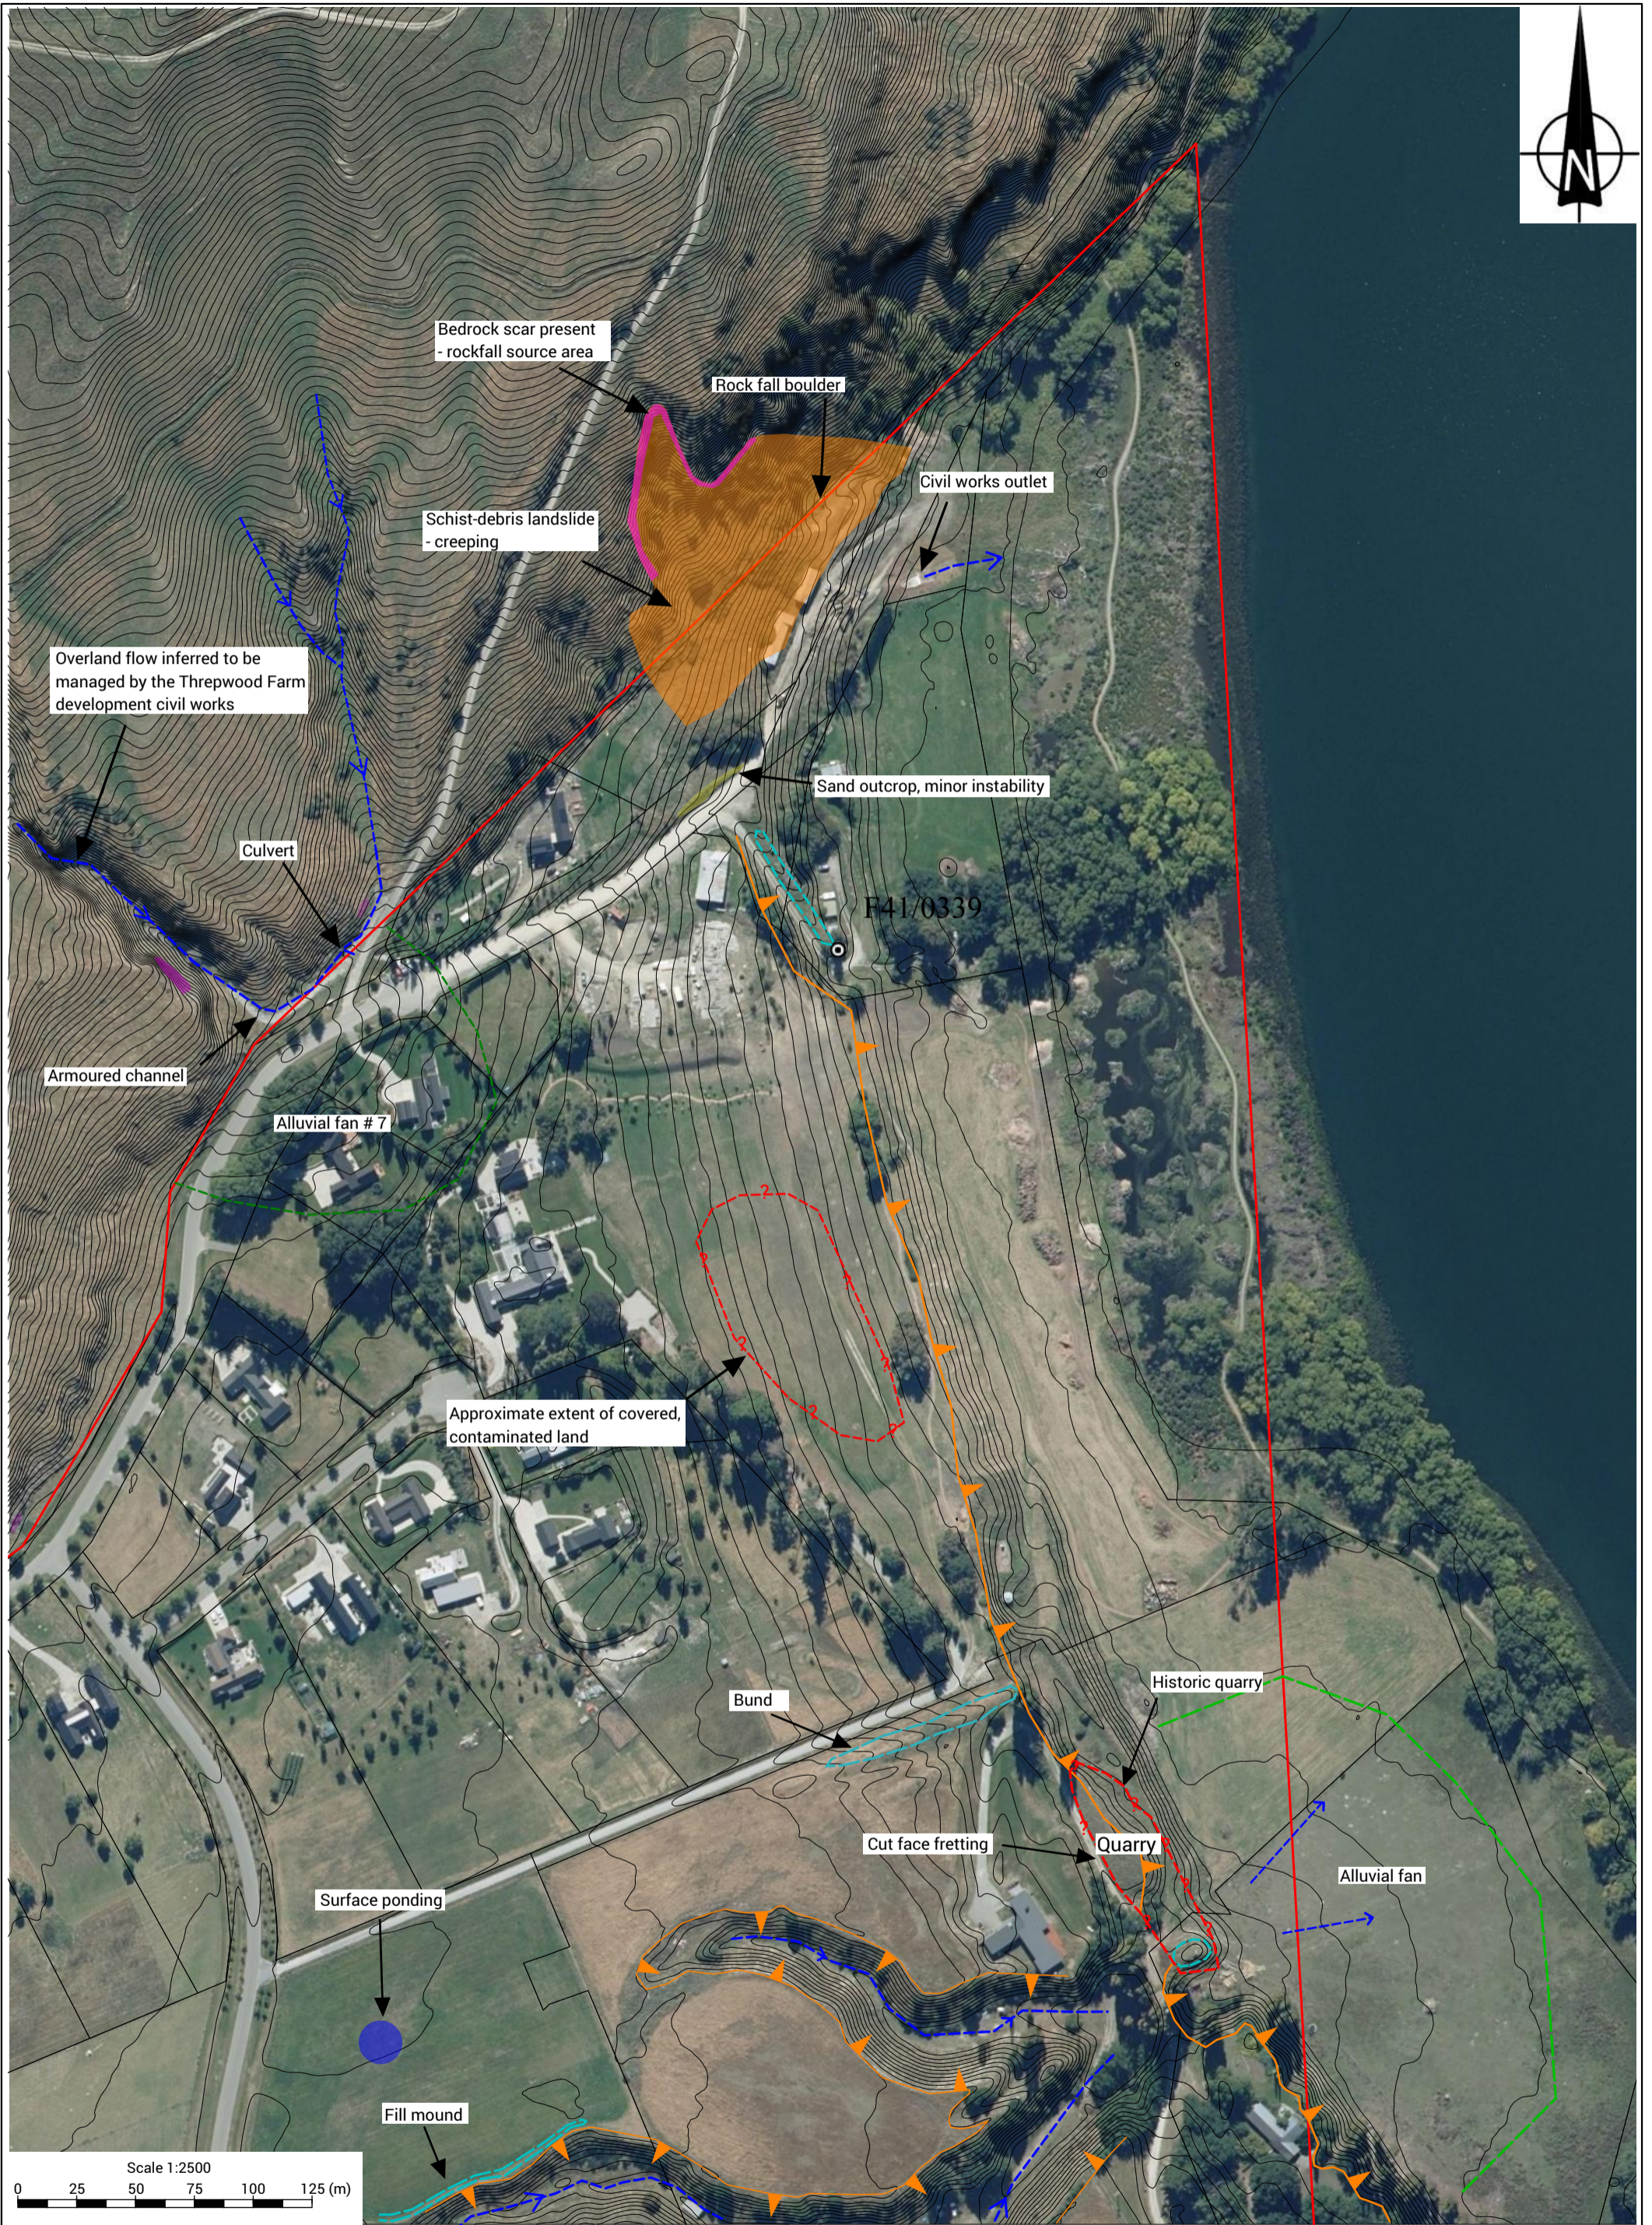
FIG No: **FIGURE 7**

A small historic landslide feature was observed above the north-eastern end of the hillslopes, in the location shown in Figure 7, Appendix A. Subvertical schist bedrock forms the scarps. This schist debris landslide is inferred to be slowly creeping in response to heavy rainfall and seismic events.

An anecdotal area of historic lime quarrying is present within the eastern slopes of the subject site, as shown in Figure 7. This area is localised however, any fill material associated with this activity could be subject to settlement following a major regional earthquake event. Any foundations proposed within this area will require specific engineering design and assessment at detailed design stage.

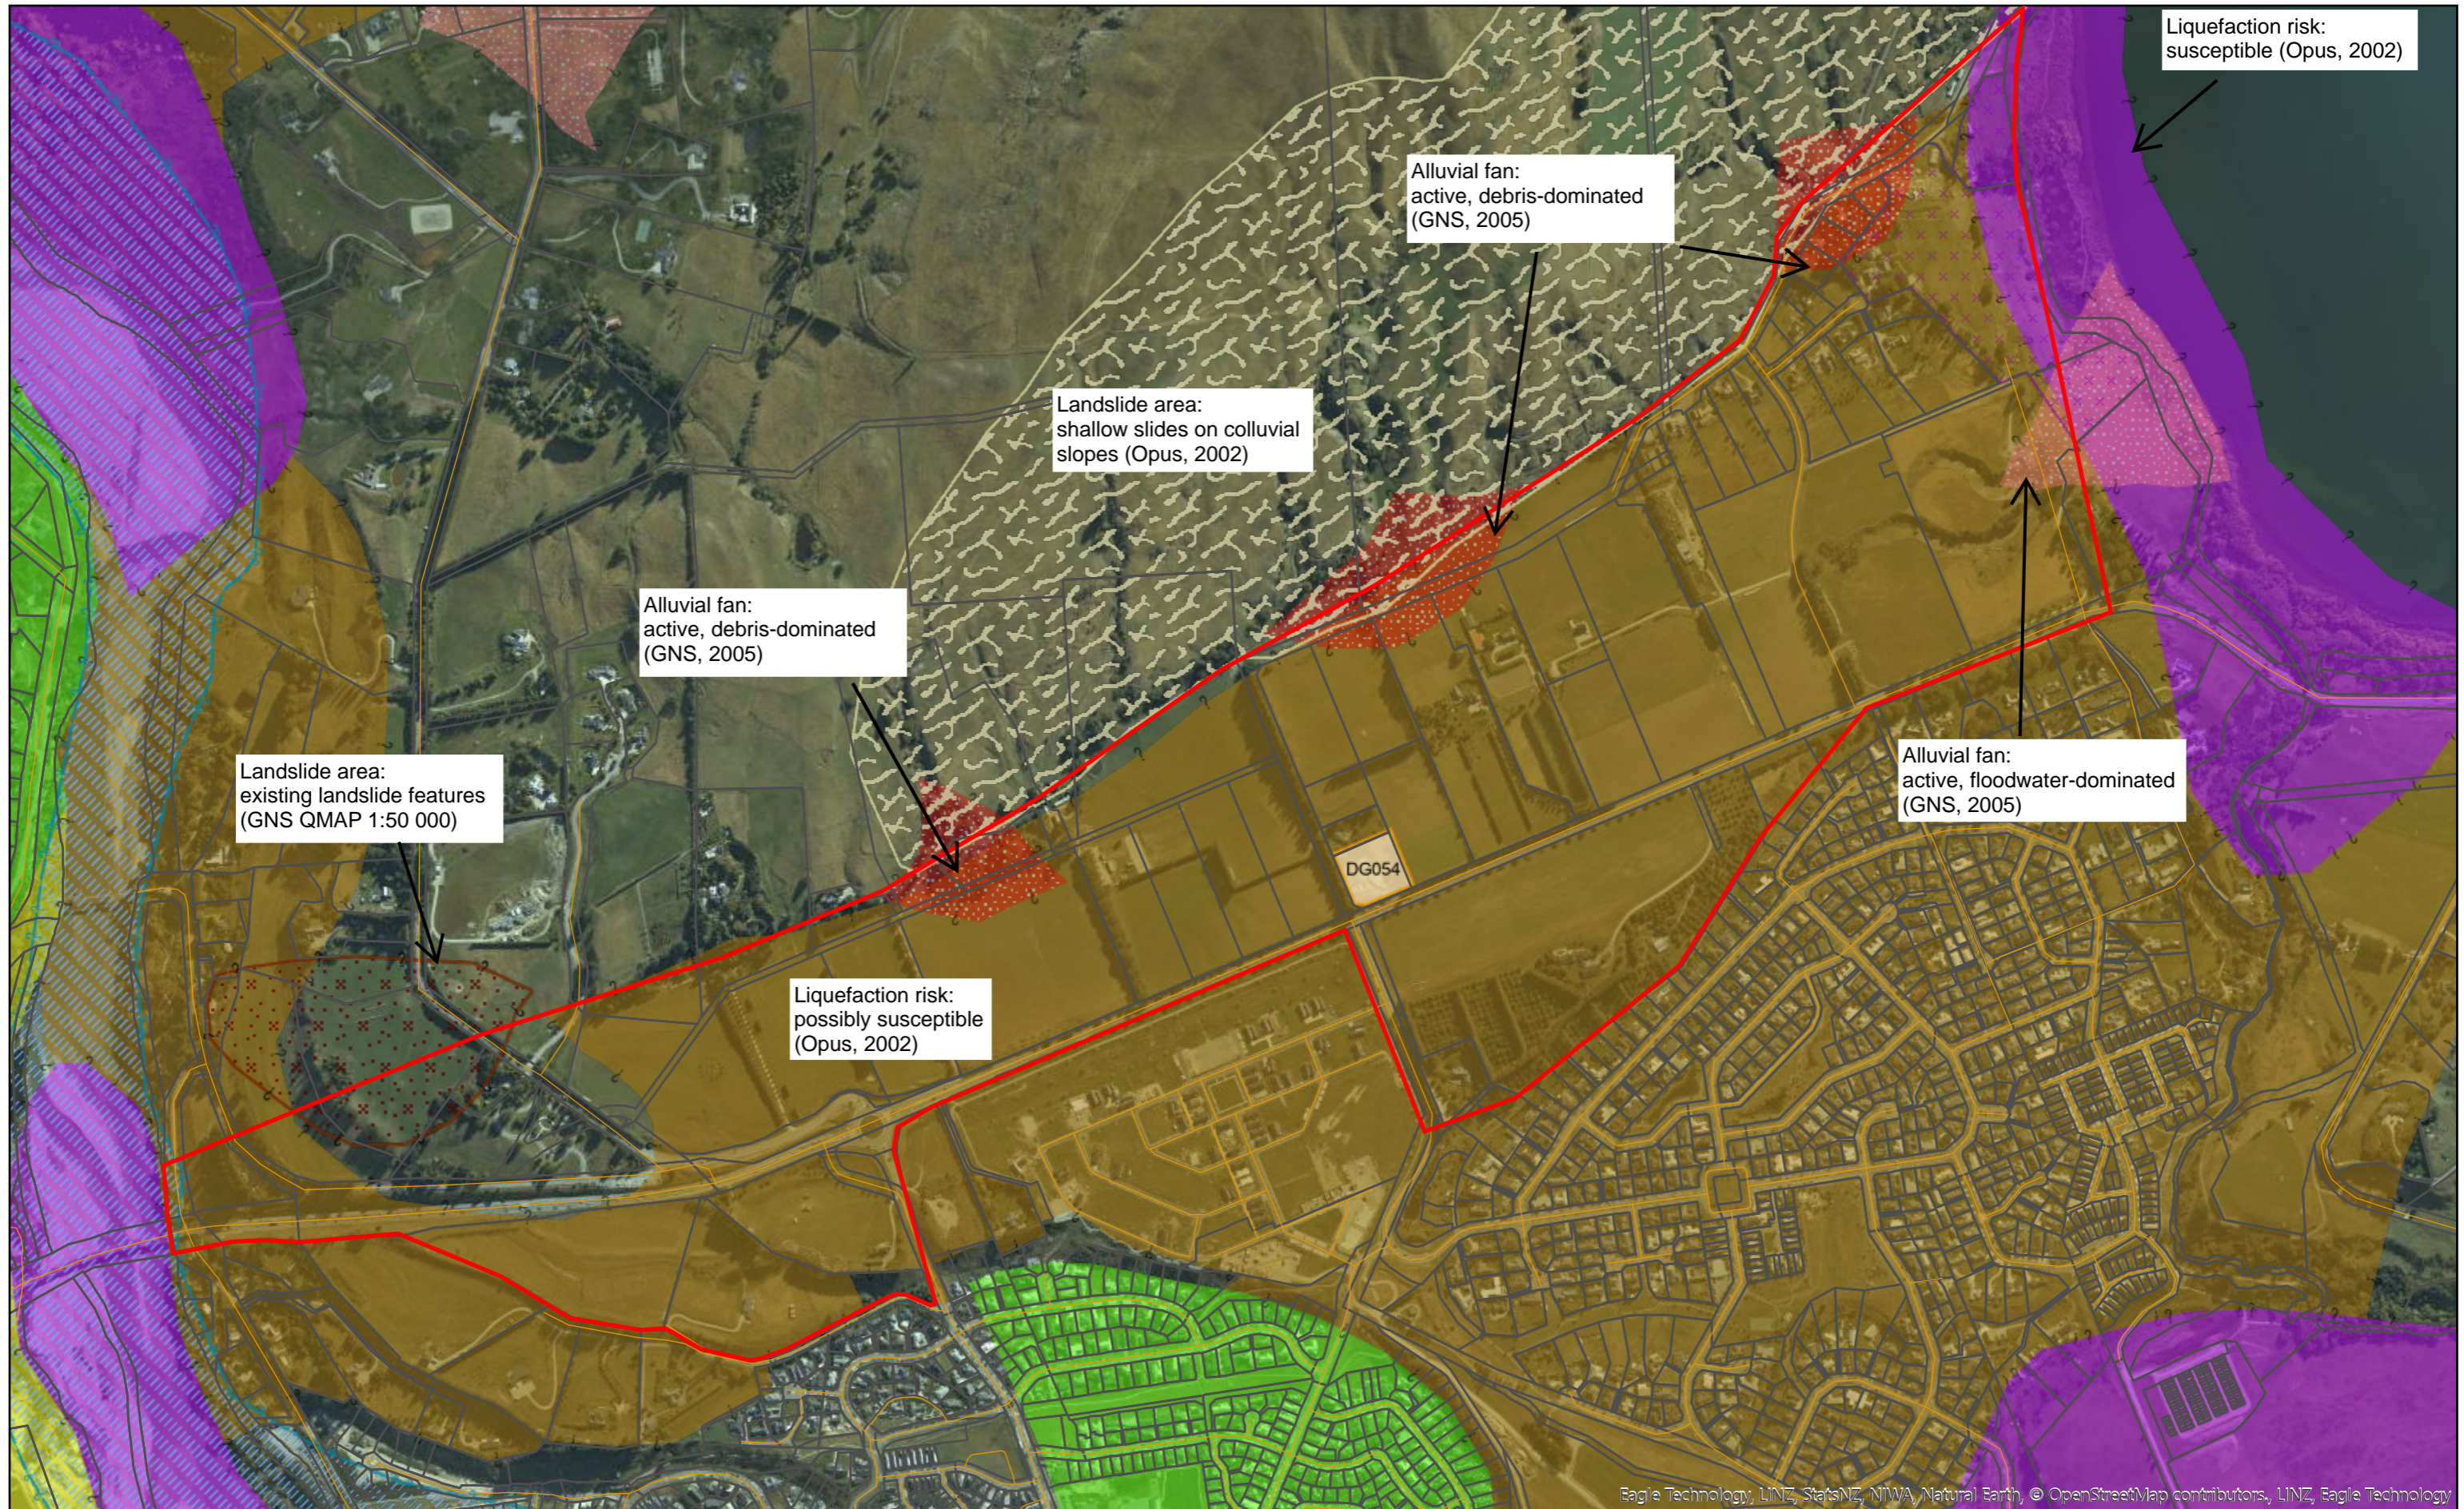
QLDC Natural Hazards Map

The majority of the site is identified on the Queenstown Lakes District Council (QLDC) natural hazard maps as being 'possibly susceptible' to liquefaction (Opus, 2002), with the eastern part identified as being 'susceptible' to liquefaction (Opus, 2002) and the north-western part not being mapped as being subject to a liquefaction risk. Our assessment indicates there is low liquefaction risk for the area mapped as 'possibly susceptible' to liquefaction (Opus, 2002) due to the significant depth to the regional groundwater table (approximately 39-51 m). No further investigations are considered necessary with respect to liquefaction in this area.

The northern hillslopes are identified on the QLDC Hazard Maps as a landslide area 'susceptible to shallow debris flows' (Opus, 2002. Hazards Register Part II Stage 2 Risk Management Study). This hazard area is not mapped to extend onto the site, and apart from localised gully erosion upstream of the alluvial fans, no deep seated, recent or active instability of the soil slopes were observed on the hillslopes from the study area during the site walkover inspection. Further details regarding the alluvial fan hazard are discussed in Section 5.5.

The QLDC hazard maps identify three alluvial fans along the northern hillslopes, as shown in Figure 9, Appendix A. These alluvial fans are all mapped as active, debris-dominated (GNS, 2005, regional scale mapping). Geomorphological mapping carried out by GeoSolve identified another four alluvial fans along the northern hillslopes, in the locations shown in Figures 2-3, 5 and 7, Appendix A. The alluvial fans along the toe of the northern hillslopes have been numbered 1-7 on the attached site plans, each alluvial fan is described in detail in Table 3 below.

The QLDC hazard maps identify an alluvial fan ‘active, floodwater-dominated’ within the eastern part of the site, on the slopes above Lake Hayes as shown in Figure 9, Appendix A.

A flooding-rainfall risk from the Shotover River is identified on the QLDC hazard database along the western perimeter of the site, partially extending into the lower slopes. If development is proposed within this area, further assessment is required to determine flood-mitigation measures, such as minimum floor levels.

If development is proposed on the western shores of Lake Hayes, within the area mapped as 'susceptible' to liquefaction (Opus, 2002), further assessment will be required to quantify the liquefaction and lateral spreading risk, specific foundation design may be required.
