Skyline Enterprises Ltd
 Skyline Upgrade
 Stormwater Discharge - Detailed Hazard Assessment
 Aerial Summary Plan

Skyline Enterprises Ltd
 Skyline Upgrade
 Stormwater Discharge - Detailed Hazard Assessment
 Geomorphology Summary Plan

Skyline Enterprises Ltd	
Skyline Upgrade	
Stormwater Discharge - Detailed Hazard Assessment	
Detailed Geomorphology below DL1, northern/upper zone	
FIG No:	Figure 1d
REV.	1

Skyline Enterprises Ltd	
Skyline Upgrade	
Stormwater Discharge - Detailed Hazard Assessment	
DL1 Southern Flow Path Longsection	
FIG No:	Figure 2a
REV.	1

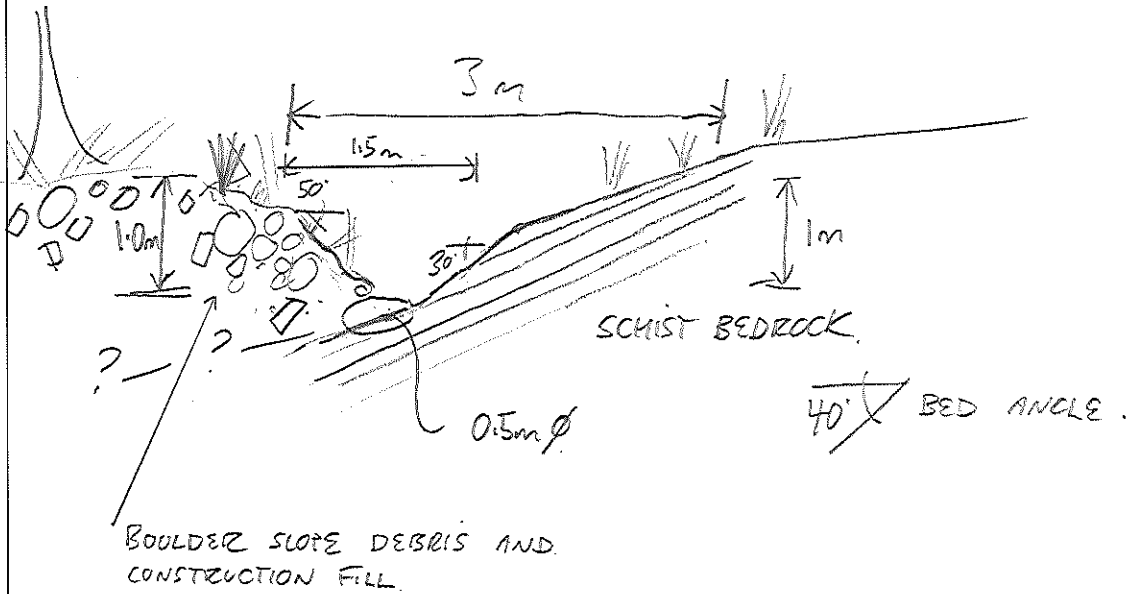
Section Number: 1a

angularity	Angular		
Depth of soil	1.0m on true right, becoming deeper.		
Average size	0.1 m+		
Max size	0.5 m		
Tightly interlocked or loose	Loose surface		
Scour erosion	Minor scour on true right		
Vegetation	Grass, shrubs, mature trees		
Depth of topsoil:	Minor, none on true left, sparse (450mm) true right

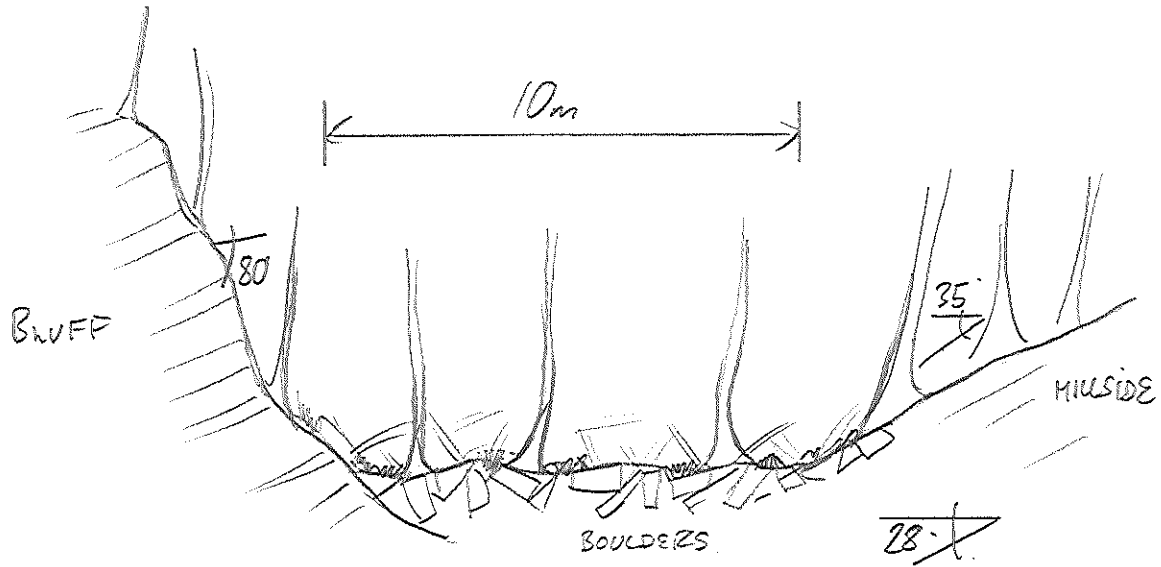
Section Number: 9a

Angularity	Angular.		
Depth of soil	Unknown estimated as 1-3m.		
Average size	0.5m +		
Max size	2m.		
Tightly interlocked or loose	Interlocked.		
Scour erosion	None, no evidence of overland flow		
Vegetation	Mature trees, ferns, young trees		
Depth of Topsoil	50-100mm, around boulders

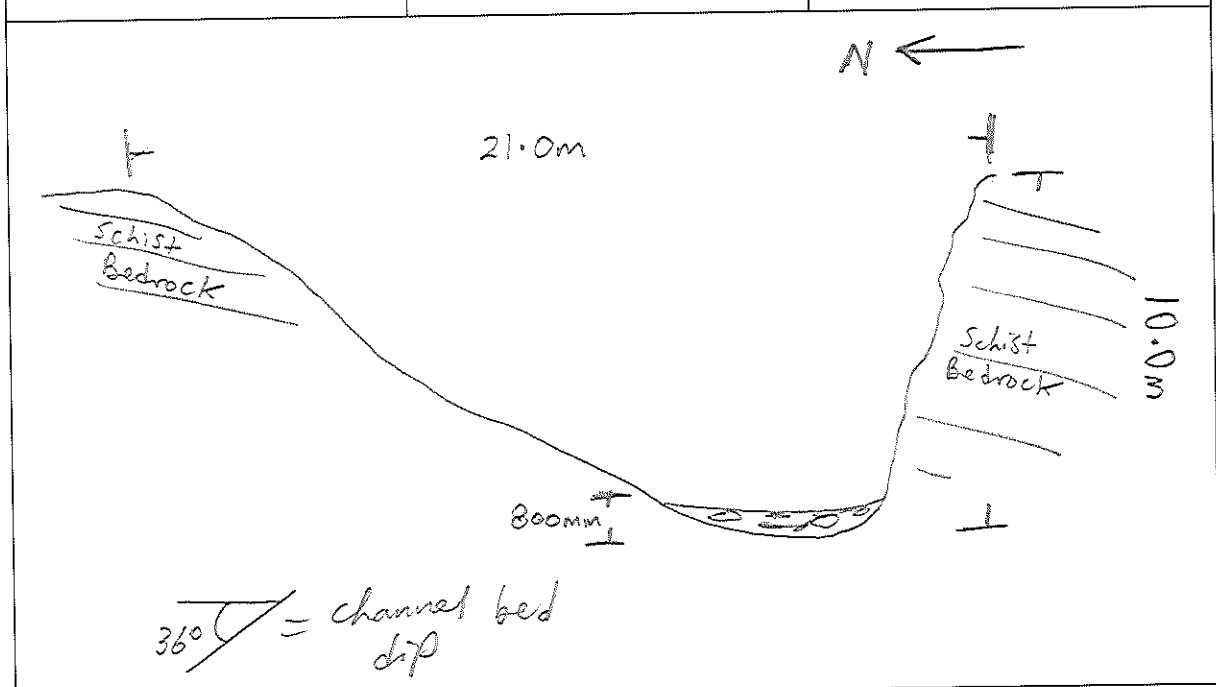
Section Number: 8b

Angularity: Angular	Schist clasts
Depth of Soil: Approx 800mm	Schist bedrock outcrops in base of channel.
Ave size: 60mm	
Max size: 900mm	angular schist boulders.
Loose/soft channel bed	J-channel levees are Schist bedrock
No Scour erosion	
Vegetation: Broken fern, well established trees	and organic debris including dead branches & trees.

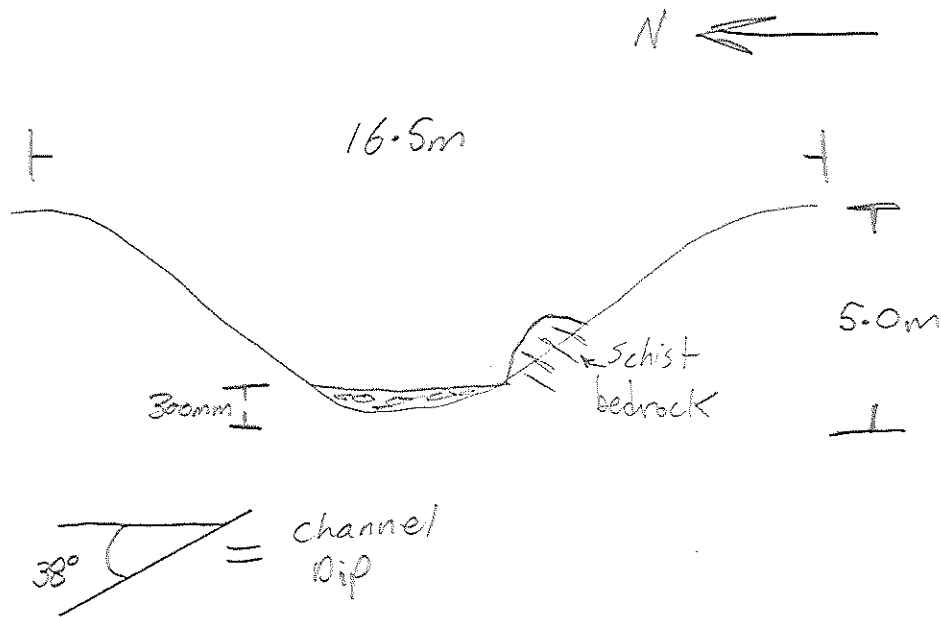
Section Number **10b**

Angular schist clasts		
Ave diam: 60mm - very little exposure of clasts on channel surface		
Max diam: 600mm angular schist clasts		
Depth of soil: Approx 300mm of loose/soft organic SILT and organic debris		
Scour Erosion: None		
Loose/soft channel bedload with schist bedrock levees		
Vegetation: Short green grass, bracken fern, well established trees		
Channel is choked full of organic debris.

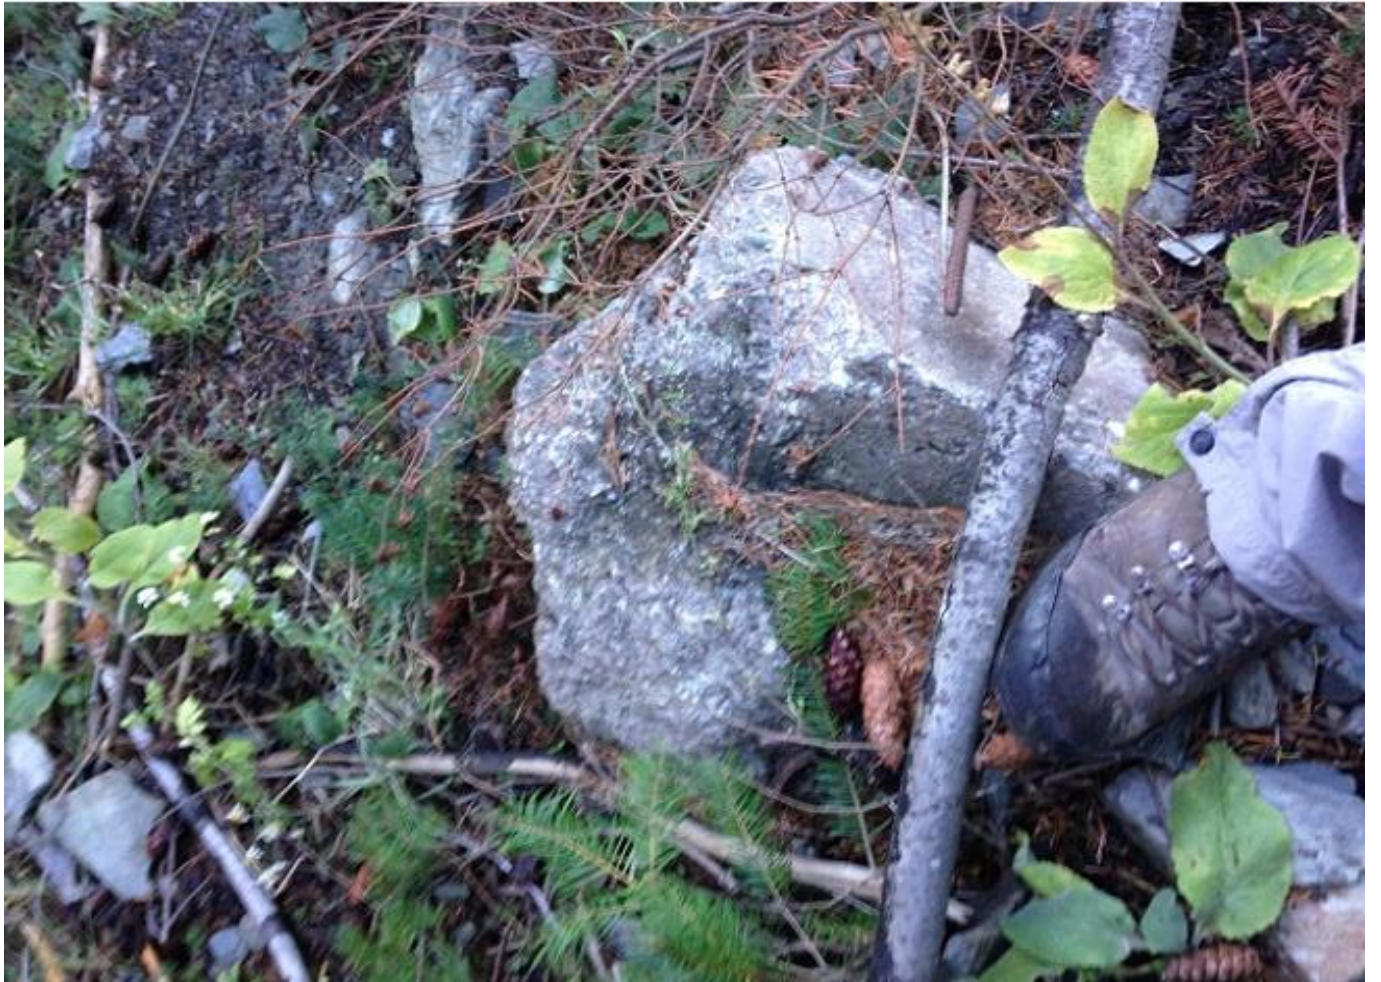
Photograph 28a. Concrete indicating the presence of fill materials

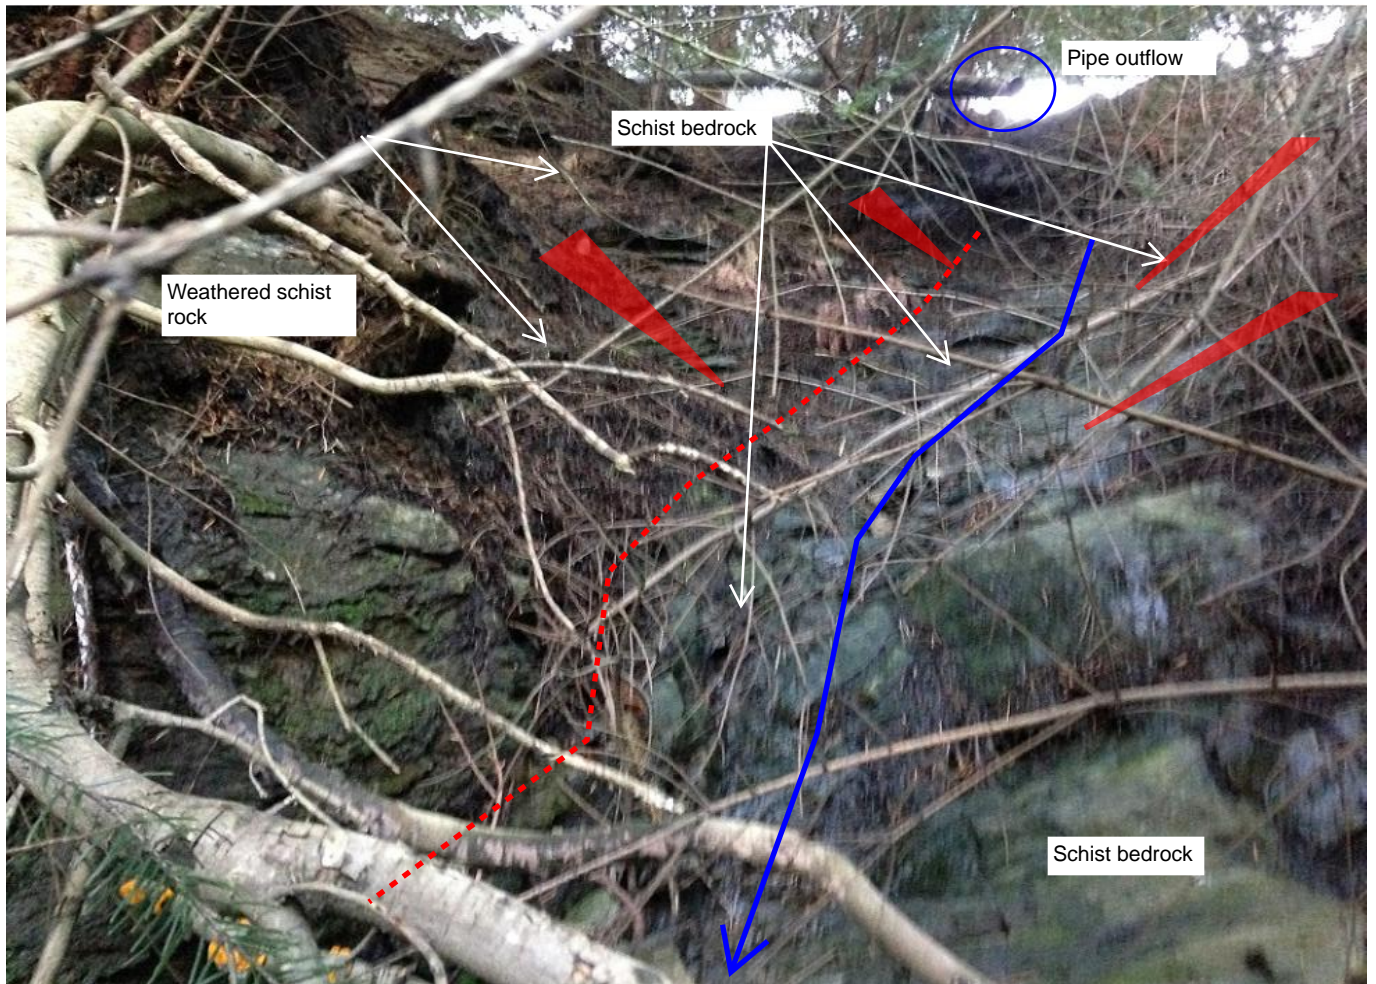
Photograph 29a. DL1 outflow onto rock at the top of the slope

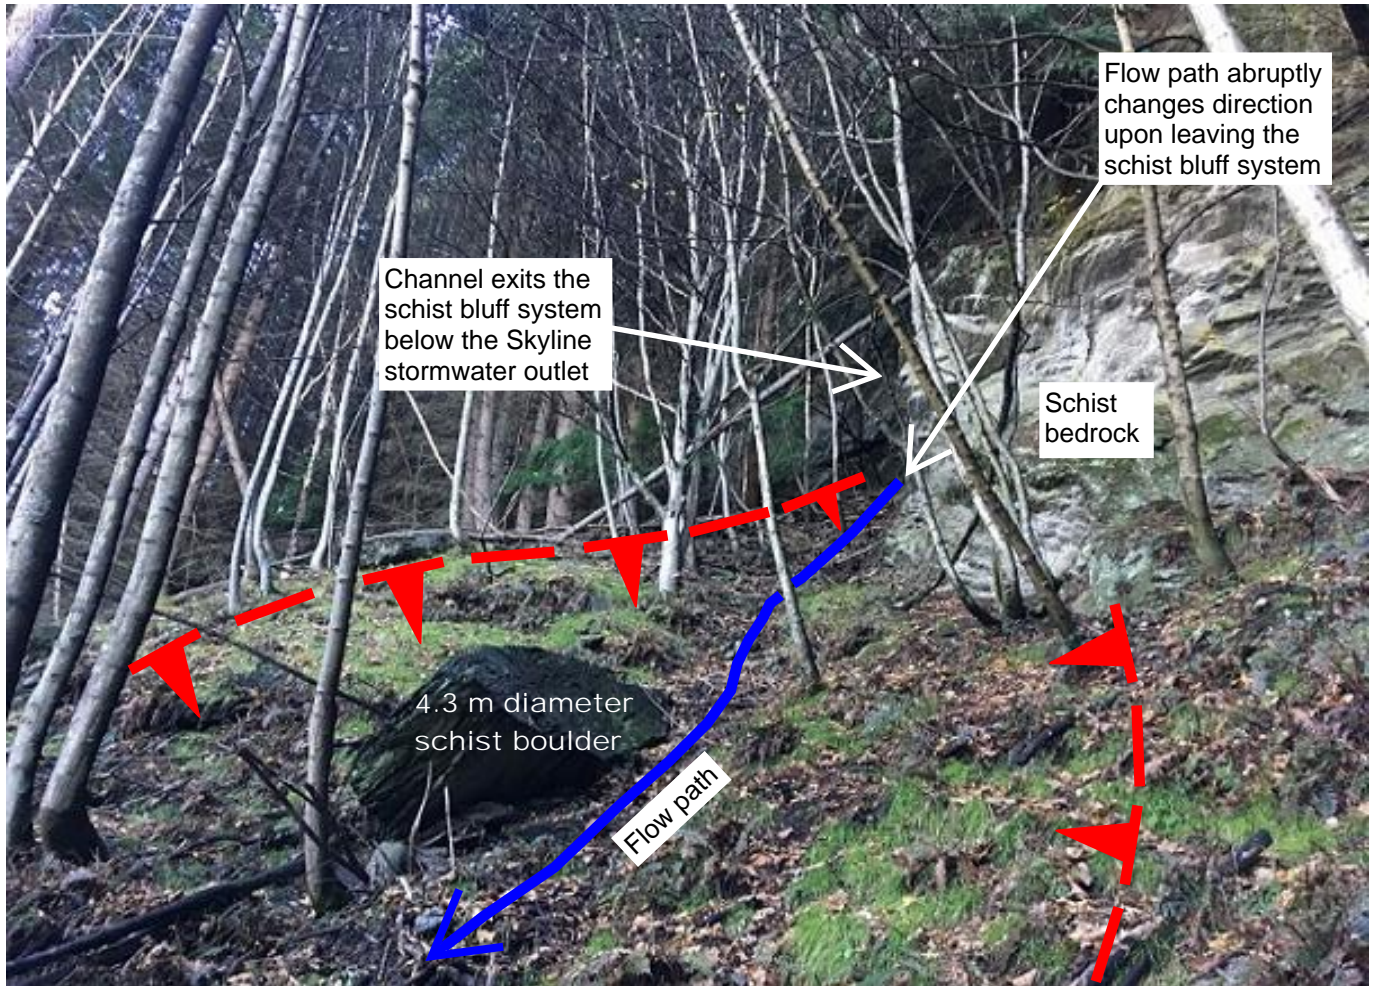
Photograph 1b. DL2 flow channel Section 1b. Flows discharge from the Skyline stormwater outlet above the schist bluff system.

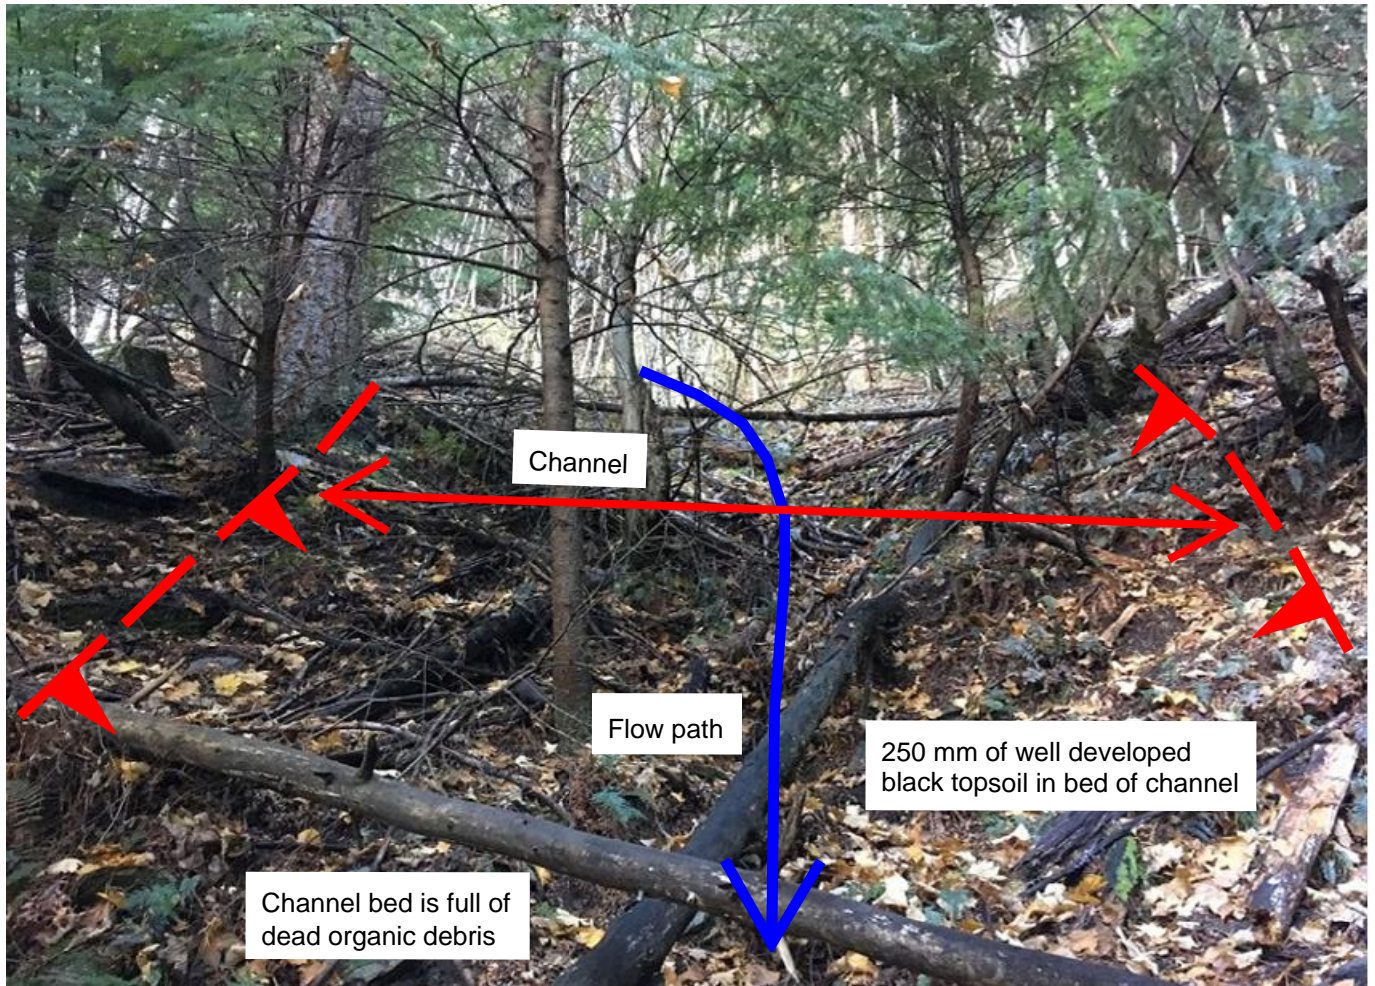
Photograph 2b. DL2 flow channel Section 2b. Immediately below Section 2b there is no clear flow path. Dispersal/bifurcation of overland flows is expected above a large, partly exposed, boulder blocking the channel.

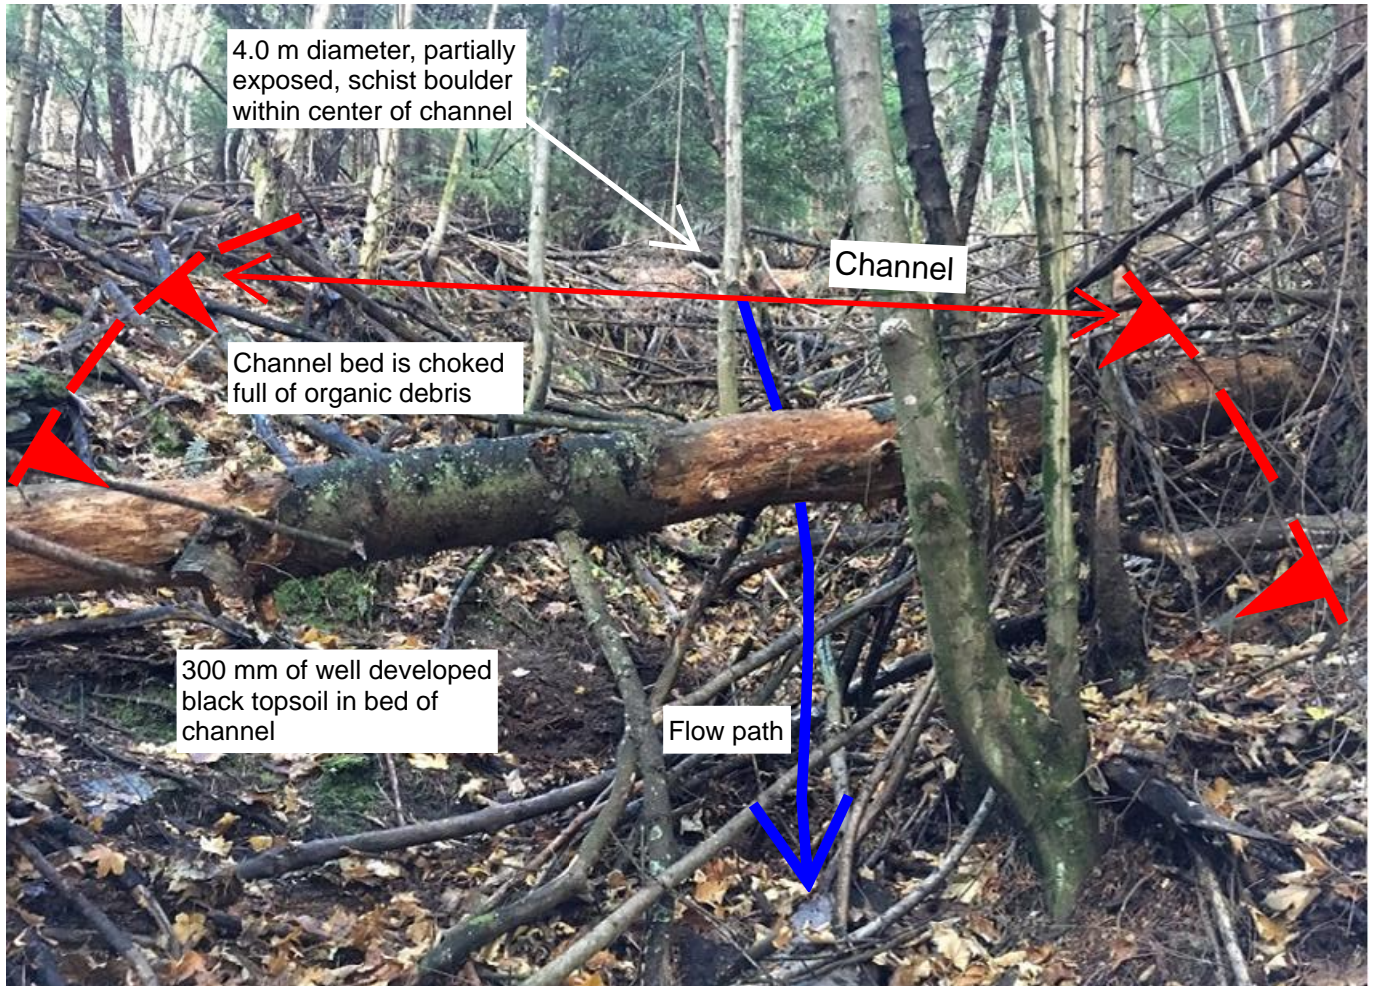
Photograph 3b. DL2 flow channel Section 3b, downstream of a schist boulder within the center of the channel. Poorly defined flow paths around either side of the boulder are visible. Channel bed is full of dead organic debris.

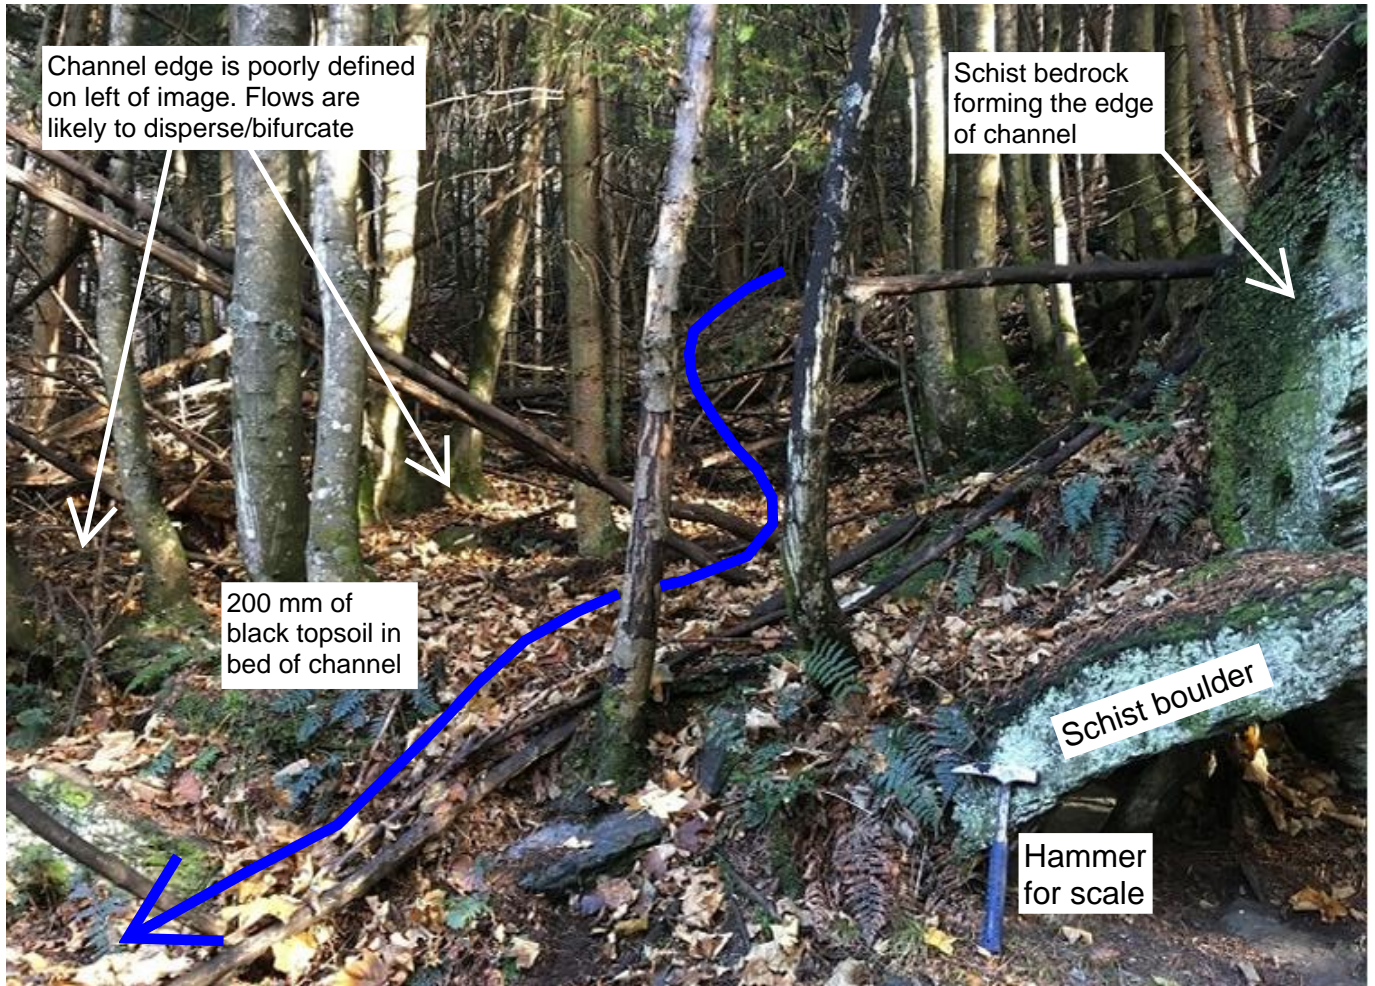
Photograph 4b. DL2 flow channel Section 4b. Heavy flows are likely to leave the channel and disperse/bifurcate across the downstream slope.

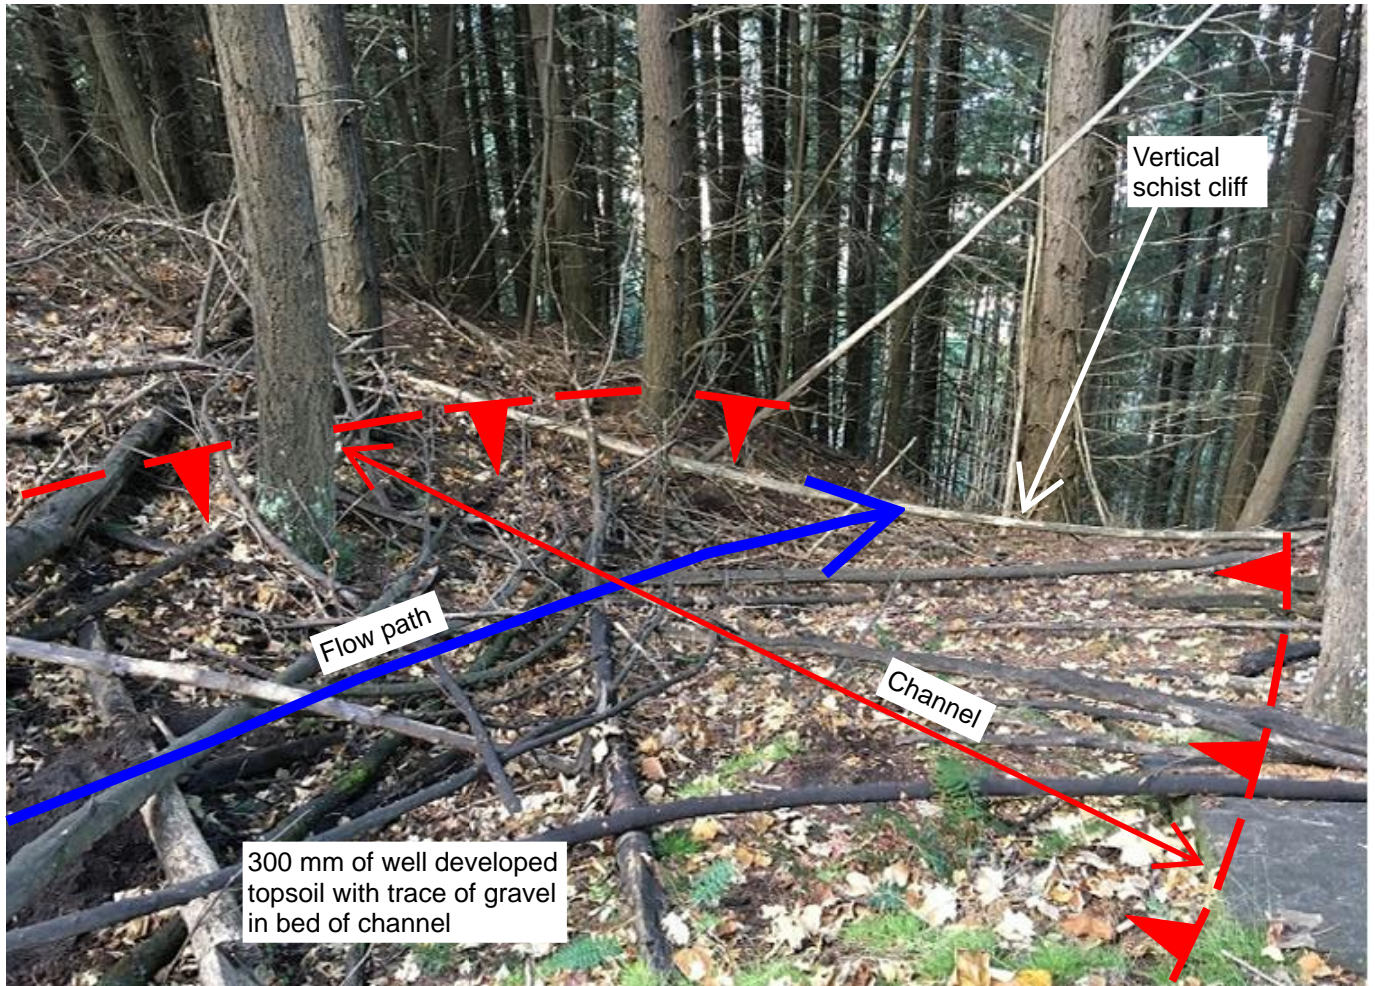
Photograph 5b. DL2 flow channel Section 5b. Flows drop down a 10 m high vertical schist bluff.

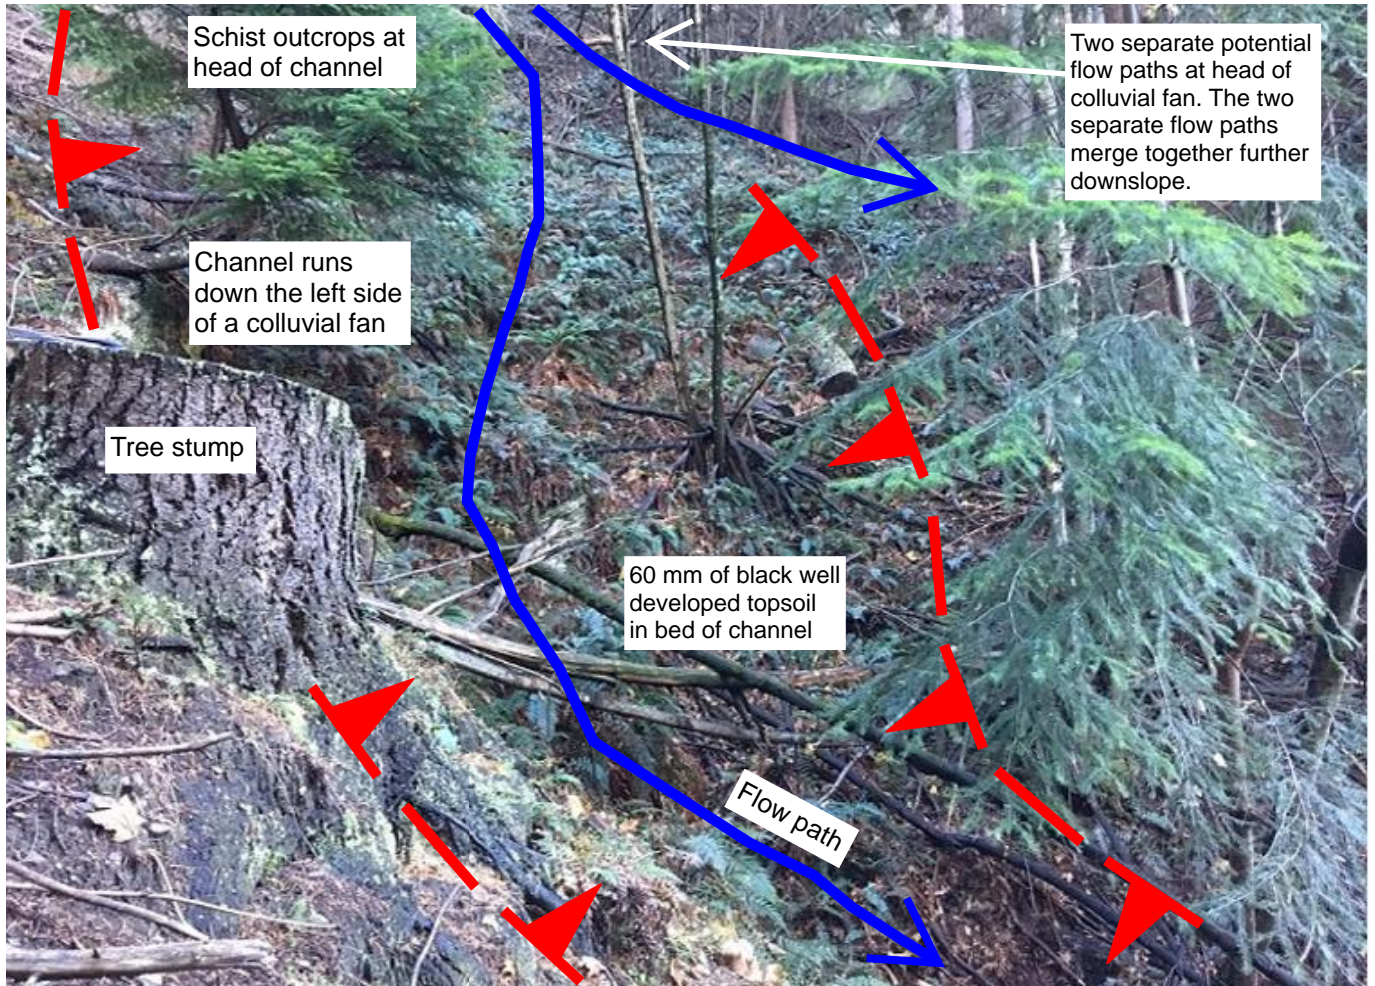
Photograph 7b. DL2 flow channel Section 7b. Flows coming down the bank from above have the potential to flow down one of channels which merge together again further downslope.

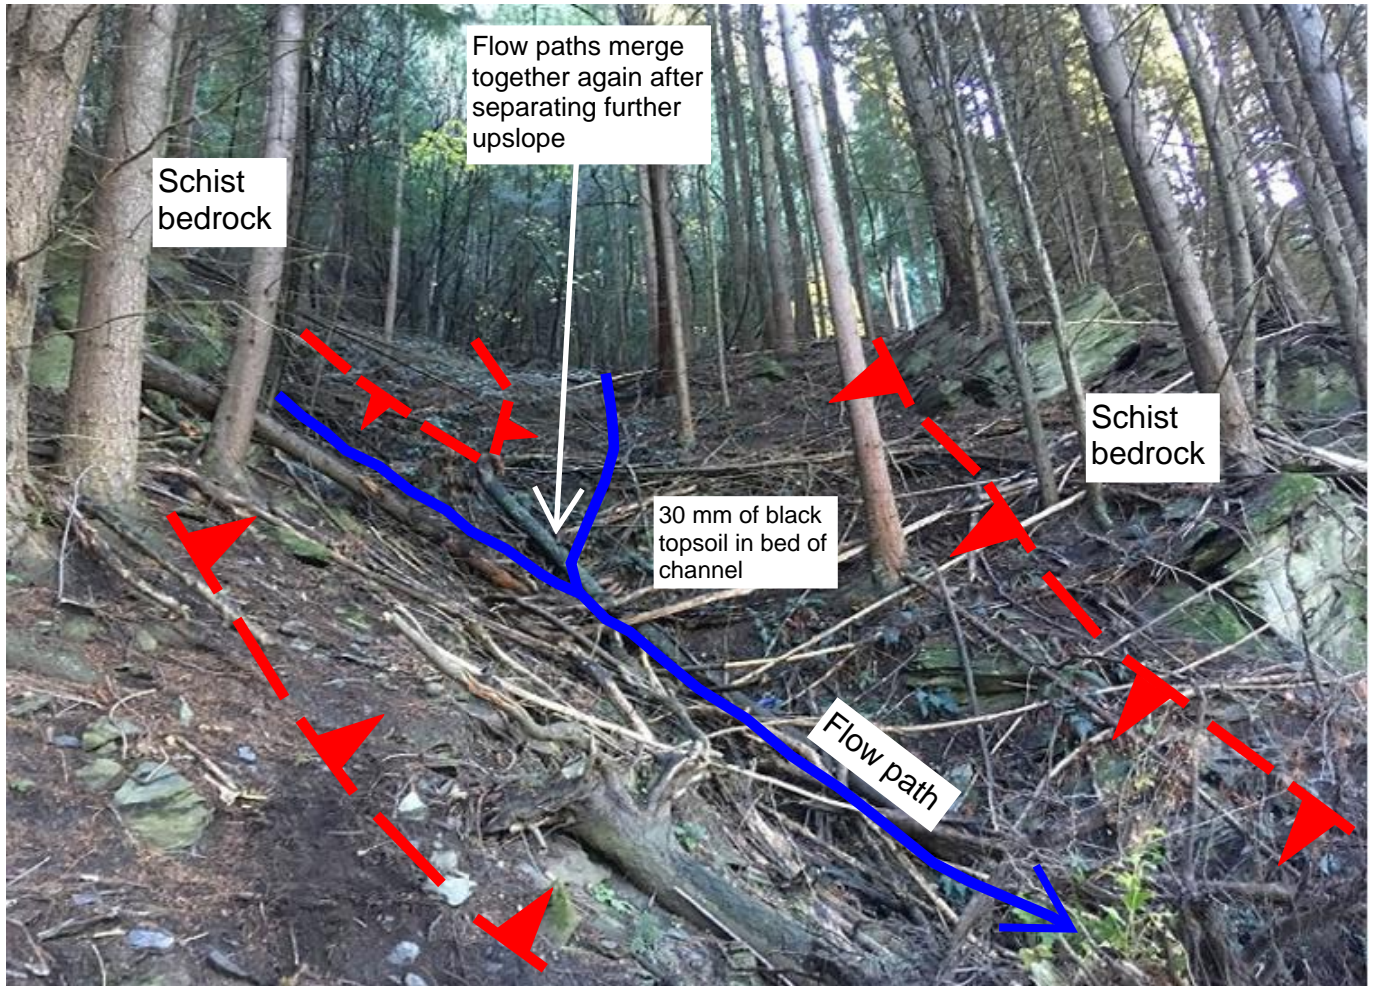
Photograph 8b. DL2 flow channel Section 8b. The two flow paths now merge back together again after separating further upslope above channel Section 7b.

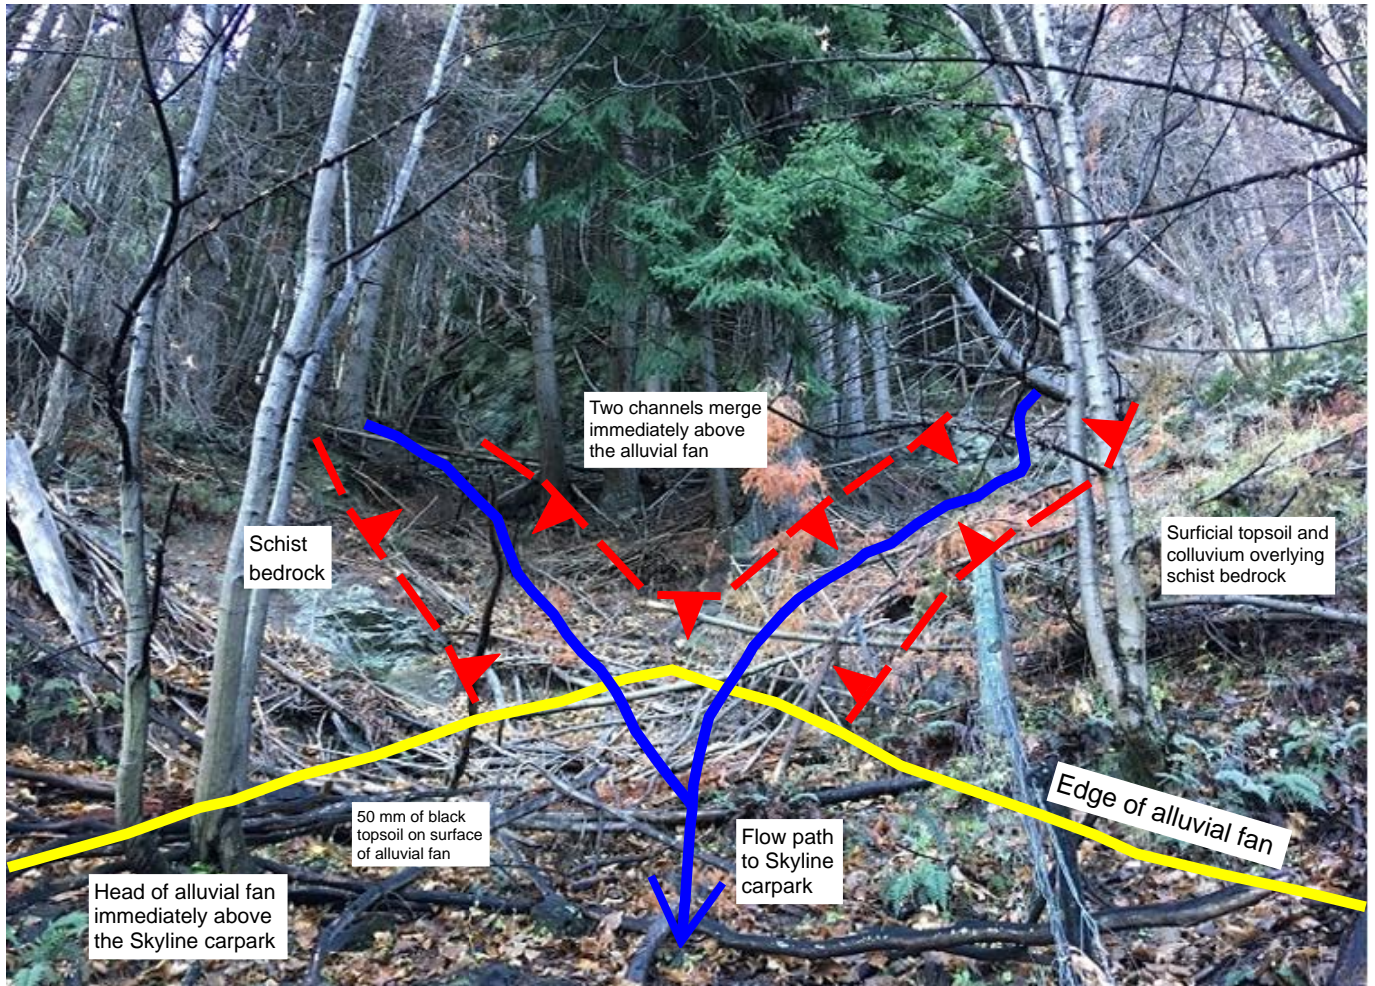
Photograph 10b. DL2 flow channel Section 10b. Two separate flow channels merge immediately upstream of an alluvial fan. The alluvial fan is positioned immediately above the existing Skyline carpark.

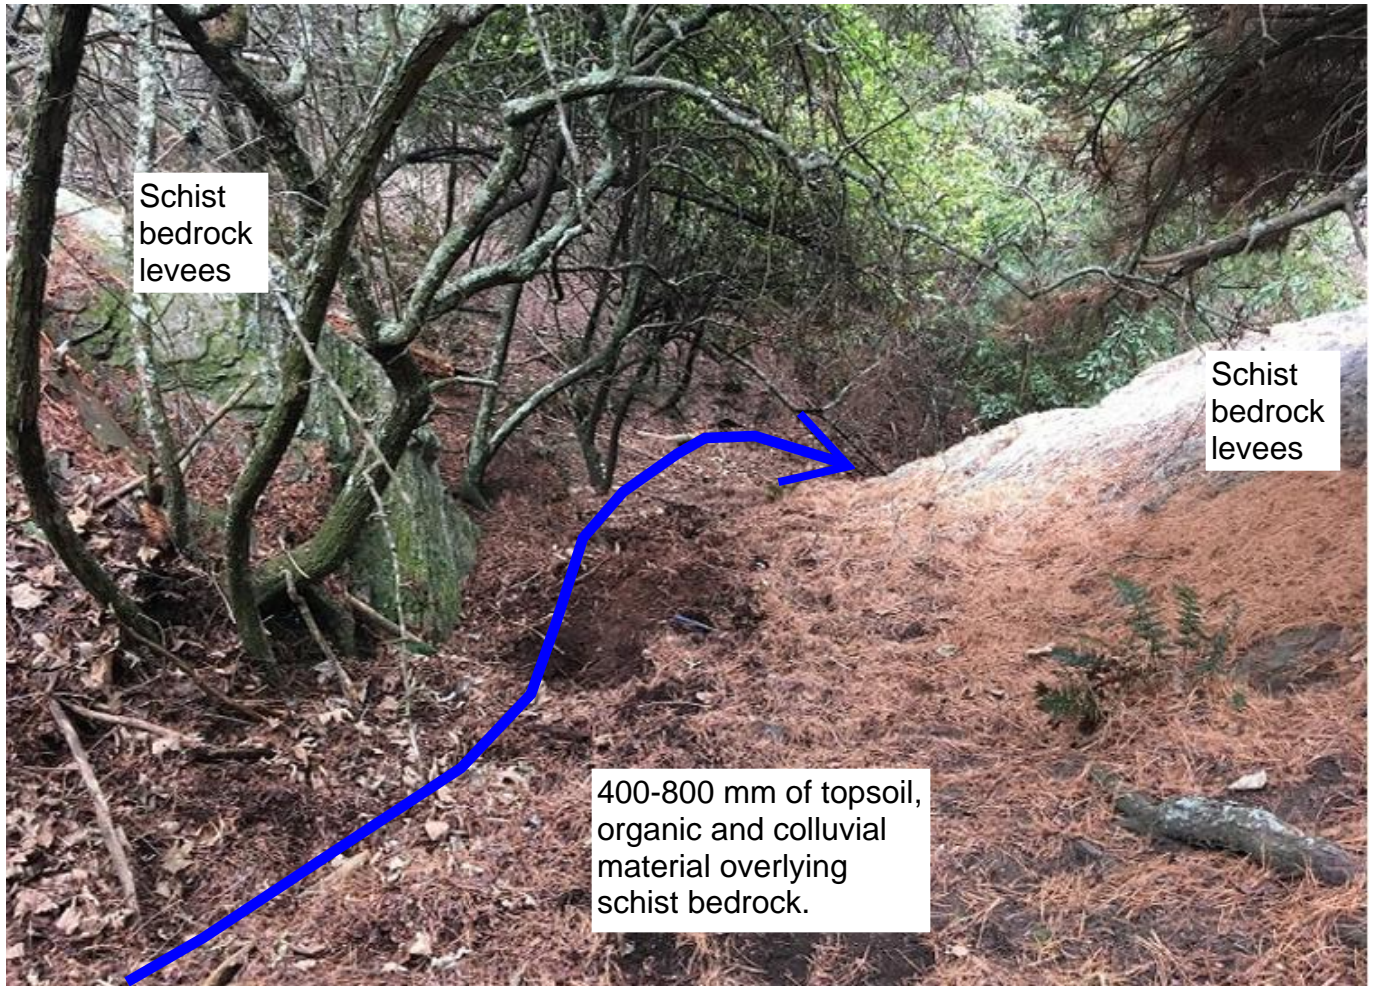
Photograph 11b. DL2 flow channel Section 11b. No evidence of recent scour erosion.

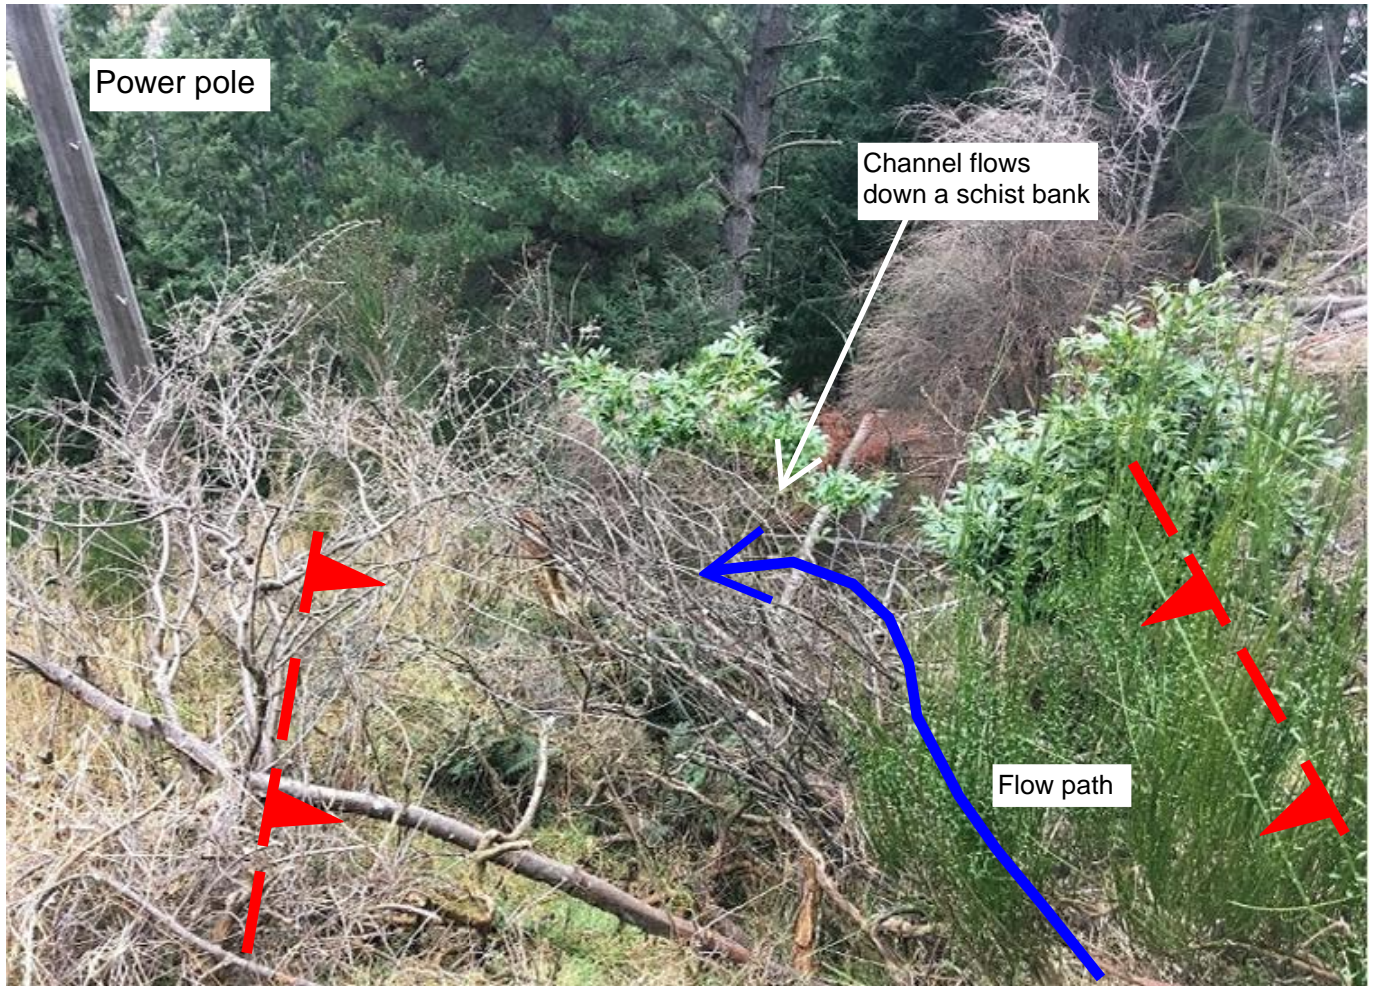
Photograph 12b. DL2 flow channel Section 12b. Channel bed is heavily vegetated in grass, fern and broom scrub.

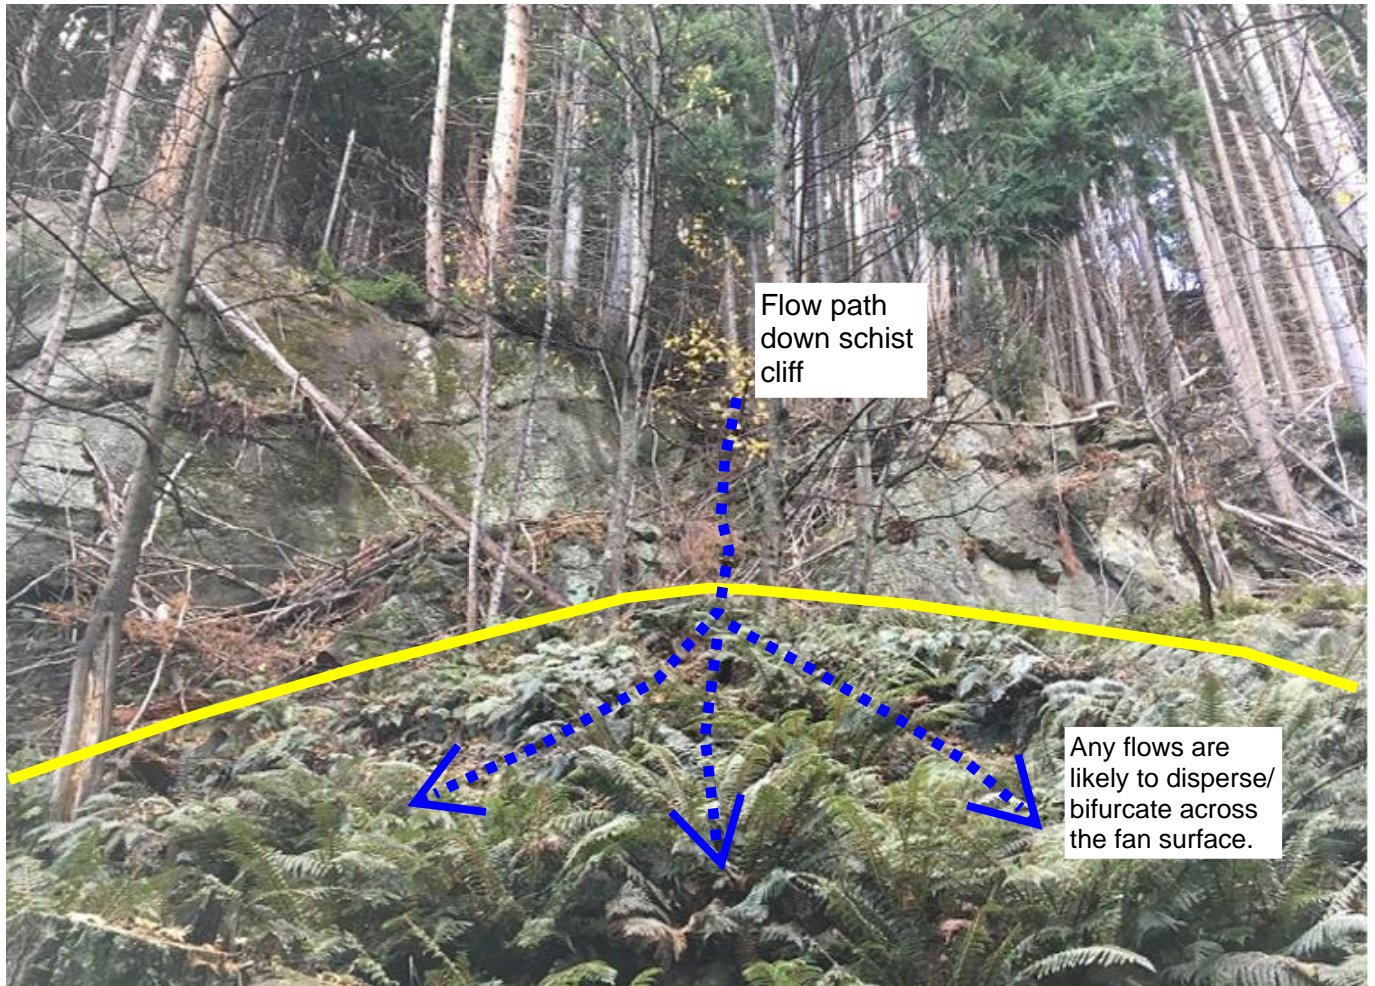
Photograph 16b. DL2 map area general photograph. Colluvial fan at the base of a schist bluff. The fan surface is densely vegetated in fern and there is no evidence of recent activity or erosion. Any flows coming down the cliff face at the head of the fan are likely to disperse/bifurcate across the fan surface. There is no defined channel.
