Skyline Enterprises Ltd
 Skyline Upgrade
 Stormwater Discharge - Detailed Hazard Assessment
 Aerial Summary Plan

Skyline Enterprises Ltd
 Skyline Upgrade
 Stormwater Discharge - Detailed Hazard Assessment
 Geomorphology Summary Plan

Skyline Enterprises Ltd	
Skyline Upgrade	
Stormwater Discharge - Detailed Hazard Assessment	
Detailed Geomorphology below DL1, northern/upper zone	
FIG No:	Figure 1d
REV.	1

Skyline Enterprises Ltd	
Skyline Upgrade	
Stormwater Discharge - Detailed Hazard Assessment	
DL1 Southern Flow Path Longsection	
FIG No:	Figure 2a
REV.	1

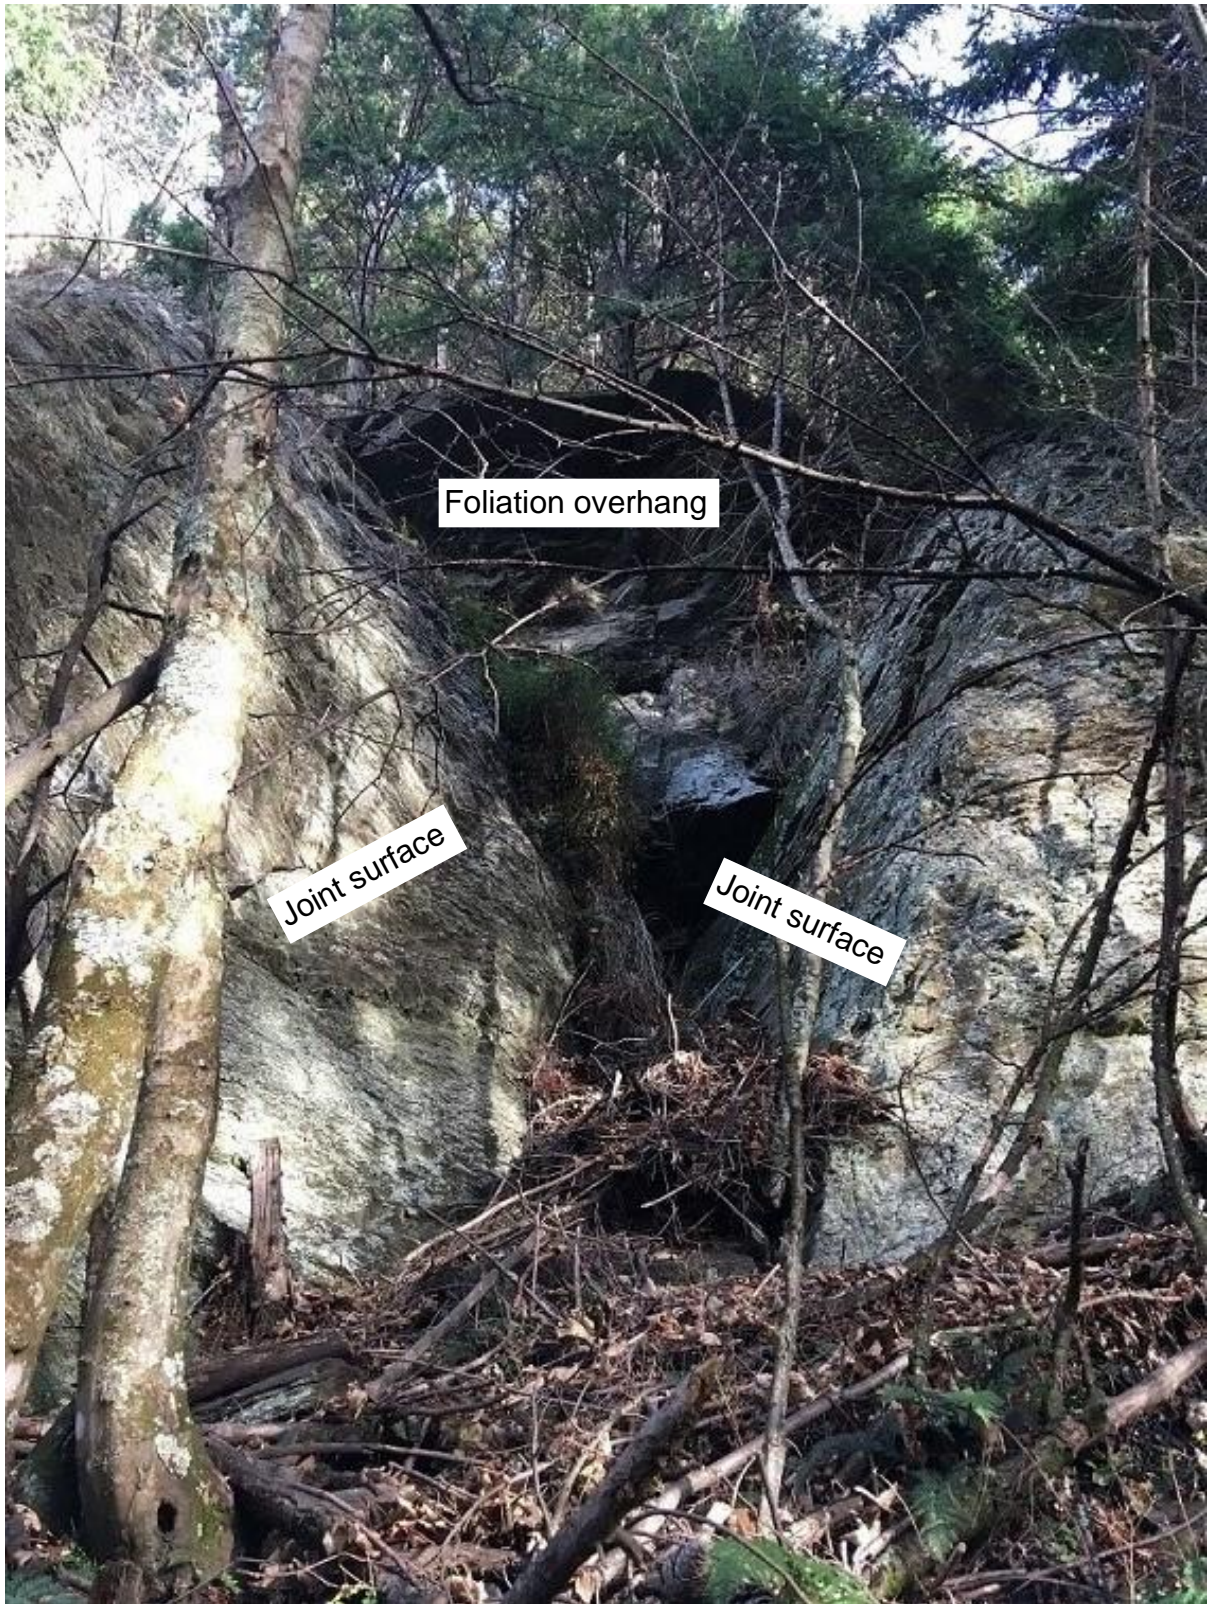
Photograph 17b. DL2 map area general photograph. Historic post glacial wedge failure in schist bluff.

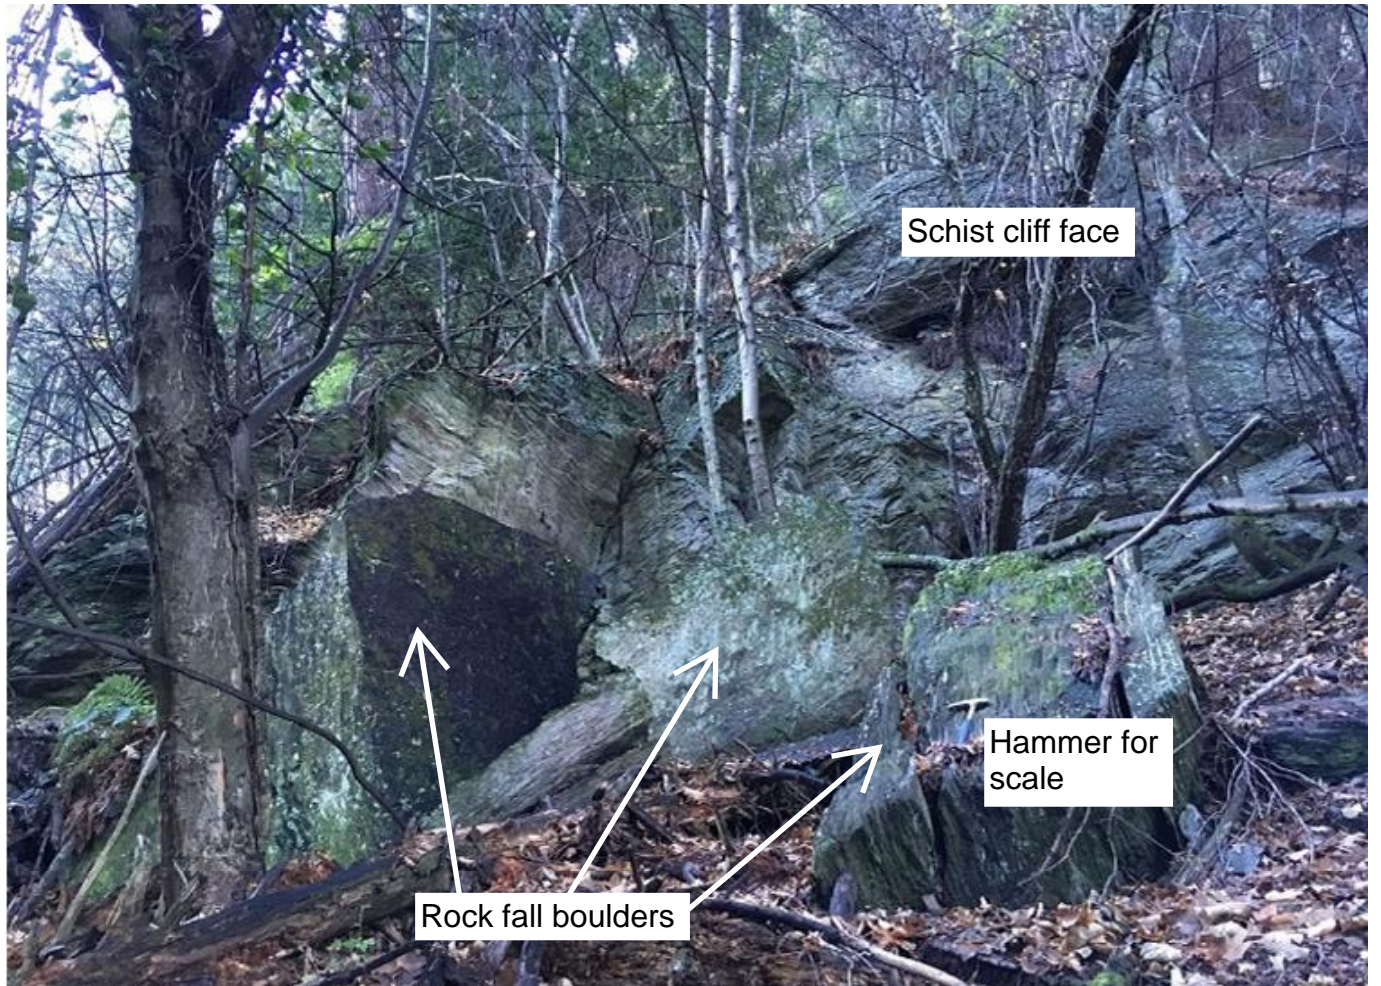
Photograph 19b. DL2 map area general photograph. Historic rock fall north of the existing Skyline carpark.

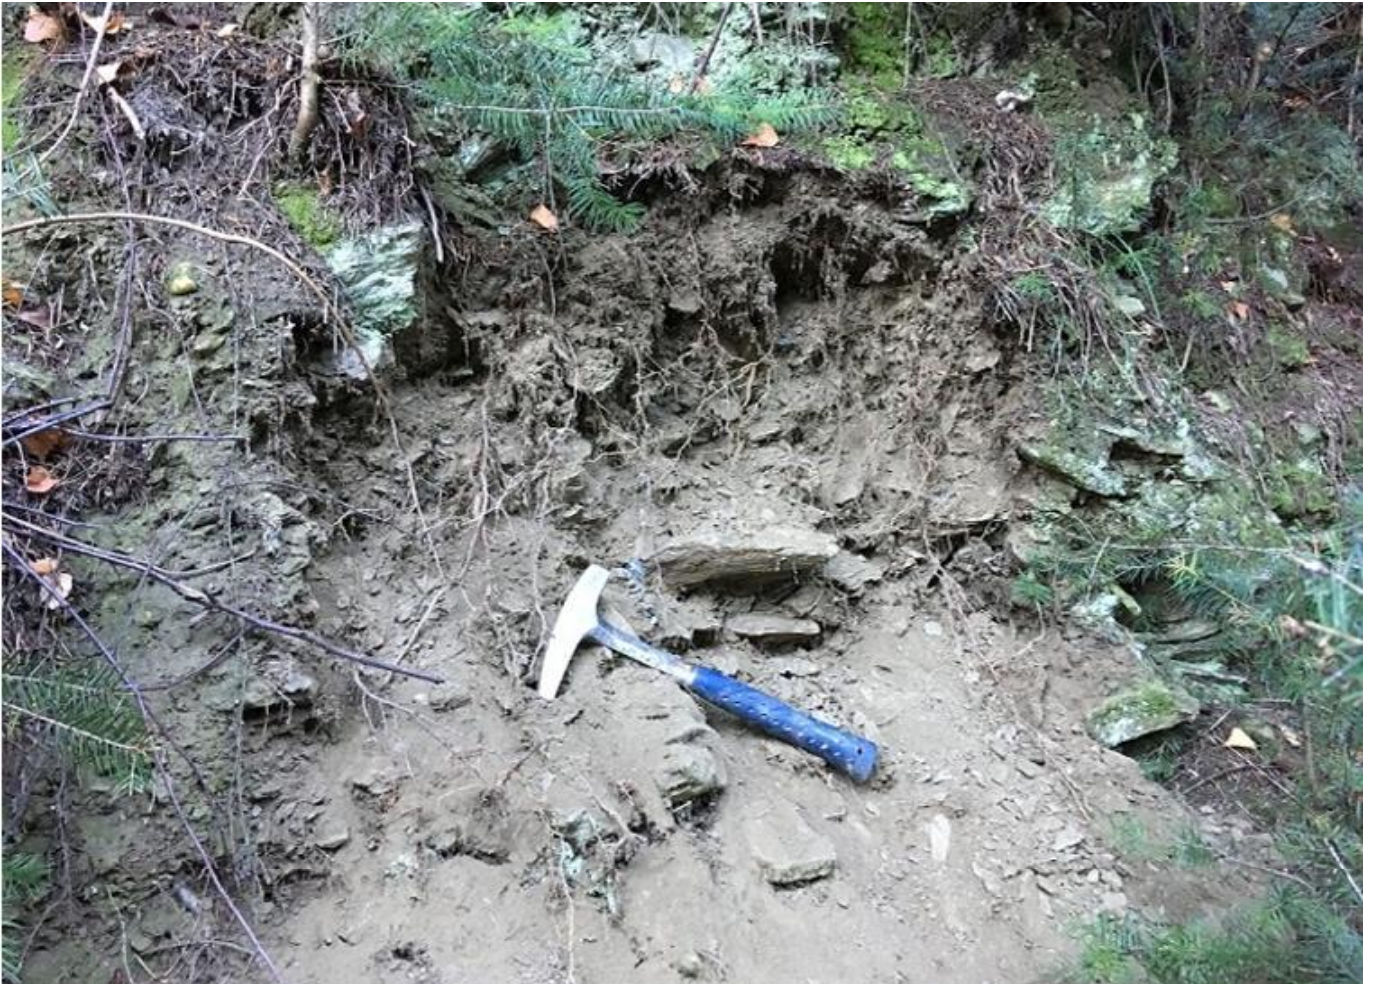
Photograph 20b. DL2 map area general photograph. Alluvial fan sediment exposed in excavated batter cuts above the existing Skyline carpark. Hammer for scale. Soils comprise silty sandy GRAVEL with minor to some cobbles and boulders.

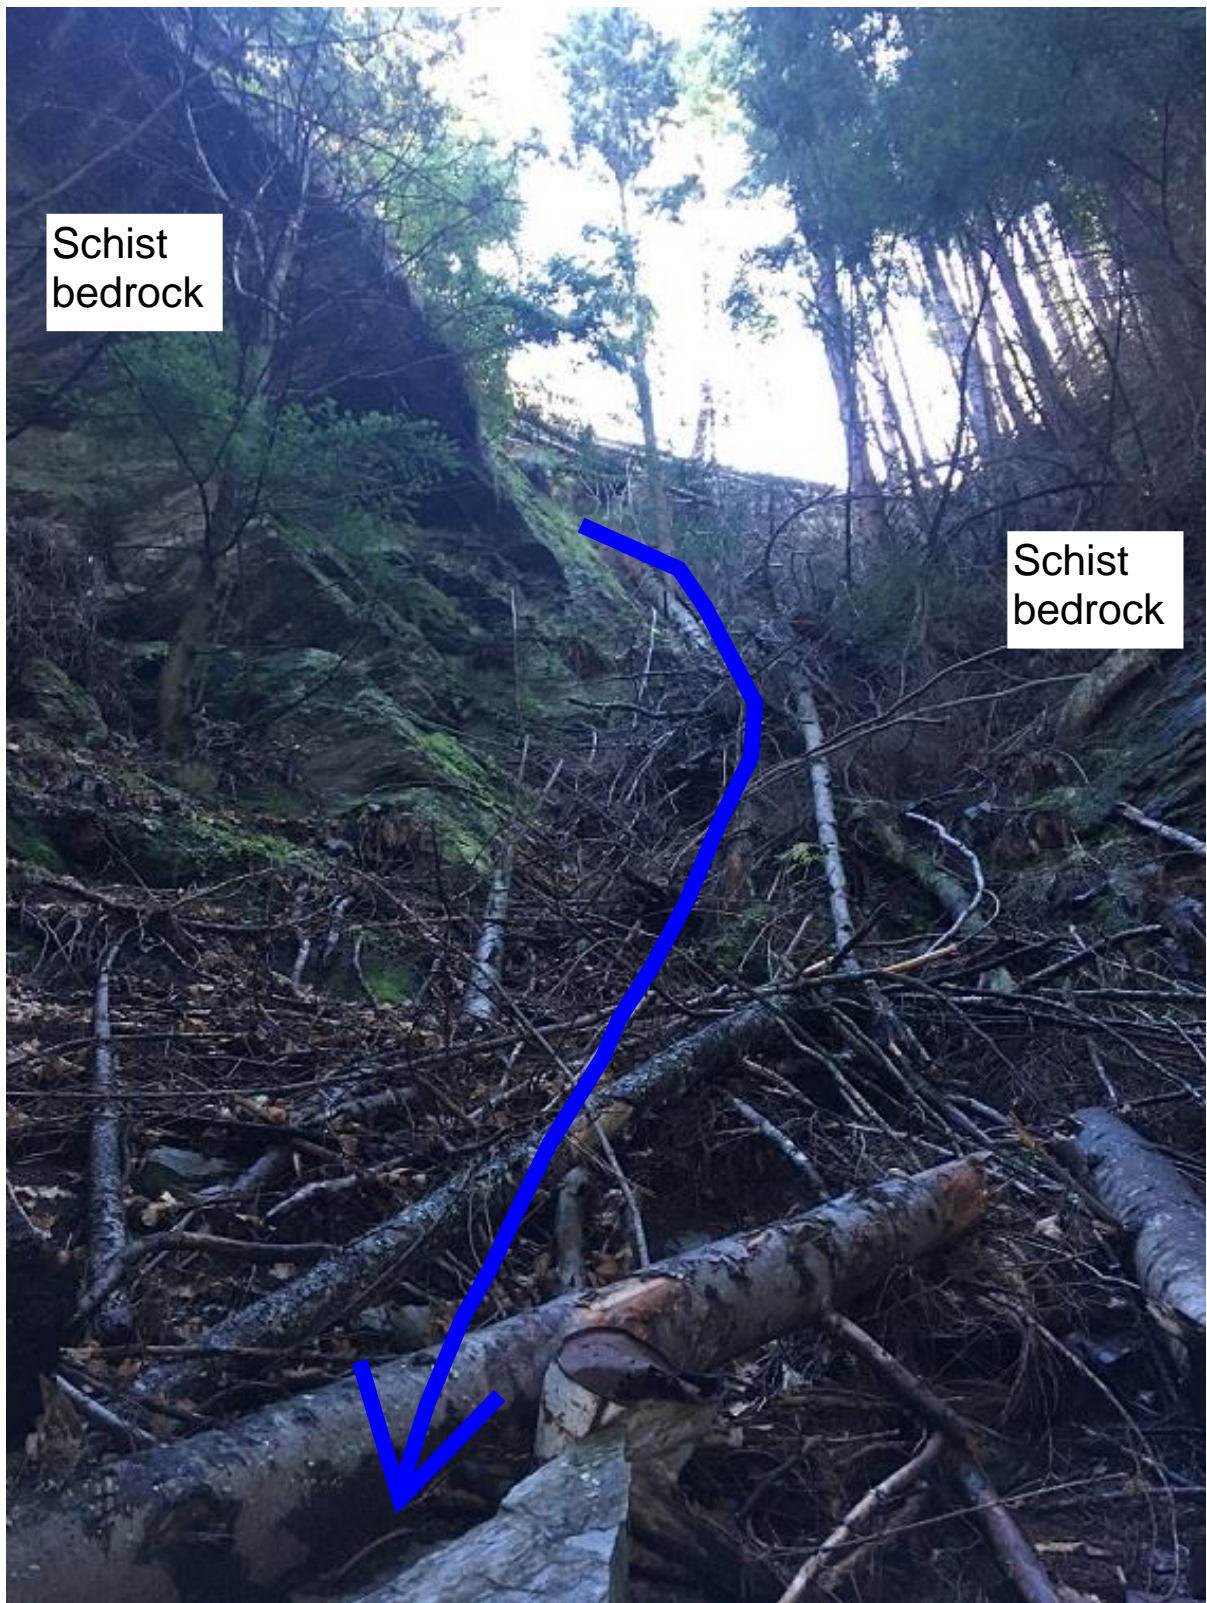
Photograph 21b. DL2 map area general photograph. Channel bed within the schist bluff system immediately below the Skyline stormwater outlet. Active stormwater seepage could be observed seeping down the cliff face to the left of image.

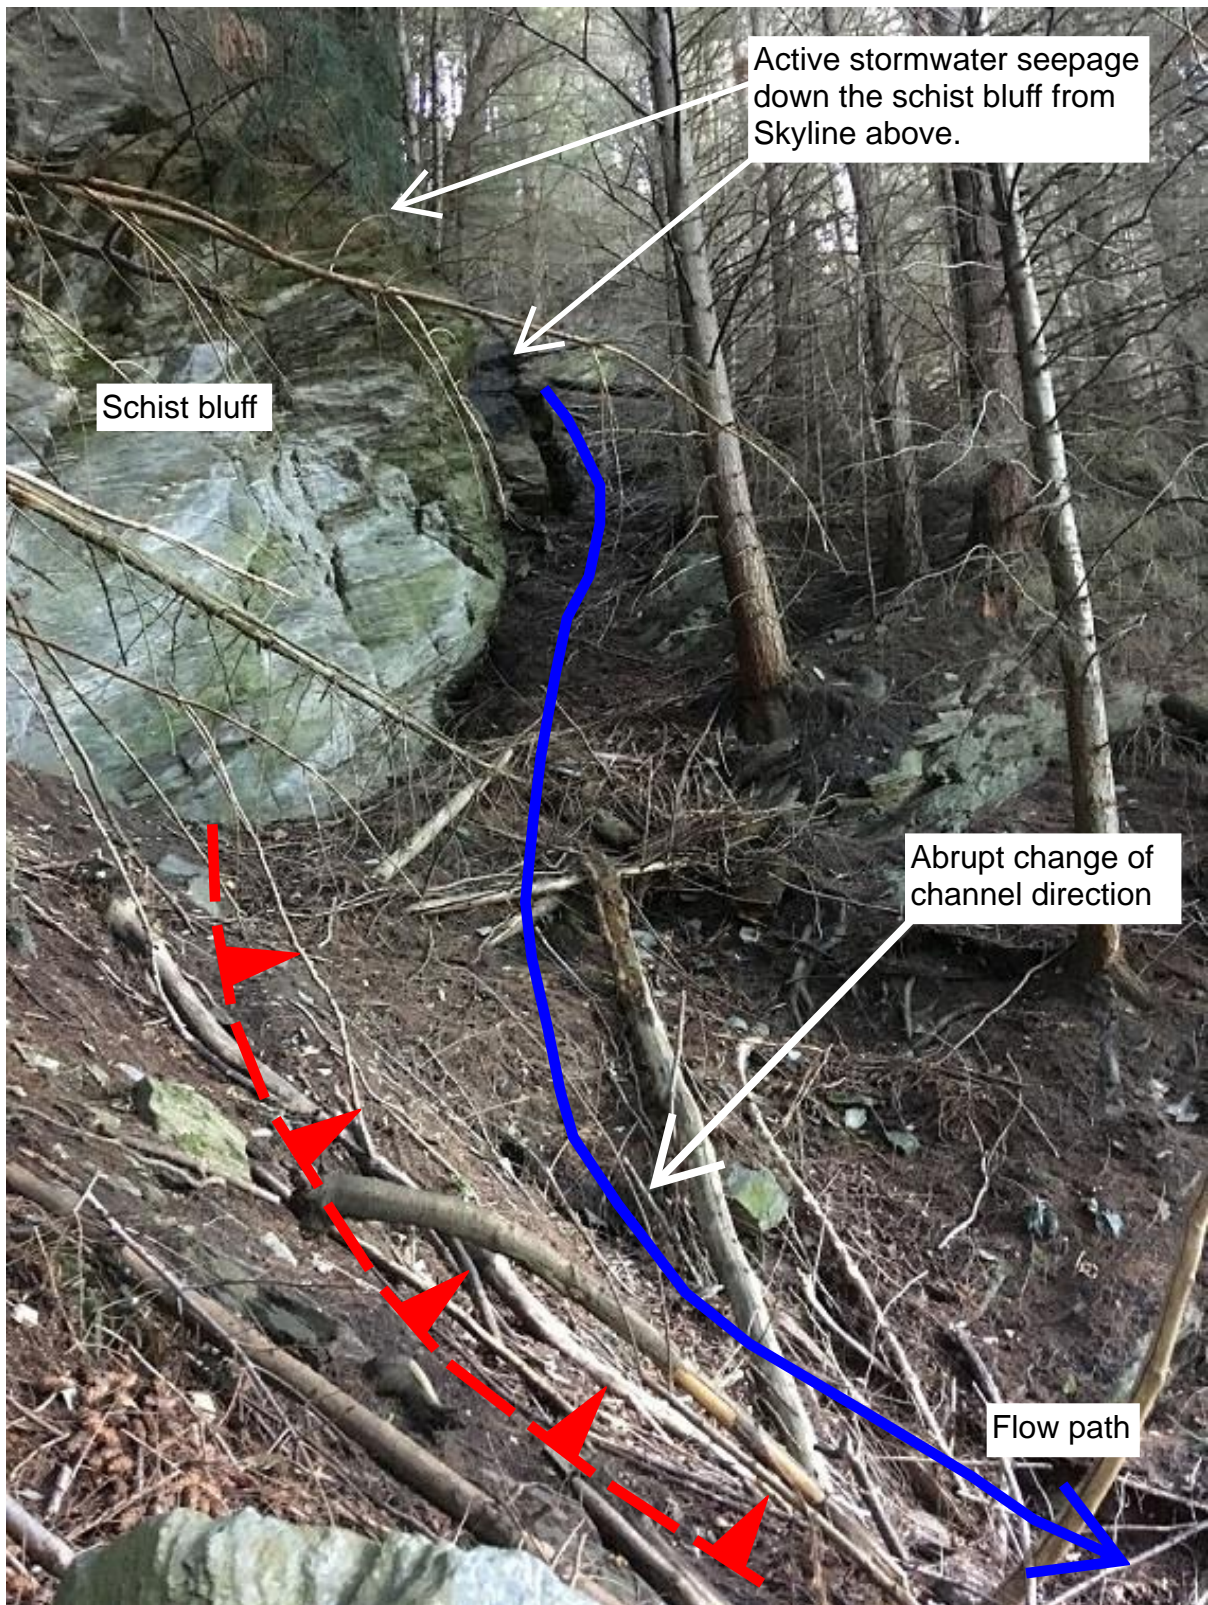
Photograph 22b. DL2 map area general photograph. Channel leaves the schist bluff system immediately below the Skyline stormwater outlet.
