LCLR MINOR WORKS BUTLERS GREEN RETAINING WALL REMEDICATION

C-19-047

BUTLERS GREEN
RETAINING WALL REMEDIATION OPTIONS

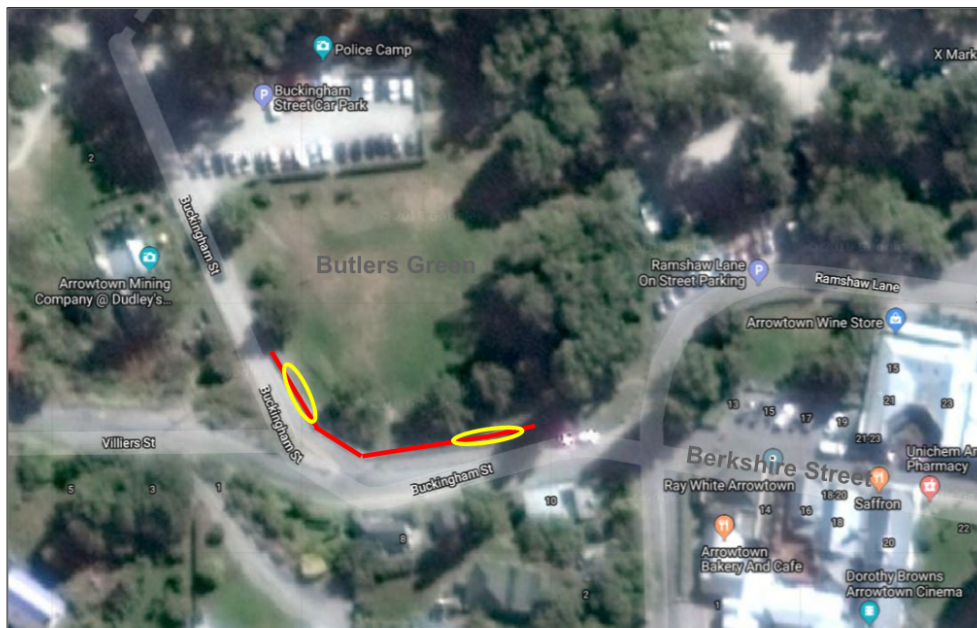
The Butlers Green wall has two bulging sections with a deflection of approximately 600 mm. This deflection has resulted in cracking of some stones and loss of stones in some areas. Aside from these two failures, much of the remainder of the wall is deformed or settling.

Figure 1 – Location Plan (wall marked in red, primary bulging areas marked in yellow)

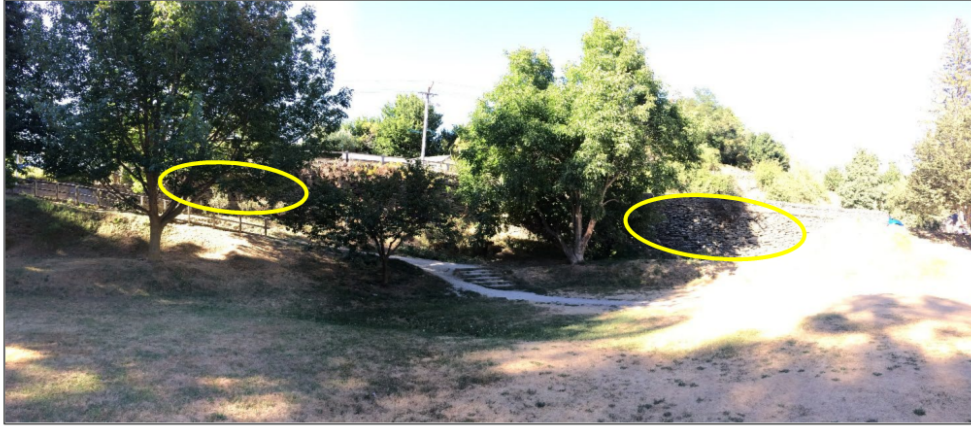
These failures are likely to have occurred as a result of saturated soil behind the wall due to heavy rainfall events or services leaks. When the wall becomes saturated, soil shear strength is reduced and increases active pressure behind the facing. Sudden collapse of the wall is increasingly likely with subsequent saturation of soils and/or if subject to earthquake loading.

Figure 2 – The Retaining Wall viewed from Butlers Green, bulging areas marked in yellow

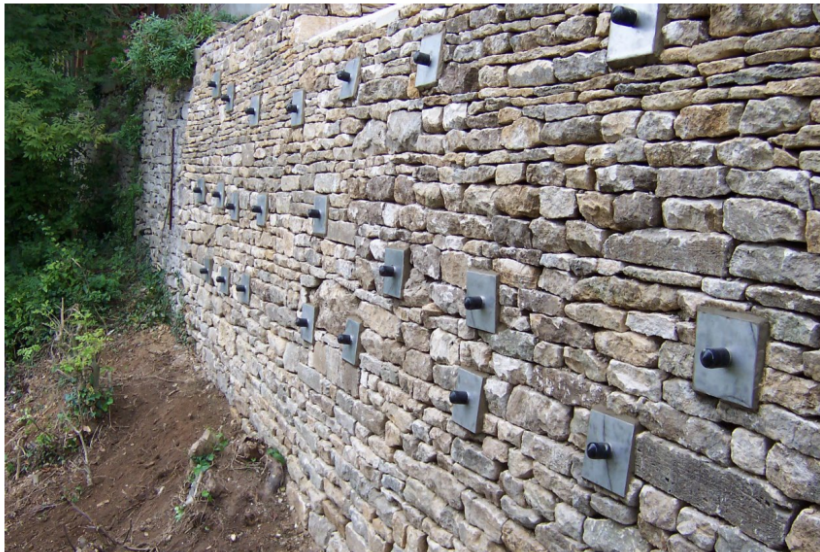
Figure 3 – Closely spaced self-drilling anchors with small plates

This option involves the use of self-drilling anchors drilled through the wall facing and anchored behind the moving soil block. To capture the facing, pattress plates (steel washers) would be placed over the ends of the anchors. The pattress plates could have a rustic appearance to be sympathetic to the structure. We have assumed a generic "X" shape in our concept sketches, though a quick google search reveals extensive pattress plate options.

We anticipate that the anchors would be placed in several rows with higher concentrations at the least stable areas. There is likely to be a design trade-off between the pattress plate size and the spacing of the anchors. Detailed design is required to determine the optimal spacing for facing retention vs slope stability.
