Memorandum

To	Ben Greenwood
Copy	Rob Bond
From	Paul Jaquin
Office	Queenstown
Date	23 January 2020
File	
Subject	Meads Road

Damage has occurred to Meads Road around the 17th December 2019, to east of the Bee Burn stream and alluvial fan, below Peak AA9B, and to the west of the Terrace Stream Fan.

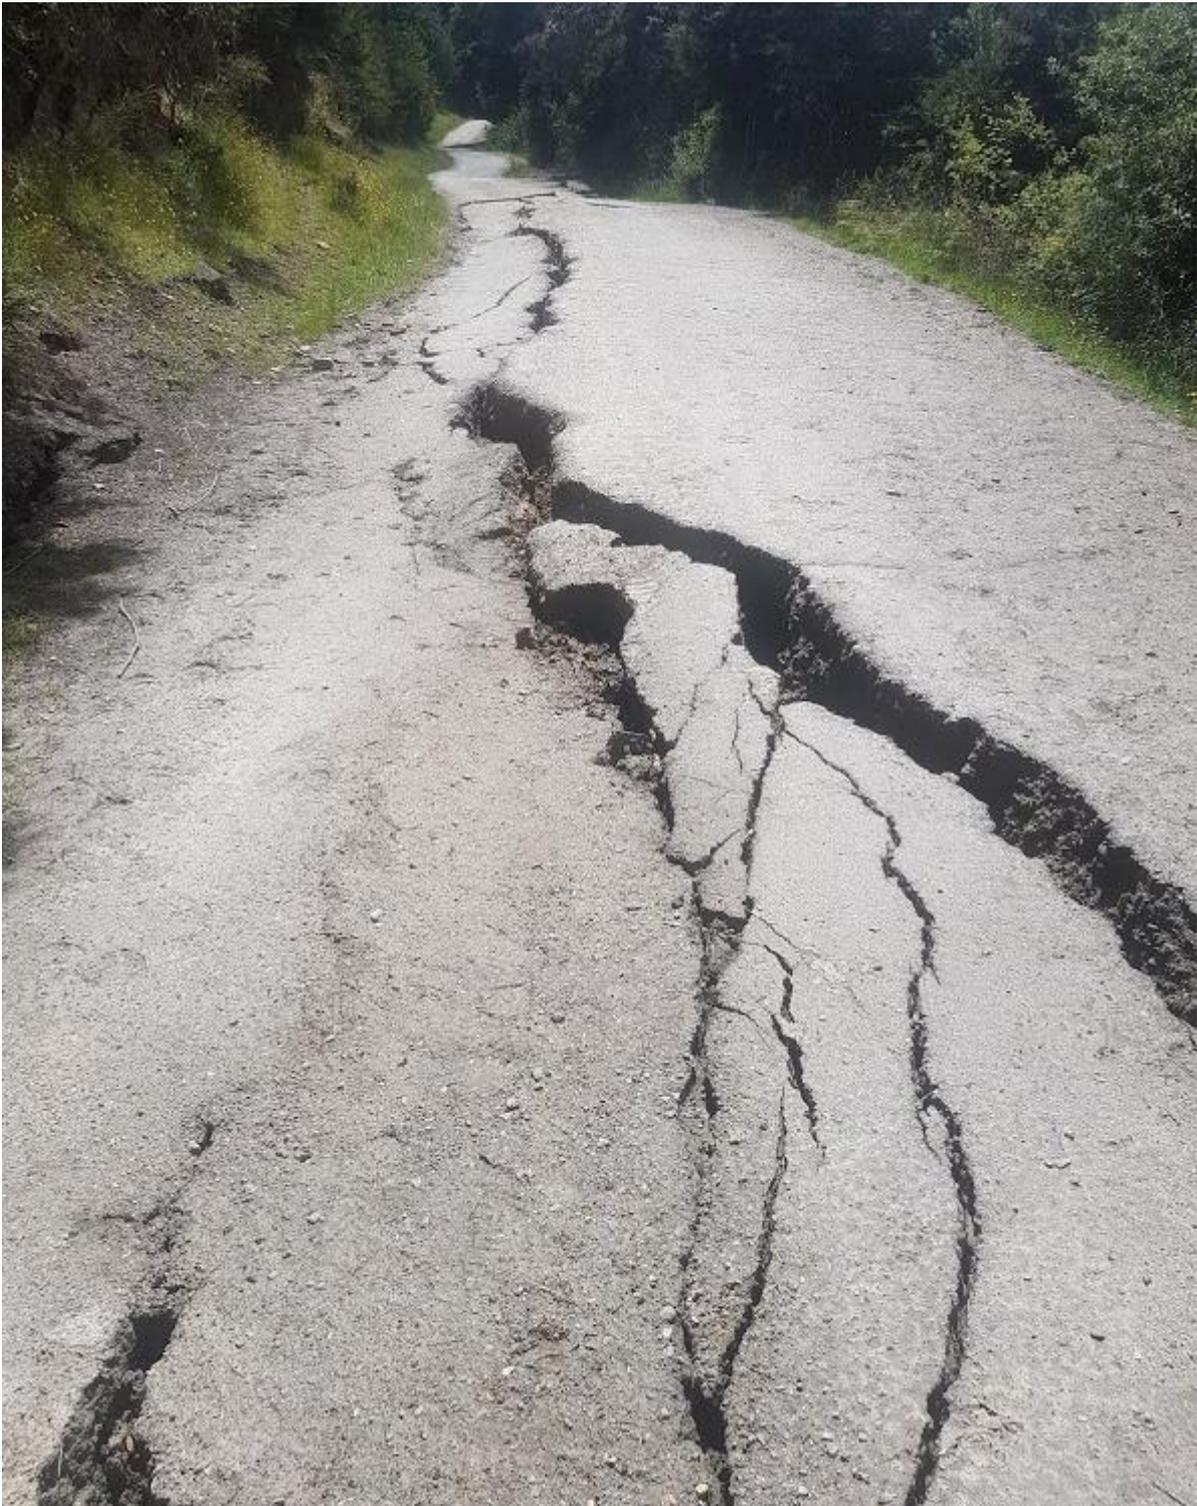
Hair line cracking in the road appeared a week or so prior, and were gradually increasing in size. The length of the crack is approximately 60m, and at the time of the visit the vertical displacement was approximately 150 – 200mm.

The cracking appears to be in the form of a slip circle headscarp, with the cracking across the whole width of the road, and some movement into the up slope area.

The slip appears to be a deep seated rotational failure through the Holocene Fan deposits. A number of slip surfaces may have formed, meaning a rigid scallop shaped block of soil has rotated. This has manifested itself as a series of headscarp cracks at road level.

Photograph 1 - Looking east at the headscarps

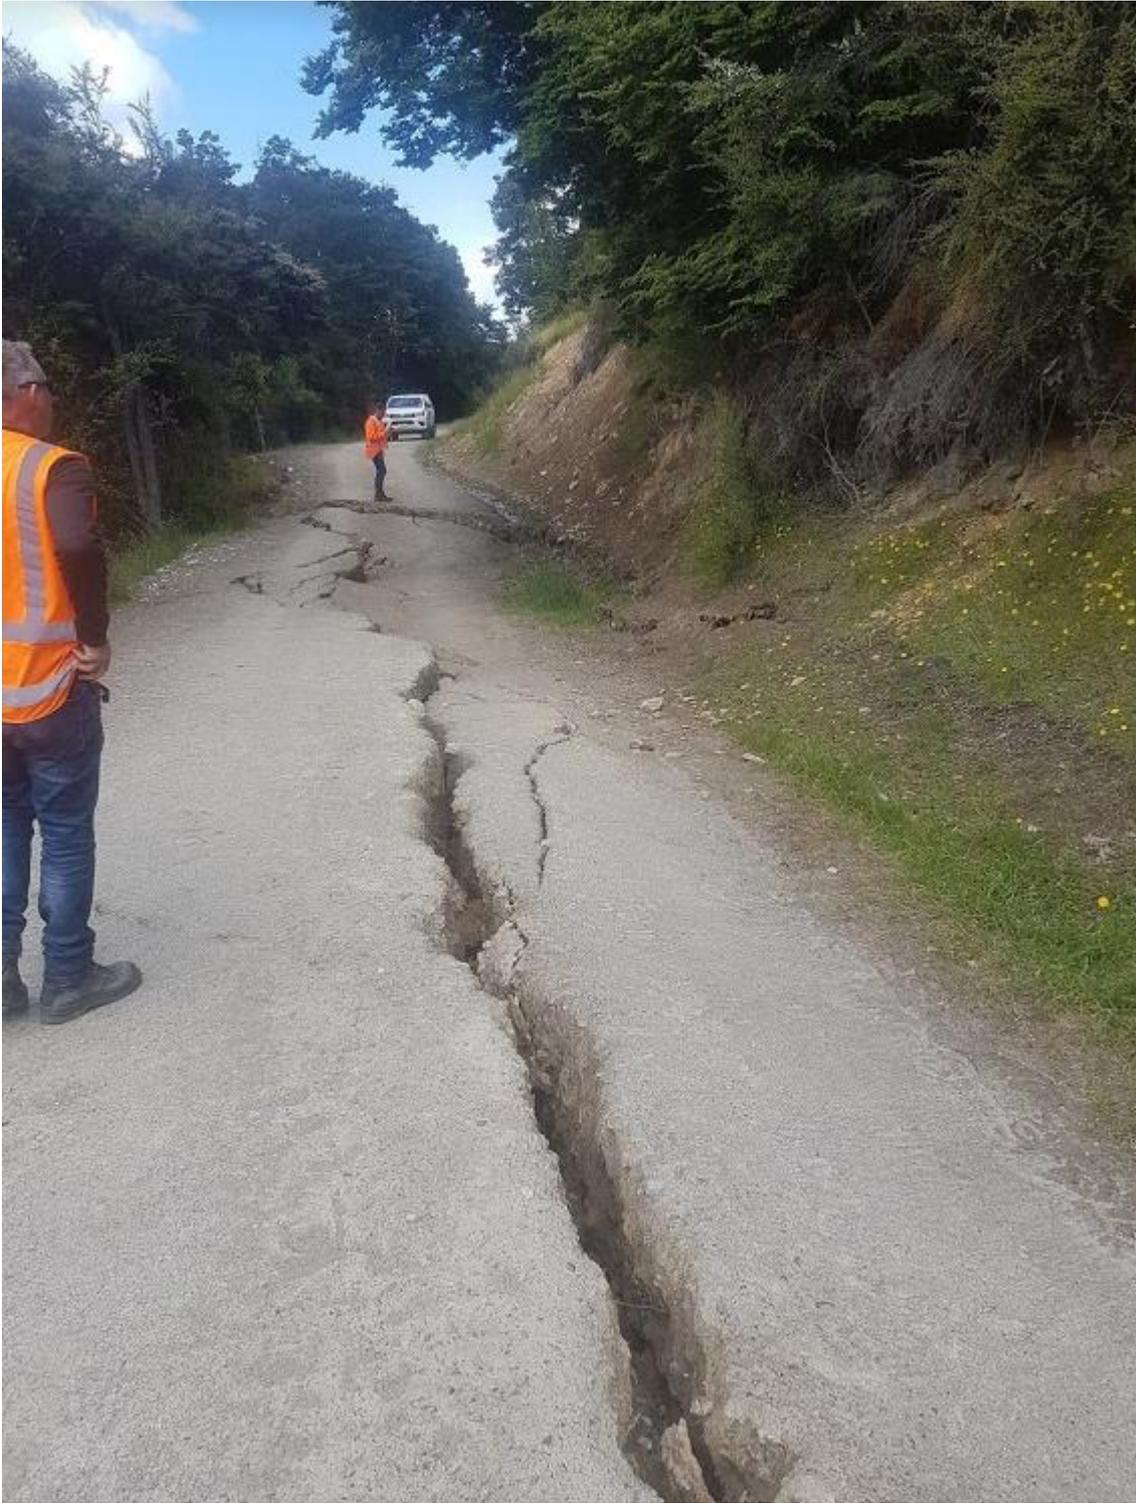
Photograph 2 - Looking west from the slip

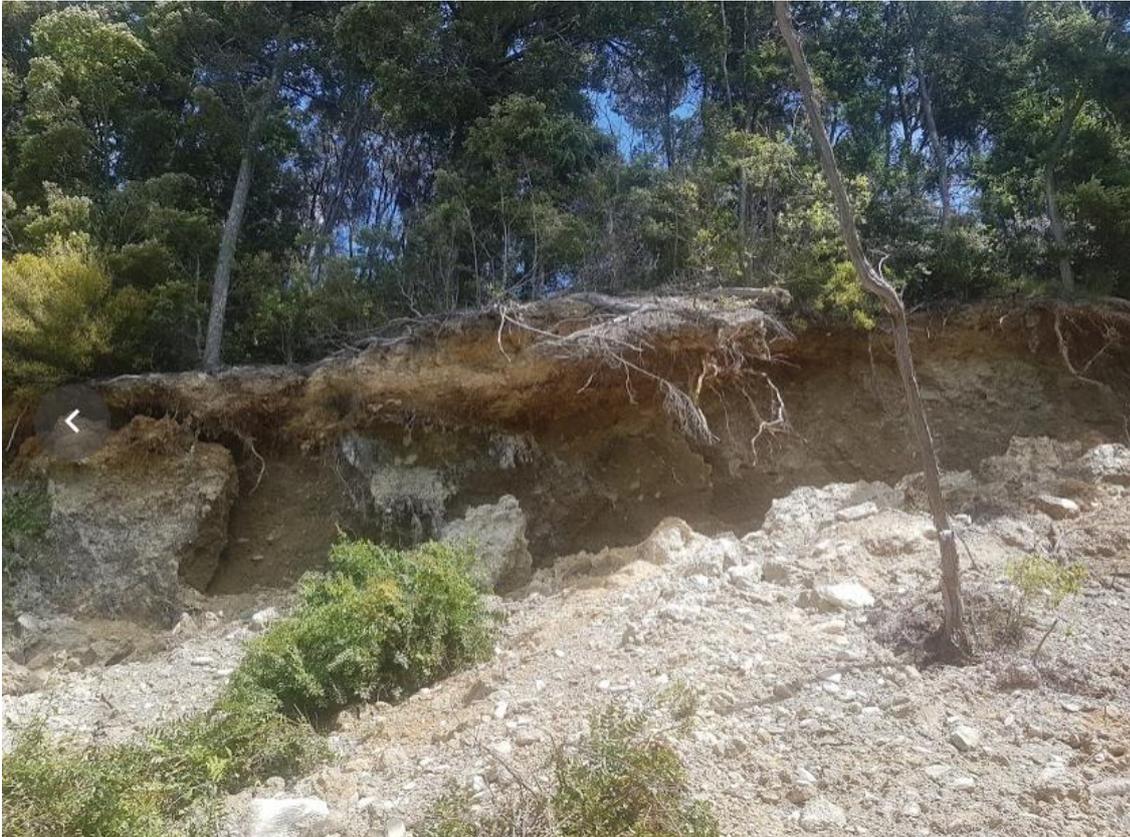
Wave action on the lake may also have contributed to the removal of material in the vicinity of the base of the slope, compounded by the high water levels at this time

Photograph 3 - The area below the slip, with some washed out material

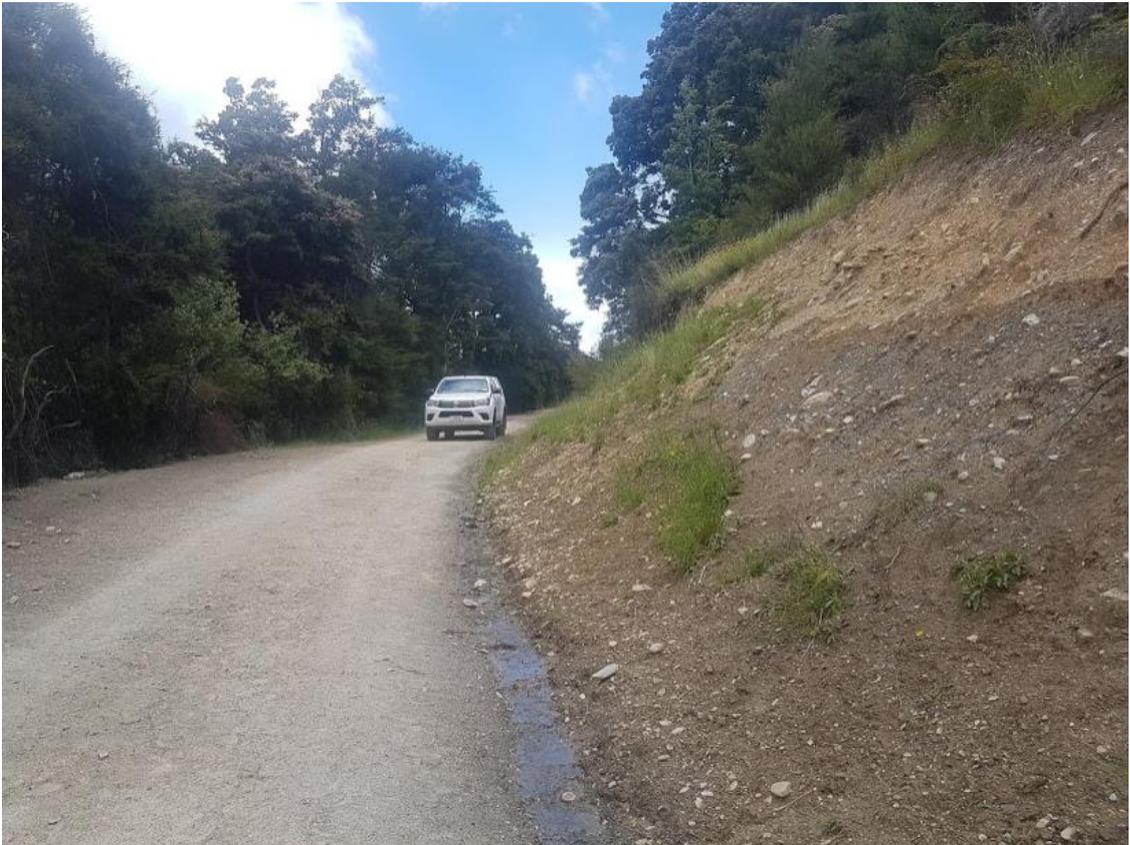
Photograph 4 - Looking west from the slip

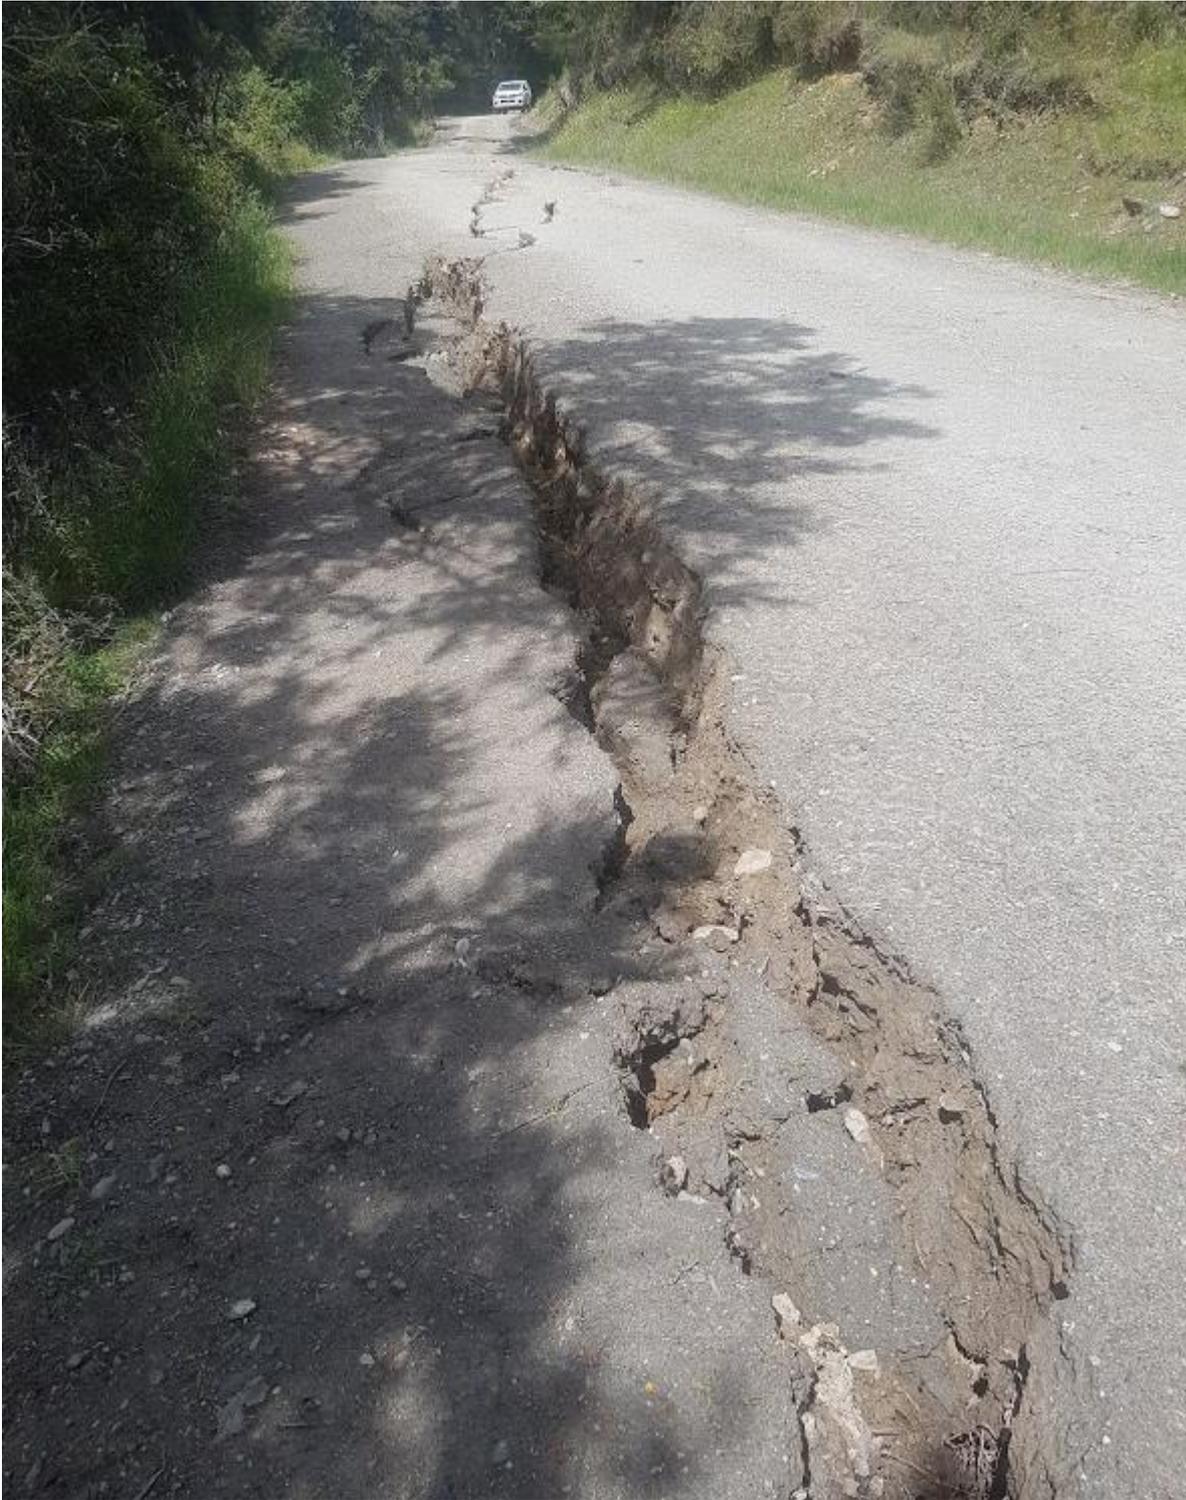
Photograph 5 - Looking west from the slip

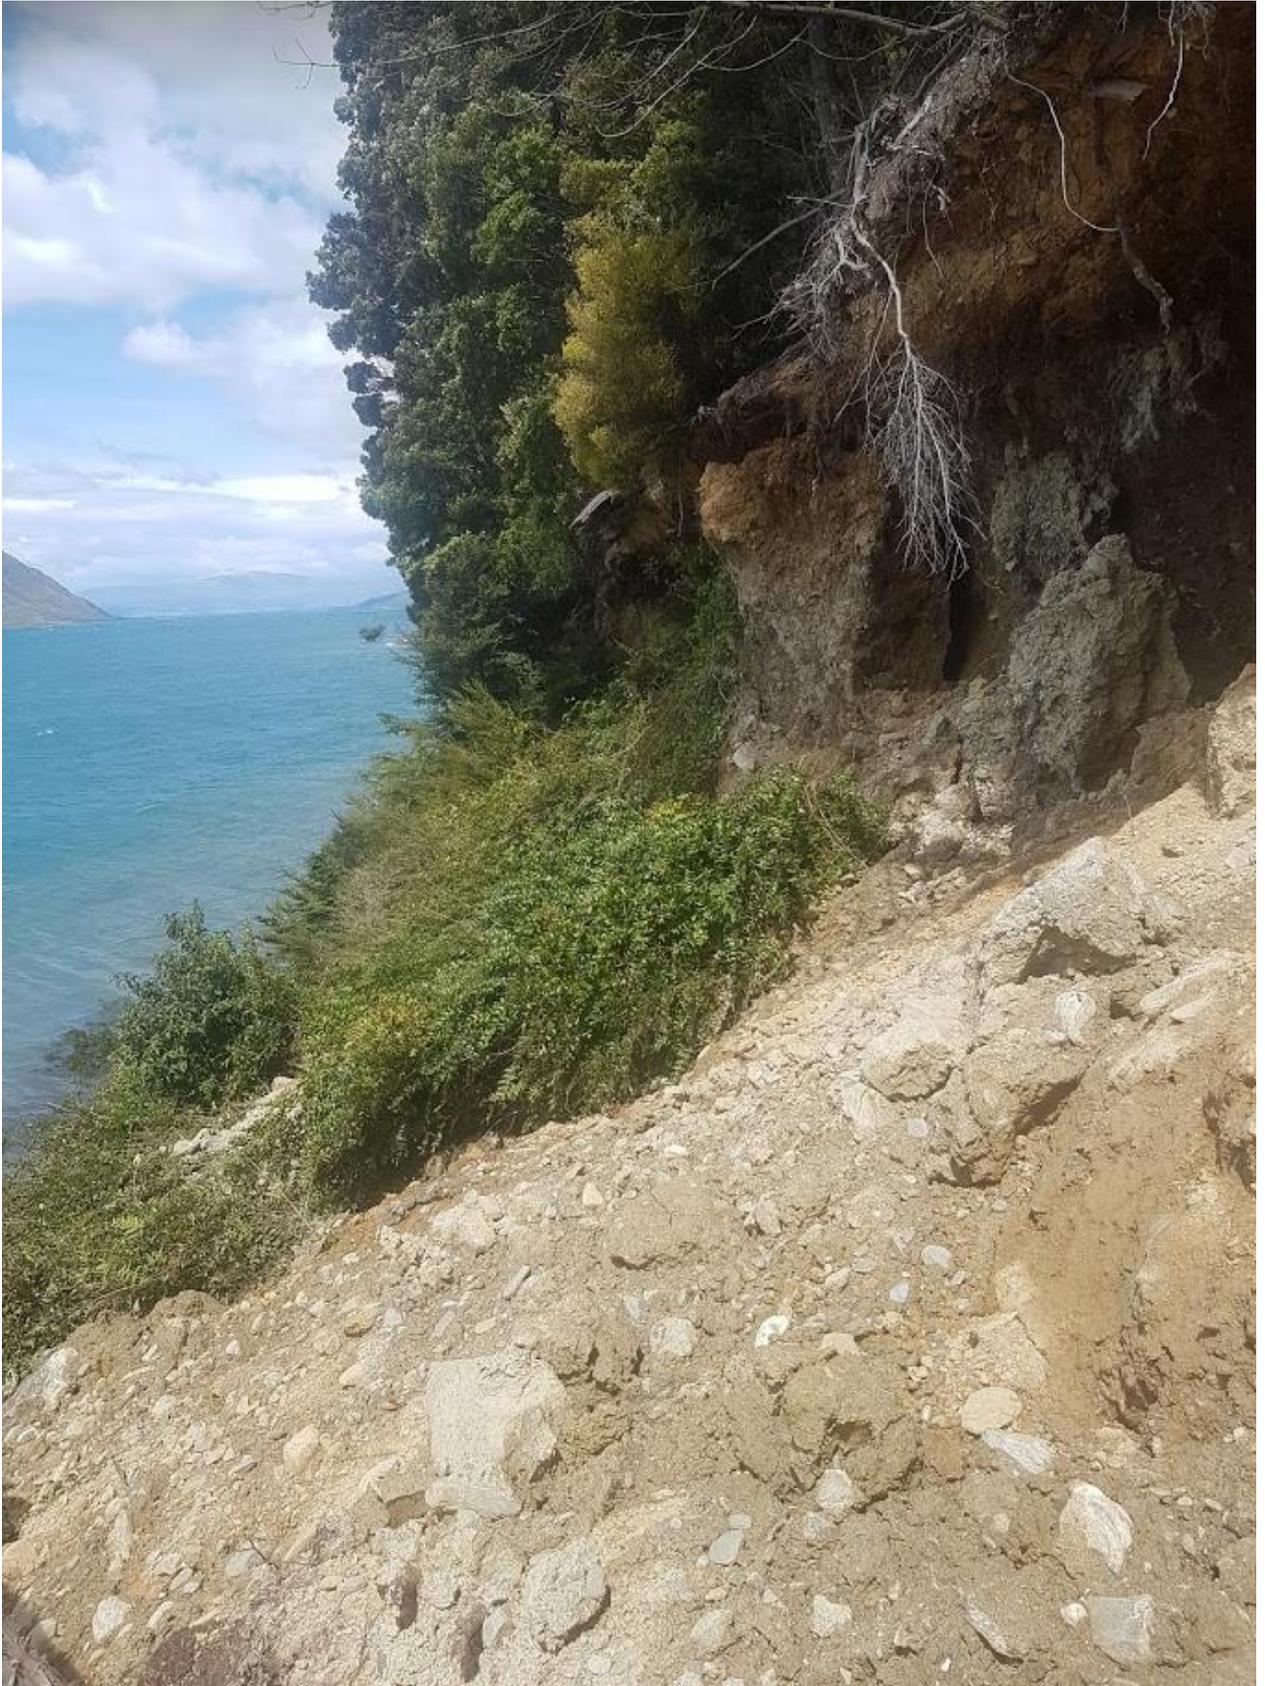
Photograph 6 - Below the slip to the lake
