Appendix B: Earthworks and Geomorphic Plan

Skyline Enterprises Ltd
 Skyline Debris Removal
 Access Track
 Geomorphology Plan A

Skyline Gondola Corridor, Queenstown Tree Removal Natural Hazard Assessment

Stormwater Discharge – Detailed Hazard Assessment

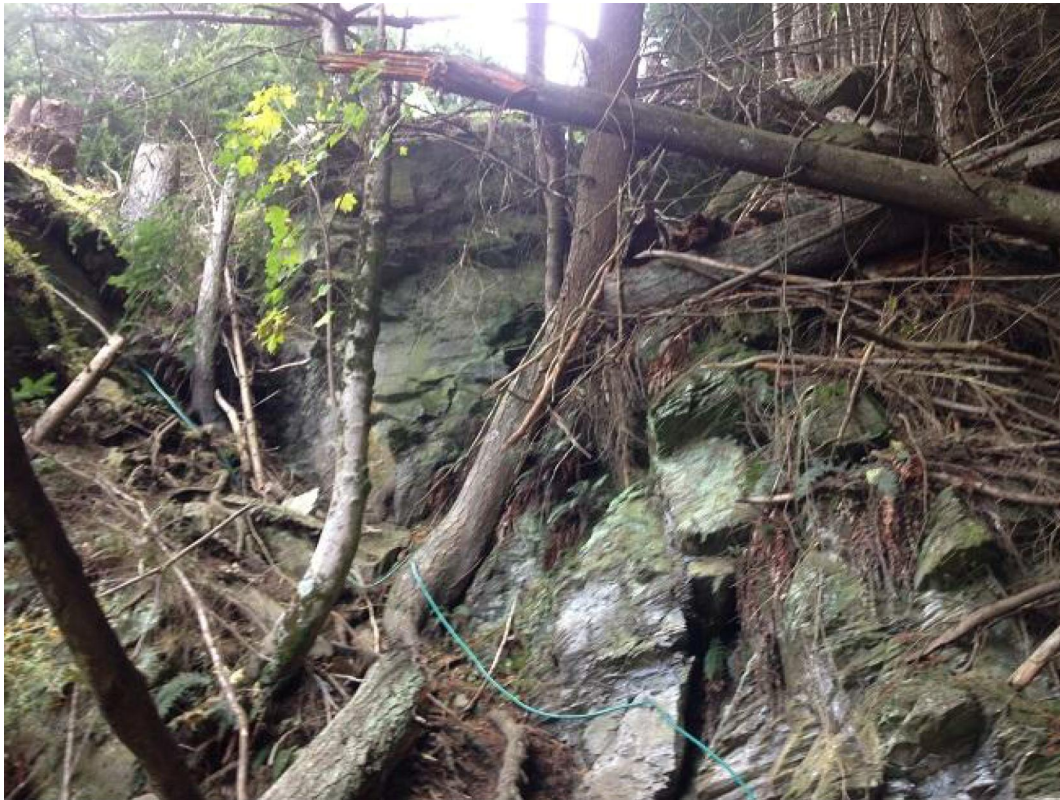
The bluffs often extend through the corridor and into the forested areas on either side. The trees are frequently present immediately at the crest of the bluffs in these areas, and in several cases the root systems extend over the crest and/or are present in open cracks within the rock mass (See photograph 1).

Photograph 1 Area of bluff with defects affected by root growth

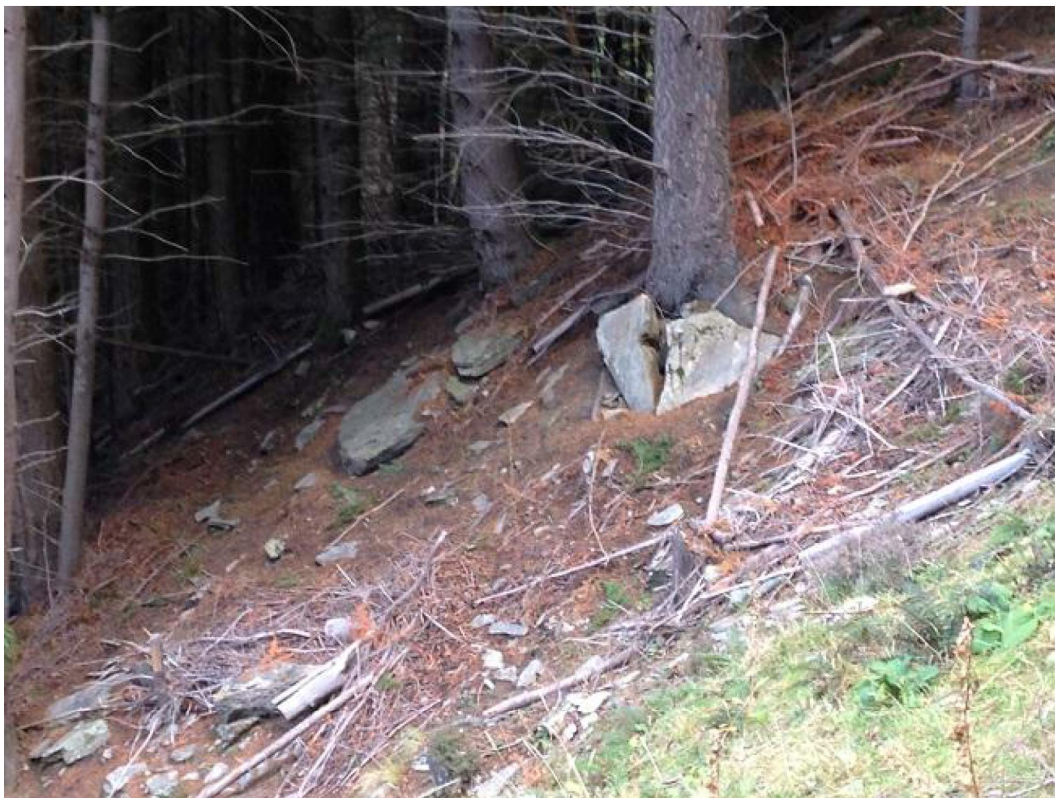
Photograph 2 Area showing dense forest with thin soils and surface boulders, Typical of Area Type A.

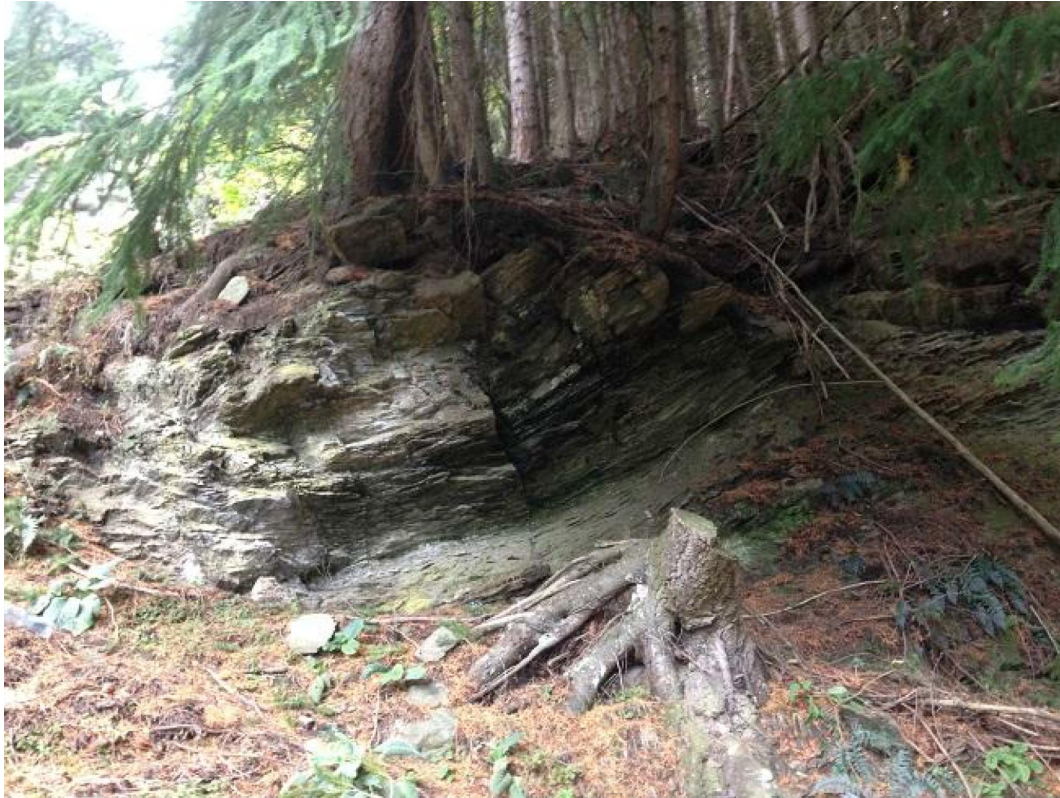
The schist bedrock was typically quartz rich with a persistent planar foliation dipping at 15-25° towards the South West (oblique to the Hillside). Persistent sub-vertical defects, with orientations typically oblique to the bluff faces, are widespread with spacing's generally of 1 to 5m, however, locally areas with closely spaced defects were observed. The rock mass is generally un-weathered to slightly weathered, however pockets of moderate weathering were observed in areas with close defect spacing (see Photograph 3).

Photograph 3 Low bluff showing closely spaced defects, moderate weathering along defect surfaces, root growth penetration, and potential for small block fall from the crest.

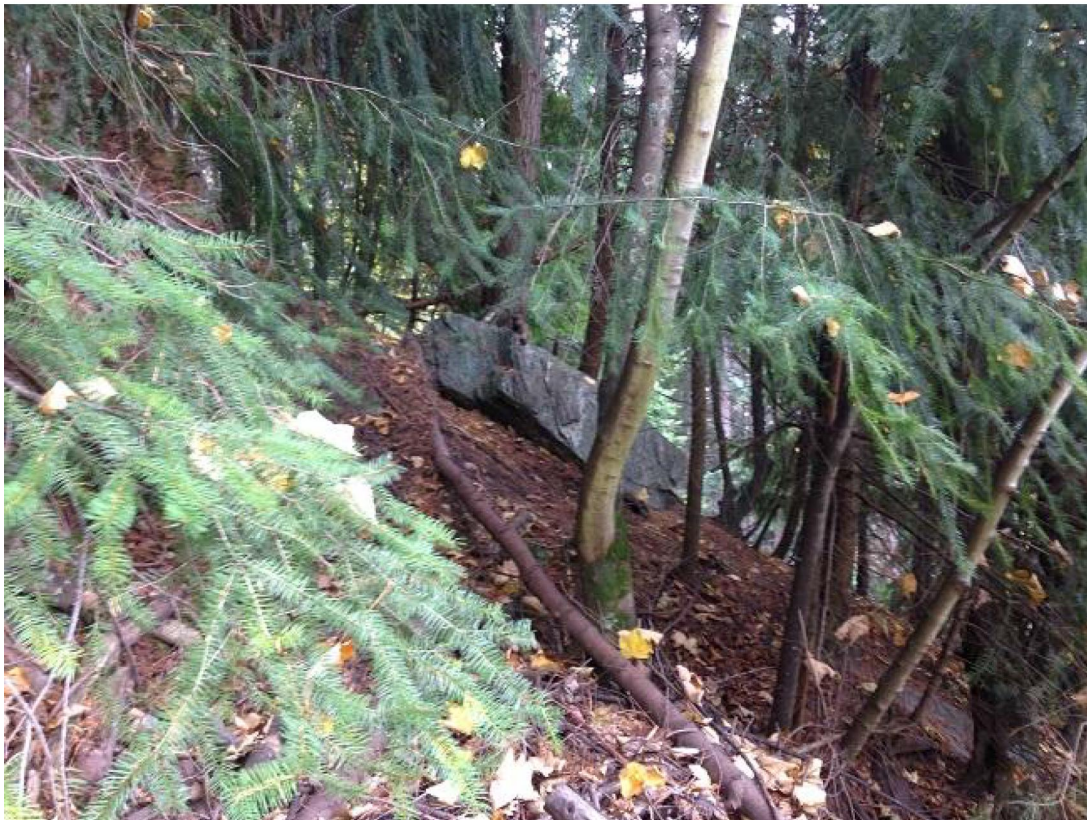
Photograph 4 Recent failed block, approximately 1.0m in length, present in the trees immediately adjacent to the gondola corridor.

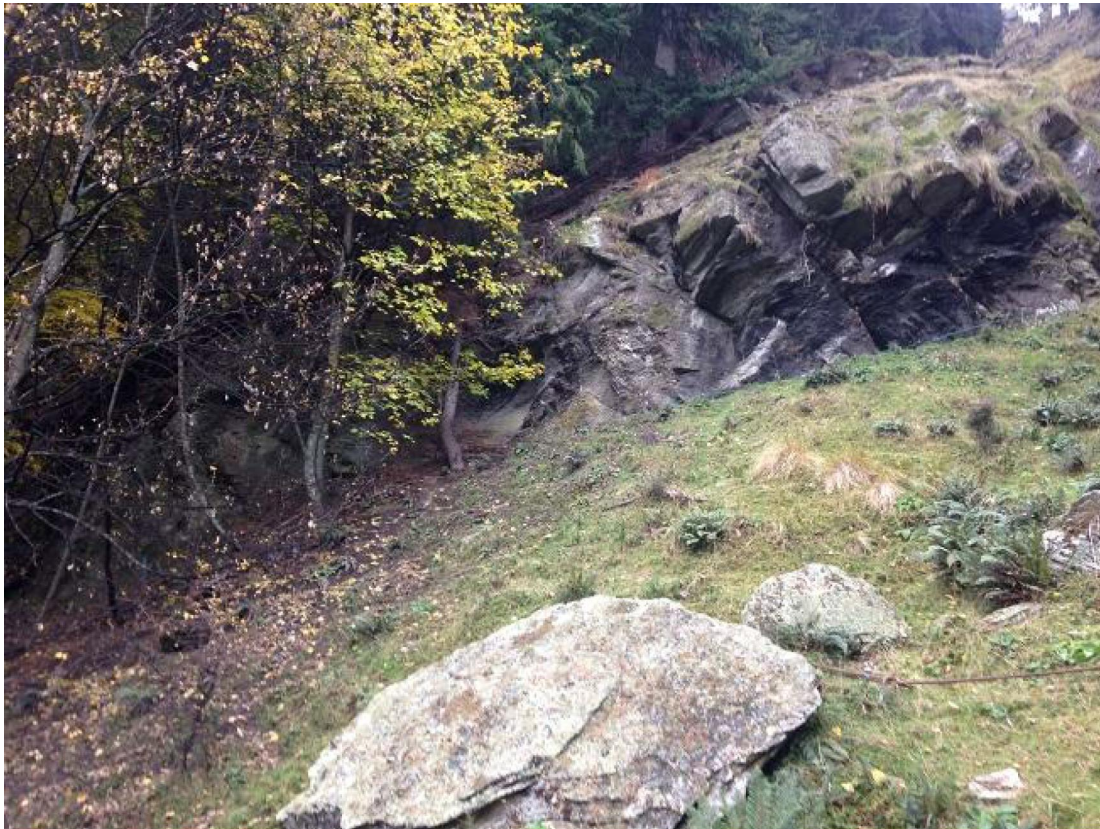
Photograph 5 Failed block beneath a major bluff. Prominent defects can be seen on the bluff face.

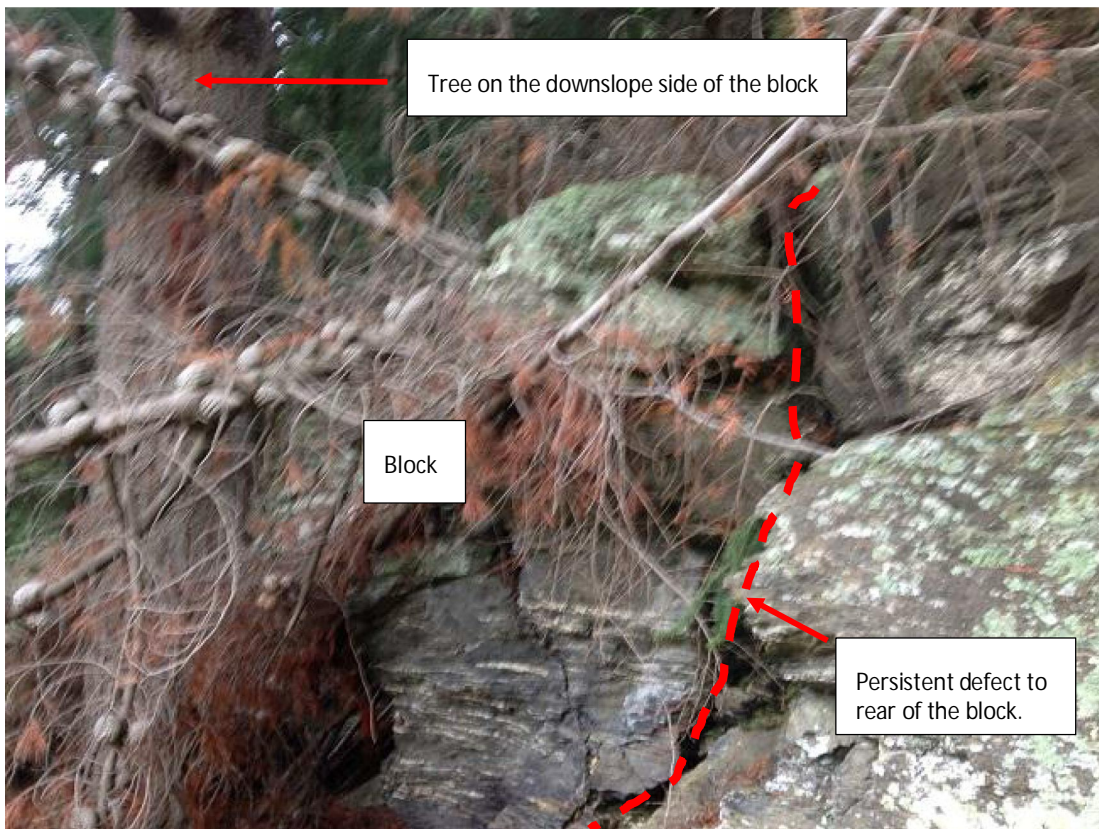
Photograph 6 Large potentially unstable block at the crest of a major bluff.

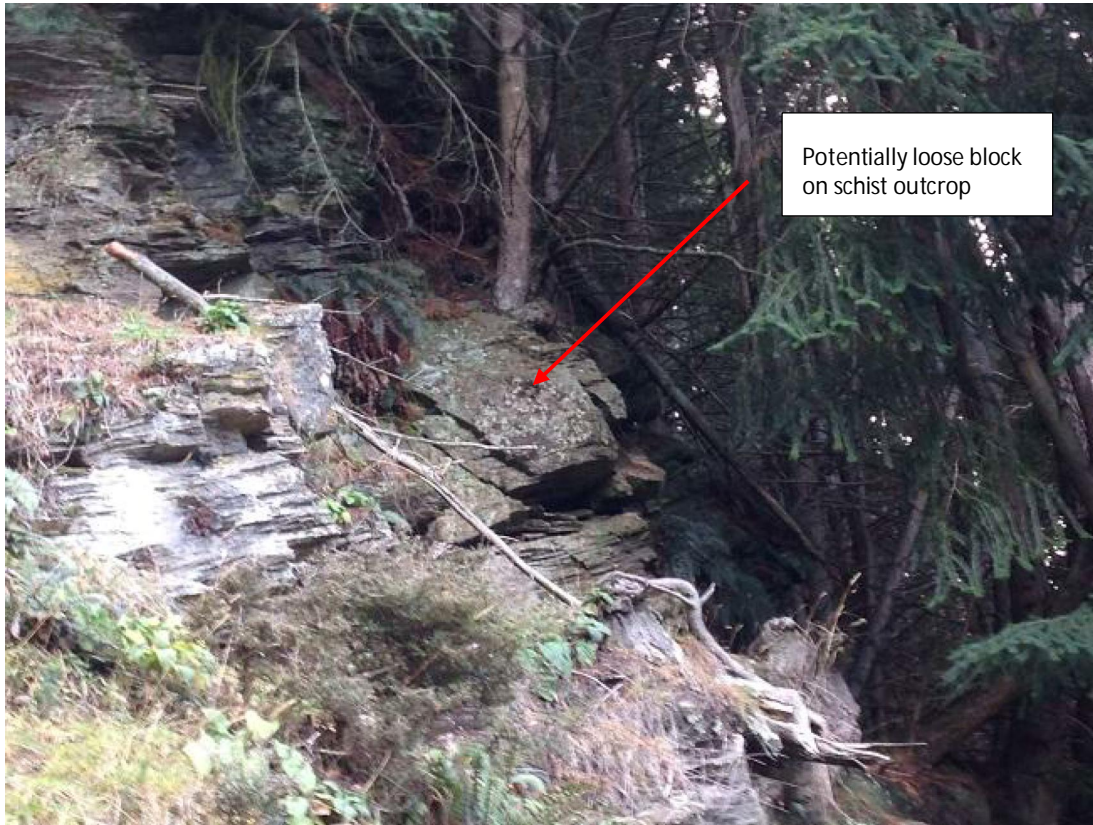
Photograph 7 Typical Area Type B, low bluffs and rock exposures with potentially unstable blocks present in the surface.

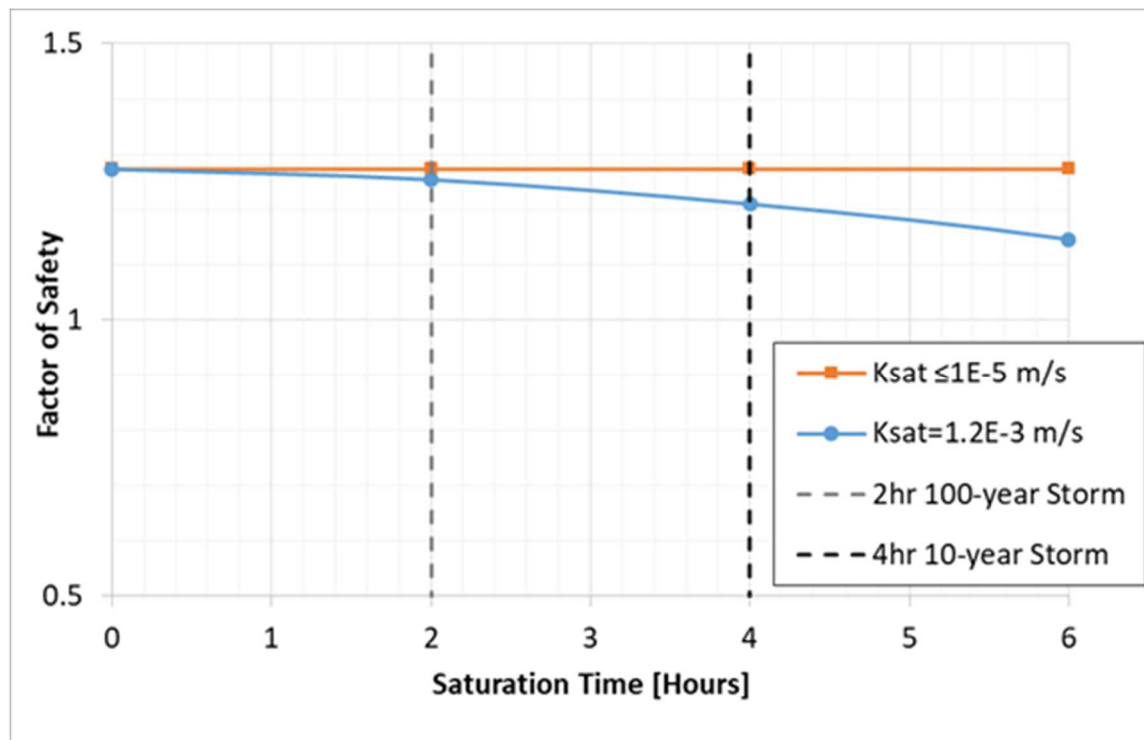
Figure 5.2 - Effect of saturation time on the analysed factor of safety for slope debris

Figure 5.2 illustrates the reduction in factor of safety over time assuming the constant supply of water into the slope from upstream by a 2.5 m deep constant wall of water. The red and orange lines represent upper and lower bound permeability estimates of the slope debris. The 'true' factors of safety will lie within the envelope presented.

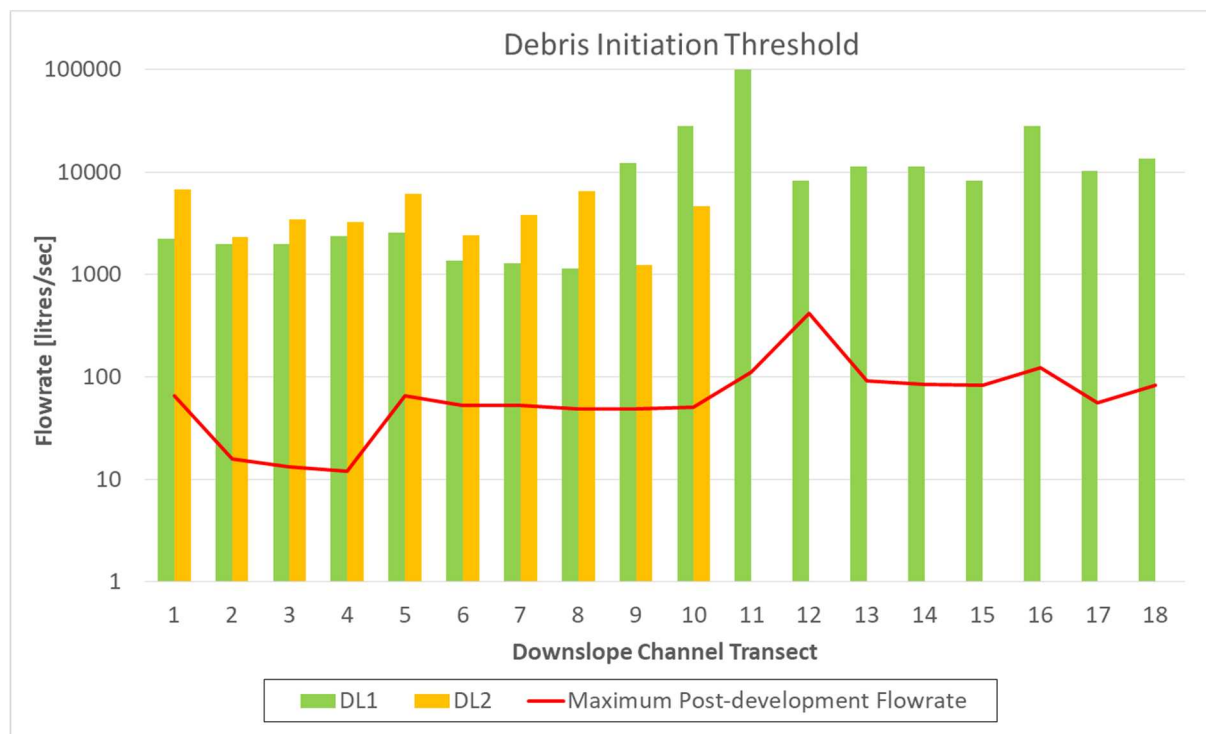
Figure 5.3 - Critical threshold for debris flow initiation downstream of DL1 and DL2. Red line represents the maximum pre- or post-development peak flowrate for the 10-year or 100-year storm at each location

Results from the empirical analysis indicate that the initiation threshold for the slope debris far exceeds the maximum post-development flowrates by two or three orders of magnitude. This agrees well with the stability modelling in the preceding sections, and with site observations.

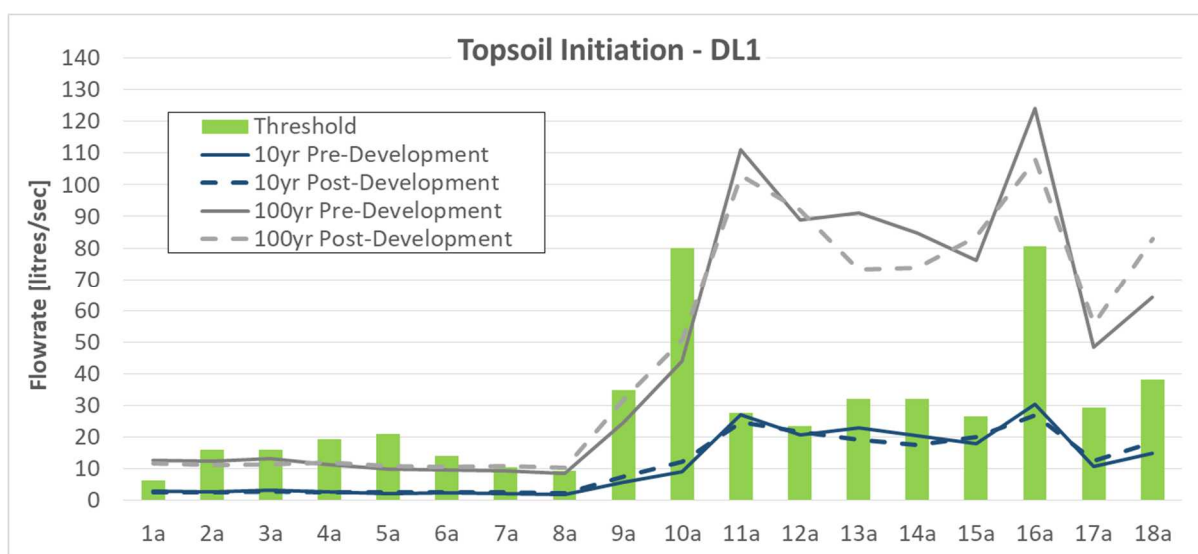
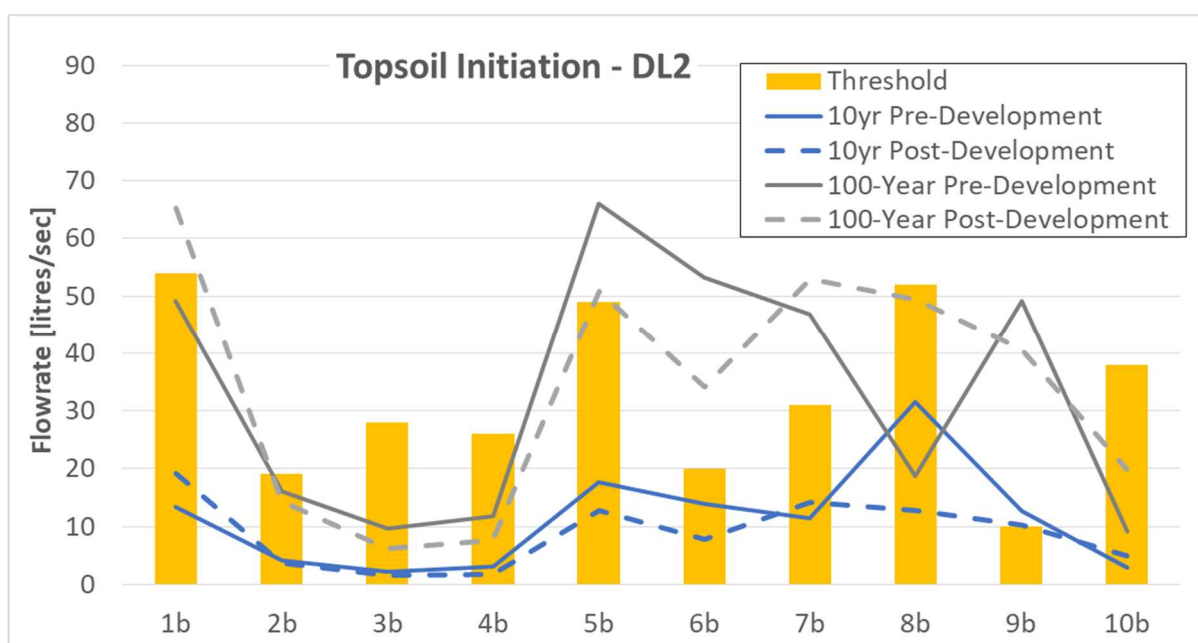
Figure 5.4 - Critical threshold for topsoil debris flow initiation downstream of DP1

Figure 5.5 - Critical threshold for topsoil debris flow initiation downstream of DL2

Results from the analysis indicate that no topsoil is mobilised pre- or post-development during a 10-year storm, with the possible exception of 9B downslope of DL2 which is initiated for the pre-development flow but not the post-development. Transect 11a and 12a downslope of DL1 are right on the threshold.

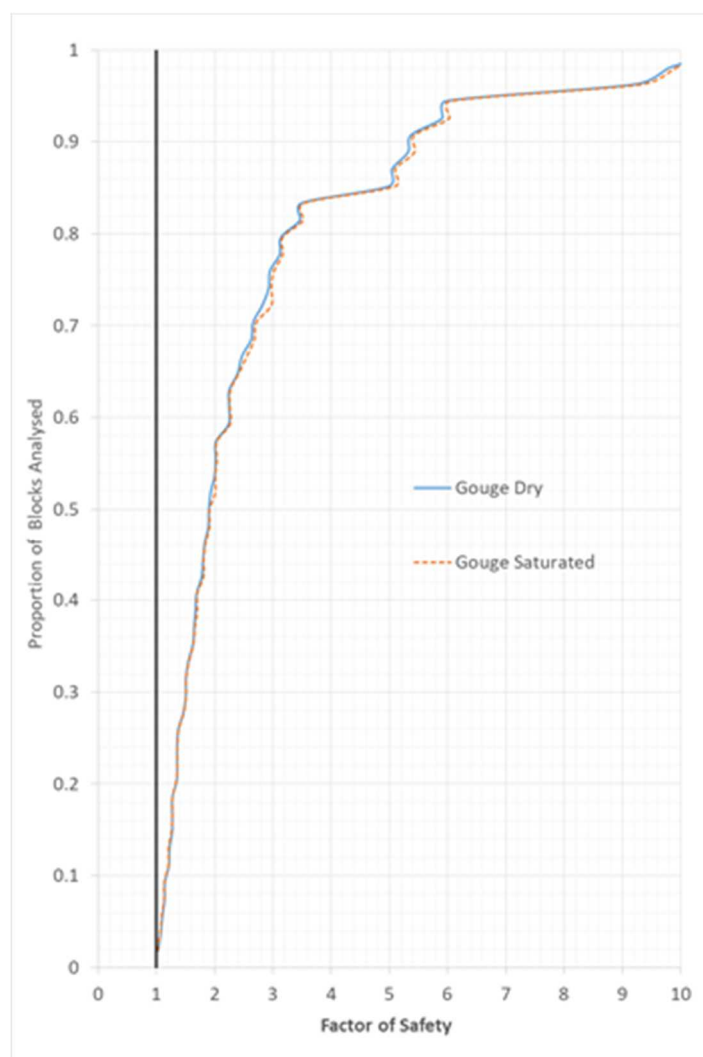
Figure 6.1 - Cumulative distribution function of calculated factor of safety for schist block sliding block analysis

The analysis demonstrates the majority of the schist blocks are reasonably stable in their present condition which agrees well with site observations. The slopes have reached some level of equilibrium in recent geological history, no recent large active failures are present, most instability features being 100's to 1000's of years old.
