**STATEMENT OF EVIDENCE OF ROBERT BOND ON BEHALF OF REMARKABLES  
PARK LIMITED AND QUEENSTOWN PARK LIMITED**

**(GEOTECHNICAL ENGINEERING – NATURAL HAZARDS)**

**STREAM 13 REZONING HEARINGS**

# **Geotechnical Hazard Appraisal**

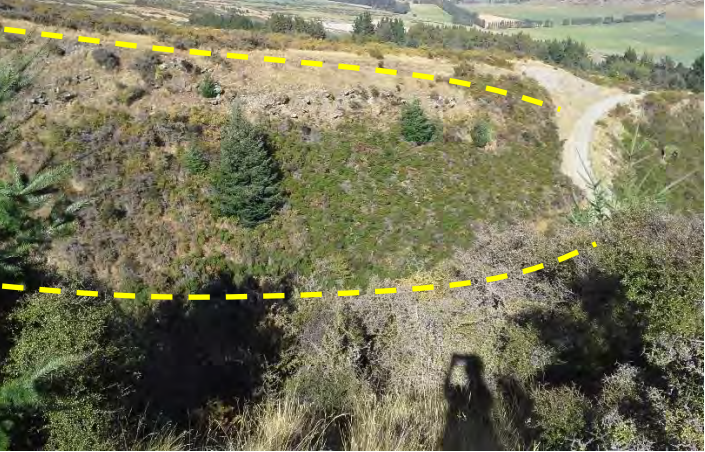
| Development Site ID | Description of Site Topography and Planned Development | Geotechnical Hazards | Proposed Site Mitigation (if any) | Photographs |
|---|---|---|---|---|
| L1 | <p>Living, Residential and Visitor Accommodation options.</p> <p>Site is flat on a ridgeline approximately 1.5km up the Remarkables Ski Field Road. 5-10m deep gully forms the southern boundary of development area. Site is currently vegetated with a mixture of tussock, grass and matagouri.</p> | <p><b>Scour</b> <b>Shallow landslide</b></p> <p>There is a 5-10m deep gully on southern boundary of development area. It is considered there is a low risk during storm events of minor scour, shallow landslide or slope erosion along this boundary. Minor slope failure scars on gully walls can be seen upstream of site.</p> | <p>Development setback 5.0m from southern boundary.</p> | <p><b>L1: Gully along southern boundary of site, shown by dotted yellow lines (30/3/2015).</b></p> |

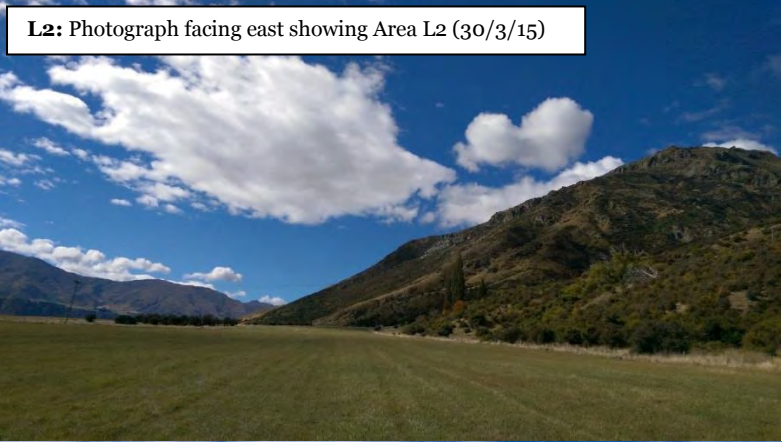
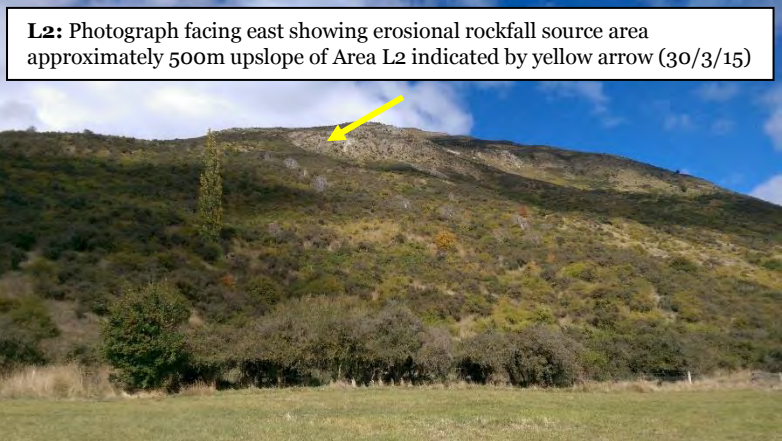
| Development Site ID | Description of Site Topography and Planned Development | Geotechnical Hazards | Proposed Site Mitigation (if any) | Photographs |
|---|--|---|---|---|
| <p><b>L2</b></p> | <p>Living, Residential and Visitor Accommodation options.</p> <p>Site is located on top of a flat high alluvial terrace that is approximately 10m above the lower terrace (V2 development area) and approximately 15m above current bed level of the Rastus Burn. Rastus Burn is reasonably well channelized into its alluvial fan at this location. The southern boundary of the site is formed by the Remarkables Mountain Range, sloping towards the site at 25-30 degrees. Site is grassed and used for agricultural grazing/airport runway.</p> | <p><b>Rock fall –No risk to Low risk</b></p> <p>An erosional rockfall source area exists at the west end of the site approximately 500m upslope of development site L2. Assessed as no to low rockfall risk to site L2.</p> <p>It is considered most of the rock debris released from this area will run into the gully directly west of L2. There is also mature scrub (Matagouri, Poplar, assorted small trees) covering the slope between the source area and the development site which will act as protection to halt rock debris. Rock run out length from the source area appears to only be around 50m downslope. No rocks were observed in Area L2.</p> <p><b>Liquefaction</b>      <b>Lateral Spreading</b></p> <p>The area is classified as possibly susceptible to liquefaction (Opus 2002) in the QLDC Natural Hazards Database.</p> | <p>No mitigation measures considered necessary.</p> | <p><b>L2: Photograph facing east showing Area L2 (30/3/15)</b></p> <p><b>L2: Photograph facing east showing erosional rockfall source area approximately 500m upslope of Area L2 indicated by yellow arrow (30/3/15)</b></p> |

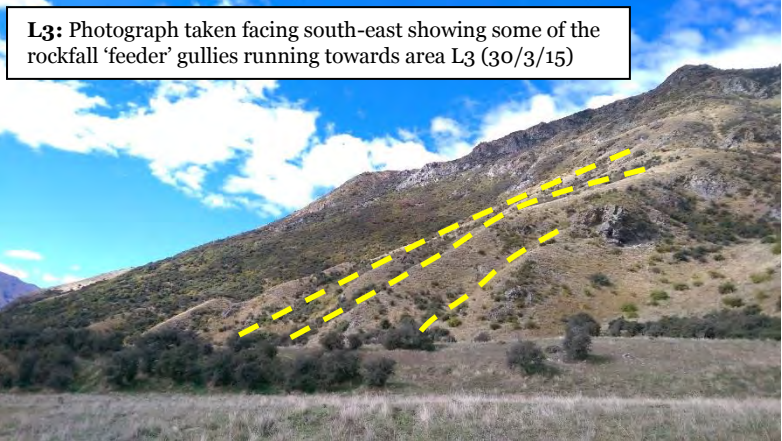
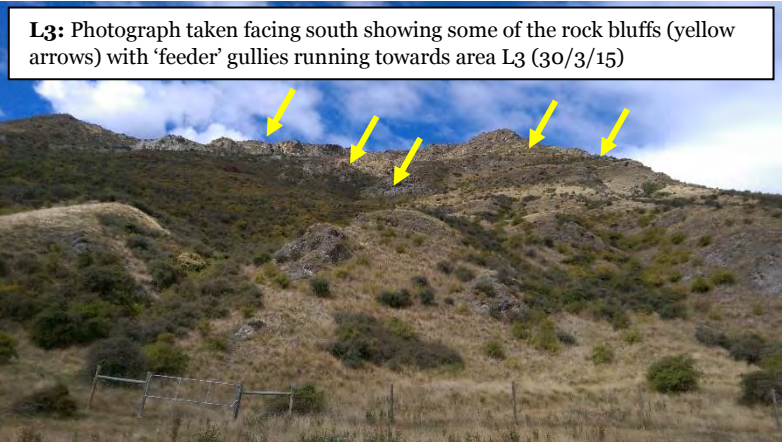
| Development Site ID | Description of Site Topography and Planned Development | Geotechnical Hazards | Proposed Site Mitigation (if any) | Photographs |
|---|---|--|--|---|
| <p><b>L3</b></p> | <p>Living – rustic. Residential and Visitor Accommodation options.</p> <p>The topography of site is slightly undulating from ancient stream channel paths, with lower and upper (south eastern side of site) alluvial terraces with around 5m height difference. The southern boundary of the site is formed by the Remarkables Mountain Range, with slopes of 25 to 30 degrees.</p> <p>The site is approximately 10m above current bed level of the Rastus Burn. The Rastus Burn is reasonably well channelized into its alluvial fan at this location.</p> <p>Site is vegetated with grass and matagouri and used for agricultural grazing.</p> | <p><b>Rock fall – Low to Moderate</b></p> <p>The majority of this site can be classified as no to low rockfall risk.</p> <p>The south eastern corner of the site is considered to have a low to moderate rockfall risk due to the presence of rock bluffs above the site with adversely oriented rock joints. Several ‘feeder gullies’ lead to development area L3 and a large volume rock failure from one of the bluffs could potentially release rock with enough energy to reach area L3. These rock failures are considered to be a very rare event, likely occurring in a high magnitude seismic or storm event. No evidence of recent rockfall was found in area L3.</p> <p><b>Liquefaction</b>      <b>Lateral Spreading</b></p> <p>The area is classified as possibly susceptible to liquefaction (Opus 2002) in the QLDC Natural Hazards Database.</p> | <p><i>In the area marked as Moderate Rockfall Risk on attached Map 1:</i></p> <p>Planting of large trees (non-invasive species similar size to pine) behind structures built within 100m of base of slope or directly below a ‘gully’ feature. Once structure locations are decided on they should also be assessed for rockfall risk by a suitably experienced geotechnical engineer.</p> | <p><b>L3:</b> Photograph taken facing south-east showing some of the rockfall ‘feeder’ gullies running towards area L3 (30/3/15)</p> <p><b>L3:</b> Photograph taken facing south showing some of the rock bluffs (yellow arrows) with ‘feeder’ gullies running towards area L3 (30/3/15)</p> |

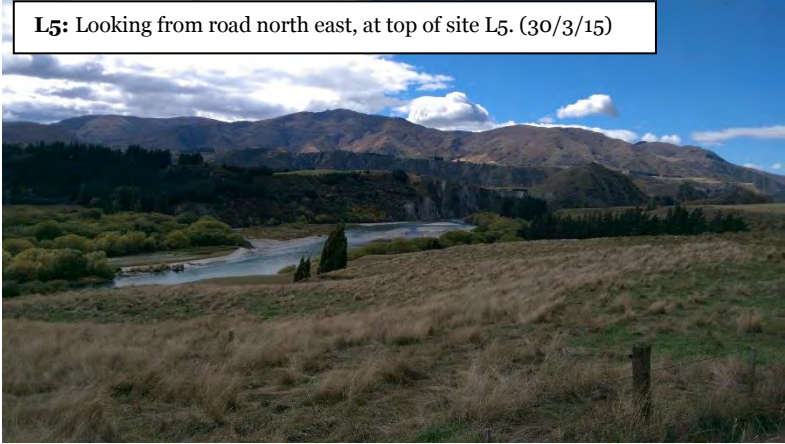
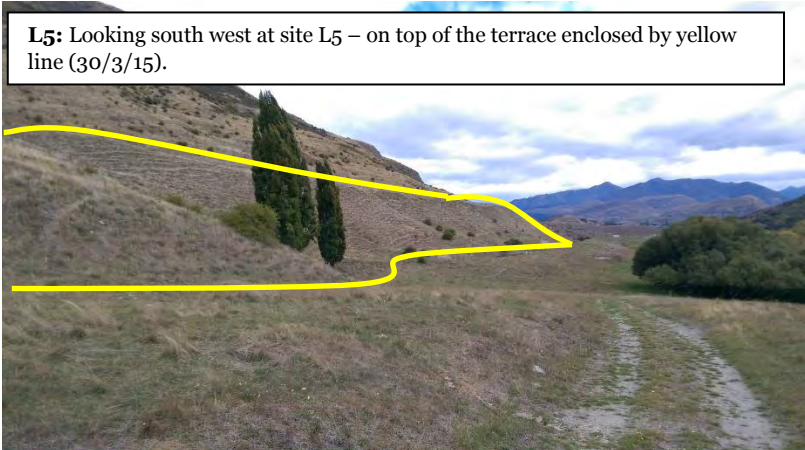
| Development Site ID | Description of Site Topography and Planned Development | Geotechnical Hazards | Proposed Site Mitigation (if any) | Photographs |
|---|--|---|---|--|
| <p><b>L5</b></p> | <p>Living, Residential and Visitor Accommodation options.</p> <p>Undulating topography, likely a mix of colluvium or alluvium from the slope located directly south overlying an alluvial terrace of the Kawarau River. Approximately 10m above a lower alluvial terrace (V3 development site). Site is currently grassed and used for agricultural grazing.</p> | <p><b>Liquefaction</b>   <b>Lateral Spreading</b></p> <p>The area is classified as possibly susceptible to liquefaction (Opus 2002) in the QLDC Natural Hazards Database.</p> | <p>No mitigation measures considered necessary.</p> | <p><b>L5:</b> Looking from road north east, at top of site L5. (30/3/15)</p> <p><b>L5:</b> Looking south west at site L5 – on top of the terrace enclosed by yellow line (30/3/15).</p> |

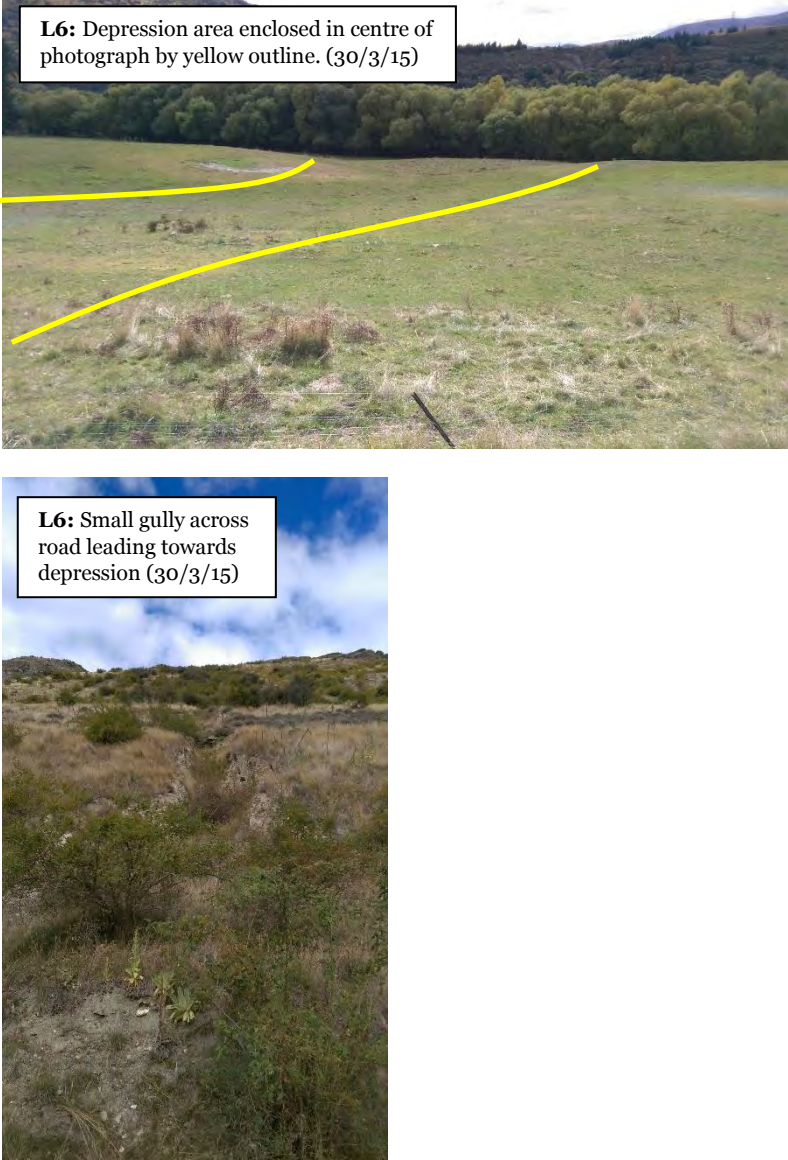
| Development Site ID | Description of Site Topography and Planned Development | Geotechnical Hazards | Proposed Site Mitigation (if any) | Photographs |
|---|---|--|--|--|
| <p><b>L6</b></p> | <p>Living - Residential and Visitor Accommodation options.</p> <p>Site is located on a flat to slightly undulating alluvial terrace of the Kawarau River. A depression approximately mid-site, with a small gully leading to it from the south (across road). The site is currently grassed and used for agricultural purposes.</p> | <p><b>Flooding</b></p> <p>The depression in the centre of this site could indicate that water flows down the small feeder gully into the site during periods of rainfall – either ponding here or continuing onto the Kawarau River beyond.</p> <p><b>Liquefaction</b>      <b>Lateral Spreading</b></p> <p>The area is classified as possibly susceptible to liquefaction (Opus 2002) in the QLDC Natural Hazards Database.</p> | <p>Observations of site during rainfall to determine amount of ponding and water flow. Either installation of drainage culverts to carry flow through site or perhaps formation of a landscaped pond at this location.</p> | |

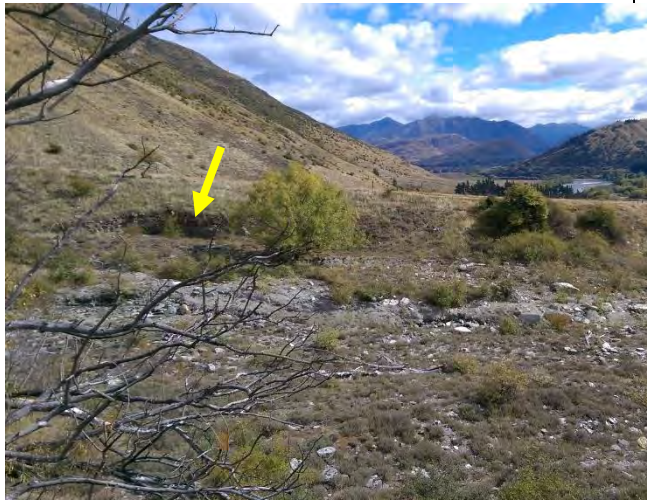
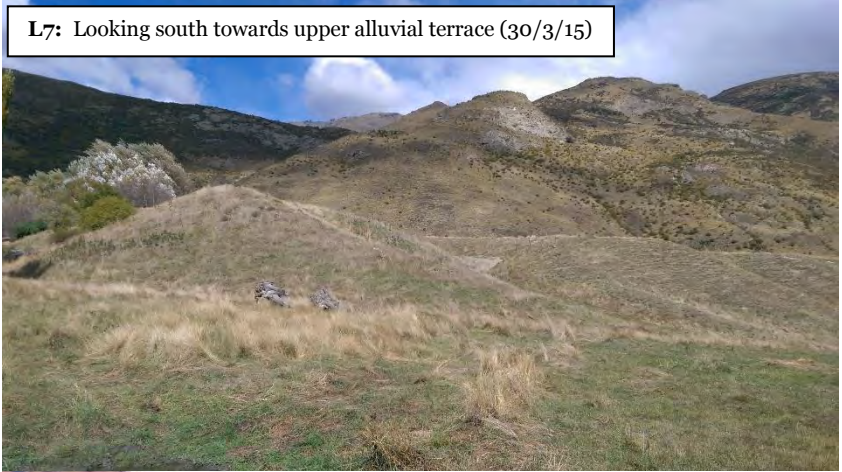
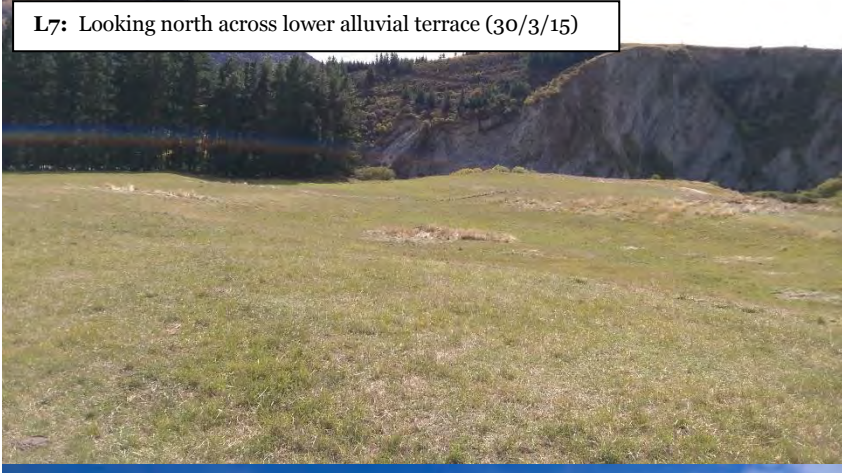
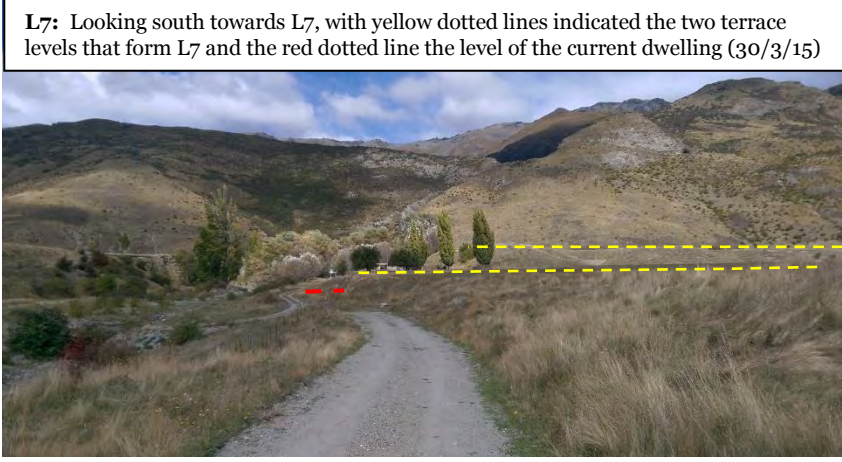
| Development Site ID | Description of Site Topography and Planned Development | Geotechnical Hazards | Proposed Site Mitigation (if any) | Photographs |
|---|--|--|---|---|
| L7 | <p>Living - Residential and Visitor Accommodation options.</p> <p>The L7 site comprises two alluvial terraces – an upper terrace approximately 5m (upper reaches) to 10 m above the current bed level of Owen Creek, and a lower terrace approximately 5.0m above the current bed level of Owen Creek. The southern boundary of the upper terrace is formed by the northern slope of the Remarkables Mountain Range (with a gradient of around 25-30 degrees).</p> <p>The L7 site is understood from the development plan provided by the client to not include the current dwelling location, which is at a lower level (approximately 2.0m to 3.0m above current bed level) and considered to have a higher risk of debris flows and flooding.</p> | <p><b>Scour</b></p> <p>A minor scour hazard exists along the eastern boundary of the L7 site from the Owen Creek. Although the flow in the Creek is normally small, the catchment area in the Remarkables Mountain Range is large indicating there is potential during a storm event for a rapid increase in flow. This flow will also likely carry rock and gravel due to the rock debris source areas currently visible upstream. The current height of the L7 terrace is considered likely to protect the site from the direct effects of debris flows or channel migration in all but the very extreme of events. However some scour of the banks is considered likely to occur annually, as shown in the photograph below (one recent scour site is indicated by yellow arrow).</p> | <p><i>Scour:</i></p> <ul style="list-style-type: none"> <li>• 20m setback for structures, Importance Level 2 -5 (NZS1170.0)</li> <li>• Planting of tree species such as willows along the creek bank to help stabilise.</li> <li>• River training measures such as channel excavation to channelize the stream and lower the bed level. Possible groyne placement upstream to direct flow away from L7 area.</li> </ul> | <p>L7: Looking south towards upper alluvial terrace (30/3/15)</p> <p>L7: Looking north across lower alluvial terrace (30/3/15)</p> <p>L7: Looking south towards L7, with yellow dotted lines indicated the two terrace levels that form L7 and the red dotted line the level of the current dwelling (30/3/15)</p> |
| | | <p>There is not considered to be a rockfall risk at this site.</p> | | |
| | | <p><b>Liquefaction</b>      <b>Lateral Spreading</b></p> | | |
| | | <p>The area is classified as possibly susceptible to liquefaction (Opus 2002) in the QLDC Natural Hazards Database.</p> | | |

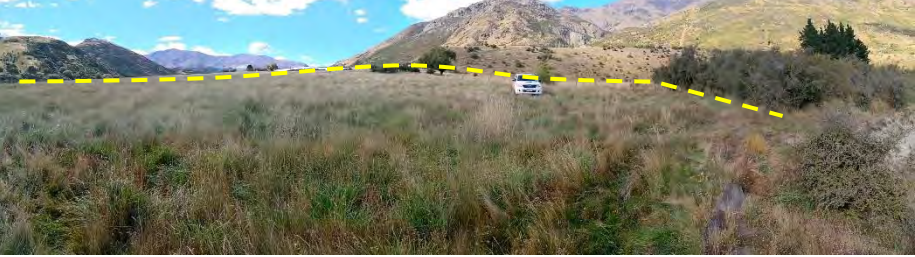
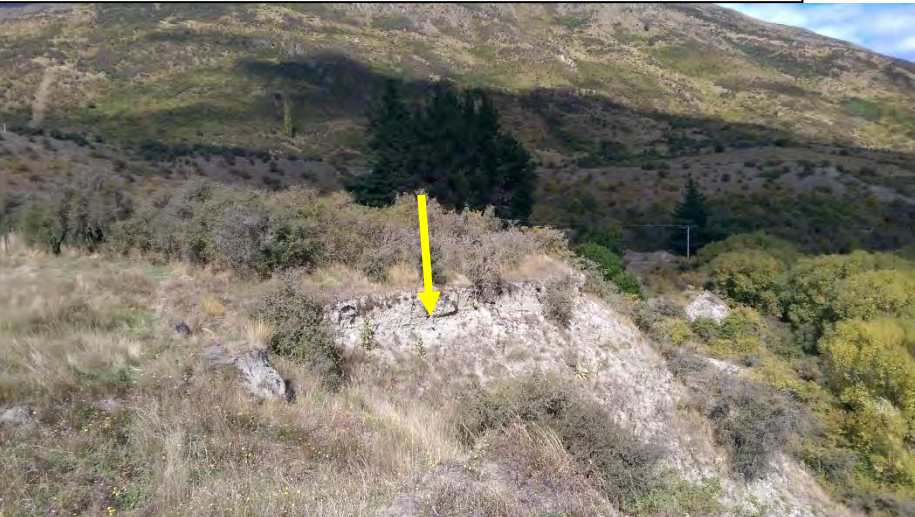
| Development Site ID | Description of Site Topography and Planned Development | Geotechnical Hazards | Proposed Site Mitigation (if any) | Photographs |
|---|--|---|---|---|
| <p><b>V2</b></p> | <p>Visitor accommodation and commercial activities, specifically at this stage linkage to the mountain via the gondola, river trail, footbridge and jetty. Eastern extent of the potential golf course and site of possible golf club rooms.</p> | <p><b>Scour</b></p> <p>The western boundary of area V2 appears to be prone to small landslips and minor surface water erosion. The Kawarau River bends sharply at this point around the Rastus Burn alluvial fan and in times of high flow likely erodes the toe of the slope. However at the time of inspection the amount of erosion and slope failure appeared minimal and surficial only. There is no sign of any deeper seated slope failure such as tension cracking. The alluvium is relatively tightly packed at this point and hence reasonably resistant to erosion.</p> <p><b>Liquefaction</b></p> <p>The area is classified as possibly susceptible to liquefaction (Opus 2002) in the QLDC Natural Hazards Database.</p> | <ul style="list-style-type: none"> <li>- 20m setback for structures from the western boundary, Importance Level 2 -5 (NZS1170.0)</li> <li>- Monitoring of amount of erosion and slope release regularly. Consider the use of erosional control matting if rate of erosion is rapid.</li> <li>- Planting of trees and shrubs close to slope crest where possible to help mitigate against the effects of erosion and slope release.</li> </ul> | <p><b>V2:</b> Panoramic photograph showing site V2, approximately enclosed by yellow dotted line. (30/3/15)</p> <p><b>V2:</b> Erosional slope failure at along the Kawarau River edge of area V2 (30/3/15)</p> |

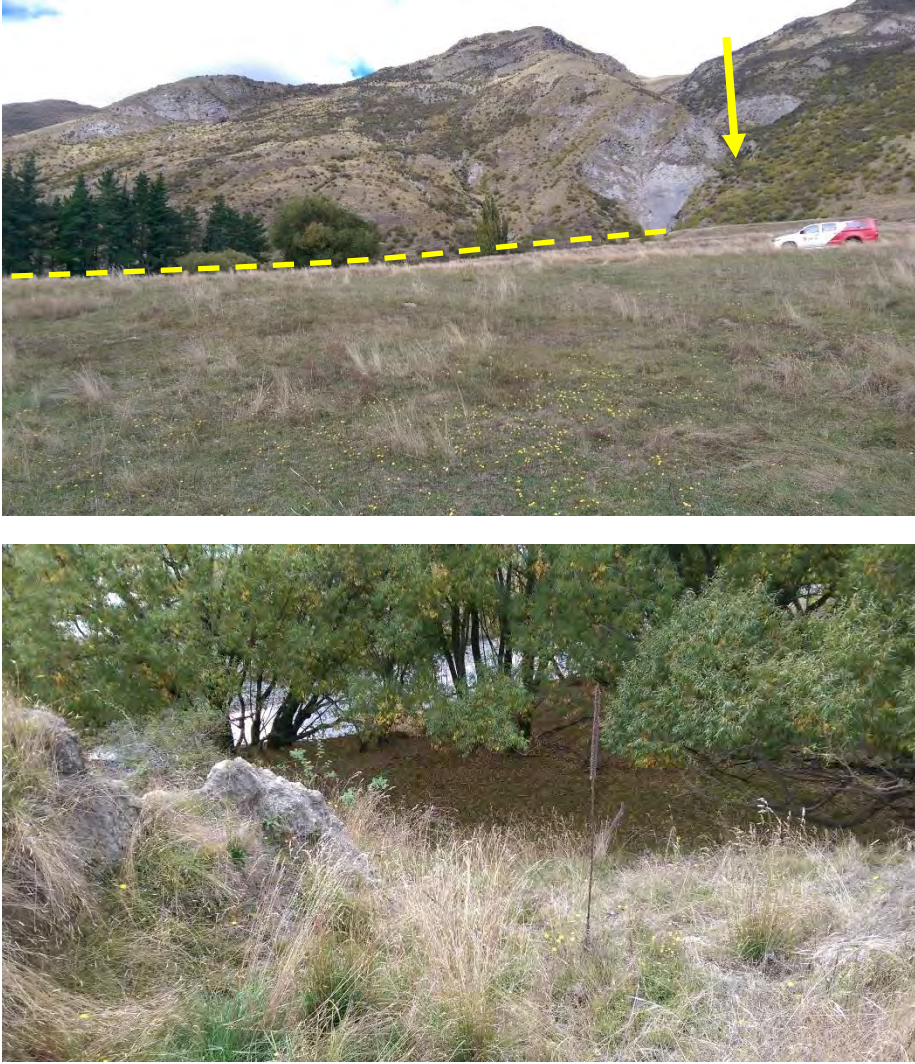
| Development Site ID | Description of Site Topography and Planned Development | Geotechnical Hazards | Proposed Site Mitigation (if any) | Photographs |
|---|--|---|---|---|
| <p><b>V3</b></p> | <p>Commercial and accommodation facilities supporting people using the river trail. It also links a jetty to the river.</p> <p>The site is located on a lower alluvial terrace, approximately 3-5m above the Kawarau River flowing west to east and a small tributary (name unknown) flowing south to north.</p> | <p><b>Scour</b></p> <p>This site is around 5.0m above the average flow level of the Kawarau River and around 3.0m above a floodplain of the River. In times of high flow it is likely that this lower floodplain will flood and cause surficial failures and scour erosion along the edge of the V3 terrace. However at the time of inspection the edge of the terrace was reasonably well vegetated with only very minor signs of surficial erosion and no sign of any deeper seated slope failure.</p> <p><b>Liquefaction</b></p> <p>The area is classified as possibly susceptible to liquefaction (Opus 2002) in the QLDC Natural Hazards Database.</p> | <p><i>Scour</i></p> <ul style="list-style-type: none"> <li>- 20m setback for structures, Importance Level 2 -5 (NZS1170.0)</li> </ul> | <p><b>V3:</b> Looking northeast across site V3. The unnamed tributary runs from the gully indicated by the yellow arrow across the back of the photograph (approx. 3.0m below V3 terrace), shown by the yellow dotted line. (30/3/15).</p> |

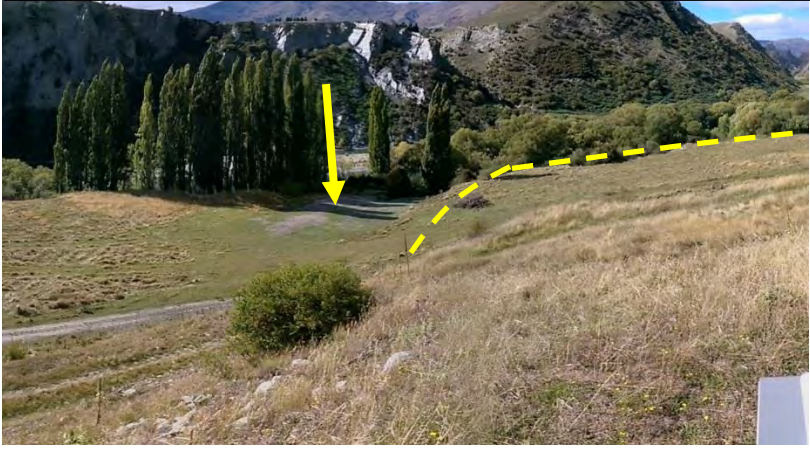
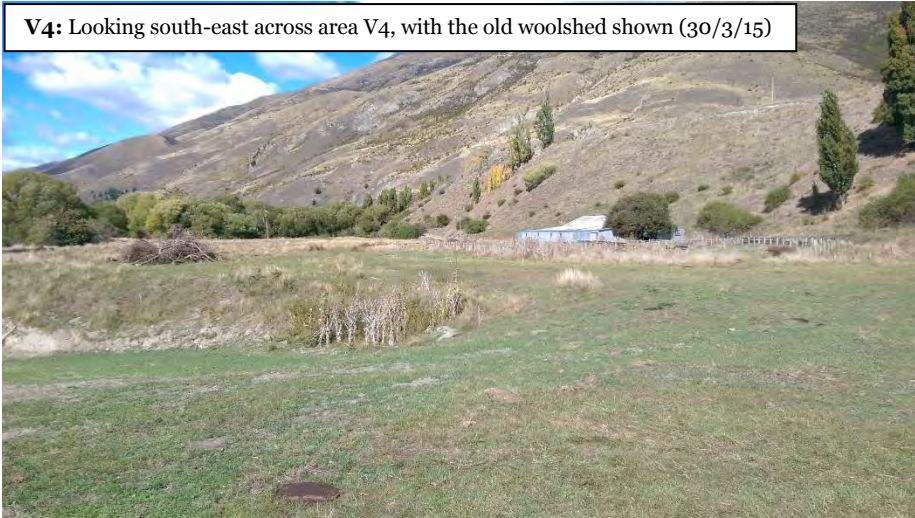
| Development Site ID | Description of Site Topography and Planned Development | Geotechnical Hazards | Proposed Site Mitigation (if any) | Photographs |
|---|---|--|--|--|
| <p><b>V4</b></p> | <p>Commercial recreation activities, possibly including a café and restaurant to support the users of the river and trail. Jetty access.</p> <p>The site is generally flat and located on a lower alluvial terrace around 5-10m above the Kawarau River. There is a refuse tip (recently covered in) on its western boundary on a lower terrace. The station access road forms the southern boundary to the site.</p> <p>A disused woolshed is located just off the access road approximately mid-site.</p> | <p><i>Contaminated Land Assessment</i> - Unknown influence of the recent landfill area and woolshed on surrounding ground condition.</p> <div style="display: flex; justify-content: space-around; margin-top: 10px;"> <div style="background-color: #2e8b57; color: white; padding: 5px; border: 1px solid black;">Liquefaction</div> <div style="background-color: #808080; color: white; padding: 5px; border: 1px solid black;">Lateral Spreading</div> </div> <p>The area is classified as possibly susceptible to liquefaction (Opus 2002) in the QLDC Natural Hazards Database.</p> | <p>A Contaminated Land Assessment to be carried out in the area surrounding the woolshed and along the western edge of the terrace.</p> <p>20m setback for structures, Importance Level 2 -5 (NZS1170.0)</p> | <div style="border: 1px solid black; padding: 5px; margin-bottom: 10px;"> <p><b>V4:</b> Looking north across area V4, rubbish area shown by yellow arrow and northern and western extents of the V4 area indicated by yellow line. Access road can be seen on the left of the photograph. (30/3/15)</p> </div> <div style="border: 1px solid black; padding: 5px;"> <p><b>V4:</b> Looking south-east across area V4, with the old woolshed shown (30/3/15)</p> </div> |

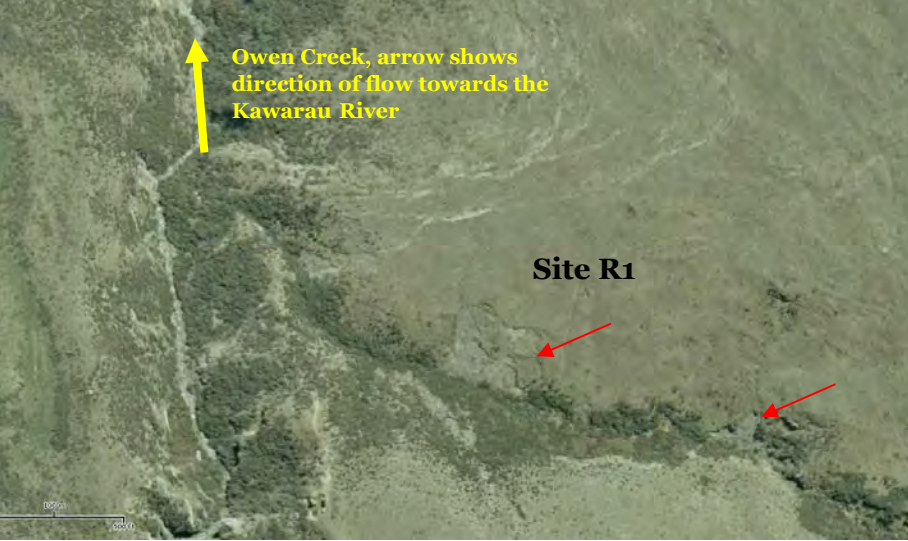
| Development Site ID | Description of Site Topography and Planned Development | Geotechnical Hazards | Proposed Site Mitigation (if any) | Photographs |
|---|--|--|--|--|
| <p><b>R1</b></p> | <p>Low impact eco-tourism. Accessible only by helicopter.</p> <p>The site is located on a SW facing slope approximately 2.8km upstream of the confluence of Owen Creek with the Kawarau River.</p> | <p><b>Deep seated landslide</b></p> <p>SW facing slopes in Central Otago that approximately follow the direction of the regional foliation are prone to deep seated slide failure along this foliation. This is particularly prevalent when the toe of the slope is being actively downcut by a stream or river.</p> <p>From this preliminary overview analysis, it does appear that the R1 site could be prone to a deeper seated landslide failure. There are several slope failures on the same slope and the overall topography is generally hummocky which suggests ground movement. It may be possible to locate a resort building successfully at some point on this slope but it requires further detailed geotechnical investigation.</p> | <p>Further geotechnical investigation needed for situating of structures Importance Level 2-5 (NZS1170.0).</p> | <p><b>R1:</b> Aerial photograph from QLDC GIS database showing the approximate location of Site R1. Existing slope failures are indicated by red arrows (7/4/15)</p> <p>The photograph shows a topographic view of a slope. A yellow arrow points to Owen Creek, with text indicating the flow direction towards the Kawarau River. Two red arrows point to specific areas on the slope, labeled as existing slope failures. The site location is marked as 'Site R1'.</p> |

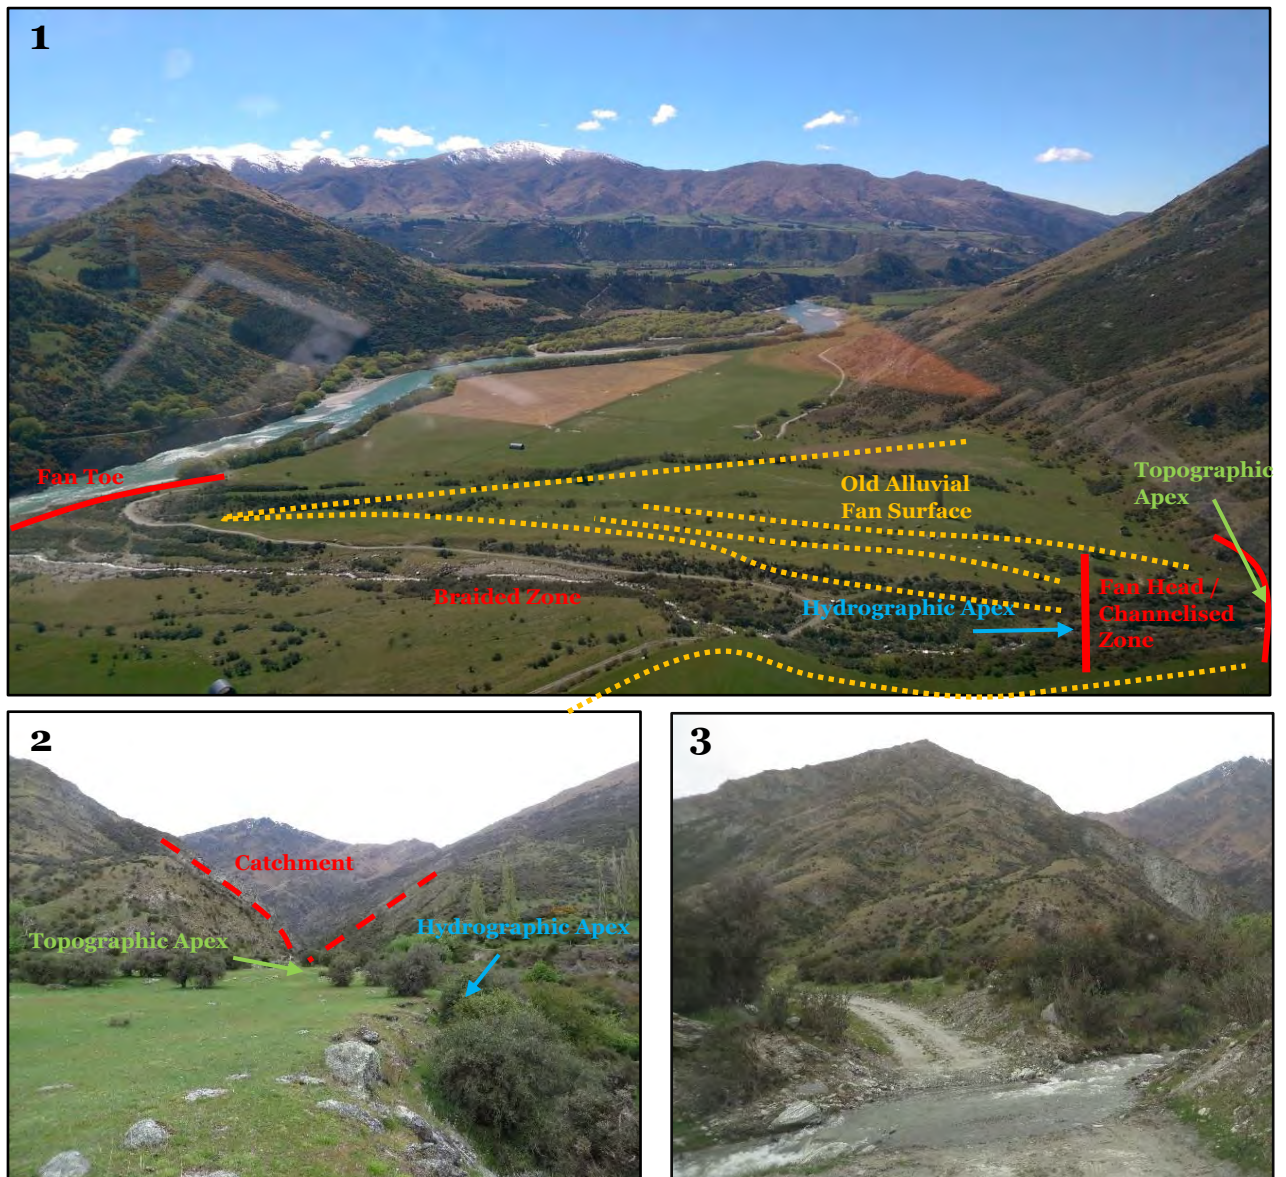
When viewing aerial images of the Rastus Burn fan it can be seen that historically overbreak of the stream channel during high flow events typically occurs to the eastern side of the fan. There appears to be at least 3-4 alluvial terraces and old stream channels in this area. Currently however, the stream is reasonably well channelized in the centre of the fan at the fan head with channel walls around 3.0m deep that are becoming well vegetated. Whilst the risk of channel overbreak to the east cannot be completely discounted, it is considered that this would only occur in an extreme rainfall event such as a 1 in 100 year intensity.

**Photograph 1 (Top):** Aerial photograph showing the Rastus Burn fan characteristics. Approximate positions of some proposed development sites are shown.

**Photograph 2 (Bottom Left):** Photograph taken on the Rastus Burn fan at approximately the location of the hydrographic apex, looking towards the topographic apex. One residential platform from development Site 15 indicated by pink rectangle.

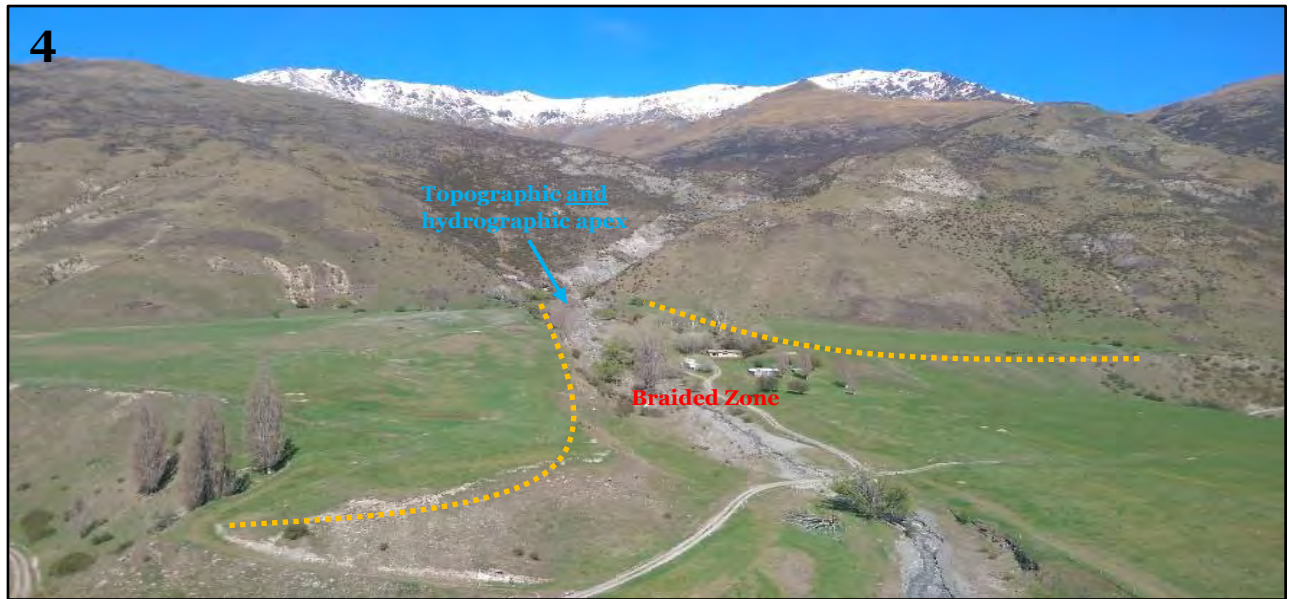
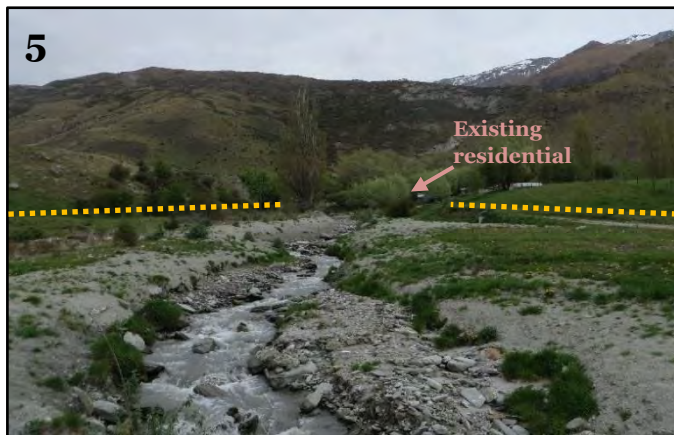
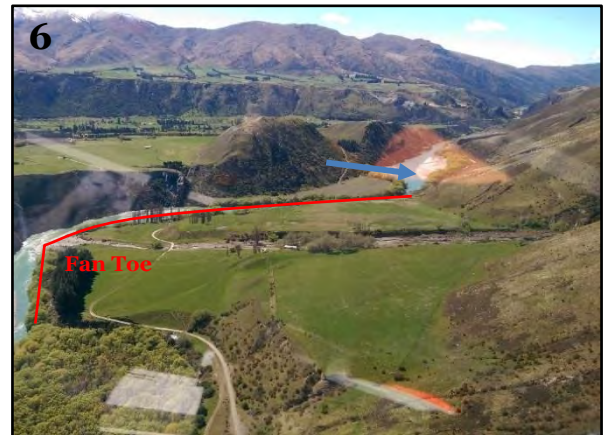
The debris deposited by the flows onto this fan is smaller in size than on the Rastus Burn, up to a size of around 200mm. Aerial photographs indicate there could be a gorge followed by a sharp bend immediately upstream of the fan apex. The gorge may a) block some of the large debris from continuing in the flow or b) act to increase the water velocity, which rapidly decelerates when the flows hits the following sharp bend, causing rapid deposition of the larger fragments at this point upstream of the alluvial fan apex.

Regardless of the reason, it appears that debris flow carrying large boulders is not a major hazard on the Owen Creek alluvial fan. However, debris flow containing material less than 200mm, flooding inundation, scour and channel migration in the lower braided section are likely to still occur.

**Photograph 4 (Top):** Aerial photograph showing the Owen Creek fan characteristics. Approximate positions of proposed development sites are shown.

**Photograph 5 (Bottom Left):** Photograph taken on the Owen Creek fan where the access road crosses the current stream bed. Old alluvial fan terraces are shown by dotted yellow line.

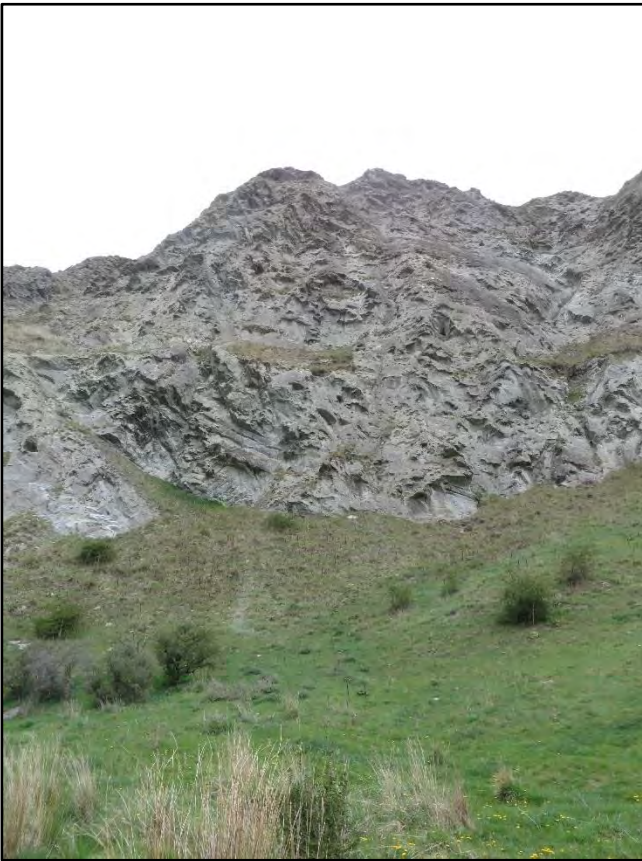
**Photograph 7 (Left):** Example of a bedrock outcrop /bluff above the access road that could release rockfall to road level  
**Photograph 8 (Bottom Left):** Example of rockfall source areas high above The Park, which could release rockfall. In this case, The Park is reasonably well protected by vegetation on the slope inbetween.

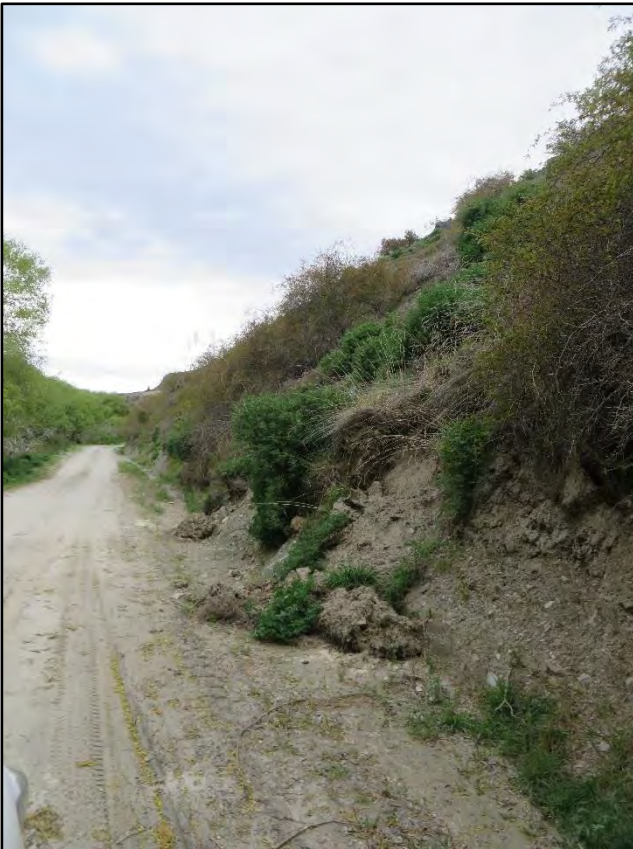
**Photograph 9 (Left):** Shallow landslip along access road (Chard Farm end of The Park)
