### Attachment 3 - Photos of Kinloch Lodge

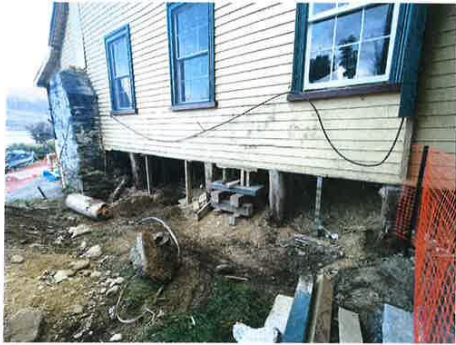
N Elevation preparation for new piles

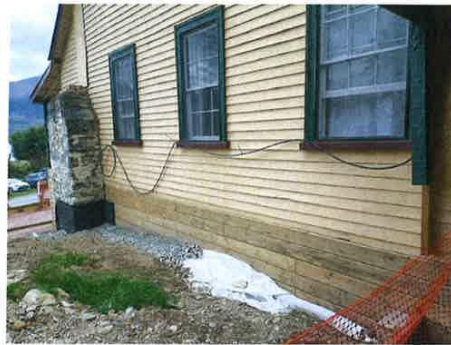
Substantial timbering for seismic bracing

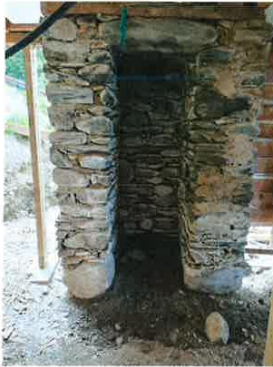
Original 1870 chimney  
Foundation (Large rocks!)

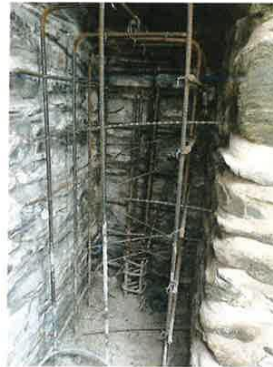
Reinforcing cage and  
ties for concrete

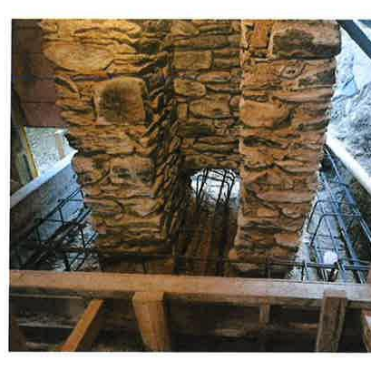
2023 concrete slab foundation  
ready for pouring

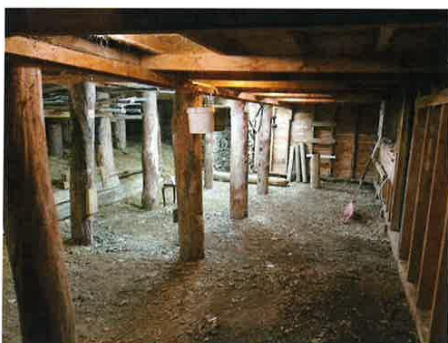
1870 totara piles, rotted and unbraced

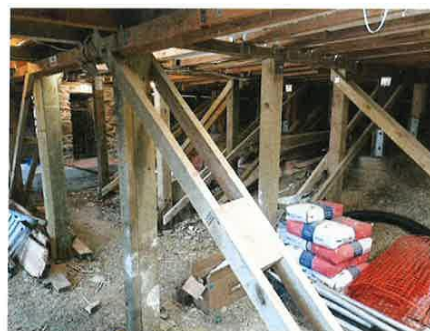
2023 piles with substantially engineered  
bracing
