Job Number: 50595

STORMWATER DISPOSAL ASSESSMENT

RD Agritech were requested to write this letter providing an assessment of stormwater disposal at a proposed subdivision on McDonnell Road, Arrowtown. Richard Newman engaged RD Agritech in a signed Short Form Agreement dated 6 December 2017.

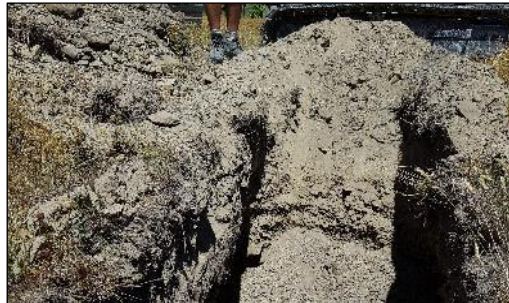
1.6	.Ooo.Ooo. .Ooo.Ooo.			
			2.0		End of test pit, unable to excavate further due to test pit walls collapsing		
			2.4				
			2.8				
			3.2				
			3.6

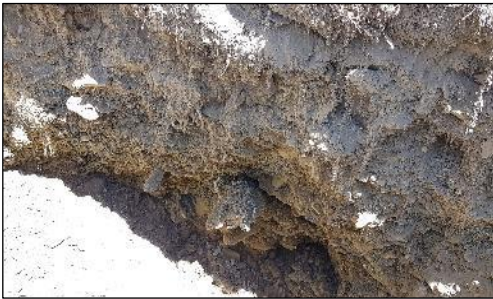
2.4		End of test pit, unable to excavate further due to dense material		
			2.8
