112 McDonnell Road, Arrowtown

Preliminary Site Investigation Report
Richard Newman

Date: January 2018
Reference: 6-XZ374.00
Status: Final
Report No: 1432

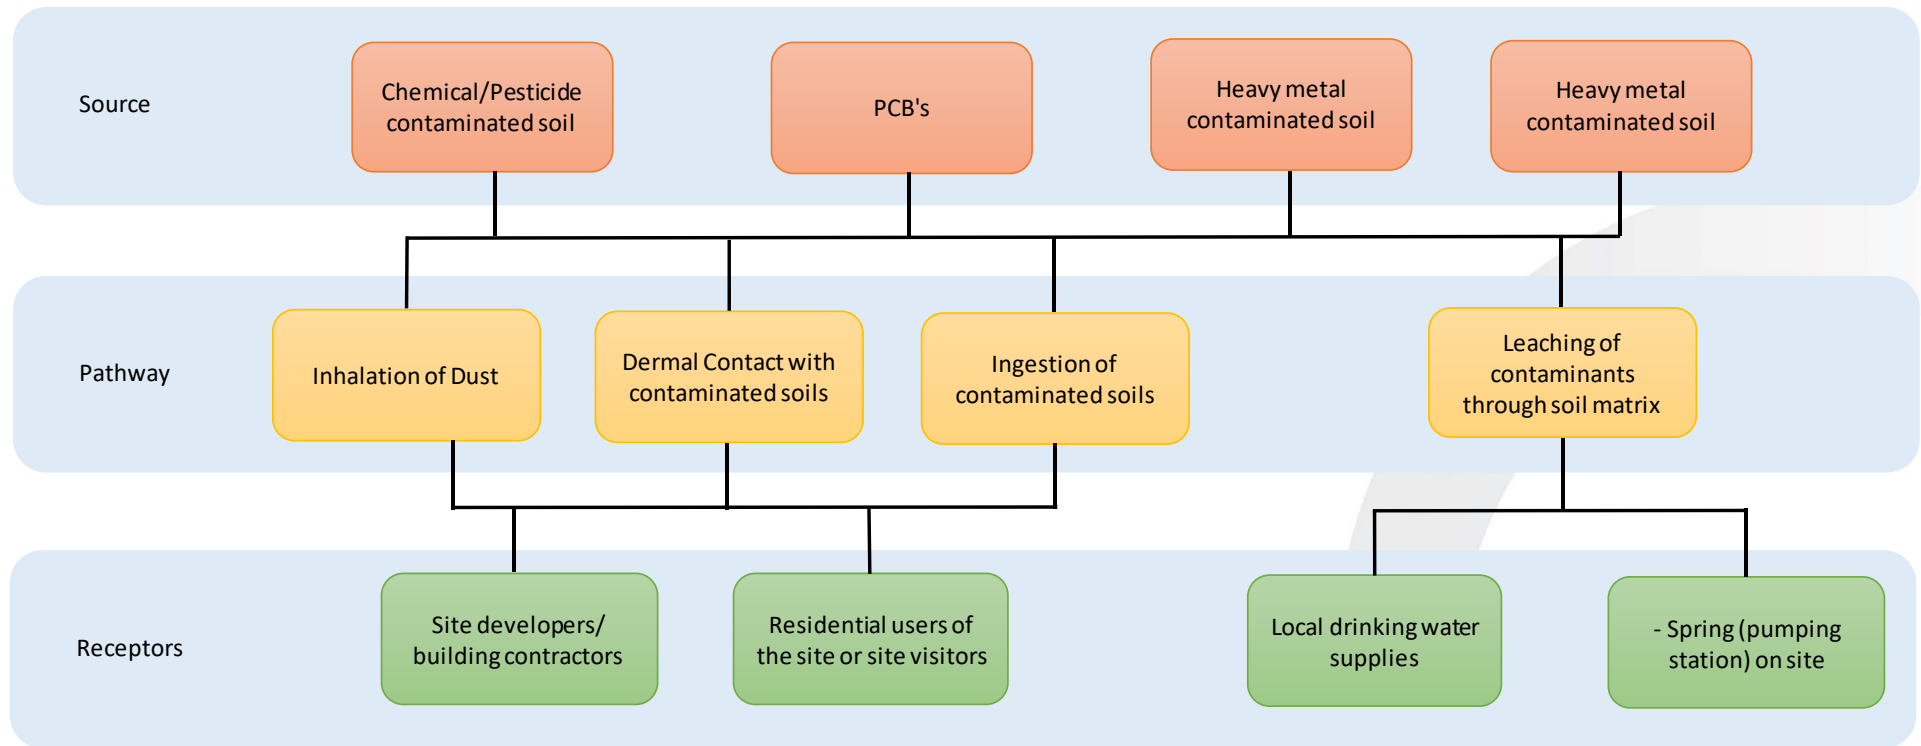
Using the data obtained from various sources and brought together within this report, a conceptual site model (CSM) has been derived for the site and is presented in Figure 5.

Figure 5: Conceptual Site Model

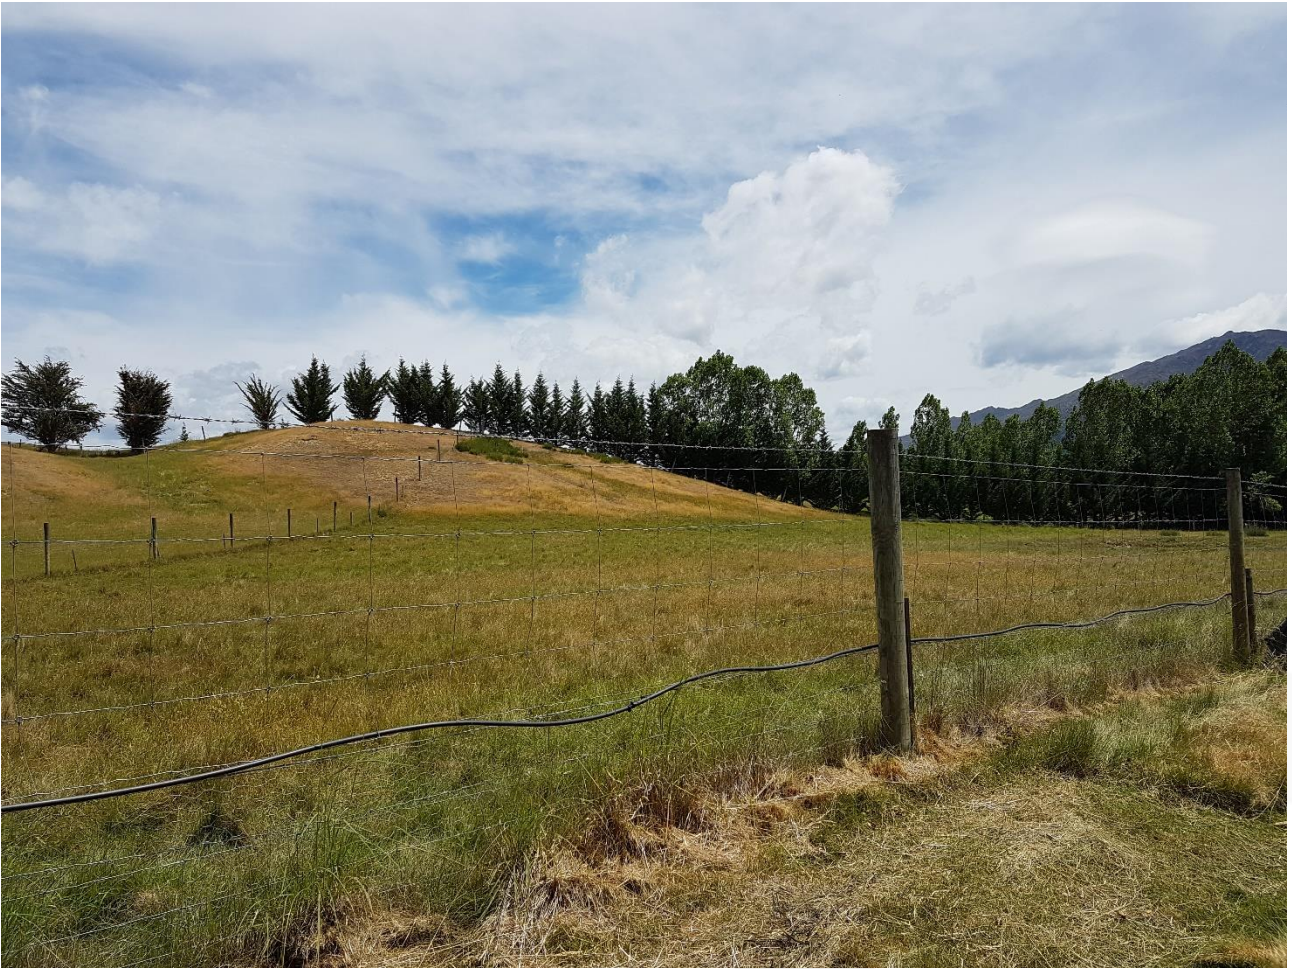
Plate 1: View north-west looking across the far western part of the site.

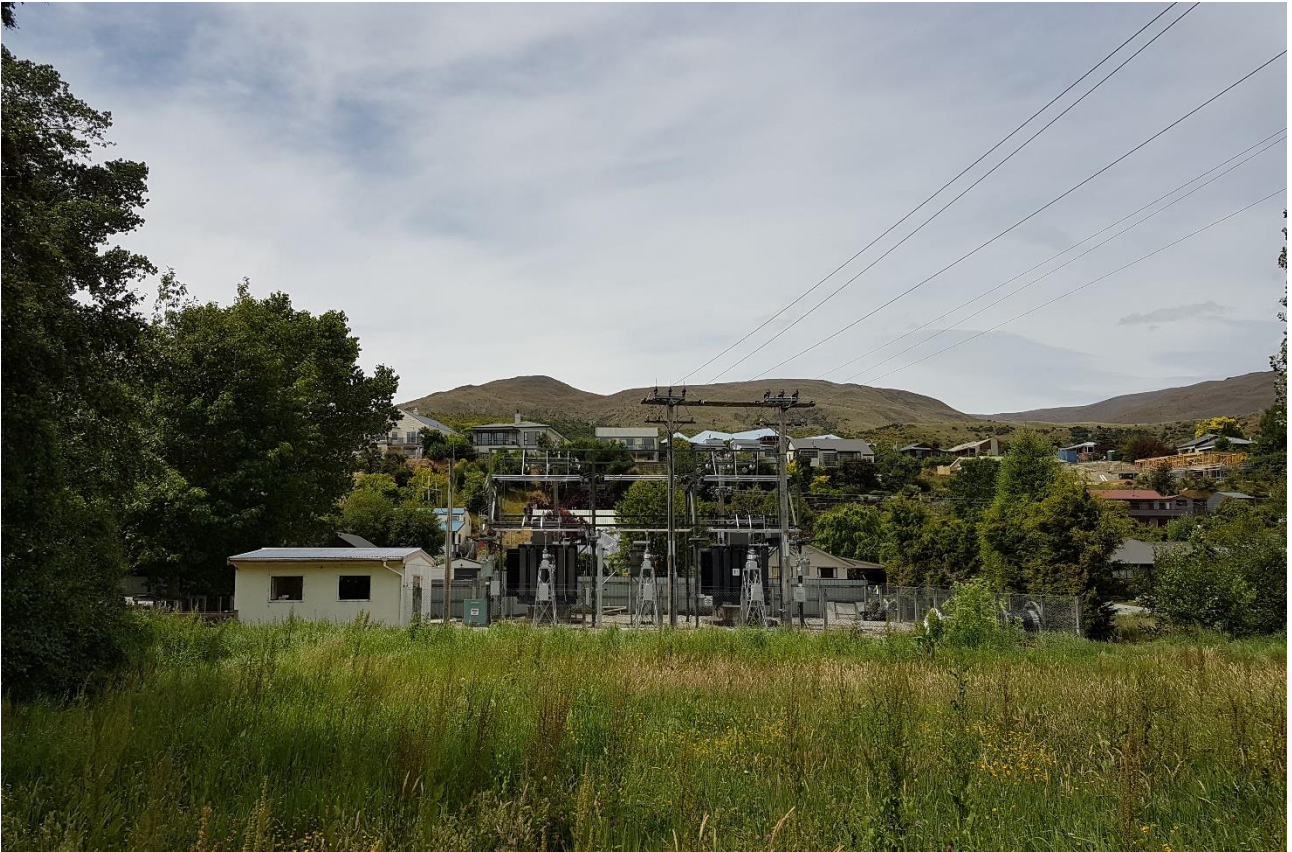
- Chemical/Pesticide use, formulation, storage and disposal
- Polychlorinated Biphenyls (PCB's) - originating from the adjacent substation
- Heavy metals
- Polycyclic Hydrocarbons (PAH) – originating from burning waste

Plate 5: electricity substation located adjacent to the north-eastern corner of the site.

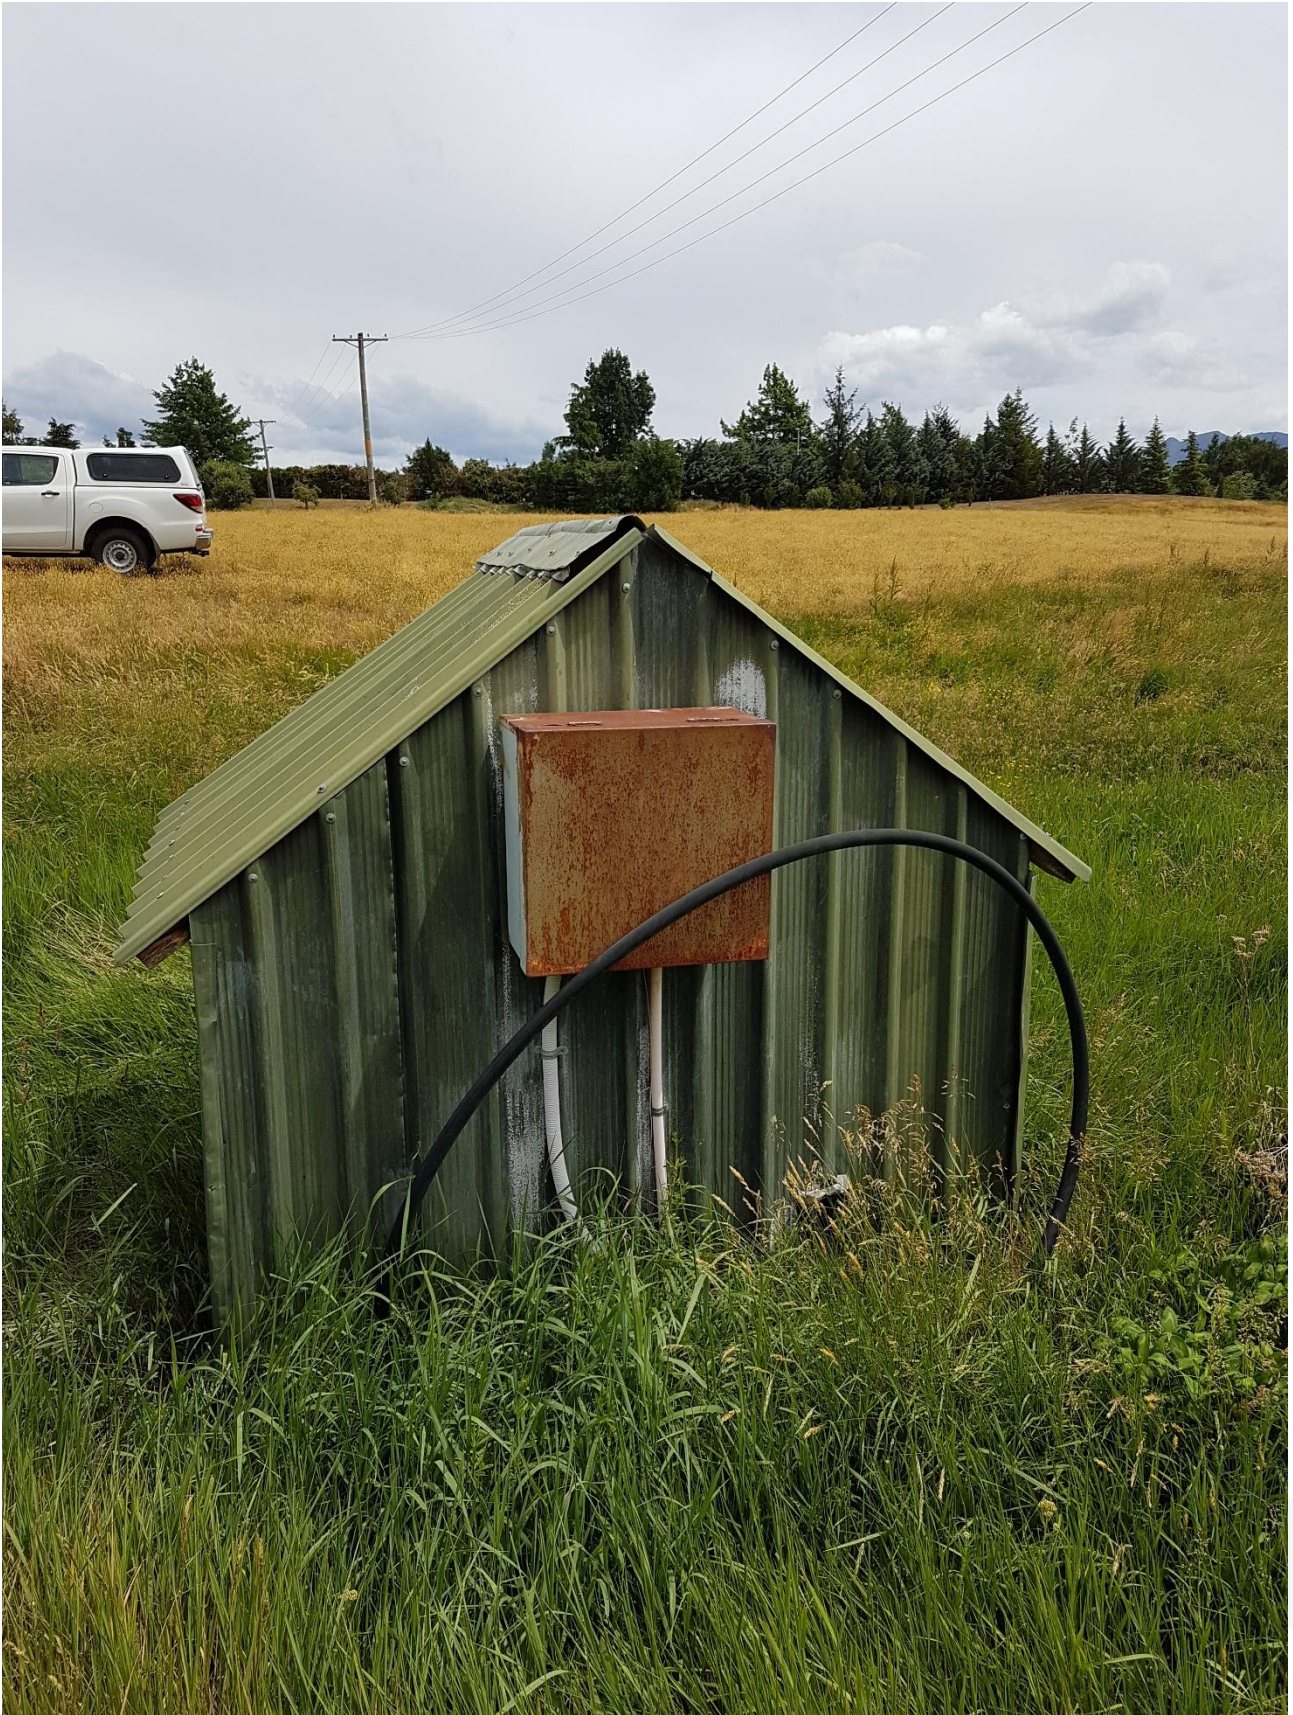
To the west of the landscaped area, next to the house driveway, there are a number of paddocks; the south-eastern paddock is utilised as a vegetable plot and also contains a number of semi mature trees. Within this area there is a small area used for burning garden waste. To the west of this paddock there is a chicken coop and enclosed section of land containing several trees. To the north of both paddocks there is a further paddock, which contains a large shed/garage including a log store, disused and cleaned spray equipment which has been discarded within the paddock, a number of young silver birch trees and a number of pet sheep. To the north of these paddocks, a large amount of wood/ brush has been stacked for burning at a later date. It is in this area that a potential waste pit was identified on historical aerial photographs, however on inspection it is apparent that the area comprises a stockpile of wood and brush for burning. A pump station is located within the large paddock in the eastern section of site, this pumping house draws its water from a natural well.

Plate 7: View of the pumping house located in the eastern paddock.

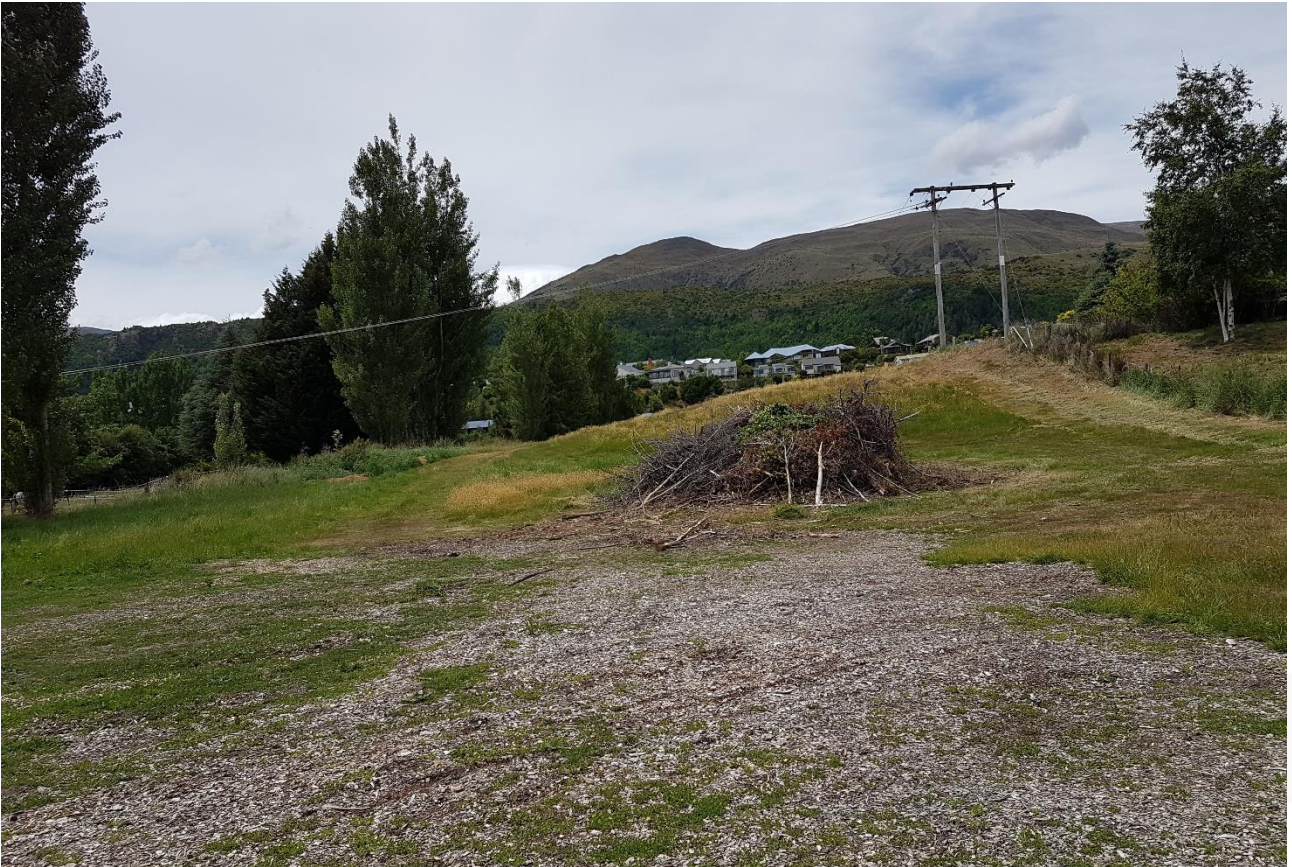
Plate 8: View west overlooking a pile of brush, wood and garden waste.

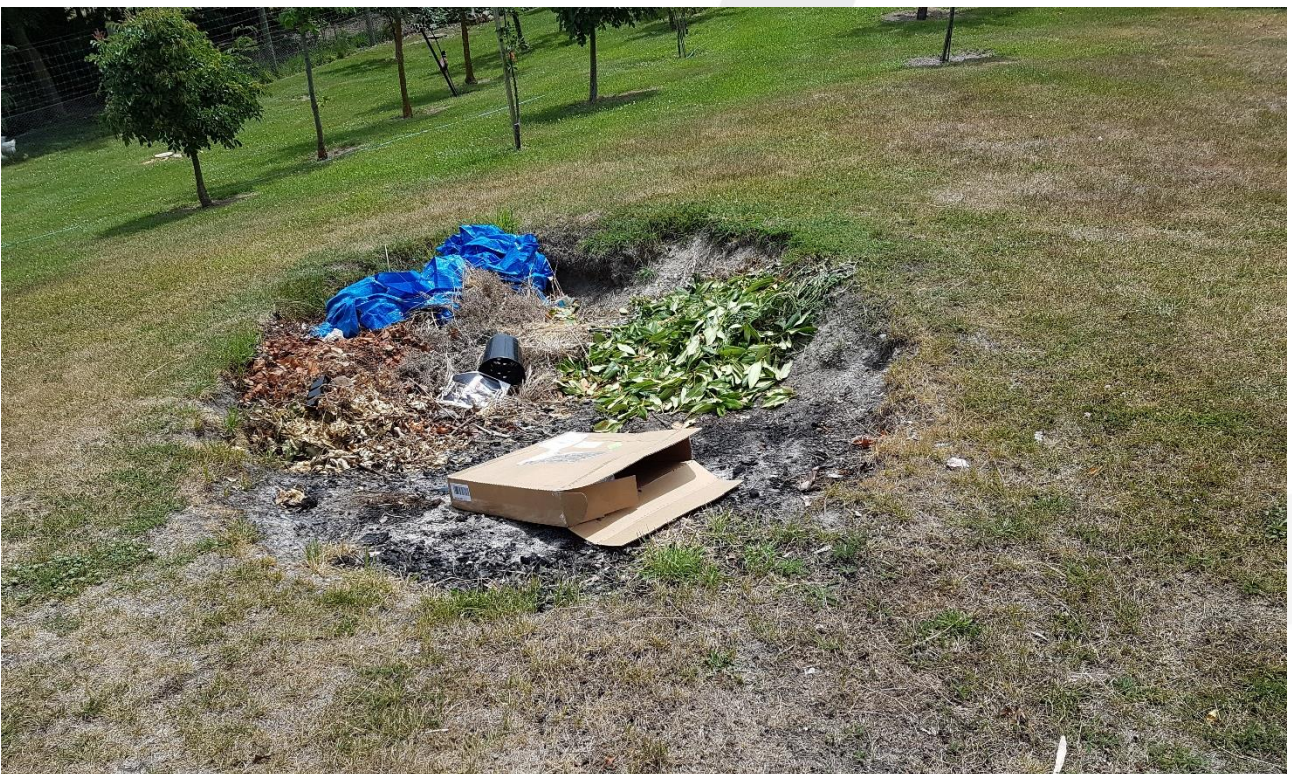
The potential contamination risk arising from the area of burnt ground was not investigated as it is to remain within the garden area of the current residential lifestyle property with no change in land use. No samples were taken from the area of the site adjacent to the substation. The site is located both hydrogeologically and topographically above the substation and as such the risk of migration of potential contamination on to the site from the adjoining substation is considered low.

Plate 9: Pile of waste in an area that has been previously used for burning.

The potential contamination risk arising from the area of burnt ground was not investigated as it would be remaining within the garden area of the current residential lifestyle property with no change of use proposed. No samples were taken from the area of the site adjacent to the substation. The site is located both hydrogeologically and topographically above the substation and as such the risk of migration of potential contamination on to the site from the adjoining substation is considered **low**. No potential sources of contamination were identified across the remaining sections of the site, however based on the homogeneity of soils across the site, findings of the site inspection and inference of the chemical analysis undertaken in the orchard, the risk to human health associated with potential contamination in the near surface soils across the remainder of the site is also considered to be **low**.

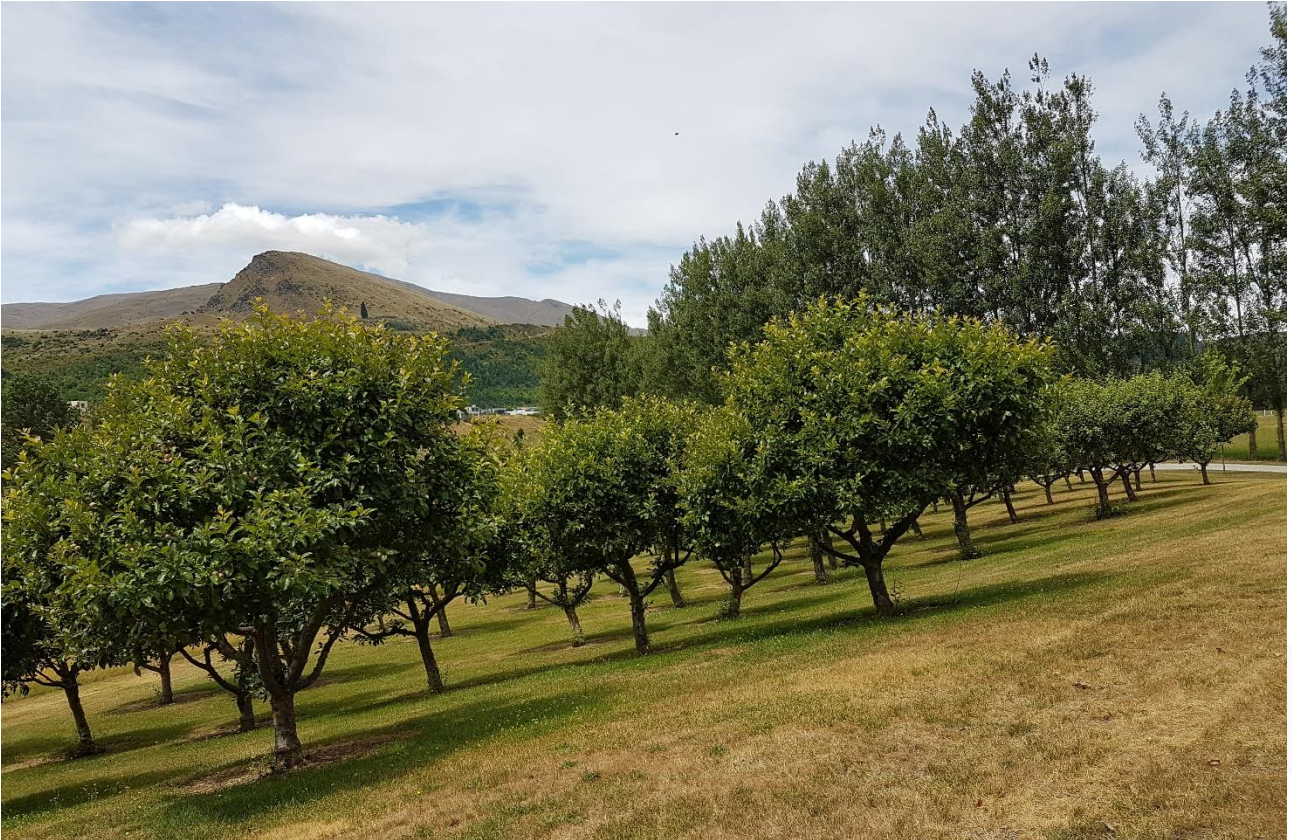
- Anecdotal evidence indicates that orchard spraying activities were undertaken on the site within the orchard area, between 1994 and 2001.
- Development proposals indicate that the site is to undergo a thirteen lot subdivision (with approved potential development platforms on each lot), with an associated a change of land use and future potential development;

Plate 12: The small apple orchard.

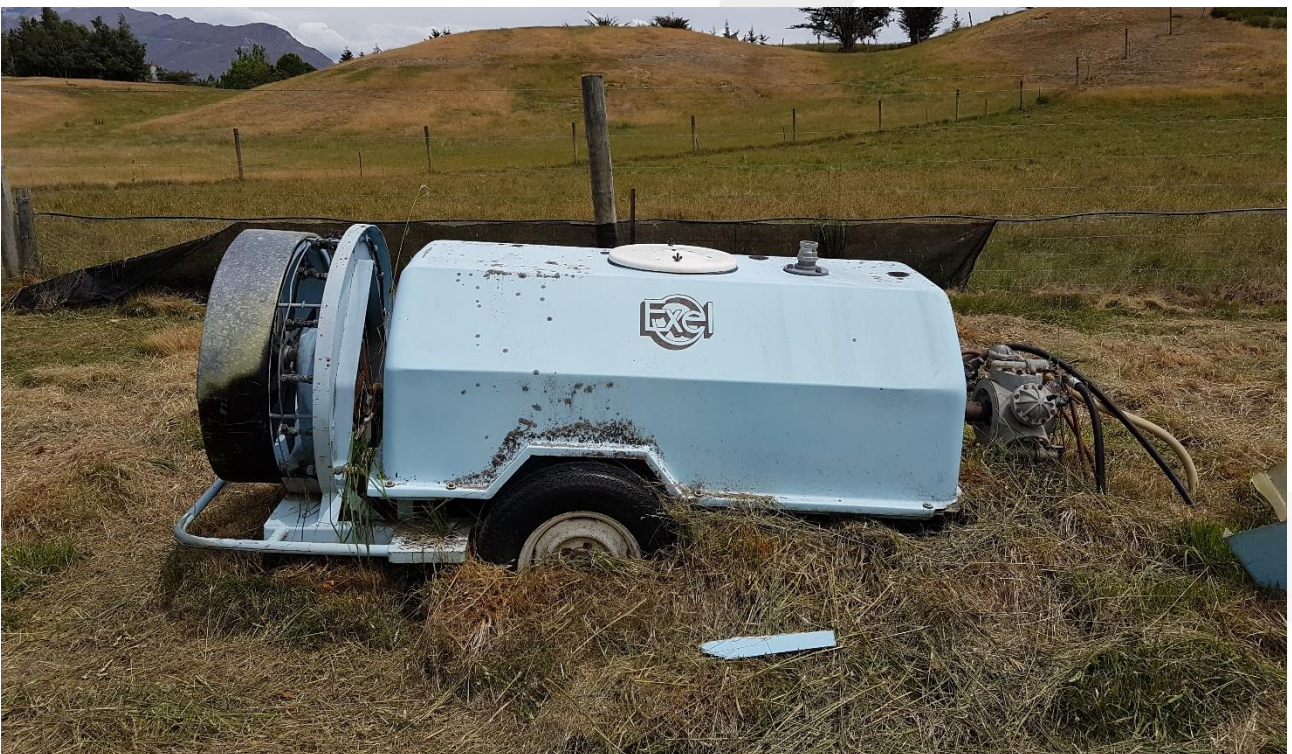
Plate 13: Unused spray equipment.

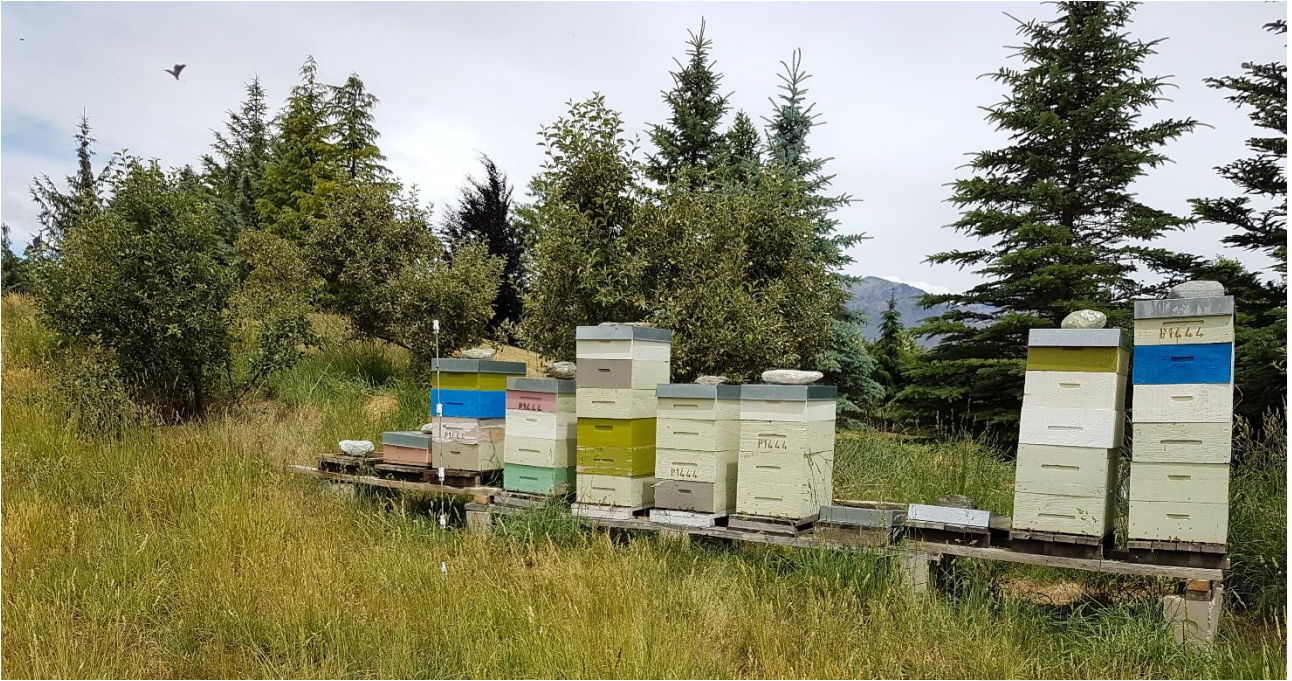
- There are several sheds/ ancillary buildings noted in the south of the site, these include some animal pens. Bee hives are noted in the centre of the site

Plate 14: Beehives.
