Hazards Register Part II Stage 2 Risk Management Study Report

Volume 1

Date: July 2002

Report No SPT 2002 / 22
Reference: 5C0185.00
Status: Final

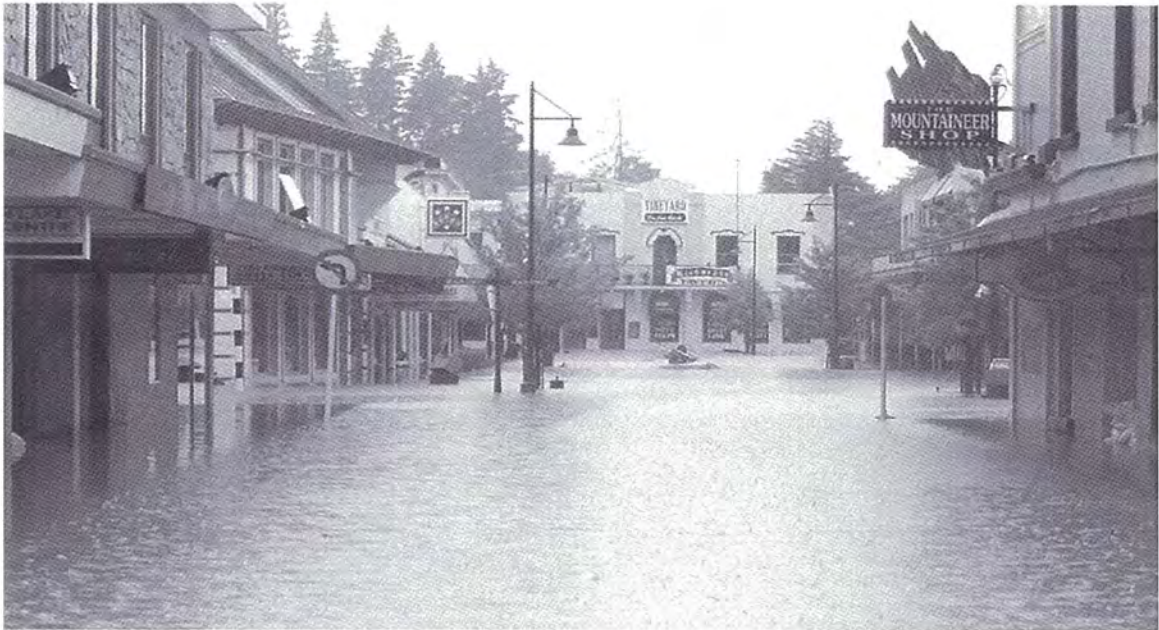
Photograph 1: Flooding at Rees Street, Queenstown, 17 November 1999
Photo: Otago Daily Times

Following the November 1999 flood (see Photographs 1 and 2), the Otago Regional Council updated the flood frequency analyses for Lakes Wakatipu and Wanaka, and for the Clutha River at Alexandra and Balclutha (ORC, 2000a). The Crown with support from local District and Regional Councils commissioned a project to investigate practicable solutions for the Clutha River flooding issues following the damage caused by the November 1999 flood. The report from this investigation (Clutha Solutions Co-ordinator, 2000) identified the issues associated with the 1999 flooding, and provided a range of recommendations. The *Flood History in the Clutha Catchment* by Opus (2000b) presents a comprehensive review of flooding in the catchment, covering the major flood events since the 1800's to 1999.

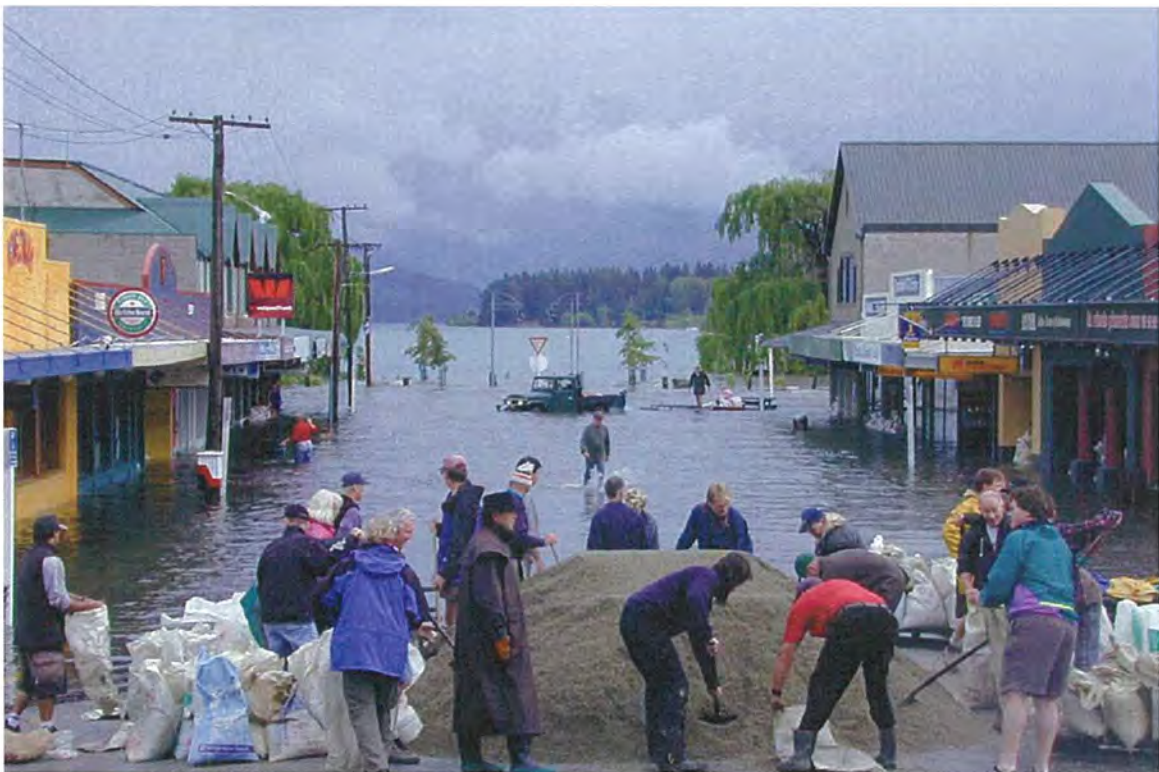
Photograph 2: Flooding at Helwick Street, Wanaka, November 1999
Photo: Otago Daily Times

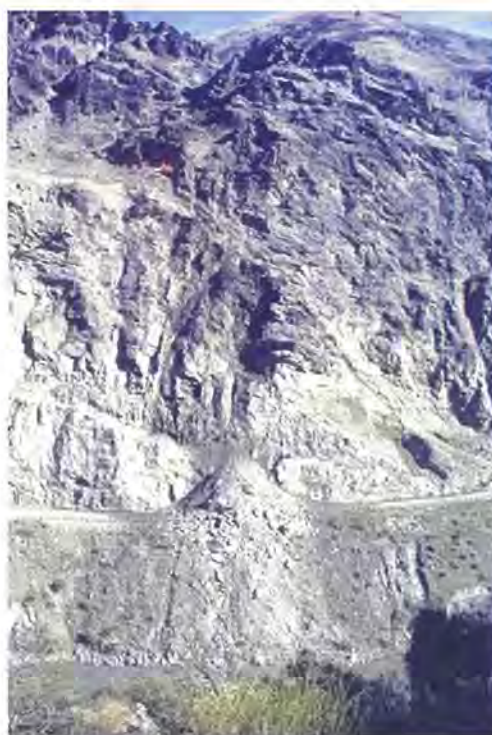
Photograph 3 - Rock Slope Failure at Nevis Bluff, along State Highway 6

Rock fall hazard has been identified in a number of areas such as Nevis Bluff, where a large rock fall / rock slide recently affected the highway, see Photograph 3. However this is outside the priority areas identified by the Council. There are also large rocks on relatively steep hillsides which present a rock fall hazard, eg in Peninsula Hill. The rock falls may be triggered by rainfall or earthquakes. These have the potential to affect areas downhill of the hillsides.

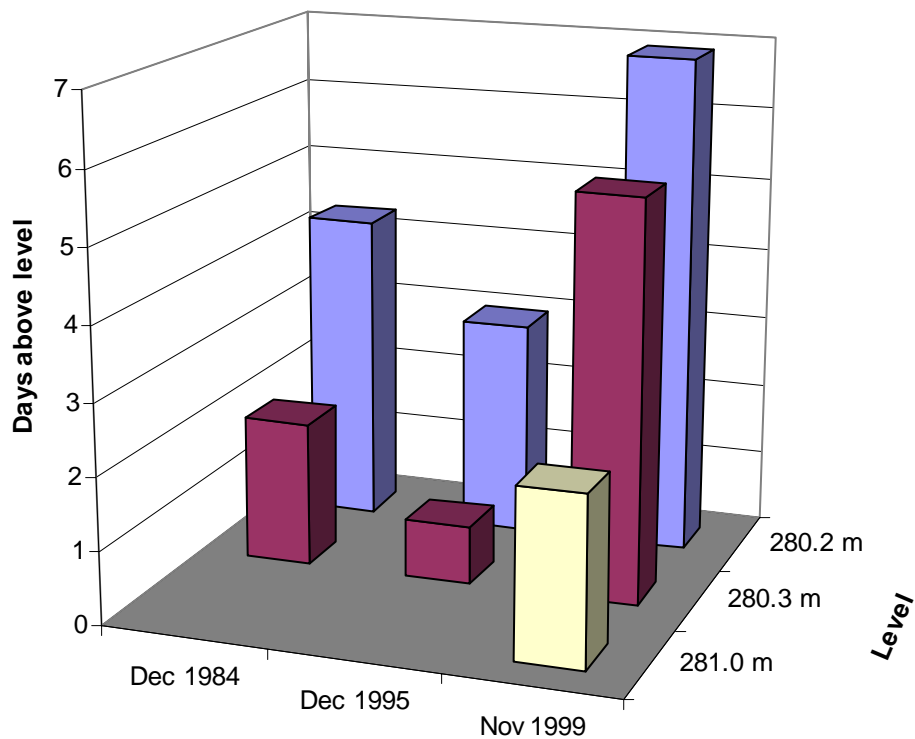
Figure 4. Lake Wanaka flood durations above certain levels.

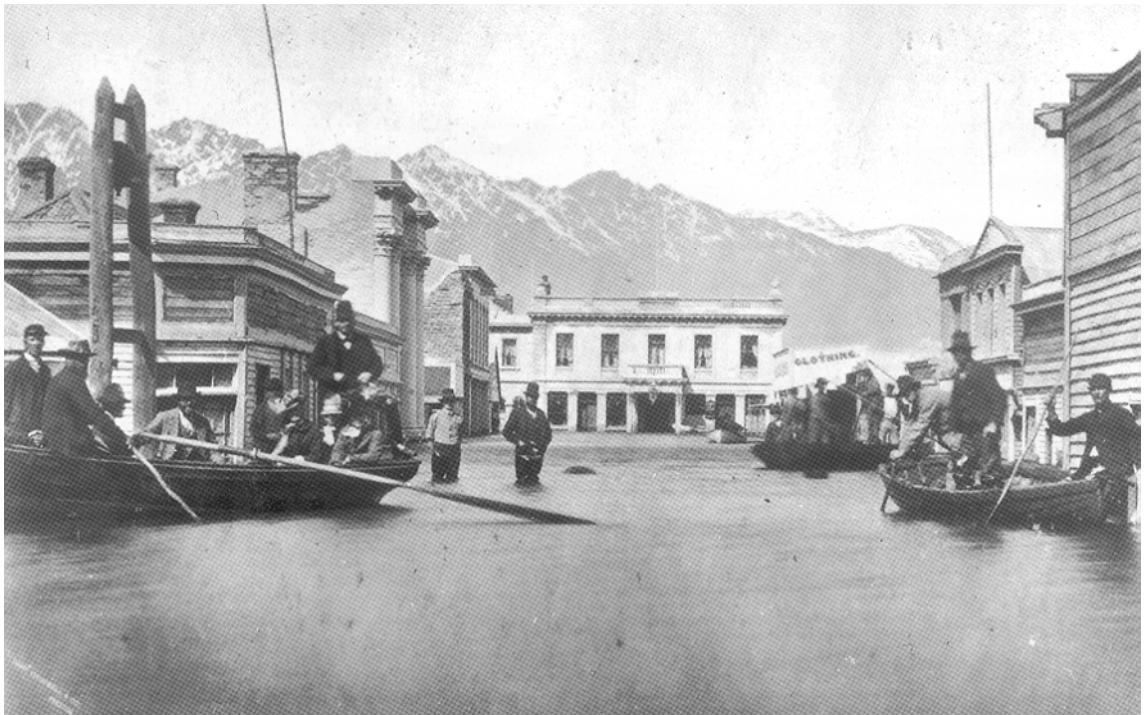
Photograph 1: 1878 view along Rees Street, Queenstown with water up to the base of windowsills at Eichardt's Hotel. Photo: Otago Daily Times

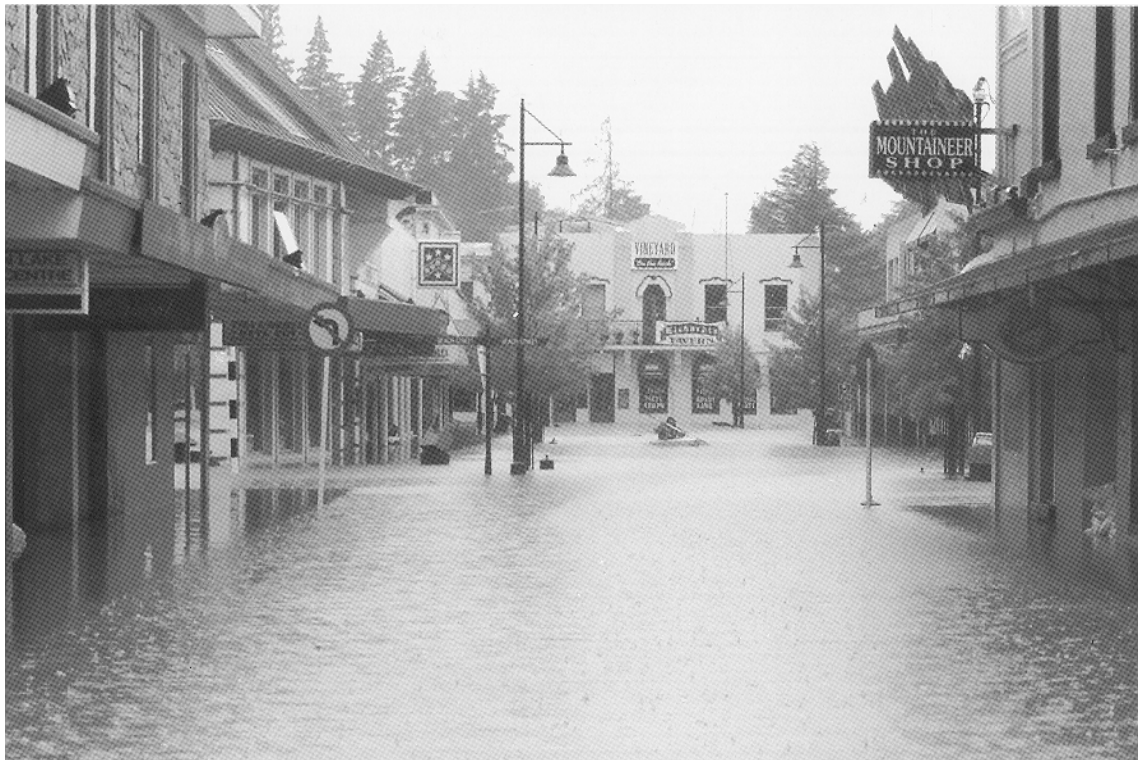
Photograph 2: 17 November 1999, the same scene during the 1999 flood, well before the flood peak. 1999 flood peak level was up to the window sills (see also Photograph 8). Photo: Otago Daily Times.

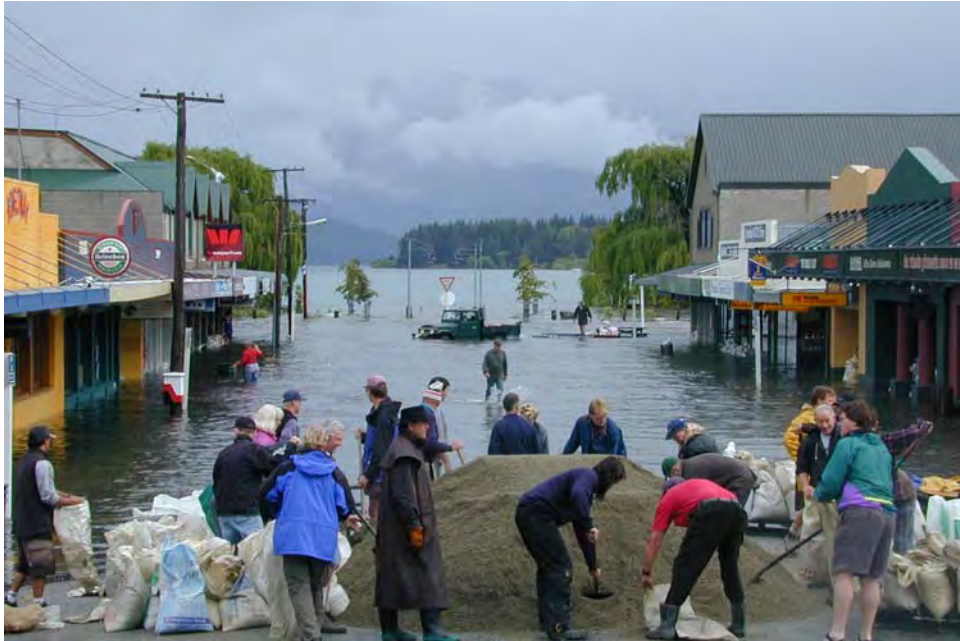
Photograph 3: Flooding at Wanaka, Helwick Street, November 1999. Photo: Otago Daily Times.

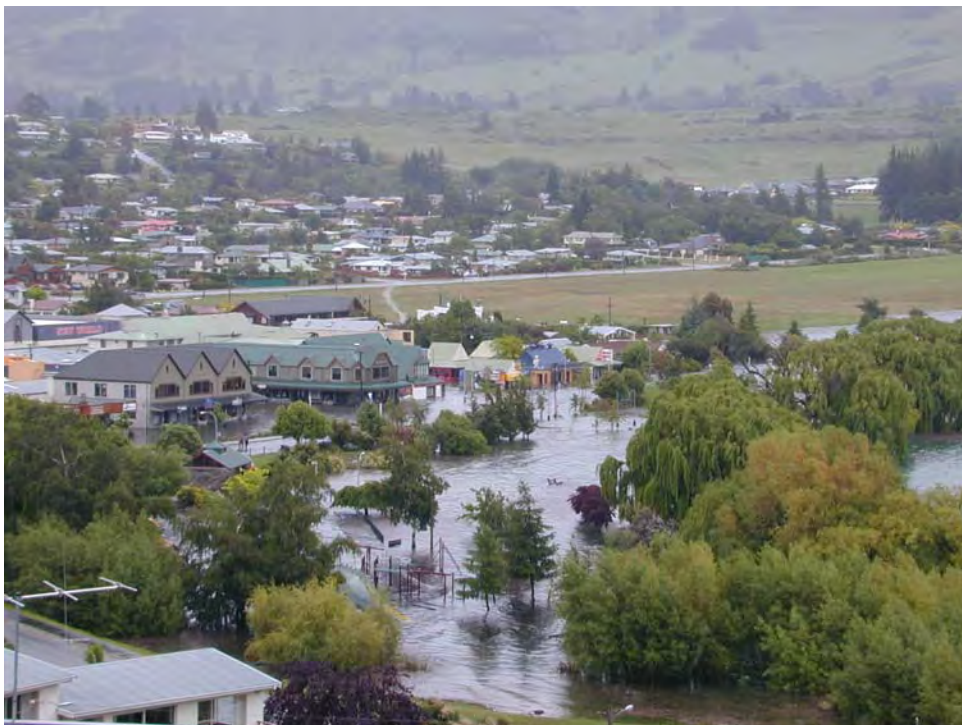
Photograph 4: Lake Wanaka spills across Ardmore Street and into the shopping area, November 1999. Photo: Otago Daily Times.
