Ladies Mile Master Plan Preliminary Site Investigation

January 2021

**Ladies Mile Master Plan
Preliminary Site Investigation**

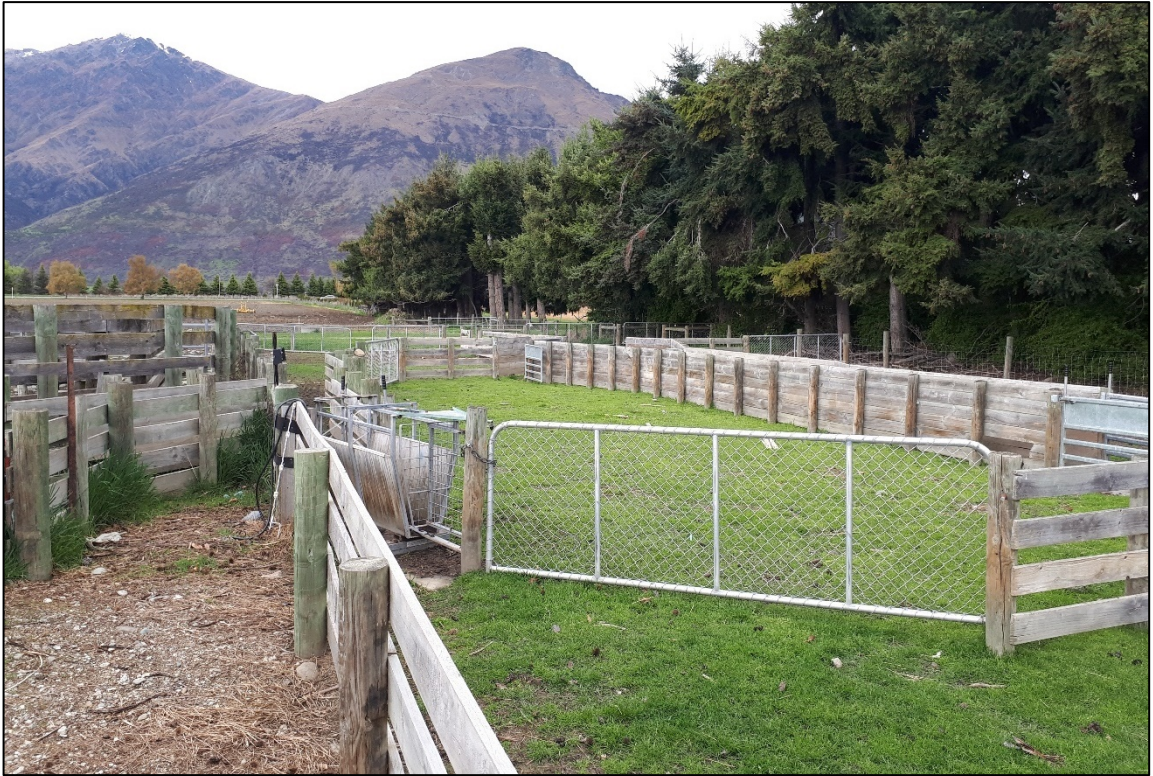
Figure 8: Stockyards at 28 Strains Road.

Between 2004 and 2010, stockyards were established at 28 Strains Road. Given the yards were established after 2004, it is highly unlikely that heavy metals or persistent organic pollutants are present at the site as a result of treating sheep. The Ministry for the Environment's 2006 guideline 'Identifying, Investigating and Managing Risks Associated with Former Sheep-dip Sites' (the Sheep-Dip Guidelines) describe recent chemicals (organophosphates and synthetic pyrethroids and insect growth regulators) as readily breaking down, and so are not identified as persistent chemicals of principal concern (Ministry for the Environment, 2006).

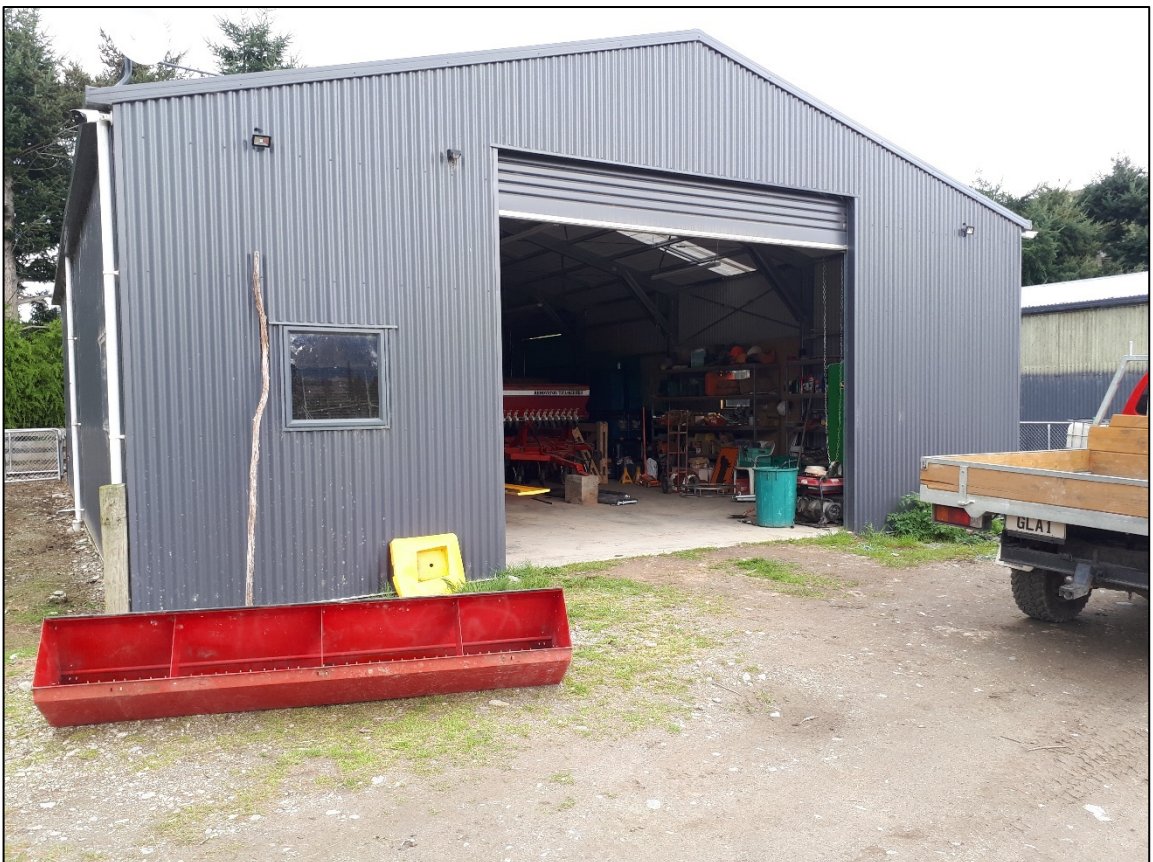
Figure 9: Workshop at 28 Strains Road.

During the site inspection, the site was in active use as a farm hub. The hanger is present on site and used for equipment storage. The shed next to the existing hanger is used as a general workshop for maintenance and repair of farm vehicles. An empty above ground fuel tank is stored along the western boundary of the site. Fuel is supplied from a mobile trailer. A 1000 L intermediate bulk container of waste oil was located outside of the hanger. There was no evidence of any animal dips or spray races at the stockyards, or bulk fertiliser storage associated with the previous use of the airstrip.

Further investigation is recommended to assess the risk to human health under the NESCS if land use change or soil disturbance are proposed in this area.

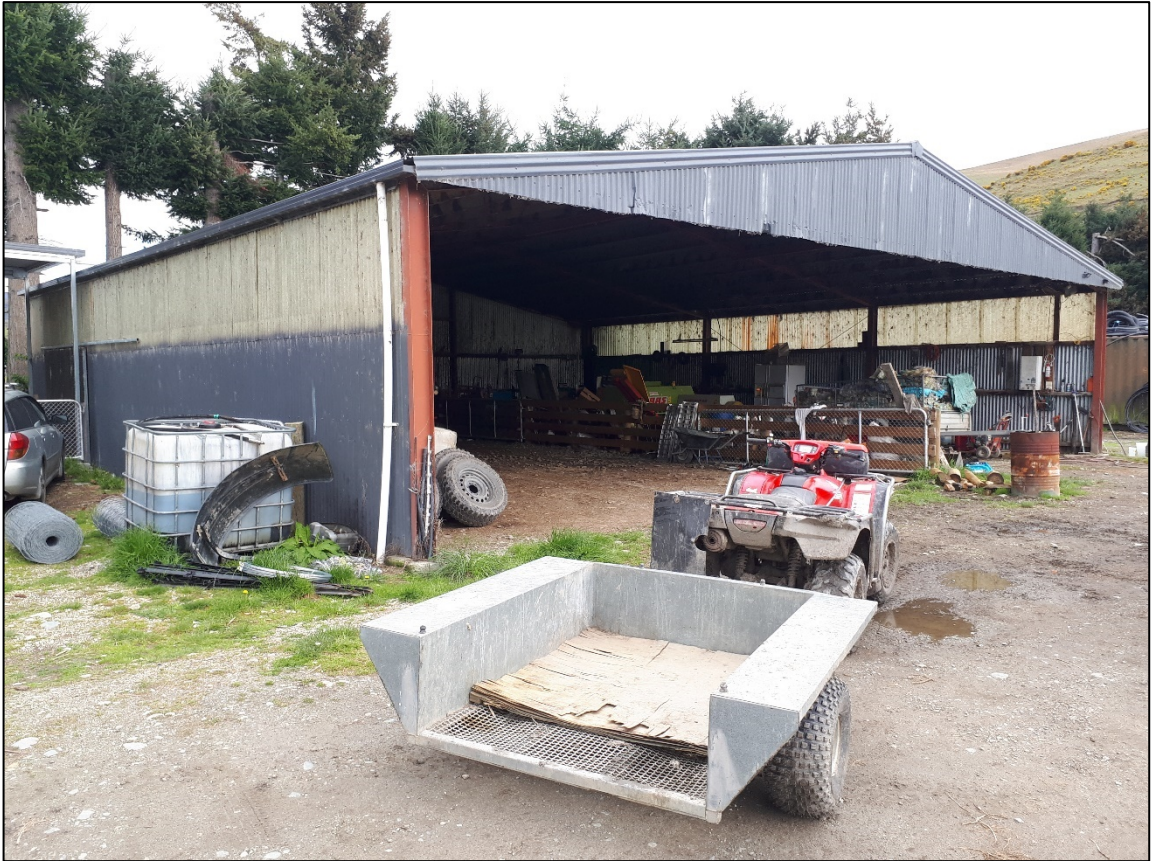
Figure 11: Former hanger building at 28 Strains Road.

The hangar was associated with a rural airstrip, which is visible in the 1976 and 1979 historic aerial photographs, as well as the 1999 topographic map. Rural airstrips are commonly associated with bulk fertiliser storage for loading top dressing planes. If storage and handling of fertiliser was undertaken at the site for top dressing, it most likely took place near the hangar, within close proximity to road/track access.

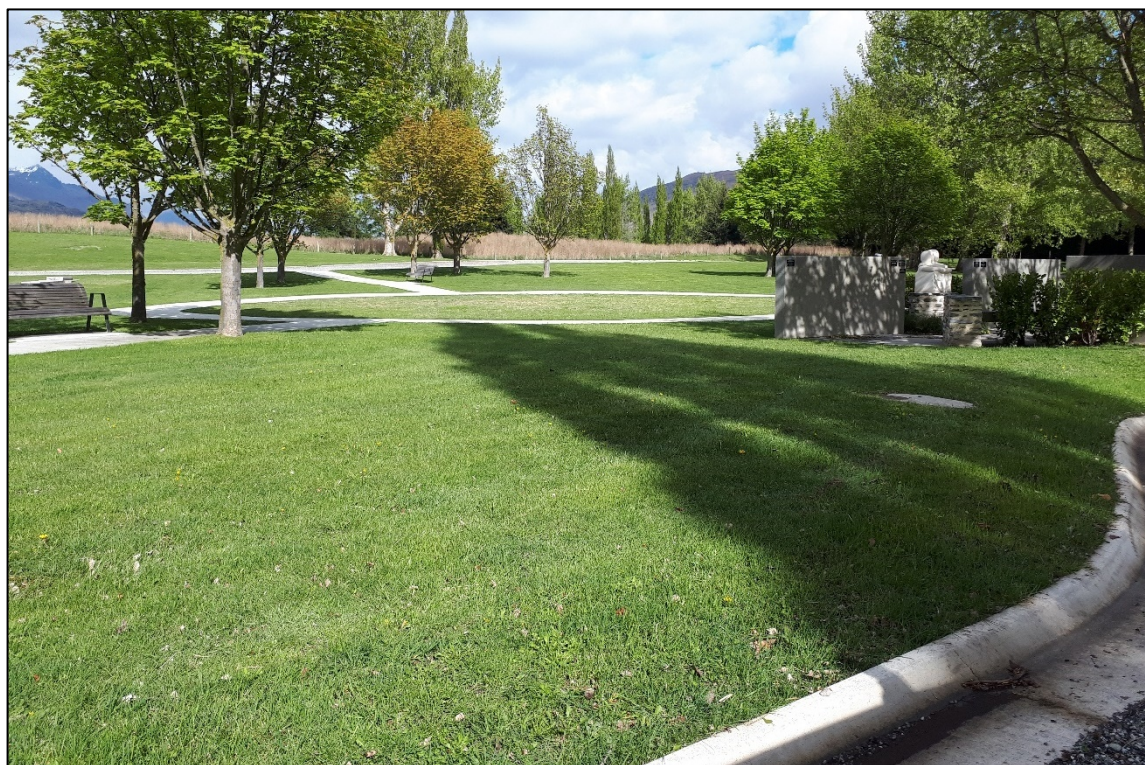
Figure 13: Lower Shotover Cemetery

The Lower Shotover Cemetery is located on Spence Road. Land currently used for burial is located within Part Section 62 Block III Shotover SD, Part Section 888R Block III Shotover SD and Part Section 62 Block III Shotover SD.

Hazardous substances that may be associated with this land use include nitrates, lead, mercury, formaldehyde, and biological hazards. Although it is unlikely that the cemetery will change use as part of future development, further investigation may be required to assess the risk to human health if land use change on or adjacent to the site is proposed, as cemeteries can pose a risk to groundwater.

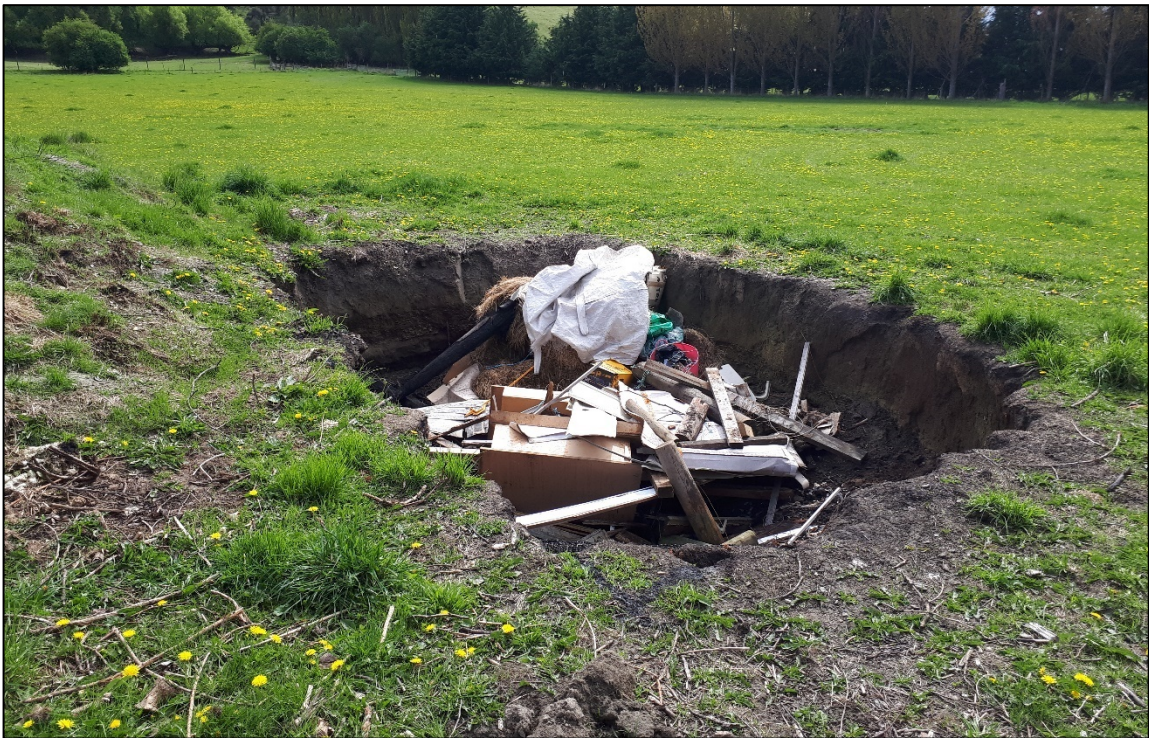
Figure 14: Farm landfill on Pt Sec 46 Blk III Shotover SD.

plastic, and wiring. There was evidence of the contents having been previously burned.

Contaminants of concern include heavy metals, petroleum hydrocarbons, and pesticides. Further investigation is recommended to assess the risk to human health under NESCS if land use change or soil disturbance are proposed in this area.

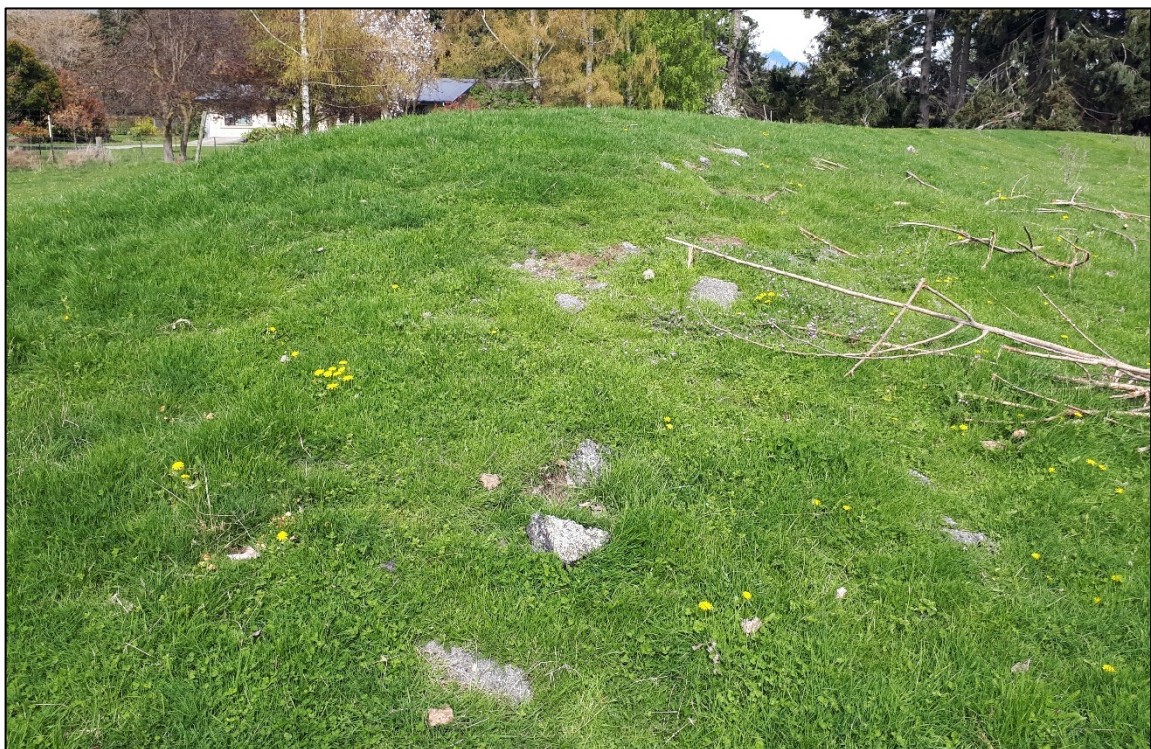
Figure 15: Raised mound located on Pt Sec 50 Blk III Shotover SD.

A wide range of potential contaminants can be associated with uncontrolled fill. To characterise uncontrolled fill, a broad analytical suite is recommended, including heavy metals, asbestos and petroleum hydrocarbons.

Further investigation is recommended to assess the risk to human health under NESCS if land use change or soil disturbance are proposed in these areas.

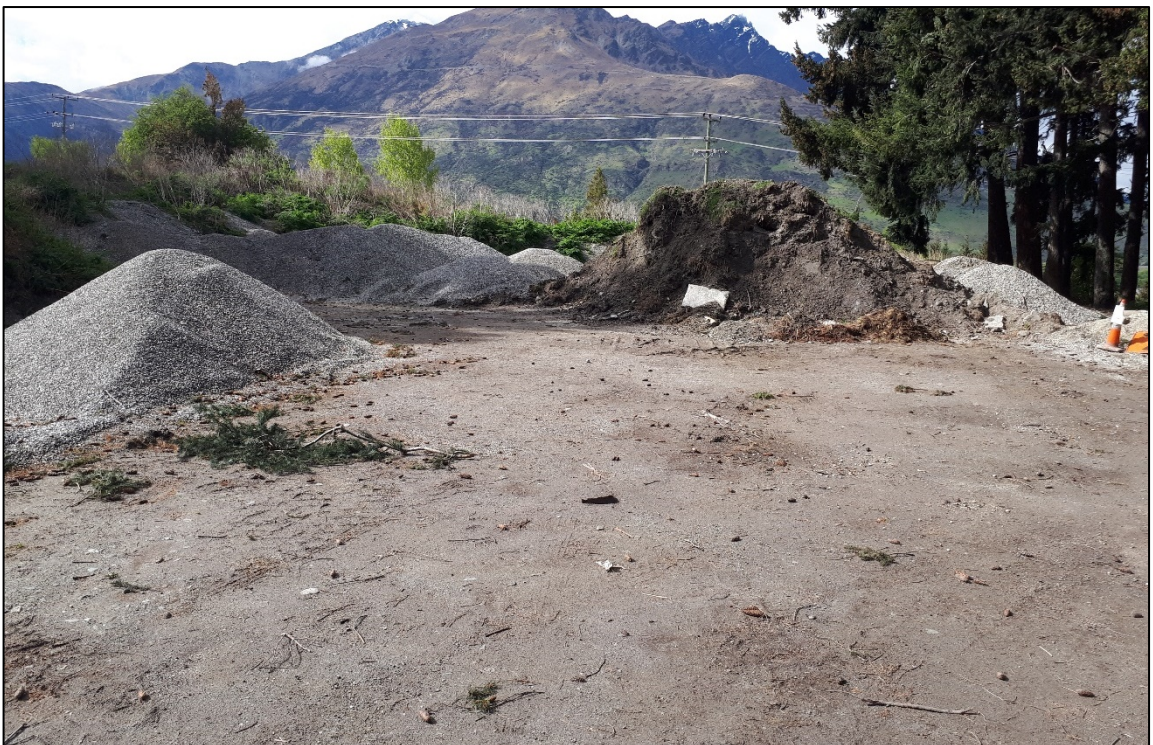
Figure 17: Stockpiles of material within Sec 159 Blk III Shotover SD.

Sec 159 Blk III Shotover SD – Sec 159 Blk III Shotover SD, located on Spence Road, is currently used as an aggregate and topsoil storage area. During the site inspection, it was observed that, within the pines, there had been filling over the embankment and some areas of illegal dumping.

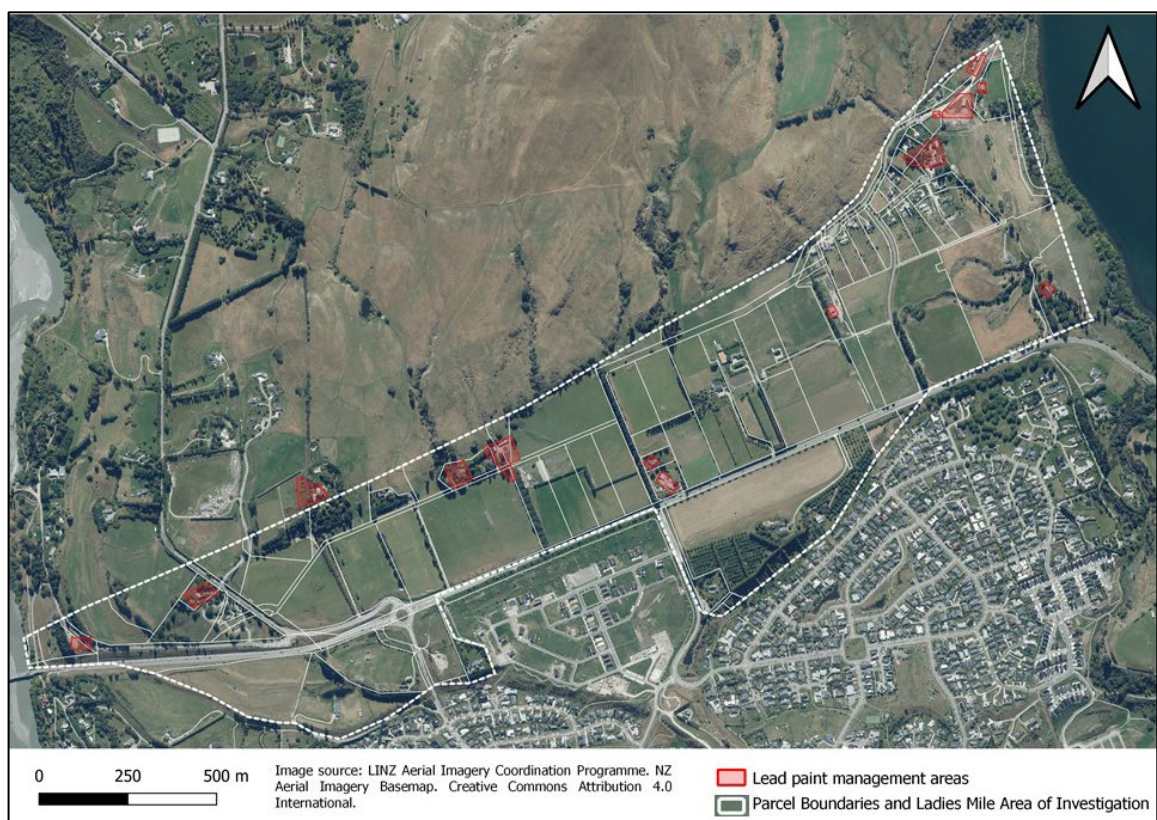
Figure 20: Lead Management Areas

Potential lead management areas are marked in Figure 20.

In many cases, the identified buildings will not contain lead painted exteriors (for example, brick houses), and these sites do not meet the 'more likely than not' threshold to be considered HAIL. However, if development is proposed within these areas, including change of land use, or earthworks, further assessment should be completed to determine likelihood of lead impacts to soil in sufficient concentration to pose a risk to human health.

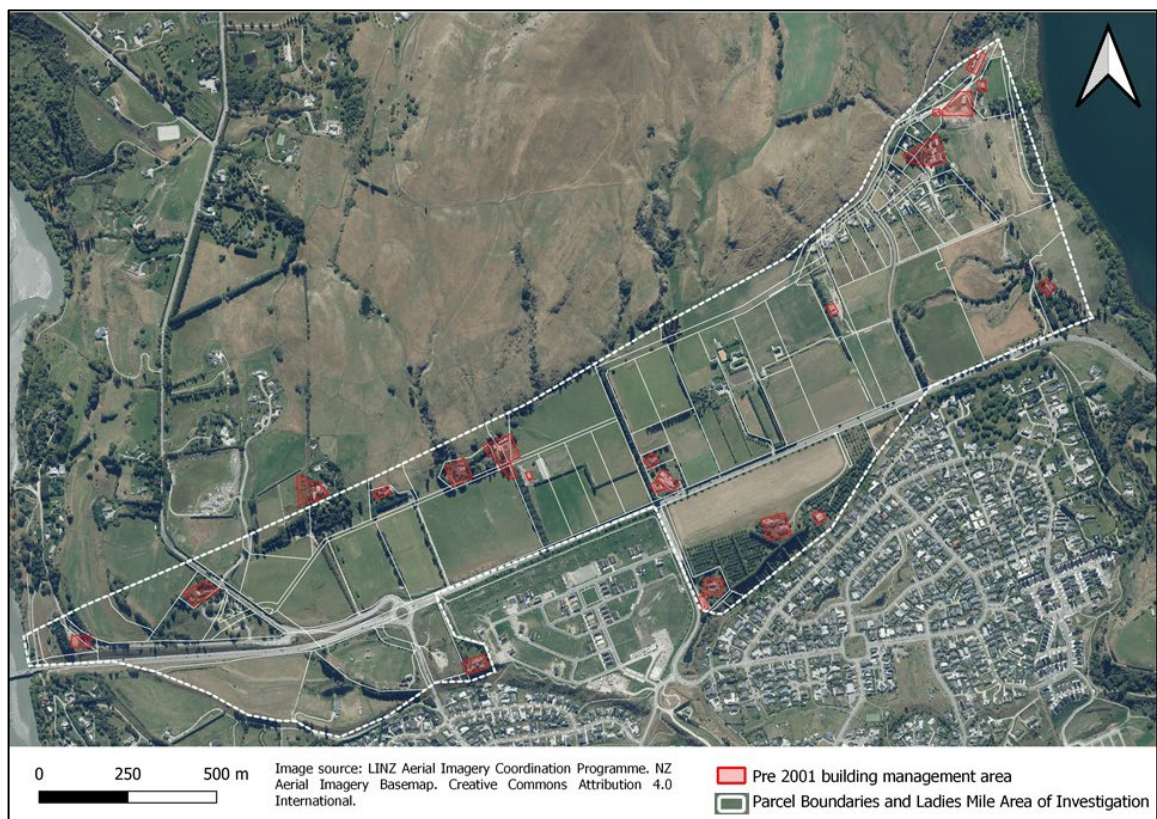
Figure 21: Pre-2001 Buildings

The outlines of buildings constructed prior to 2001 (the nearest aerial photograph to 2000) were used as a conservative cut-off for the potential presence of asbestos. Buildings were identified by cross referencing the NZ Building Outlines GIS layer from the LINZ data service, with 1959, 1976, 1984 and 2001 aerial photographs. Small temporary buildings present during rural land use that were most likely hay sheds, constructed from timber, have been omitted.

Pre 2001 buildings are marked in Figure 21.

In many cases, the identified buildings will not contain asbestos in a deteriorated condition and these sites do not meet the 'more likely than not' threshold to be considered HAIL. However, if development is proposed within these areas, including change of land use, or earthworks, further assessment should be completed to determine likelihood of asbestos impacts to soil.

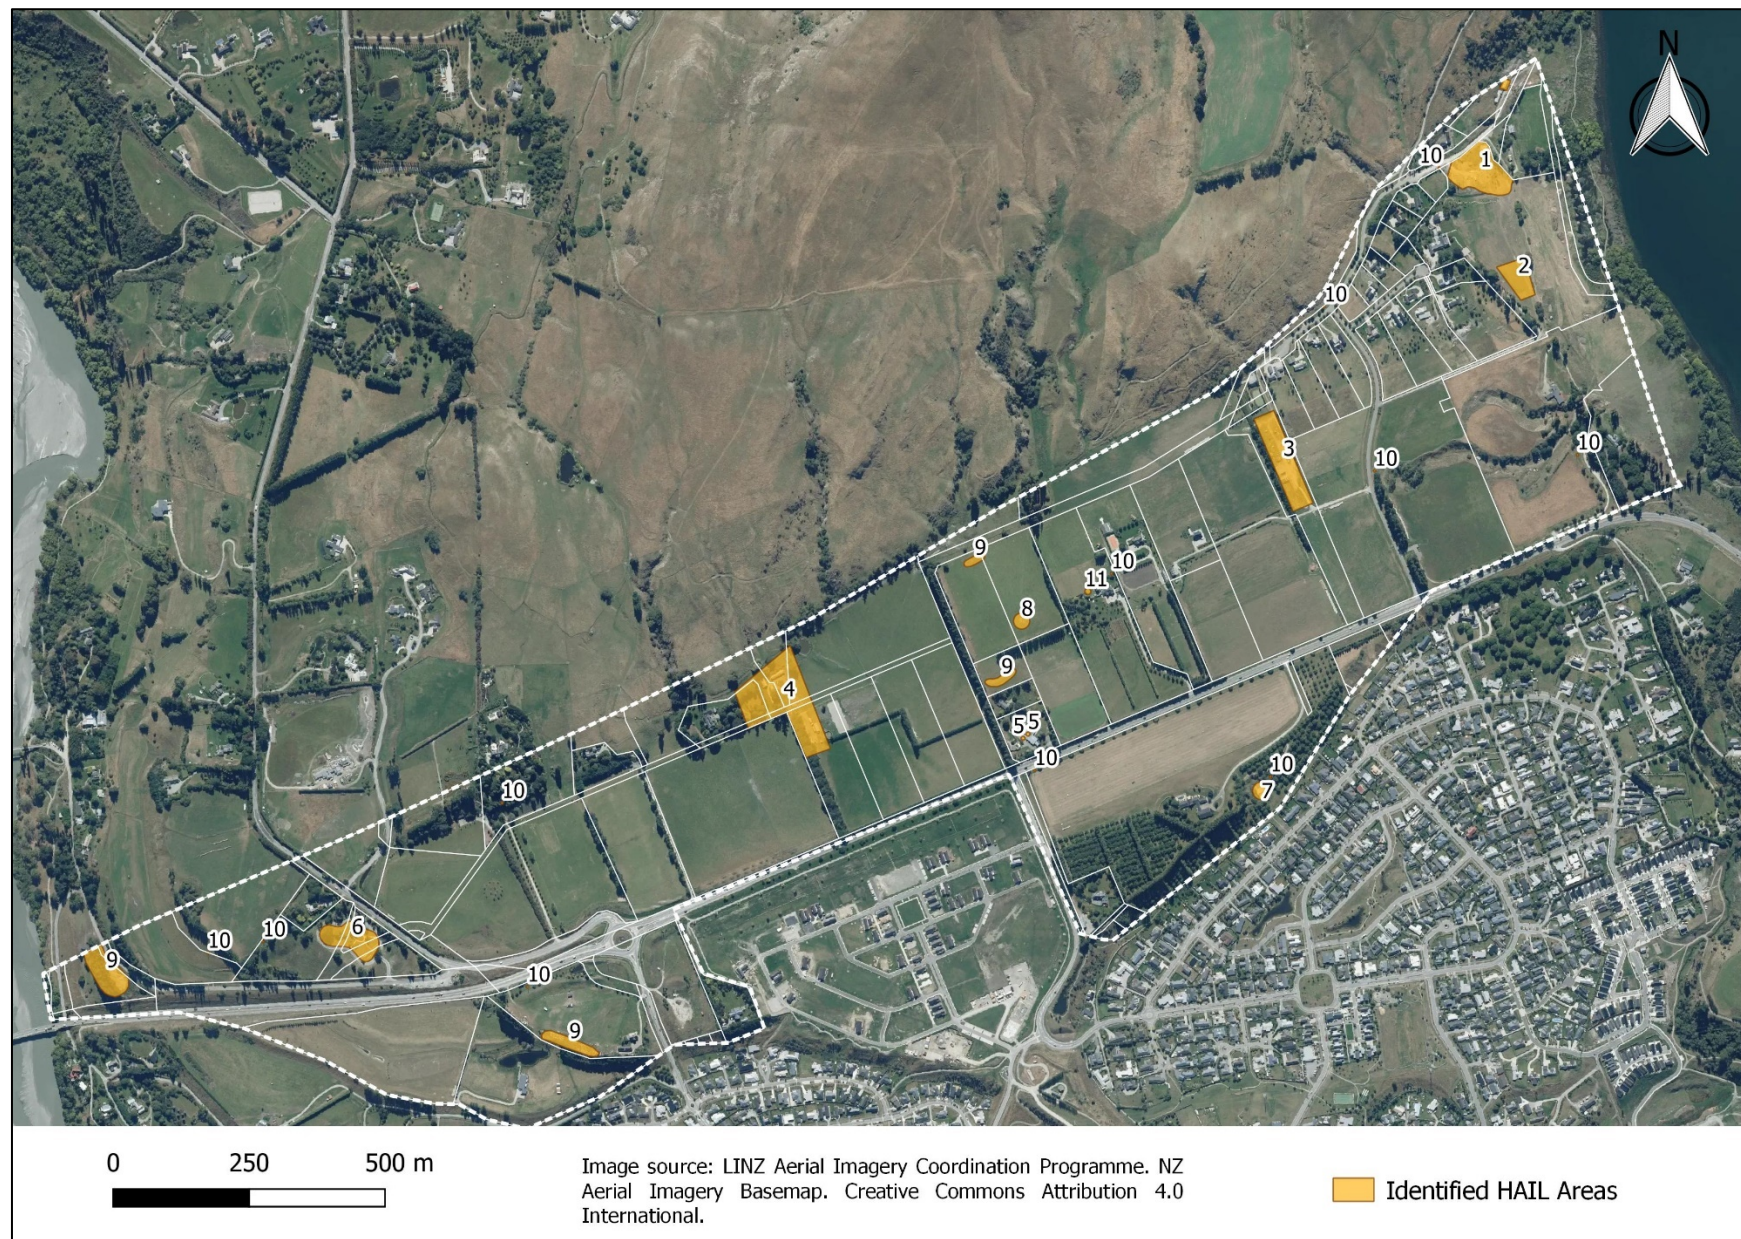
Figure 22: Identified HAIL sites

Legal description / Address	HAIL Category	Contaminants of concern	Recommendations
<p>Spence Road (Section 159 Block III Shotover SD) 33 Lower Shotover Road (Lot 1 DP 17388) Glenpanel Farm Hub (Lot 1 DP 20162, Lot 5 DP 463532, Lot 2 DP 463532, Lot 4 DP 463532) Ladies Mile Pet Lodge 465 – 467 Frankton-Ladies Mile Hwy (Lot 1 DP 12822 & Lot 16 DP 12921) 28 Strains Road (Lot 2 DP 475308) Threepwood farm buildings (Lot 1 DP 542712, Lot 100 DP 542712, Lot 22 DP 378242, Lot 2 DP 388976)</p>	<p>I. Any other land that has been subject to the intentional or accidental release of a hazardous substance in sufficient quantity that it could be a risk to human health or the environment</p>	<p>Lead and other heavy metals</p>	<p>Further investigation may be required to assess the risk to human health under NESCS if activities listed under the NESCS are proposed.</p>
<p>Spence Road (Section 159 Block III Shotover SD) 33 Lower Shotover Road (Lot 1 DP 17388) Glenpanel Farm Hub (Lot 1 DP 20162, Lot 5 DP 463532, Lot 2 DP 463532, Lot 4 DP 463532) Ladies Mile Pet Lodge 465 – 467 Frankton-Ladies Mile Hwy (Lot 1 DP 12822 & Lot 16 DP 12921) 28 Strains Road (Lot 2 DP 475308) Threepwood farm buildings (Lot 1 DP 542712, Lot 100 DP 542712, Lot 22 DP 378242, Lot 2 DP 388976) 396 Frankton-Ladies Mile Hwy (Lot 1 DP 27866) 399 Frankton-Ladies Mile Hwy (Lot 1 DP 22874) 466 Frankton-Ladies Mile Hwy (Lot 2 DP 536321)</p>	<p>E1. Asbestos products manufacture or disposal including sites with buildings containing asbestos products known to be in a deteriorated condition</p>	<p>Asbestos</p>	<p>Further investigation may be required to assess the risk to human health under NESCS if activities listed under the NESCS are proposed.</p> <p>Buildings identified for demolition should be assessed for asbestos containing material. If asbestos building materials are present, development within these areas will require management in accordance with the Health and Safety at Work (Asbestos) Regulations 2016. Management measures during building removal or demolition should include the management of asbestos in soil.</p>
