Heritage Incentive Grant Application – Gravity Cottage, 9 Gorge Road, Queenstown

ARCHAEOLOGICAL ASSESSMENT

Archaeological Assessment of House & Site
9 Gorge Road, Queenstown

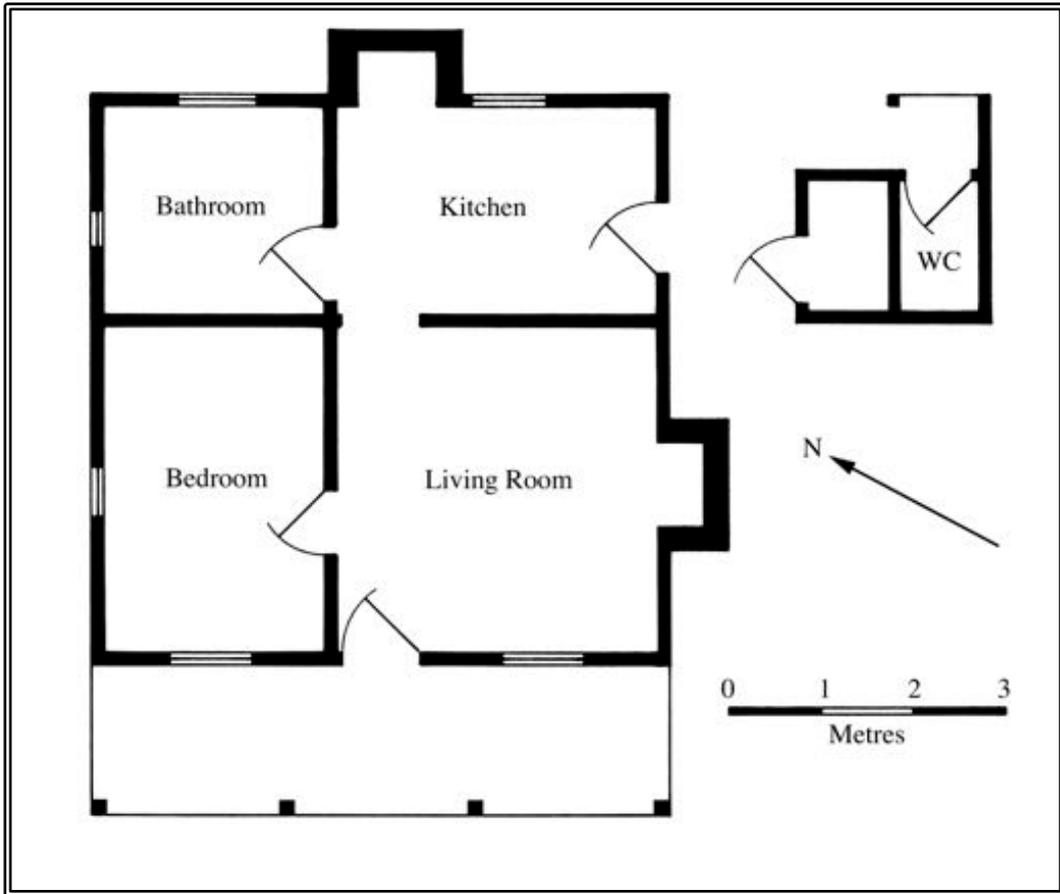
Figure 8
Floor plan of the cottage at 9 Gorge Road.

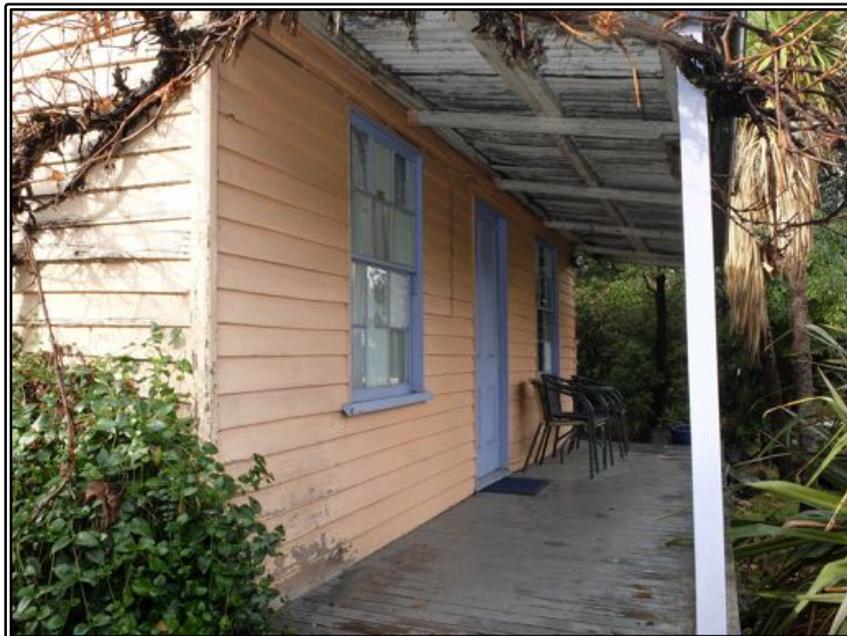
Figure 9

The front wall has the typical ‘Colonial Georgian’ proportions of a central door with a window placed symmetrically on either side. The door and windows all appear to be original. The door has four panels, and there is no ornamental architrave, just a ½ inch thick finishing board around the doorway. The windows are both 12 light sash windows, and again appear to be the original fittings. One is missing an astragal, with a double-sized pane inserted instead. Once again there is no ornamental architrave. It appears that the original door and windows (together with the wall itself) have been protected from the weather by the veranda, allowing them to survive in such good condition. The veranda itself is an original feature, but it is difficult to say which elements (if any) are original. The deck (Figure 13) is certainly relatively modern. The roof structure (Figure 12) is older, but close inspection would be necessary to determine if any of the timbers are original.

Looking along the front wall of the cottage. This wall is in the best condition of the four exterior walls because of the protection afforded by the veranda.

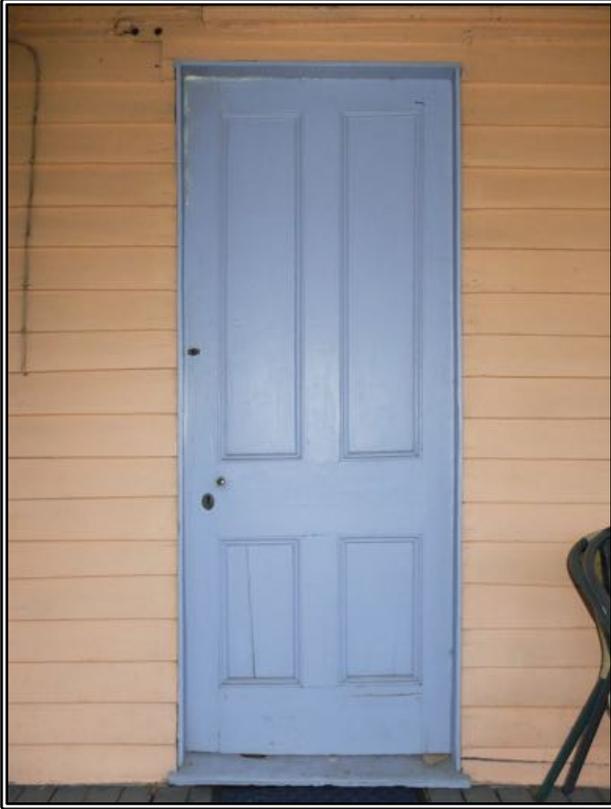
Figure 10
The front door of the cottage.

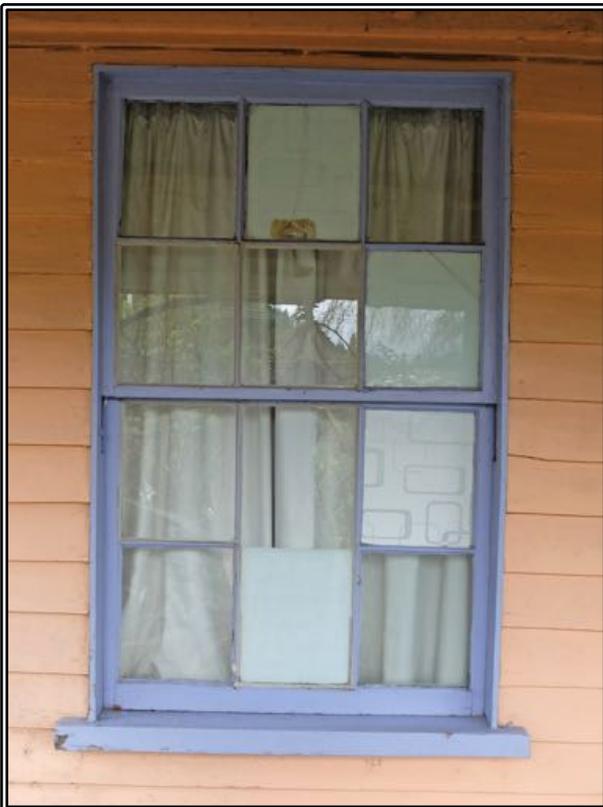
Figure 11
The left hand (north) front sash window of the cottage.

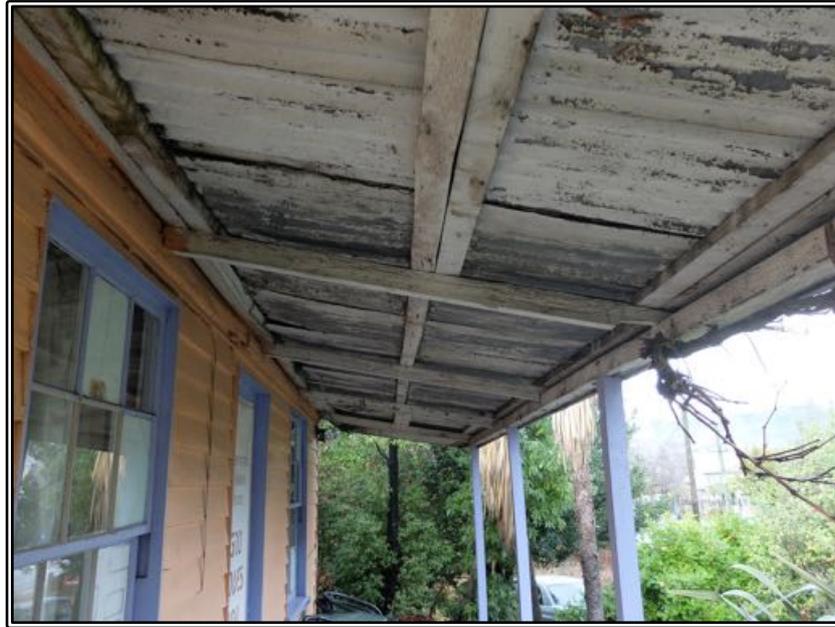
Figure 12
The veranda roof structure.

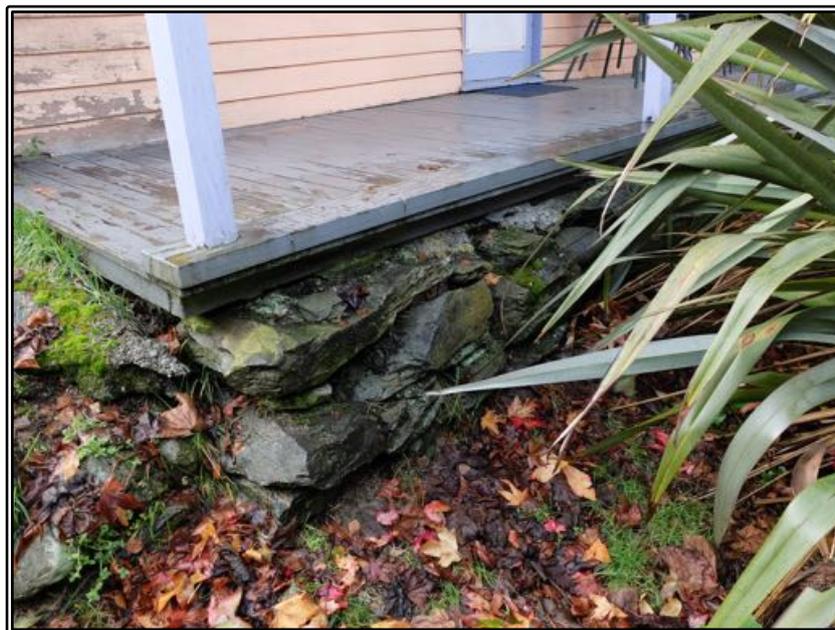
Figure 13
The veranda deck and supporting stone revetment.

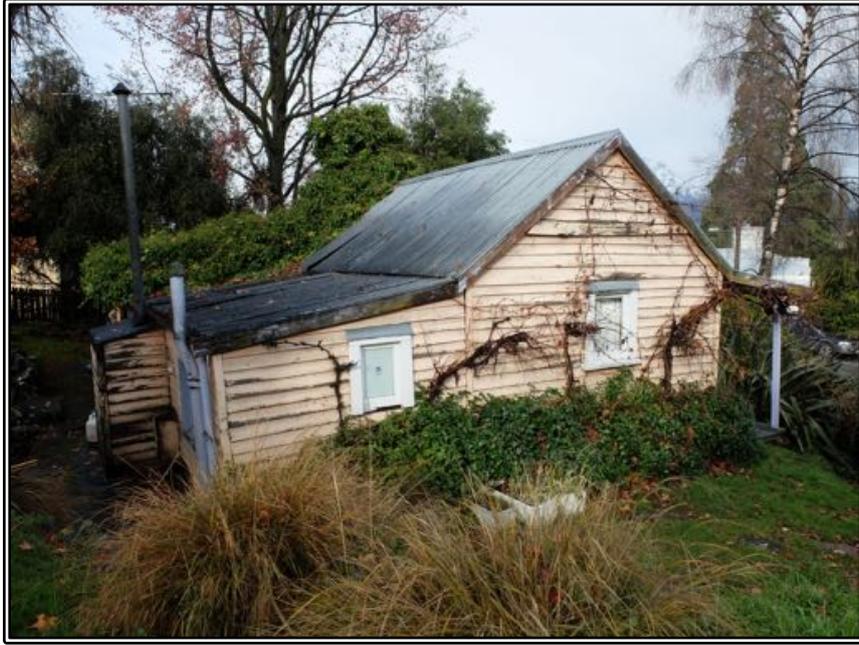
The north wall of the cottage (Figure 14) has two windows, neither of which is original. Both are single pane small casement windows with iron flashing above. One is in the centre of the gable end wall (for the bedroom) and one is in the lean-to section (for the bathroom). This wall is in need of maintenance, as the paint finish on the weatherboards is in poor condition (with missing patches) and the barge boards are almost devoid of paint. Garden plants cover the foot of the wall, which will be exacerbating dampness problems there. Pushing against the wall produced some movement, so there is possibly decay of the lower frame members.

Figure 14
The north end wall, showing the two casement windows.

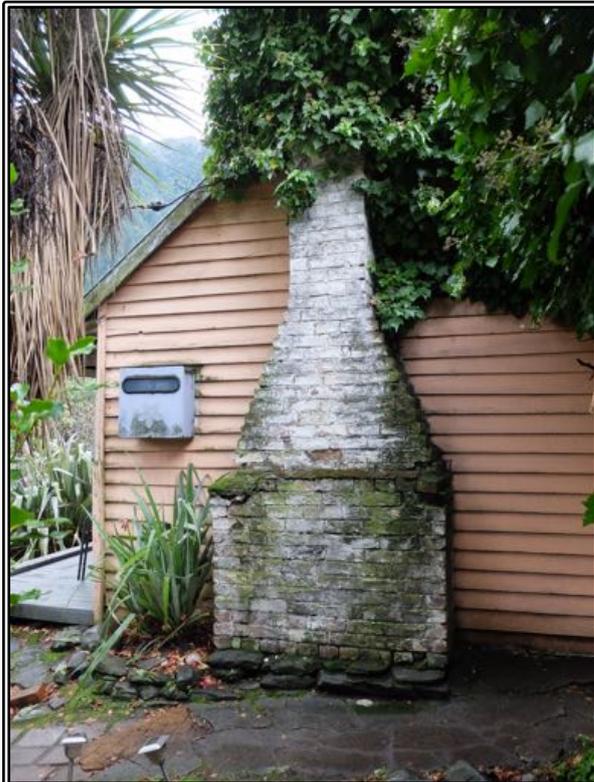
The south end wall (Figure 15) is occupied by the chimney and the back door to the house, and is linked to the outbuilding (discussed in more detail below). There are no window openings. The paint finishes are in moderate to poor condition, the bargeboards in particular being almost bare. The chimney appears generally sound, and is probably original as was built using lime mortar. This mortar is very soft and there are a number of loose bricks. Ivy covers the upper section of the gable, the upper section of the chimney and the entire top of the outbuilding. This not only obscures these features, but will be retaining moisture and causing mechanical damage.

Figure 15
The south wall of the cottage, showing the brick chimney and creepers.

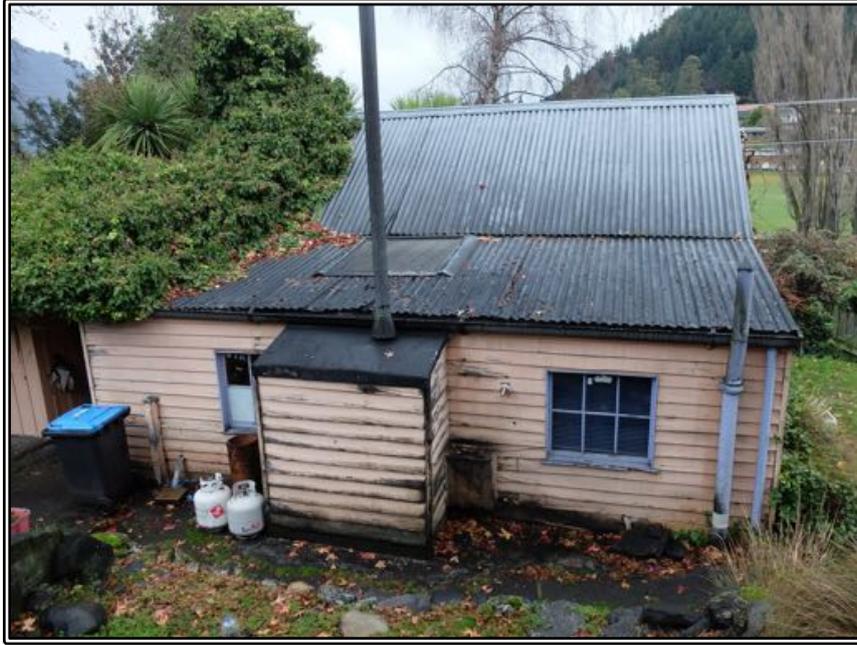
Figure 16

The rear (east) wall of the cottage includes two windows and the outwards projection for the cooker alcove in the kitchen. The windows are both six light, and do not open. They have similar detailing to the front sash windows, suggesting that they are of a similar age and are probably original. The alcove for the kitchen cooker (discussed in more detail below) is clad in similar weatherboards to the rest of the house, but it overlaps the southern rear window slightly (Figure 18), indicating that it is a later addition (again, discussed in more detail below). The paintwork on the rear wall is generally in moderate to poor condition, with considerable build up of dirt in some areas.

The rear (east) wall of the cottage, showing the small extension for the kitchen cooker alcove and the modern skylight let into the lean-to roof.

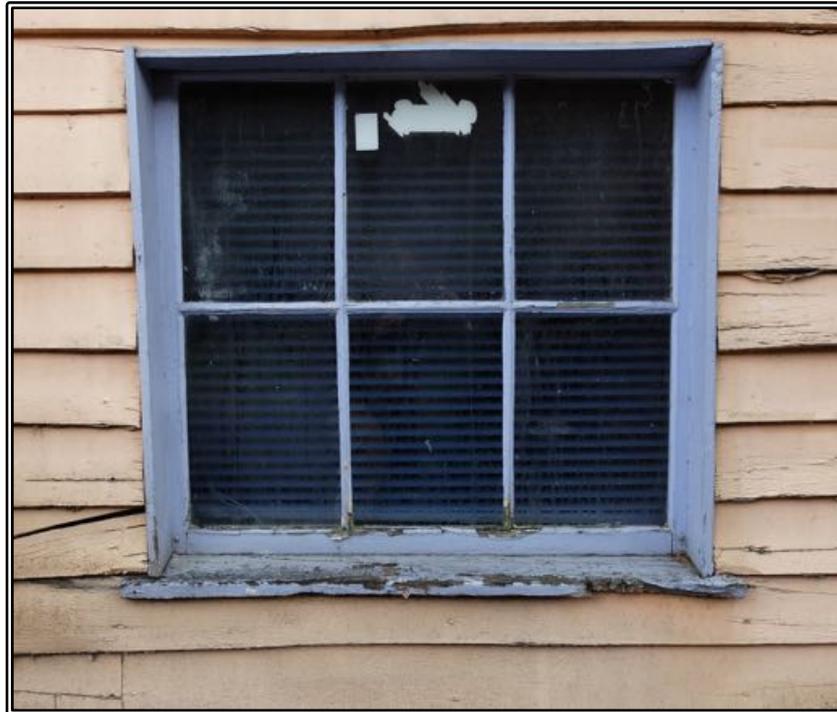
Figure 17

The northern of the two windows in the rear wall. The sill is in deed of repair, and splits can be seen in weatherboards.

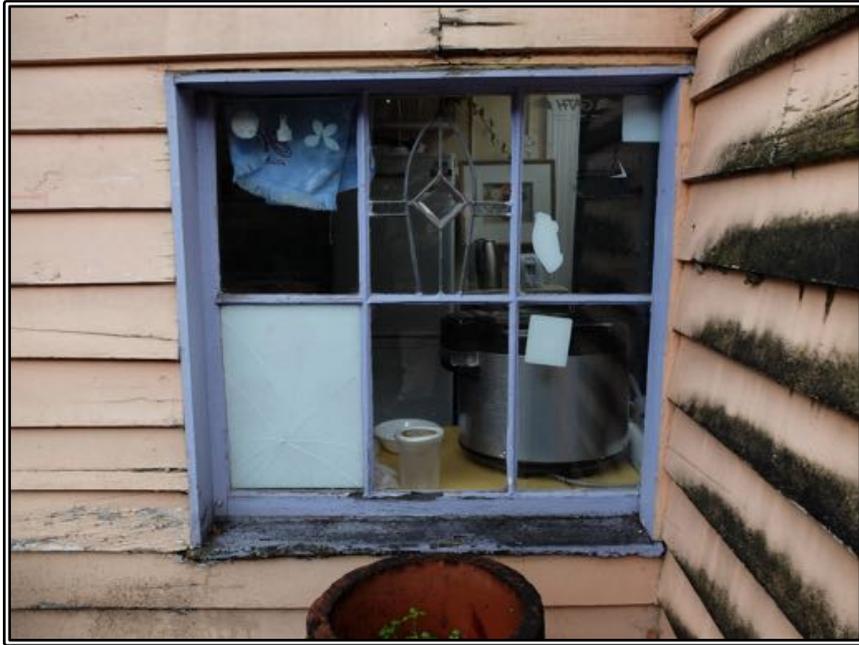
Figure 18

The southern of the two windows in the rear wall. The wall of the kitchen cooker alcove to the right has been partially built out over the window, indicating that the window existed before the alcove was added. The effects of damp and dirt can be seen on the weatherboards to the right of this image.

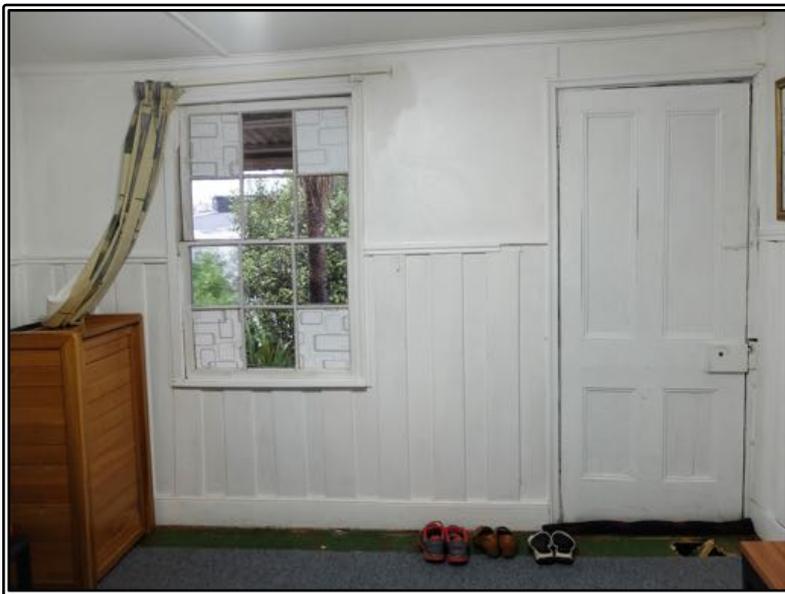
The living room is a nearly square room (3.5m by 3.4m), and is the most original interior space in the cottage. The front door opens into one corner of the room (Figure 19), and has its original lock in place, albeit currently without a doorknob (Figure 23). Timber wainscot is in place on all four walls, with a distinctive under/over layout of the vertical boards. This design is also used on the door to the bedroom (Figure 20). The simple skirting board has a single bead. The walls above the wainscot are no longer scrim on sarking, but have been panelled with fibreboard. The ceiling is also panelled with fibreboard.

Figure 19
The front wall of the living room, showing the door, window and wainscot.

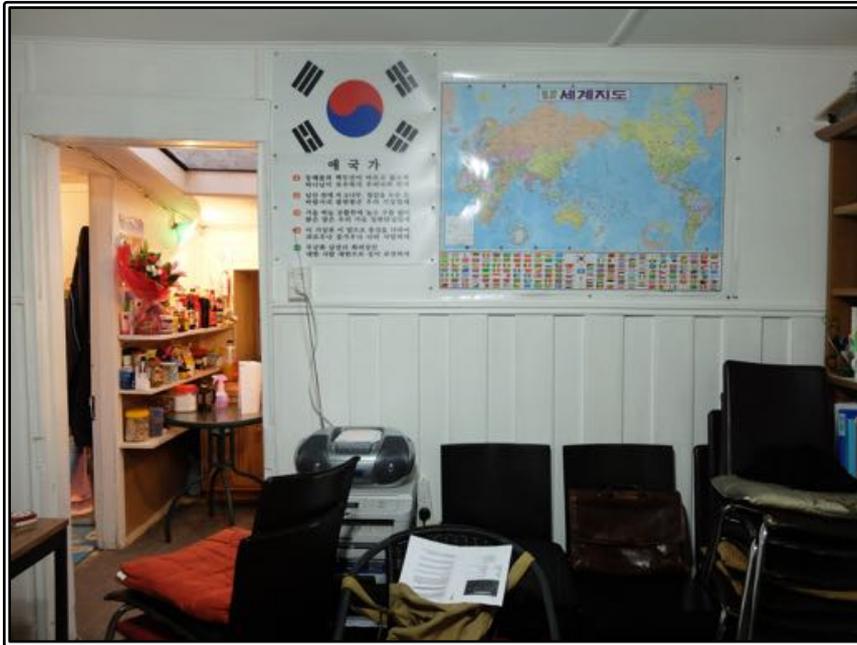
Figure 21

The rear wall of the living room. There is no longer a door in the doorway to the kitchen.

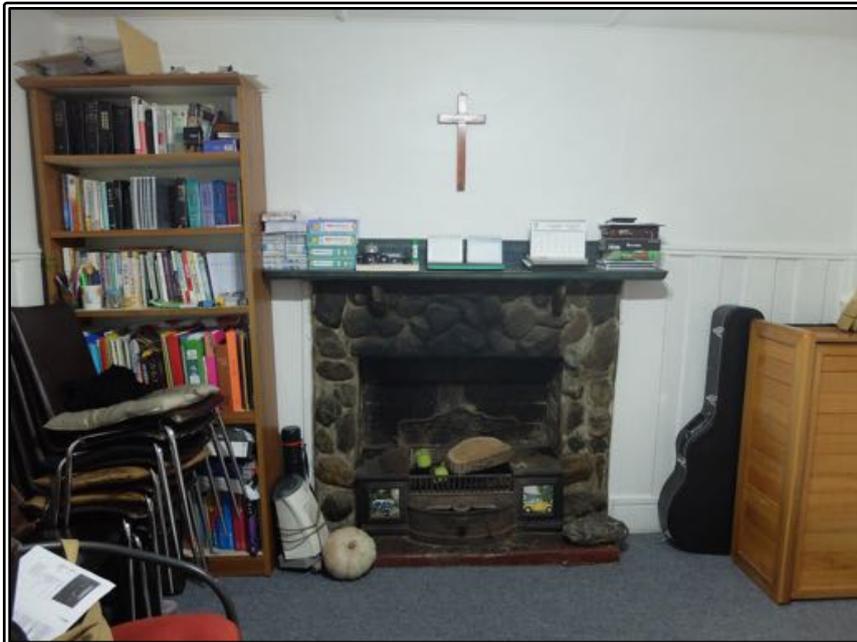
Figure 22

Although the chimney (discussed above) is original, the fireplace mantelpiece has been replaced with a cement and stone finish, topped by a wooden shelf. The cast iron grate is an old piece, but has modern decorative tiles let into it and is probably not original.

The southern wall of the living room, showing the twentieth century fireplace. The timber wainscot remains in place.

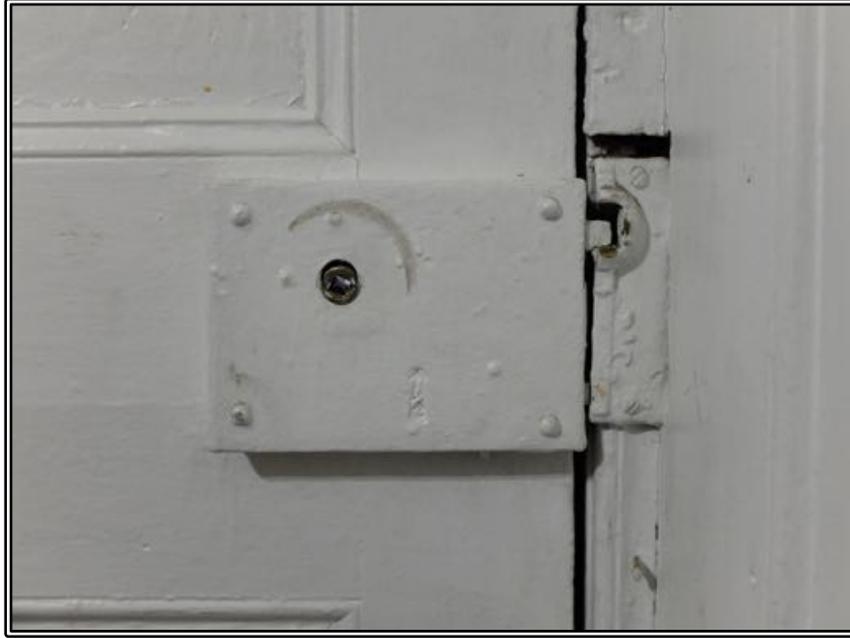
Figure 23
The front door lock, with the doorknob removed.

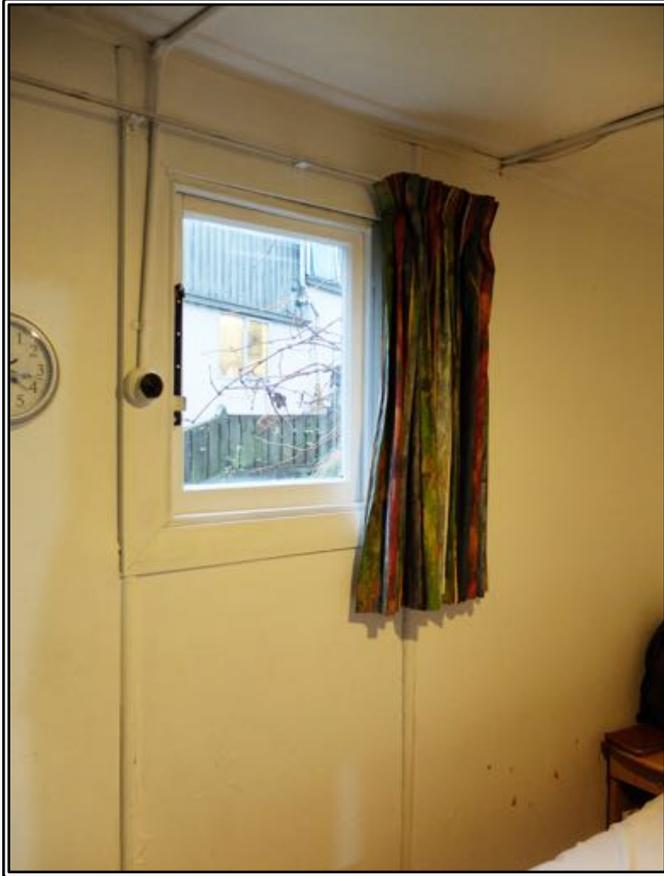
The bedroom occupies the other area within the front of the cottage. It is a very small room, just 3.5m wide and 2.37m deep. The door (with its distinctive panelling to match the living room wainscot) is original, with the braces and door lock on the bedroom side (Figure 26). The wall linings are all twentieth century fibreboard, and a casement window has been let into the side wall.

Figure 25
The side wall of the bedroom,
with the twentieth century
casement window.

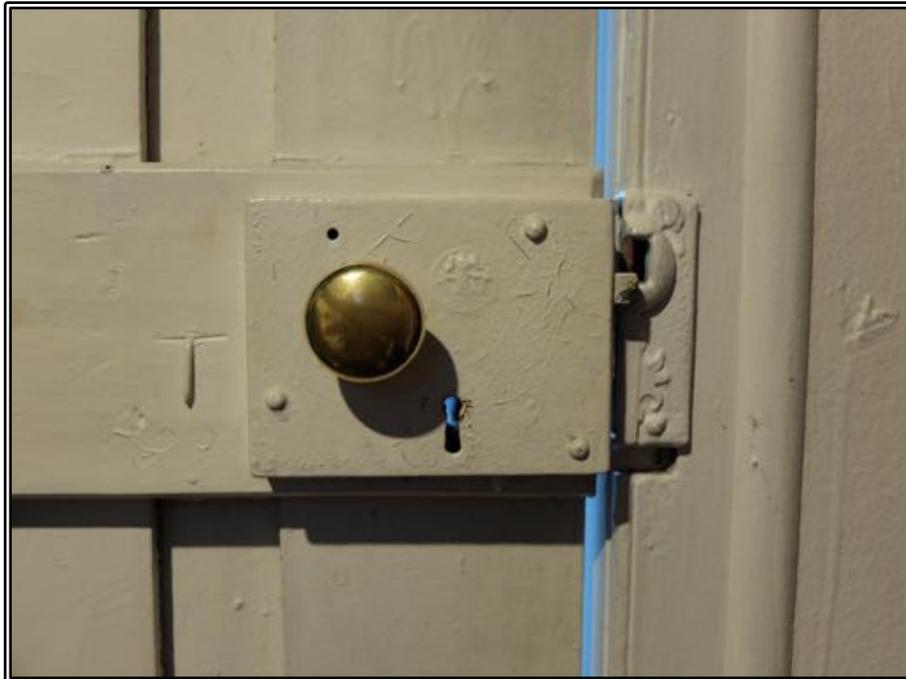
Figure 26
The original door lock on the bedroom door.

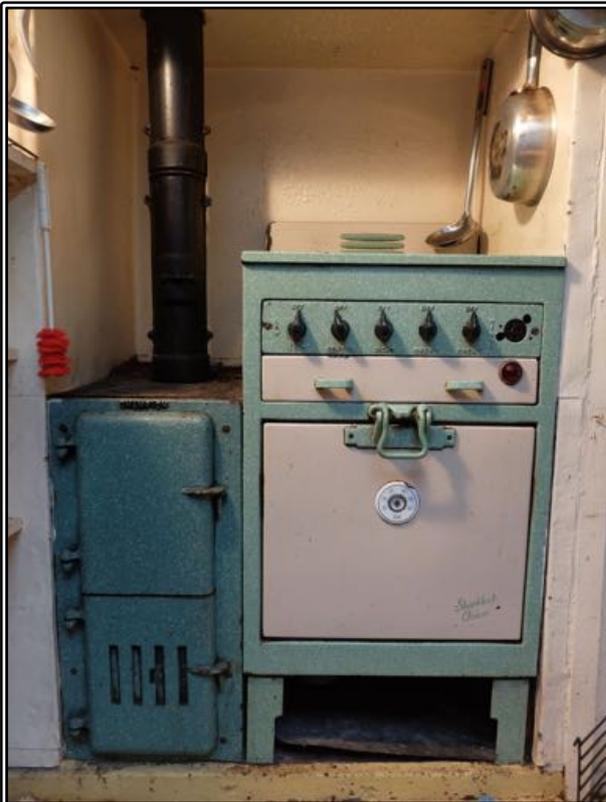
The most distinctive feature of the kitchen is the 1930s Shacklock Orion electric range set into an alcove with a Champion destructor (Figure 28). All of the other shelving and wall linings are twentieth century. A relatively modern skylight has been let into the ceiling.

Figure 28
The Champion destructor on the left and Shacklock Orion electric stove on the right. Both are in typical 1930s green (& cream in the case of the cooker) enamelled colour schemes.

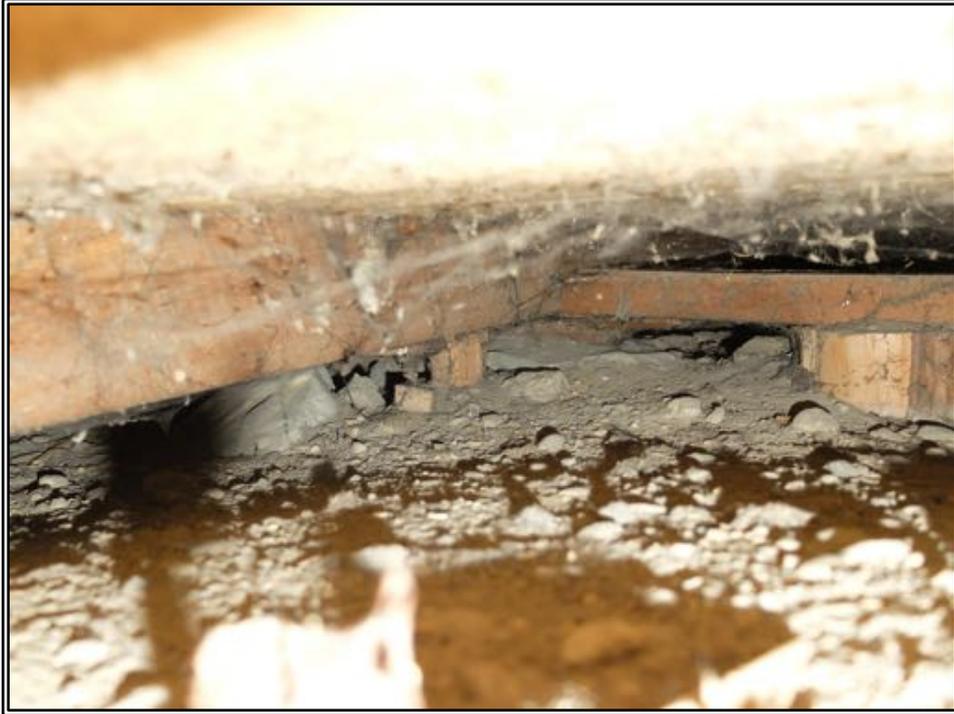
Figure 32

In general it was not possible to examine the underlying structure of the house, as it is still fully lined and inhabited. However, a hole (due to woodworm) near the front door gave enough space to allow a camera to be inserted and some of the sub-floor structure to be observed (Figure 32). This shows that (in this part of the house at least) the bearers and joists are still held off the ground by timber piles. This is in contrast to many buildings of similar age, where the floor structures now sit on the ground (to their considerable detriment). The lean-to at the rear of the house has a concrete floor, presumably laid because the rear floor did decay.

Image taken under the floor at the front of the house, showing pile, bearer and floor joist.

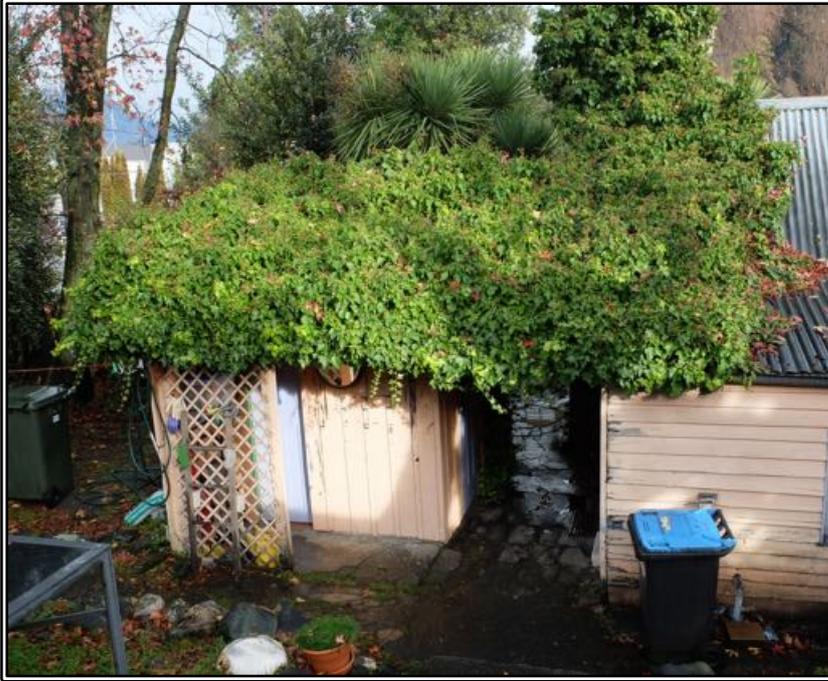
The toilet and a small storeroom are located in an outbuilding on the south side of the cottage (Figure 33). This structure is timber frames, with a mixture of weatherboard and board and batten cladding. It is largely covered by ivy. The age of this structure is not known, but it is not as old as the cottage.

Figure 33
The outbuilding
overgrown with ivy.

weatherboards is present, and ivy has been allowed to almost engulf the outhouse and end wall of the cottage. This will both retain moisture (and encourage decay) and cause mechanical damage. However, the underfloor structure is sound where it can be observed. The roof is still weathertight. The front wall of the cottage has been protected by the veranda. However, it is beyond the brief of this report to assess the structural integrity of the building.

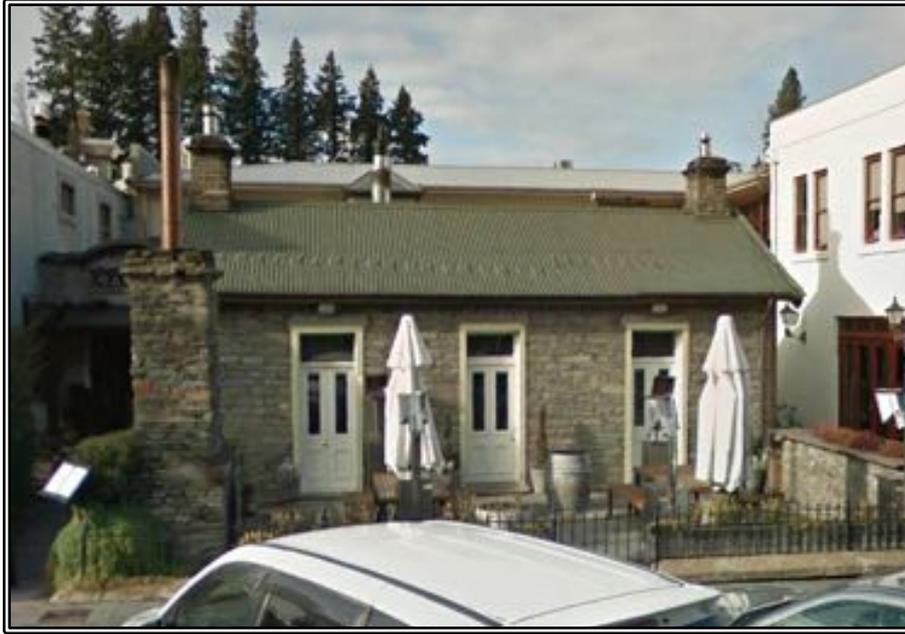
The McNeil Cottage (Heritage NZ List No. 2330, Cat 2; QLDC Item No. 36, Cat. 2) is a stone cottage on Church Street. Although the structure is protected, successive commercial refits have

seen its heritage value steadily eroded over time, and it is now quite modified. This includes the replacement of the front windows with doors, making a total of 3 doors in the front elevation.

Figure 38
The McNeil Cottage on Church Street.
