INFRASTRUCTURE REPORT

B Property Group

Waimarino Development

Bob's Cove, Queenstown

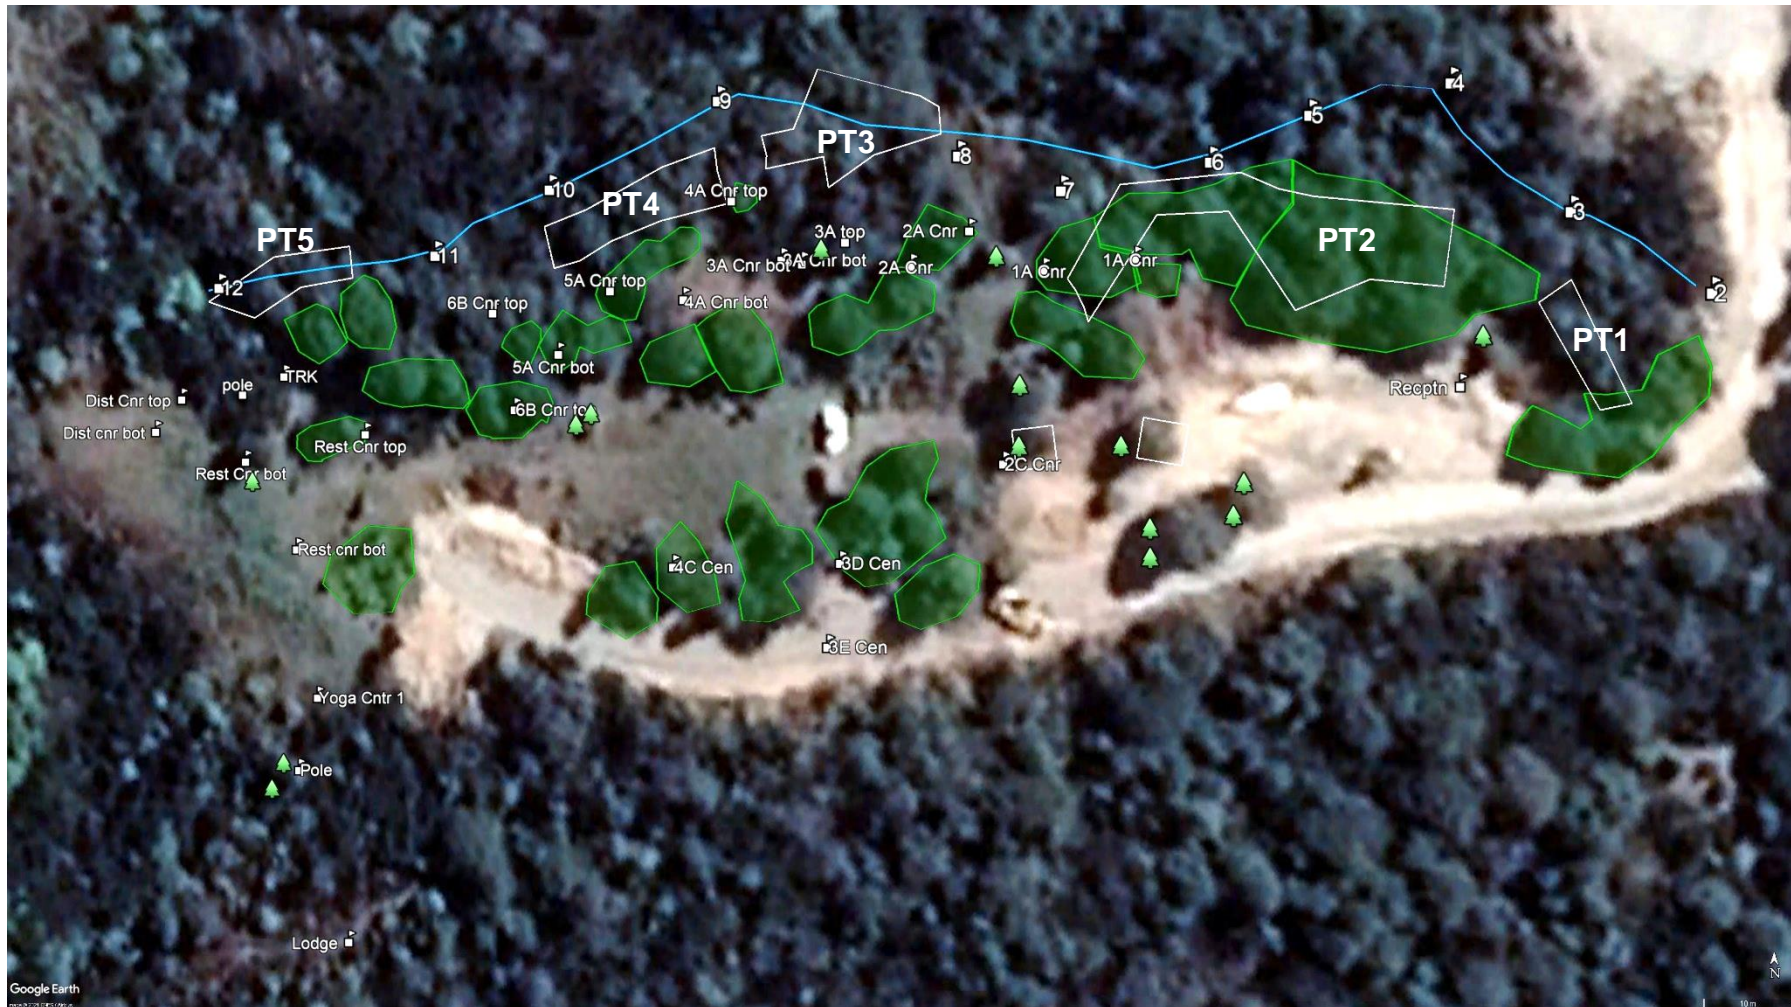
Figure 2: Protected Tree Areas identified on a previous title (RM130174): PT 1 to 5; NSN identified beech trees and lancewoods that are potentially affected as part of the ecological assessment of the proposal. Refer to **Figure 3** and **Table 1** and **2** for details of trees recorded.

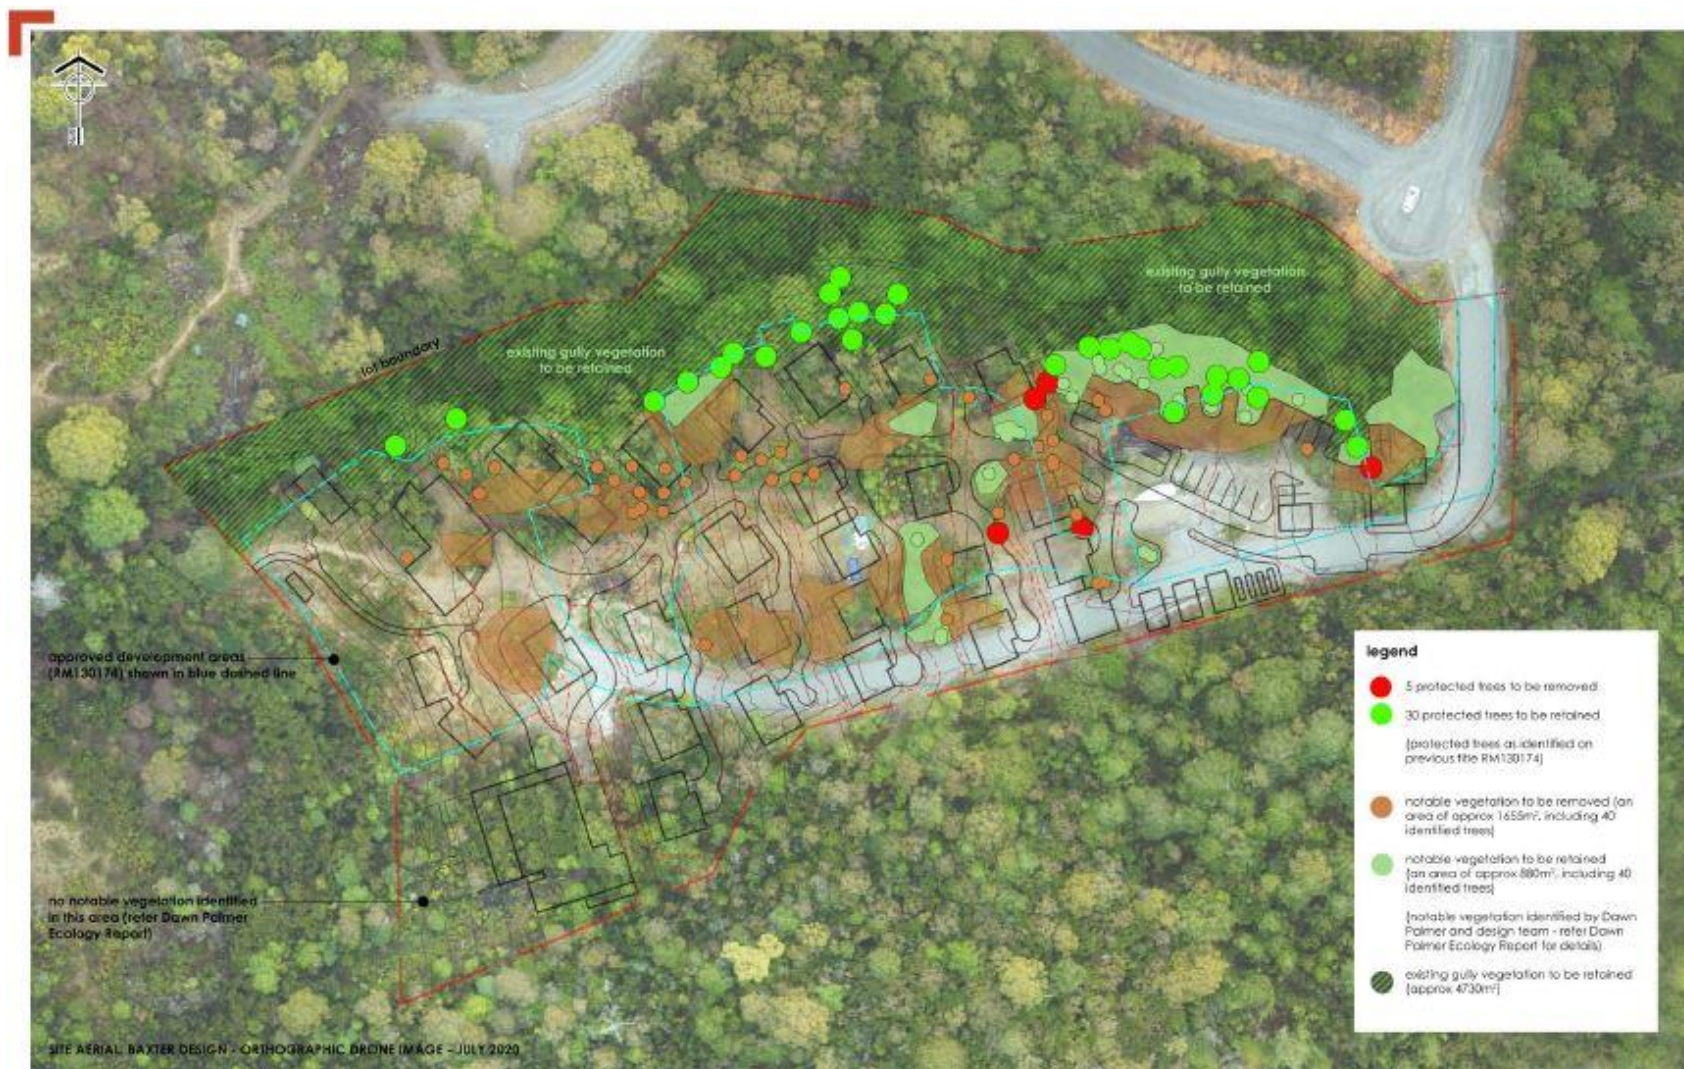
Figure 4: Existing vegetation to be removed and retained

Mature lancewoods (*Pseudopanax crassifolius*) and younger, regenerating lancewoods are also scattered throughout. One patch of lancewoods present in Area 20, **Figure 4** has retained 11 lancewoods, the largest with a diameter at breast height (DBH at about 1.4 m above the ground) of 172 mm. Refer also to **Plate 23**. Area 31 has also retained a large, multi-stemmed lancewood marked with hazard tape.

Mountain beech in NSN Area 33 (**Figure 4**) appear to have damage to their roots, the crowns have thinned, and the trees appear to be dying; these trees could be removed.

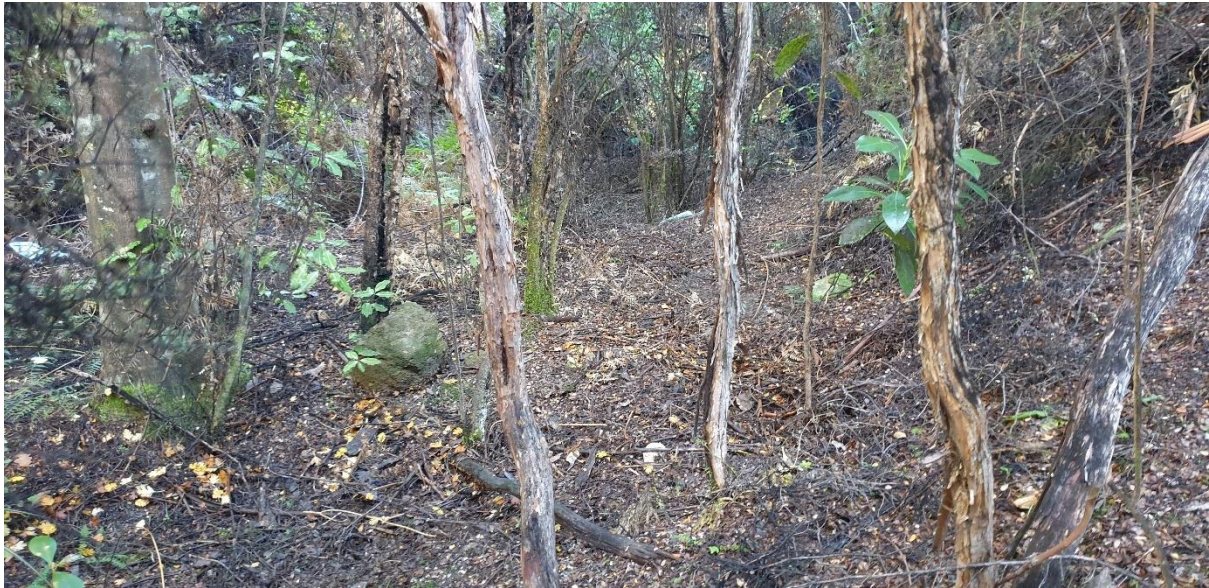
Plate 1: Waypoint 3 – View north west down the dry gully from below Tui Drive receiving environment for road discharge. Open understory with manuka (*Leptospermum scoparium*), shining karamu (*Coprosma lucida*), shade affected kohuhu (*Pittosporum tenuifolium*), bracken, mountain beech (*Fuscospora cliffortioides*) left side of view

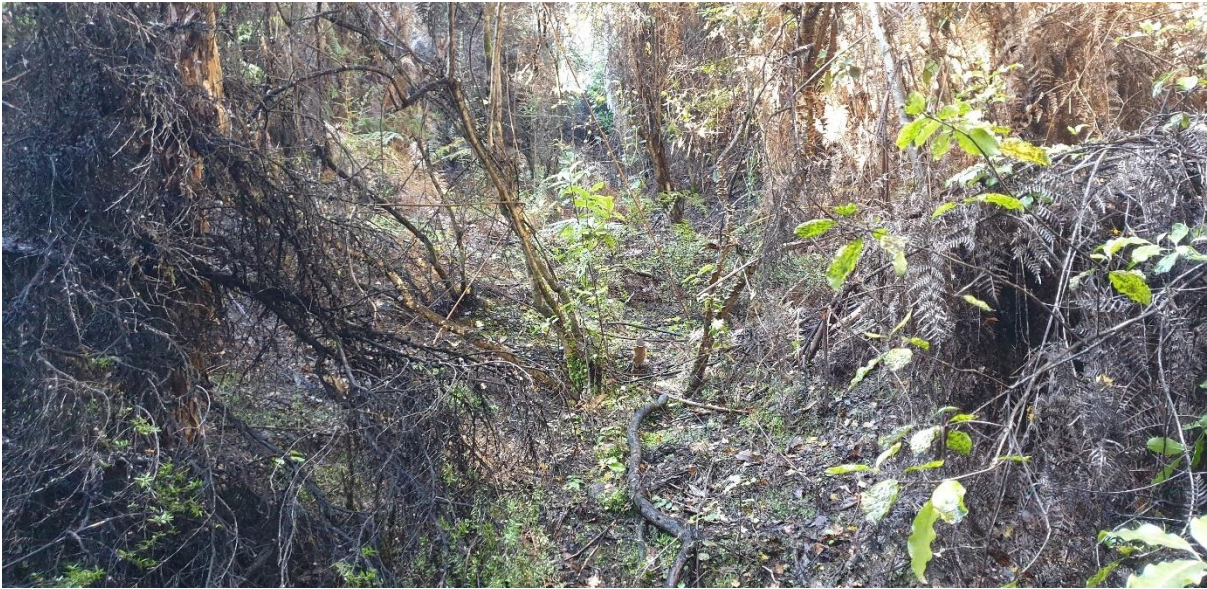
Plate 3: Waypoint 3 – View south east from below Tui Drive looking up the dry gully towards waypoint 2 (refer to Figure 2); Bush lawyer, wineberry, *Pittosporum tenuifolium*, bracken, clubmoss, Eucalypts, manuka; black sooty mould is visible on manuka.

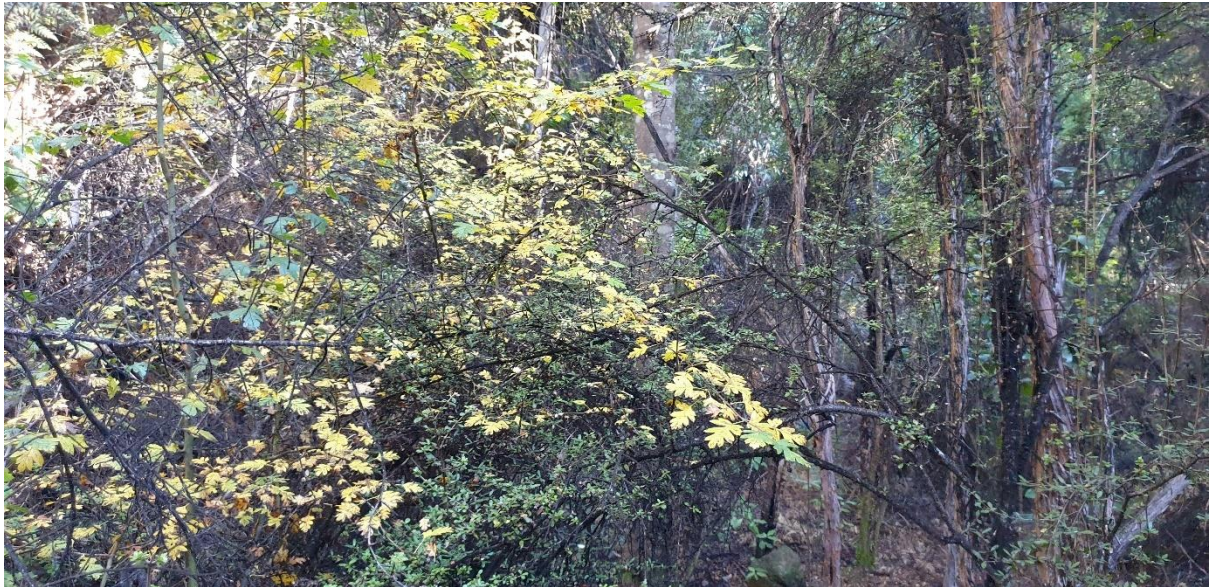
Plate 5: Waypoint 4 – View south west towards carpark and Tree Protection Area 2; hawthorn (yellow leaves), *Coprosma propinqua* (small leaved shrub) and manuka with lianes – bush lawyer – climbing over them; Eucalypt sapling, mountain beech stems visible through the dense sub-canopy

The gully community has an overstorey dominated by a mixture of mountain beech (*Fuscospora cliffortioides*), and blue gum (*Eucalyptus globulus*) with some red beech (*Fuscospora fusca*). Hawthorn (*Crataegus monogyna*) is also dense in places within the gully north of the proposed development. Manuka (*Leptospermum scoparium*) dominates the understory and canopy where there are gaps in the beech and Eucalypt canopies. Refer to **Plates 5 and 11**.

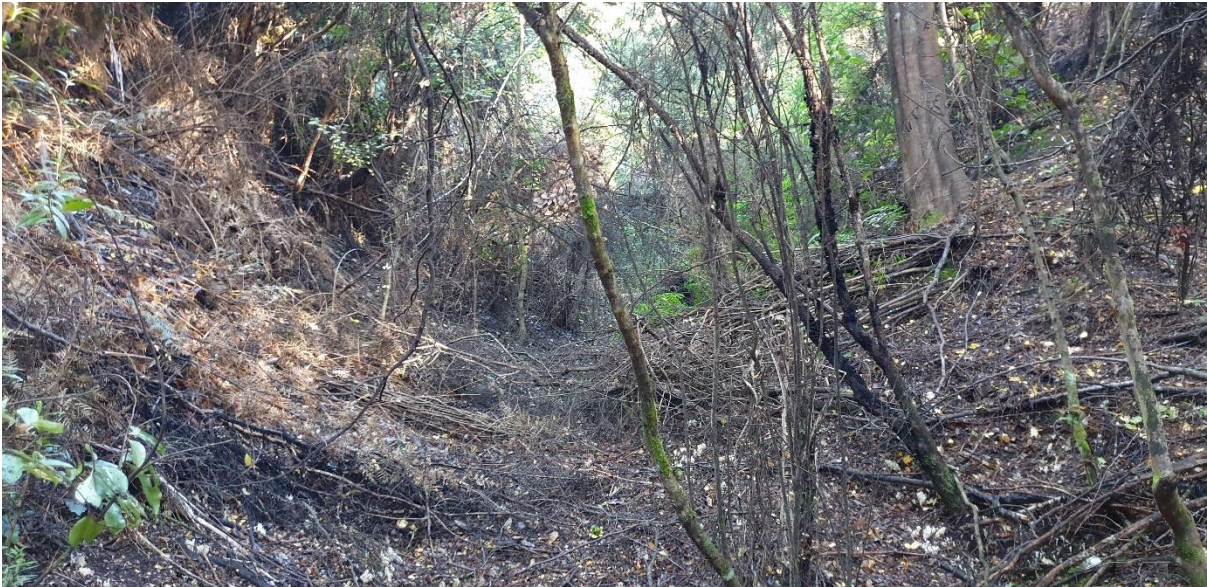
Plate 7: Waypoint 5 – View west down dry gully bed north of the carpark; mountain beech stem on right, manuka, beech and eucalypt saplings, bracken fern, broadleaf (*Griselinia littoralis*) and koromiko (*Veronica salicifolia*) on left margin of view

Plates 6 and 7 provide a view up and down the gully from waypoint 5 north or Protected Tree Area 2 (PT2), refer to **Figure 2**. If stormwater were to be discharged from the carpark between the reception area and Unit 1A, it would also affect (potentially erode or discharge sediment) into this portion of the gully environment.

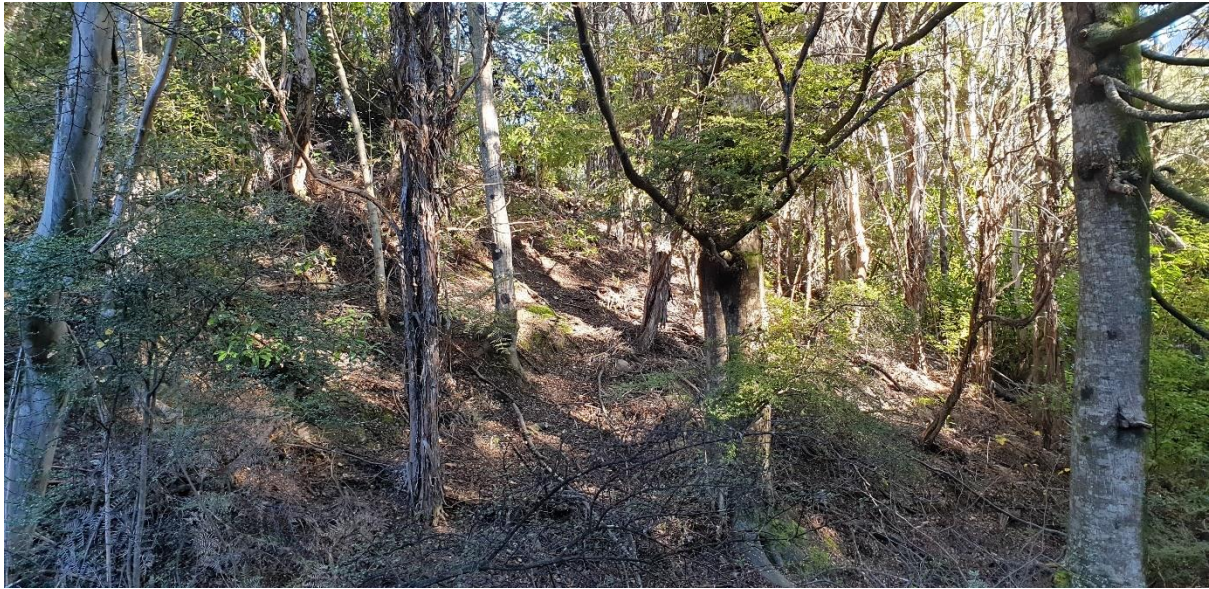
Plate 11: Waypoint 8 — View southwest from the dry gully north of and between Units 1A and 2A across the slope towards Unit 3A and 4A; beech and Eucalypt stems in Tree Protection Area 3

1. Reduce the large, felled *Pinus radiata* to hasten its decomposition and facilitate planting of natives between Units 1A and 2A. Refer **Plate 11**.

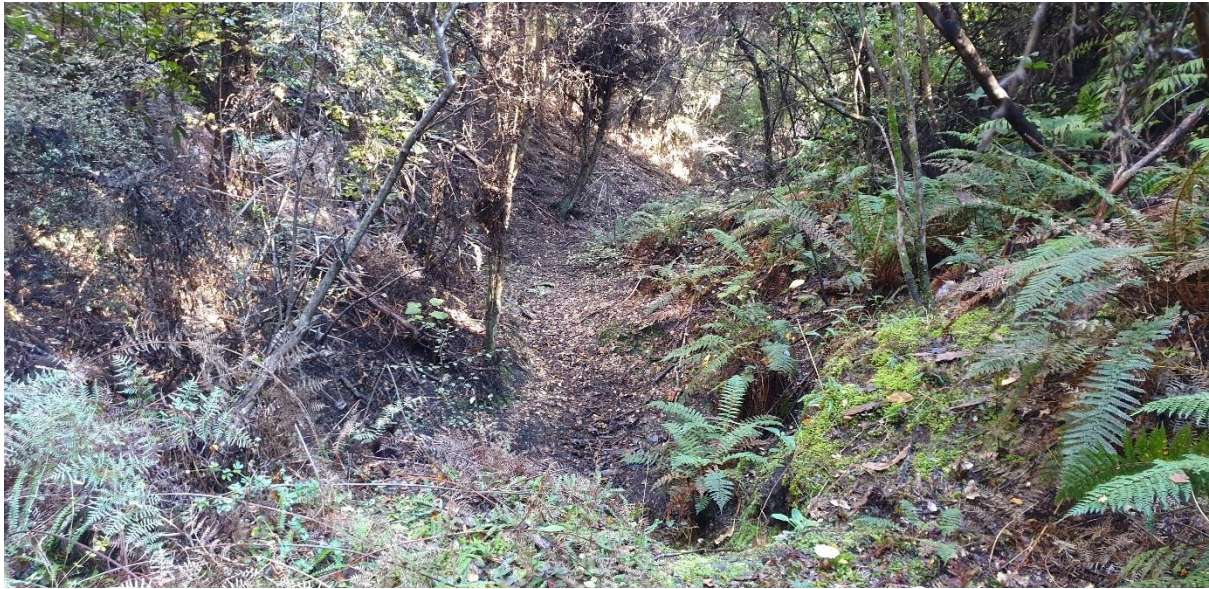
Plate 13: Waypoint 10 - located north of Protected Tree Area 4 and Units 4A and 5A. View down gully (west) at a small step interpreted as being indicative of historical flow and erosion. Species recorded at this waypoint were *Entoloma* sp. fungi - Moss, herbs, *Austroblechnum penna-marina*, (at the bottom margin of this photo), *Leptospermum scoparium*, **Crataegus monogyna*, **Eucalyptus* spp., *Carpodetus serratus*, *Fuscospora cliffortioides*, *Pteridium esculentum*, *Coprosma lucida*, *Coprosma dumosa*, *Coprosma rhamnoides*, *Pittosporum tenuifolium*, *Pseudopanax crassifolius*

Plate 13 identifies a step in the gully at waypoint 10 (refer to **Figure 2**), there is another similar step in the gully at waypoint 11.

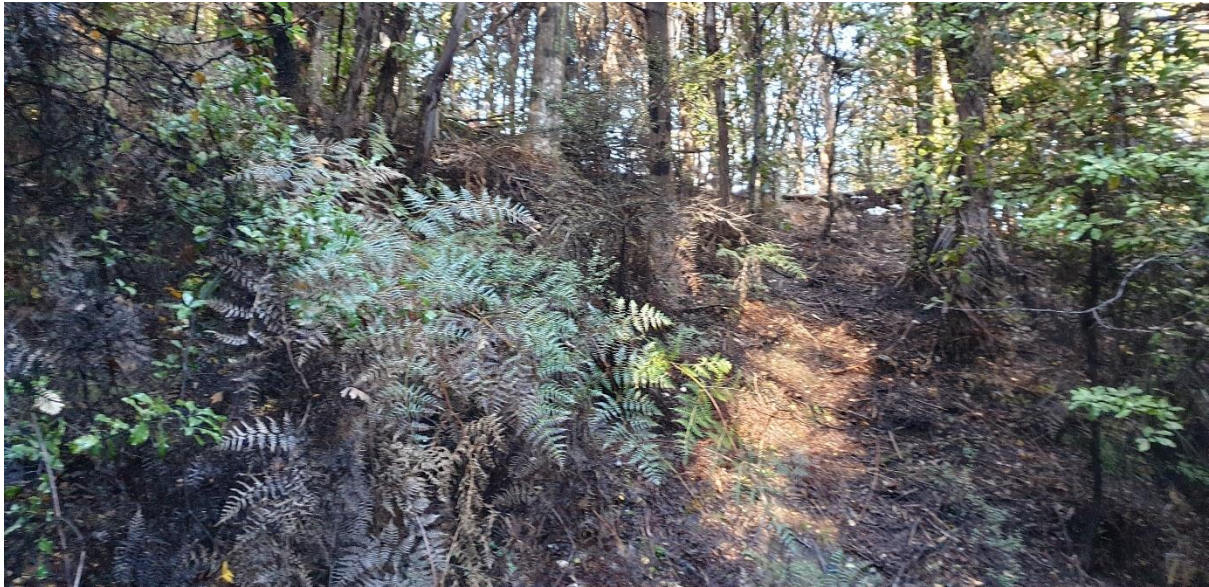
Plate 15: Waypoint 10 - View south into Tree Protection Area 4 along the steep bank near Unit 5A. Vegetation in view is mountain beech with an open understory of bracken, *Pittosporum tenuifolium*, manuka.

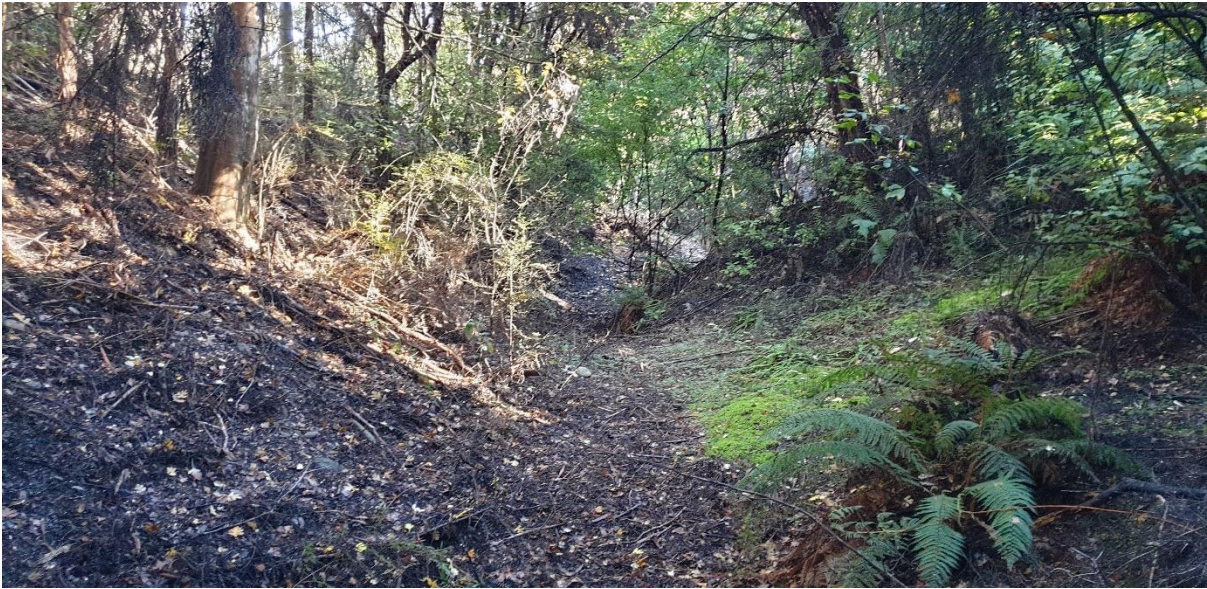
Plate 18: Waypoint 11 view down dry gully (west) from position north of Unit 6A. Beech forest, the beech trees in this area were not measured as they were considered to be beyond the footprint of the development. Clearance of the forest in this area should be limited to as little as possible.

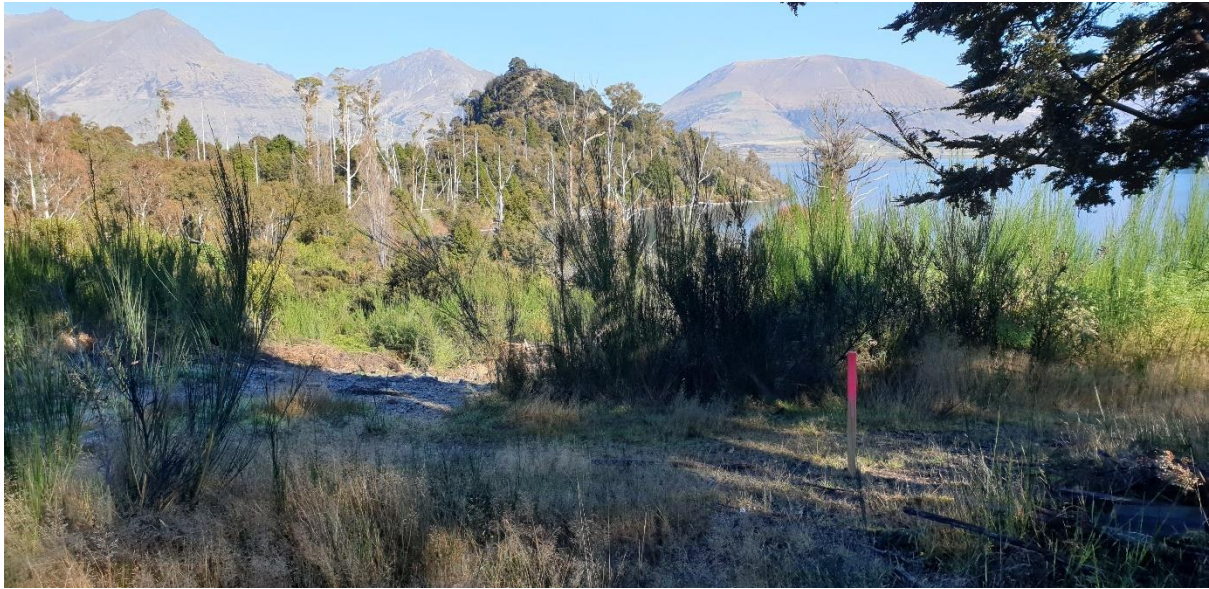
Plate 20: View from Waypoint 14 (Dist Cnr bottom peg) – View southwest from the clearing margin north of the Distillery peg viewed from edge of forest.

The footprint of the development area is generally within the site's clearing with pasture grass, introduced broom (*Cytisus scoparius*) and in places tree lupin (*Lupinus arboreus*) along with indigenous shrubs and bracken under the canopy of beech clusters near the existing access and caravan, refer **Plates 19, 20, 22 and 23**.

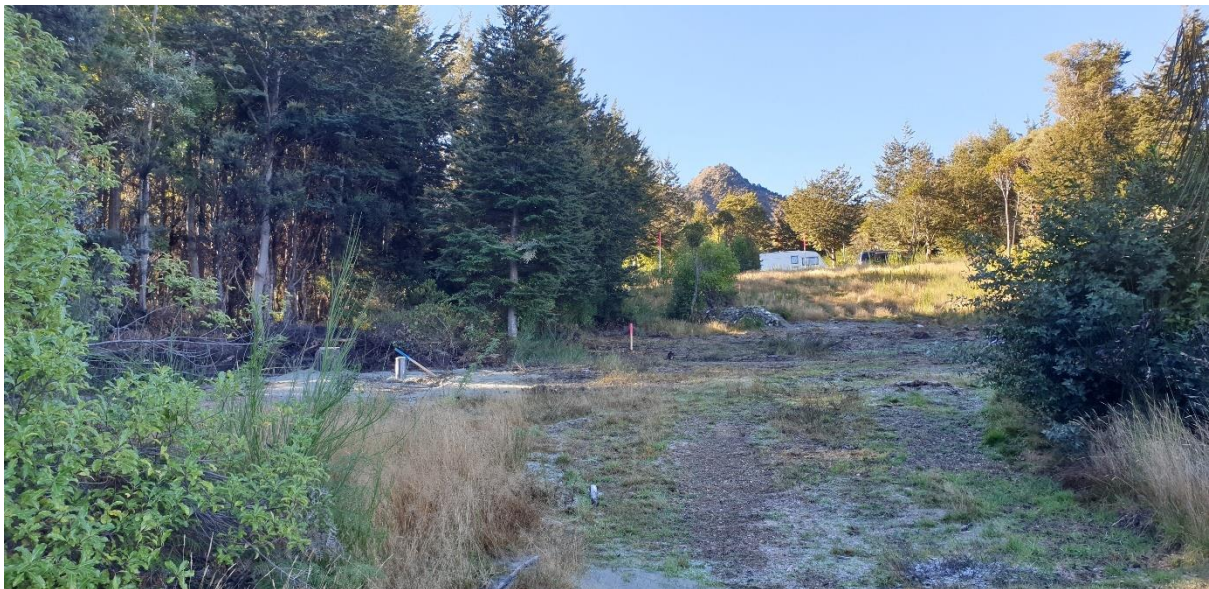
Plate 21: View east from Waypoint 13 (Rest Cnr bottom peg) towards the bore and the 6B bottom corner peg on the forest margin, the 6B unit structure would require clearance of three beech trees in view along the margin of the forest and possibly some other beech trees in NSN mapped Areas 10 and 15 within the forest, refer Figure 4.

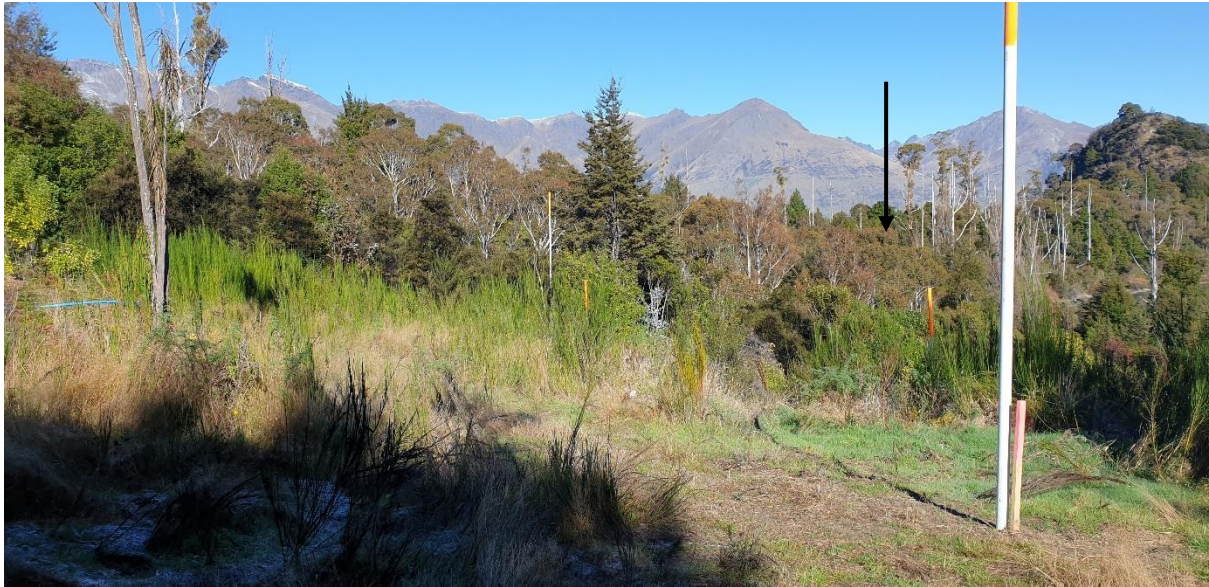
Plate 22: Waypoint 13 - View south from the Restaurant Corner bottom peg across the lower (western) portion of the site. Introduced broom infests the open clearing, NSN mapped area 20 is to the left of this view where 11 mature lancewoods have been retained to date. Eucalypt dominated canopy is visible in the distance where the Lodge residence is located, indicative location indicated with an arrow.

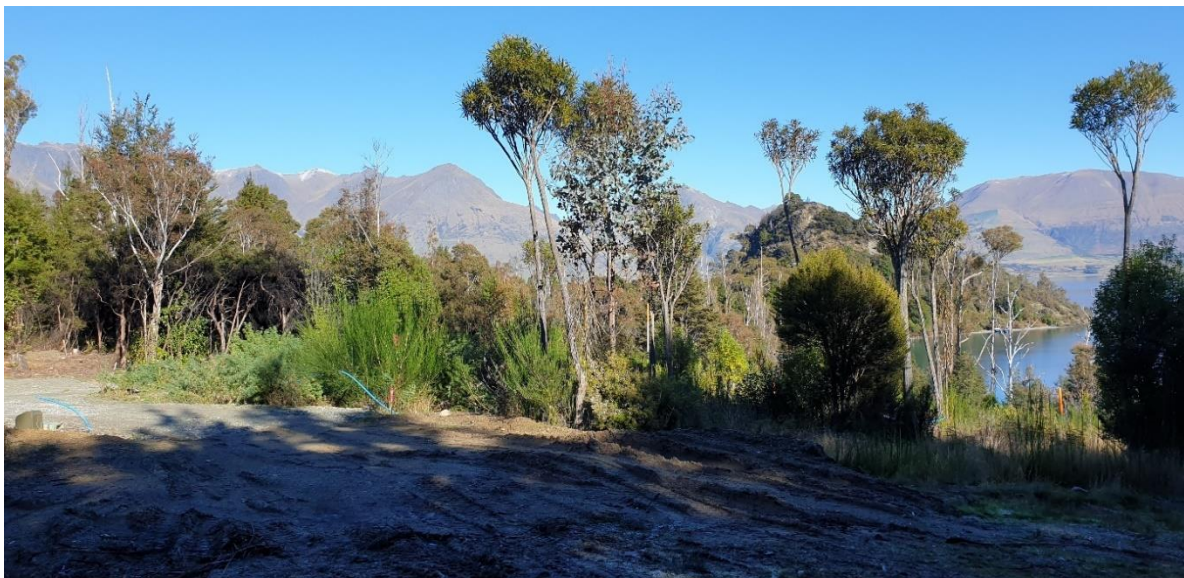
Plate 23: Waypoint 15 (bore) - View from the bore towards the stand of 11 lancewoods in the Area mapped by NSN as Area 20, refer Figure 4. Introduced broom and tutu (*Coriacea sarmentosa*) are also present.

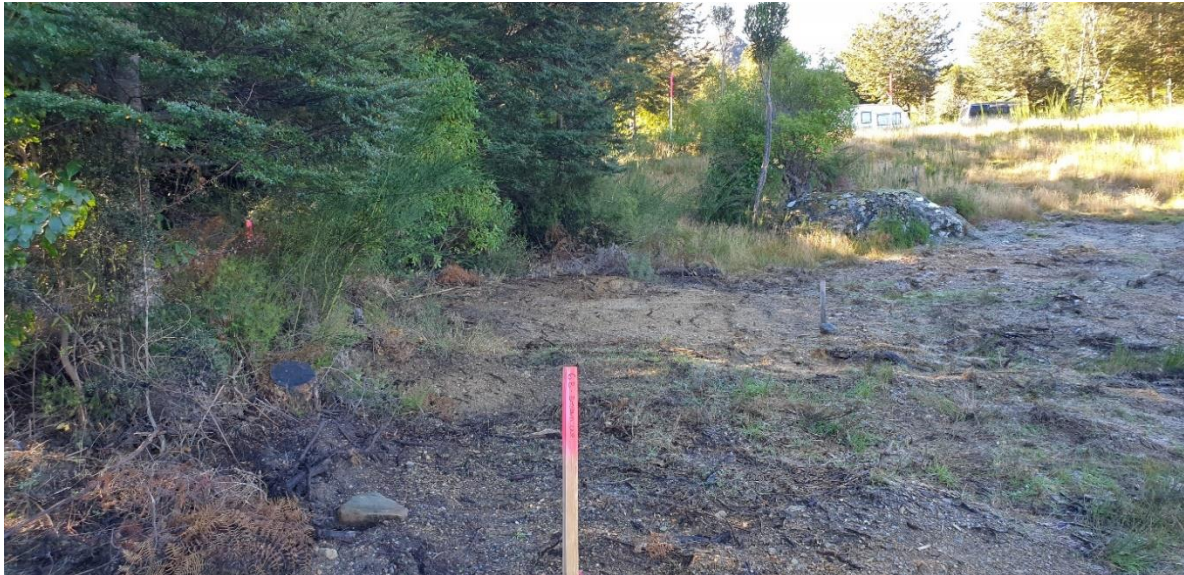
Plate 24: Waypoint 16 – 6B bottom peg, top peg just inside the margin of the forest, the structure would extend to the left of this view into the forest mapped as NSN Area 10 which includes 3 mountain beech. One of the trees is a large multi-stemmed tree marked by both a green triangle and surveyor's string. The largest stem had a DBH of 363 mm making it at least 230 years old.

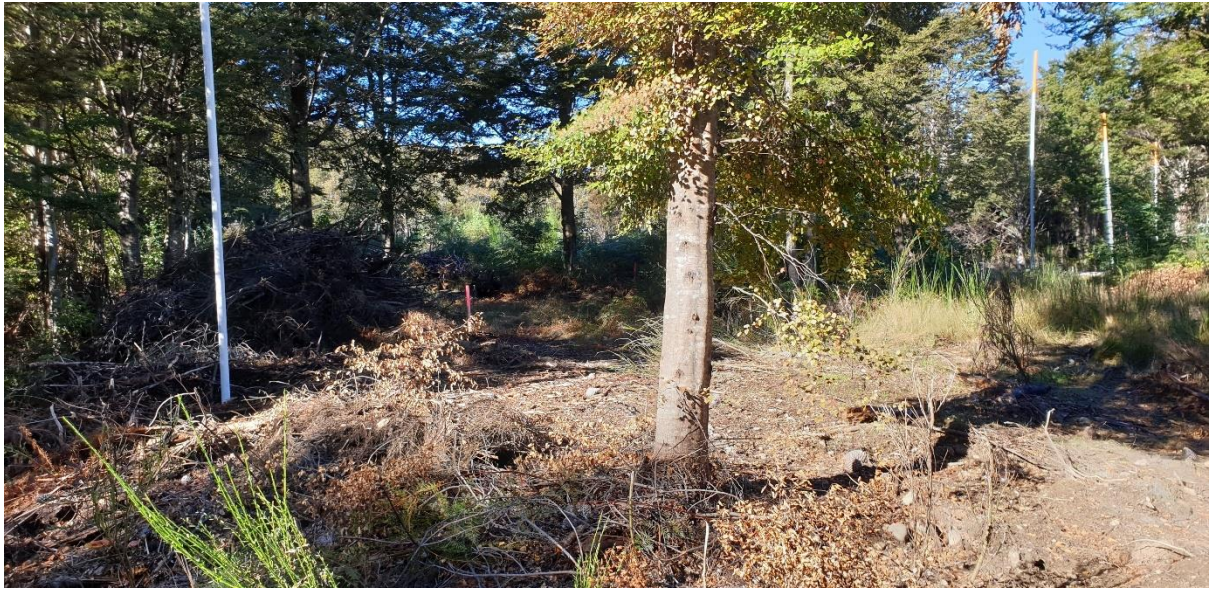
Plate 26: Waypoint 18 (2A Cnr peg) view east to isolated red beech DBH 23 mm between Unit 1A bottom corner and Unit 2A corner and NSN mapped Areas 5, 4 and 3 behind, Figure 4.

Lancewood	1	153			Edge of terrace, marked with surveyors string, between top and bottom pegs for 3A. Coprosmas, manuka, Pittosporum, prickly mingimingi and Eucalypts also present between the pegs. All to be removed
Between 6 & 7	Red beech	1	231			Isolated red beech between Unit 1A and 2A and access lane; refer Photo Plate 26; to be removed
8	Mt beech	1	323			Between 3A top peg and trapping track along top of gully; to be removed
9	Lancewood	1	73			A double -stemmed tree within the footprint of Unit 4A.near profile pole in Lepsco, Lepjun, regen Pitten, Copluc, some Eucalypts, on gully side of pole btw 3A Bot Cnr and 4A Cnr top; to be retained
10	Mt beech	3	266	363	194	A large double stemmed tree (363 + 186 mm) marked with both a green triangle and surveyor’s string, next to a large boulder with 2 large lancewoods (96 mm and a double stemmed tree 108 + 76 mm); 2 additional mountain beech in this cluster. These trees are in the footprint of Unit 6B; all to be removed

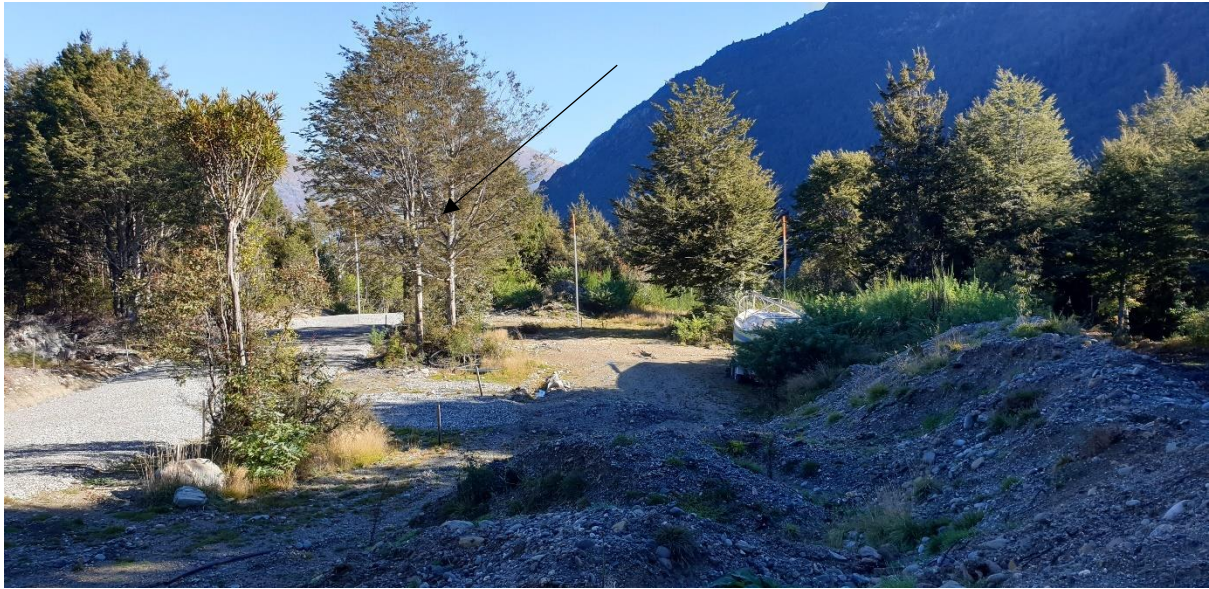
Plate 28: Waypoint 21 – View west along the existing formed road into the proposed reception and carpark area on the right. Isolated beech and lancewood trees (shown as 33 in Figure 4) are present within the footprint of the Waimarino development. Two mountain beech standing together and marked with an arrow have thinning canopies indicative of stress. The roots may have been damaged by road construction.

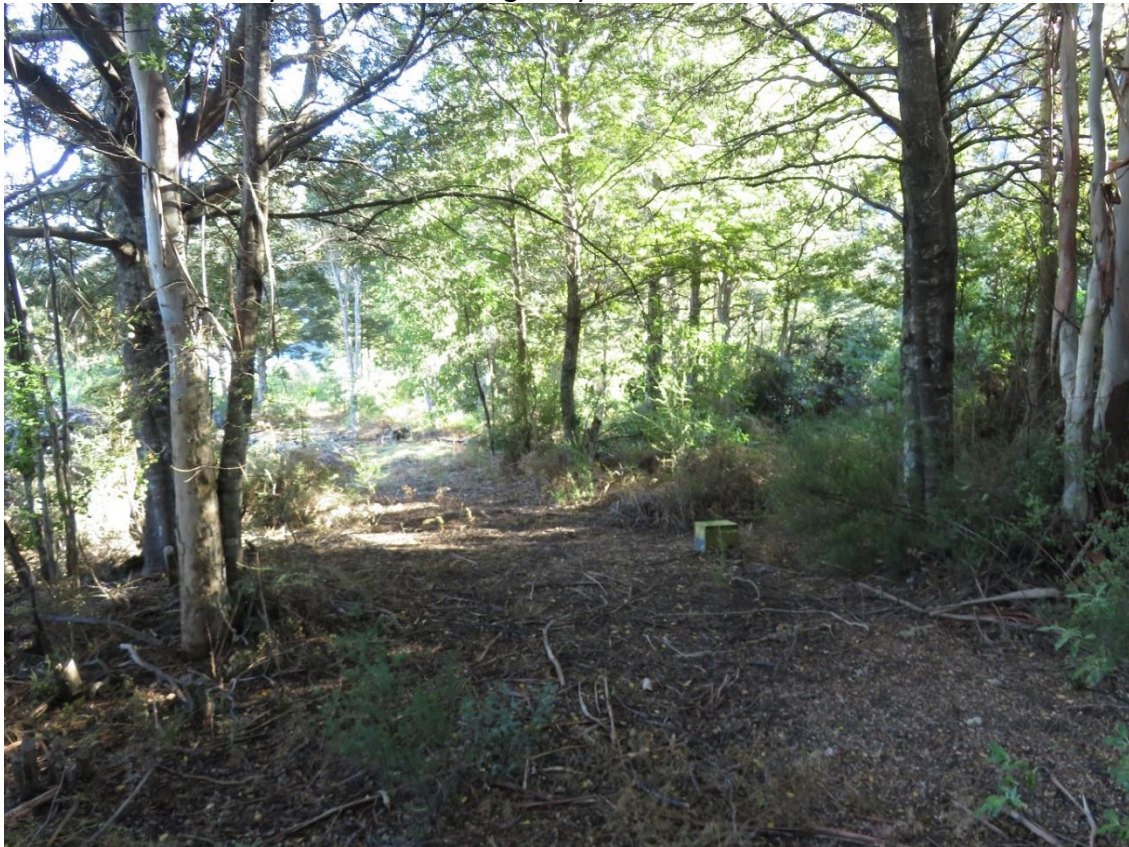
Plate 29: Waypoint 23 - View west along forest margin with a copse of beech and Eucalypts south of a cleared track. Trees in view on both sides of this track are within Protected Tree Area 2 on Figures 2, 3 and 4 north of the proposed reception and carpark area.
