Geotechnical Report for Resource Consent

Lot 3 DP 392270, Kingston Road,
Queenstown

GeoSolve Ref: 190413

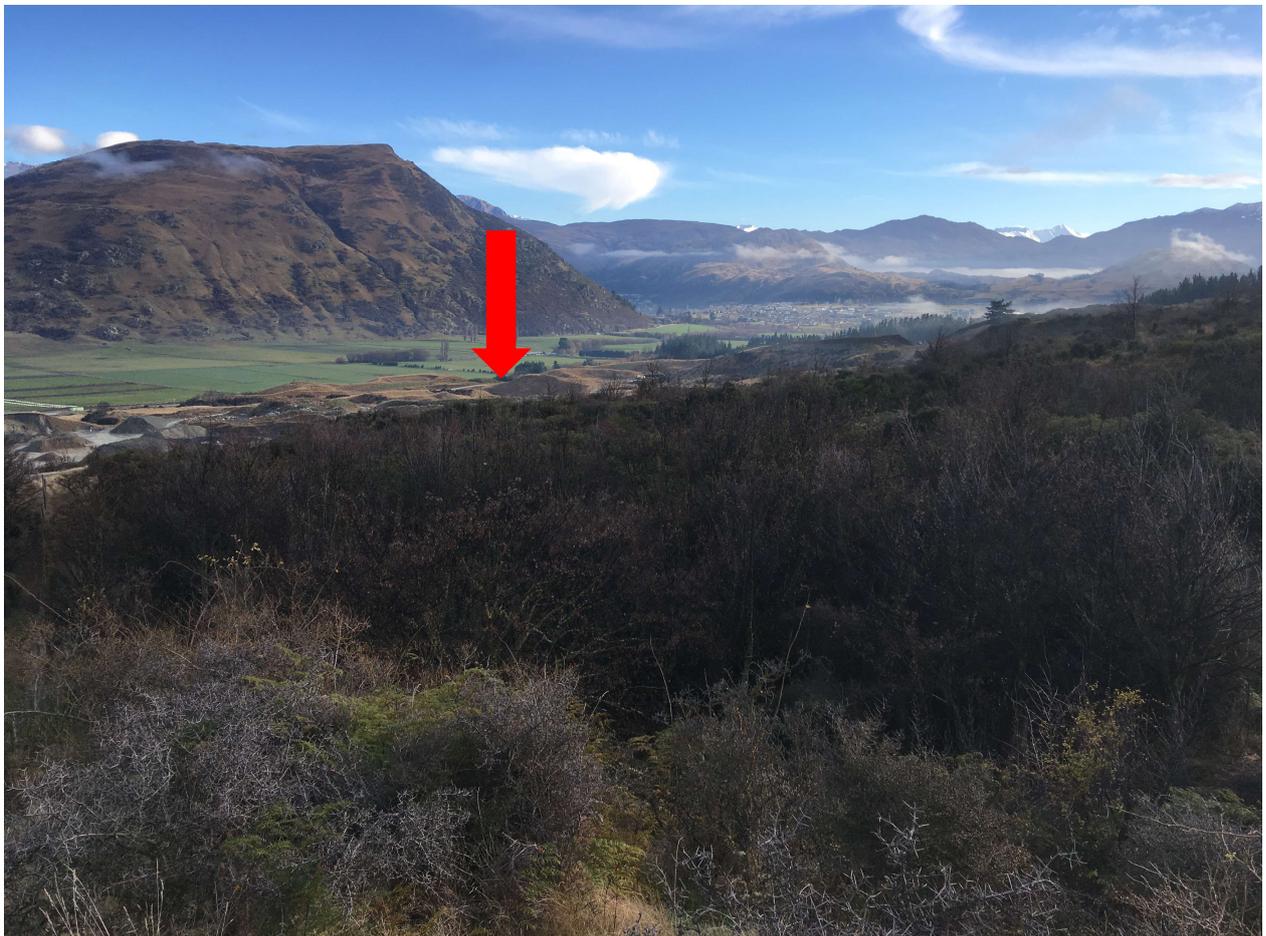
Photograph 1. Site photo looking northwest (building platform indicated by red arrow).

This report is intended to supplement a resource consent application with the local council authority. A plan showing the proposed development is detailed in Appendix A and a photo of the general area for the building platform is shown below in photograph 1 & photograph 2.

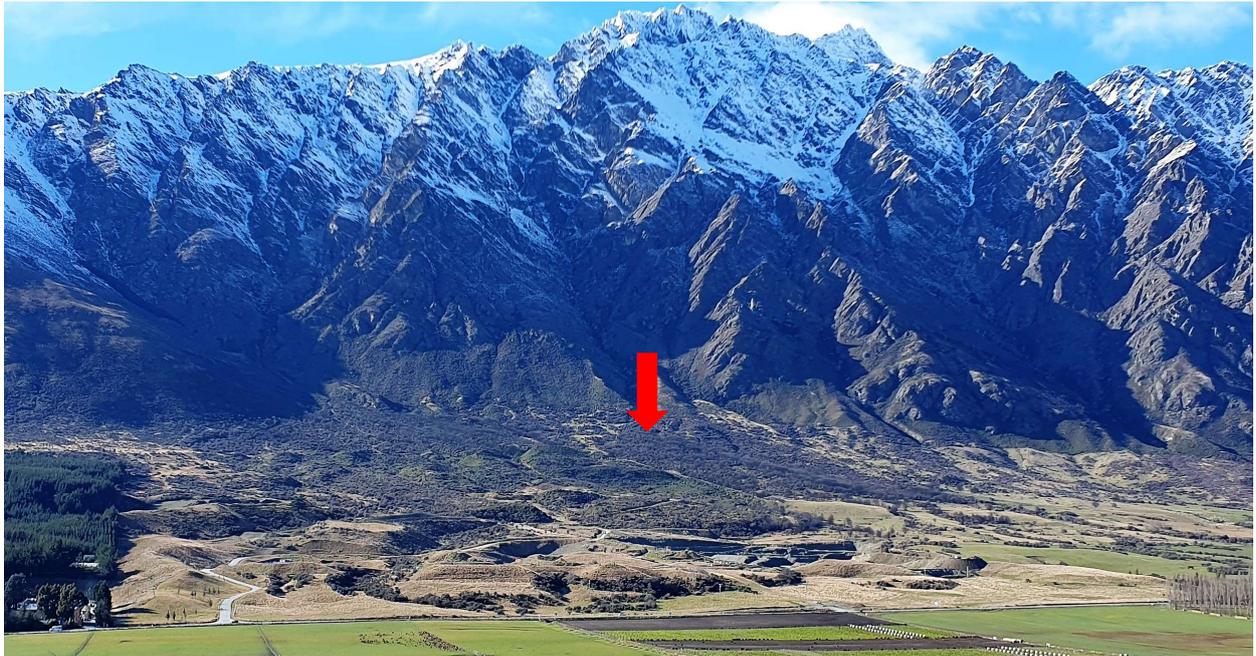
Photograph 2. Site photo looking east (building platform indicated by red arrow).
