Natural Hazards Affecting Gorge Road, Queenstown

Prepared for Queenstown Lakes District Council

Prepared by Beca Limited

12 November 2020

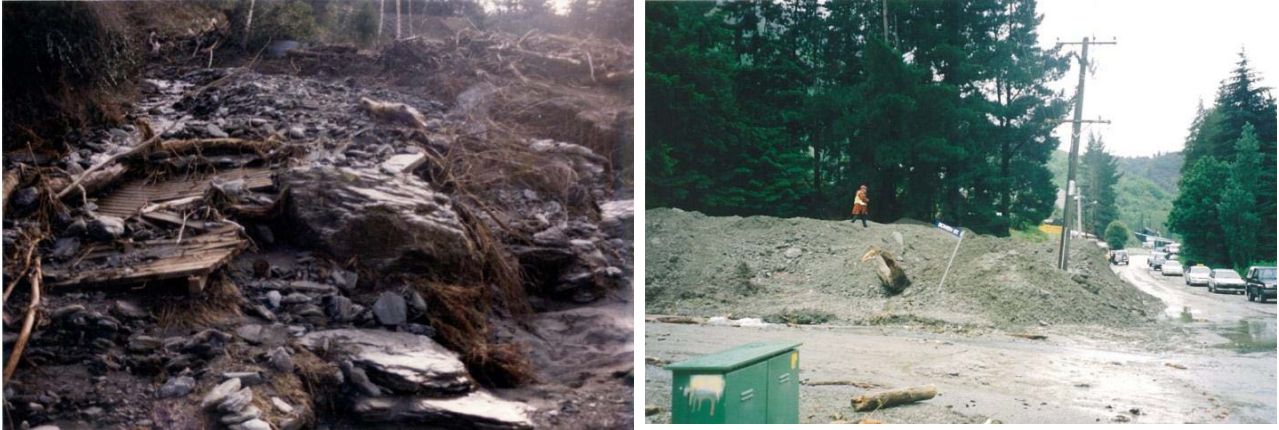
Figure 4 - Debris from the May 1986 debris flow on Brewery Creek Fan (left); and the 1999 event at the intersection of Bowen Street and Gorge Road (right). After ORC, 2011.

- One reference was found of the 1999 event being exacerbated by channel blockage dam failure upstream resulting in a significant amount of material being released over a short time (Hamilton, 2014).

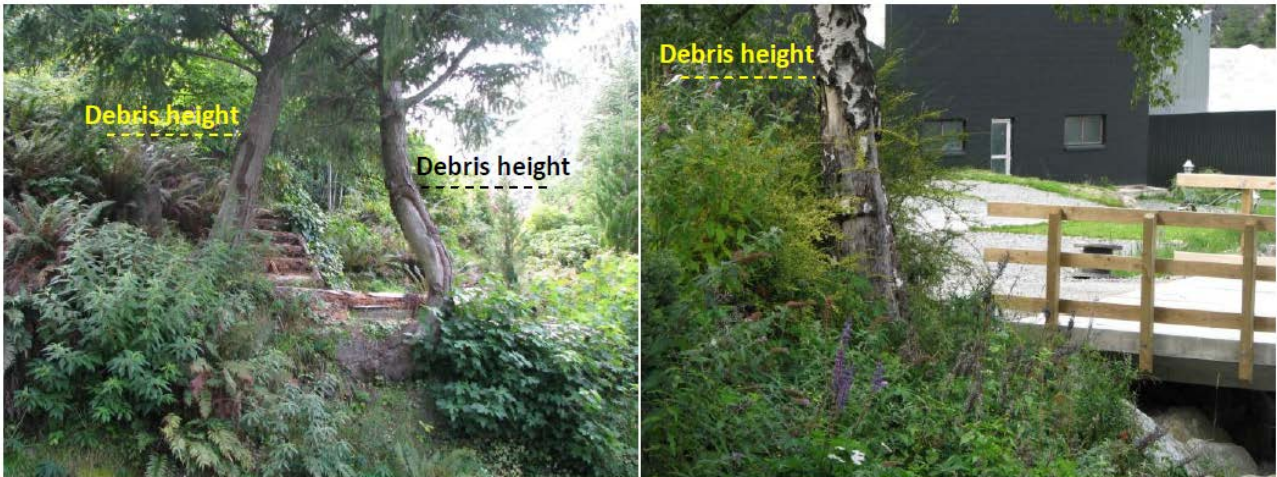
Figure 6 - Debris height from past events on trees scars in the Brewery Creek alluvial fan. Left photo is upstream of point 005 and right is at point 005 as shown in Figure 5 (ORC, 2011).

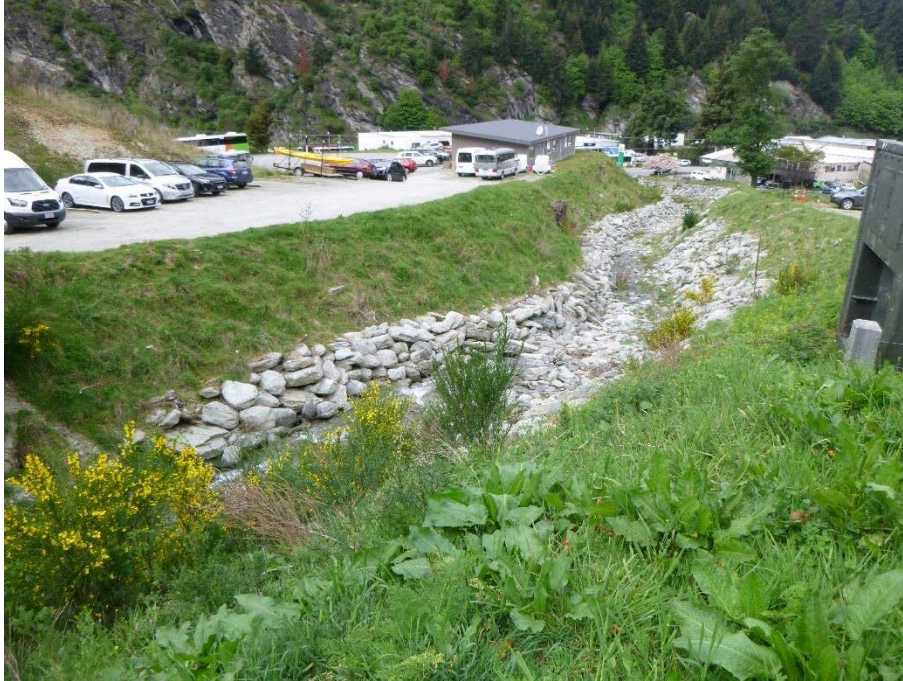
The status of the channels on each fan was noted during the walkover. Brewery Creek channel is shown in Figure 8. At the time of the site visit the channel appeared to be well maintained with little build-up of sediment or debris in the channel invert.

Figure 8 - Brewery Creek modified channel at 1 Bowen Street (2018)

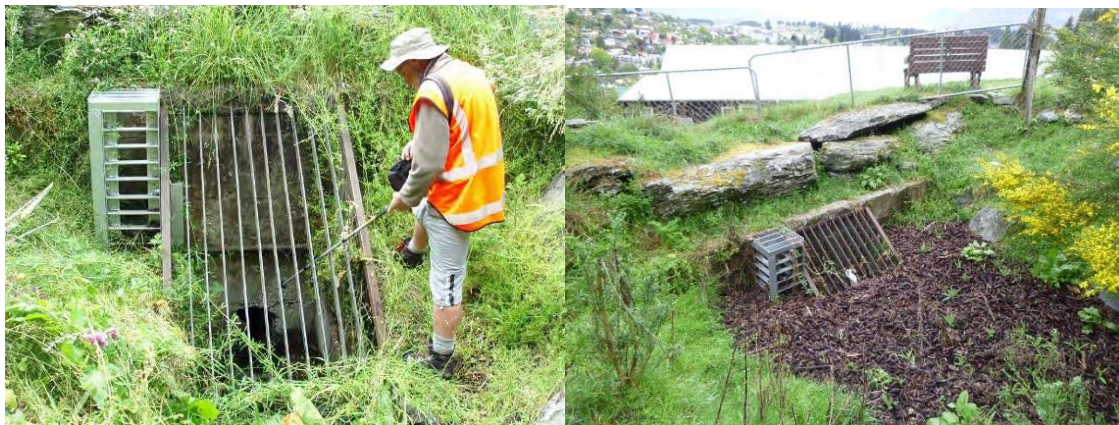
Reavers Stream is culverted from the apex of the fan above 9-11 Reavers Lane to a point below Fryer Street. The culvert is covered by a grate, presumably to limit debris entering, although there is nothing to prevent build-up of material in a debris flow event. As shown in Figure 9, a significant amount of vegetation had built up around the culvert over time, which could inhibit flow into the culvert. The culvert was cleared of debris following this initial walkover.

Figure 9 - Comparison of the Reavers Fan culvert in January 2009 (GNS) and October 2018 (Beca)

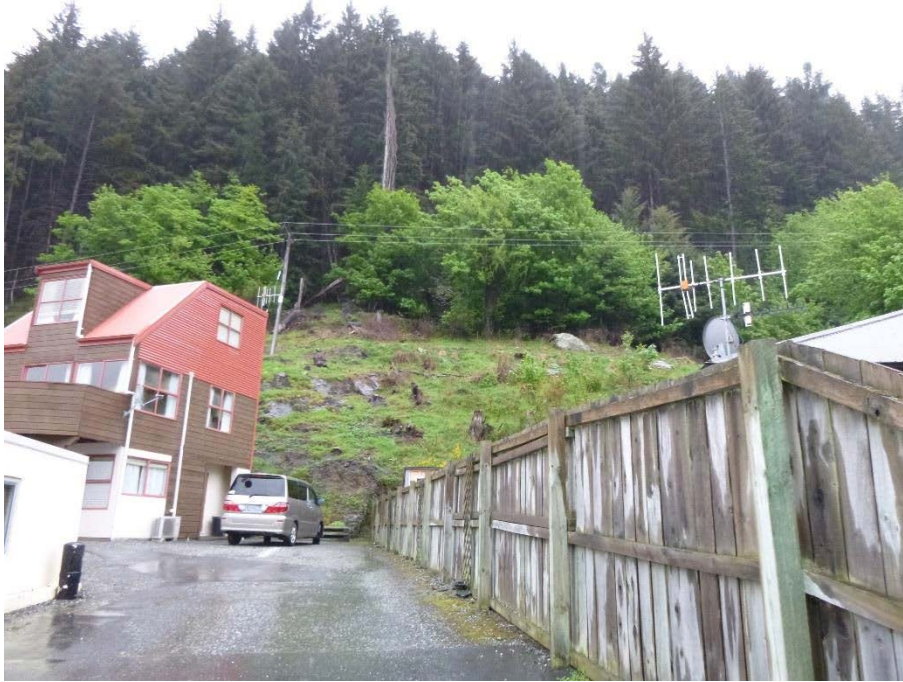
Boulders observed on the fan surface may be remnants from previous debris flow events, or physical works to create the transmission line bench, rather than rockfall. Analysis of historical aerial photos shows no evidence of rockfall occurrence, although this may not be apparent due to photo resolution.

Figure 10 – Surface boulders visible at the upper limit of Brewery Creek Fan (above Kiely Lane, 2018)

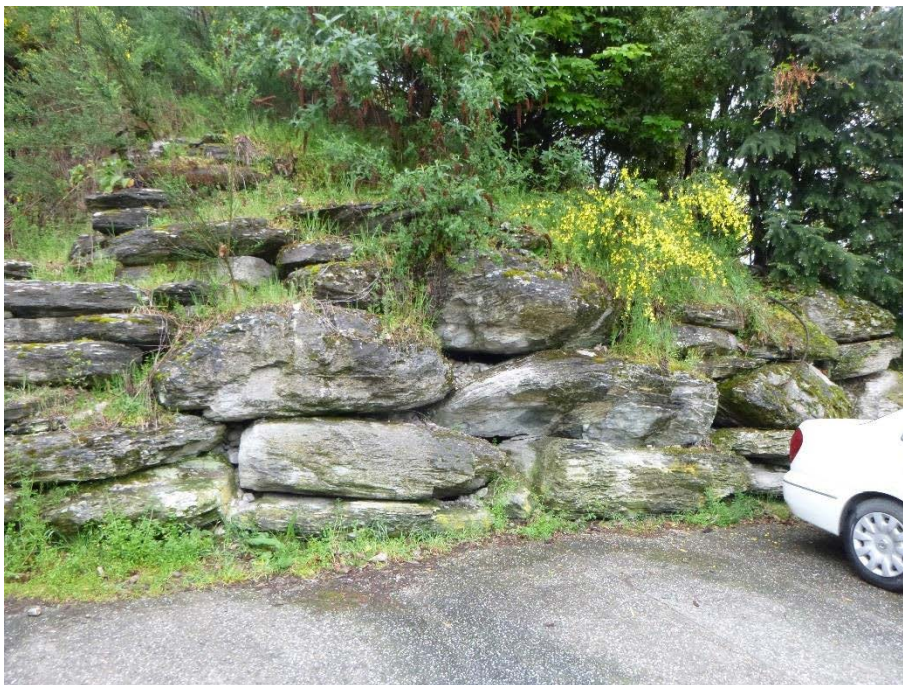
boulders used as low retaining walls (as shown Figure 11) throughout much of the upper reaches of both fans suggests a supply of boulders may have been available from the pre-development fan surface.

Figure 11 - Numerous boulders used to construct informal retaining wall on the surface of Reavers Fan (2018)

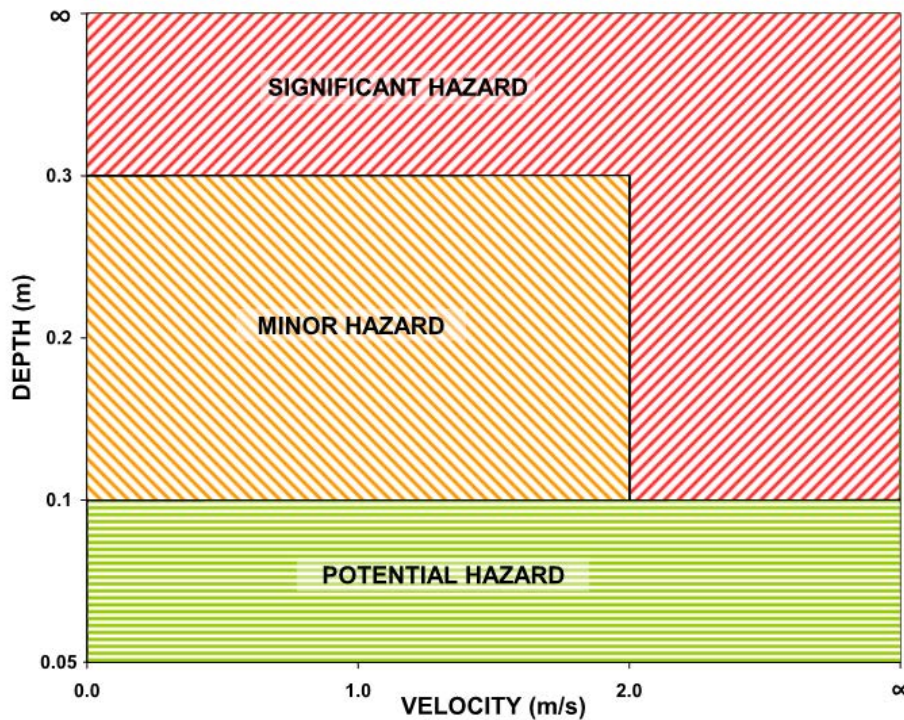
depths over 0.3m or velocities over 2m/s, Minor hazard is identified as depth between 0.1m and 0.3m and velocities up to 2m/s. Potential hazard is any velocity and depths of between 0.05 and 0.1m.

Figure 20 - Flood Hazard Classification

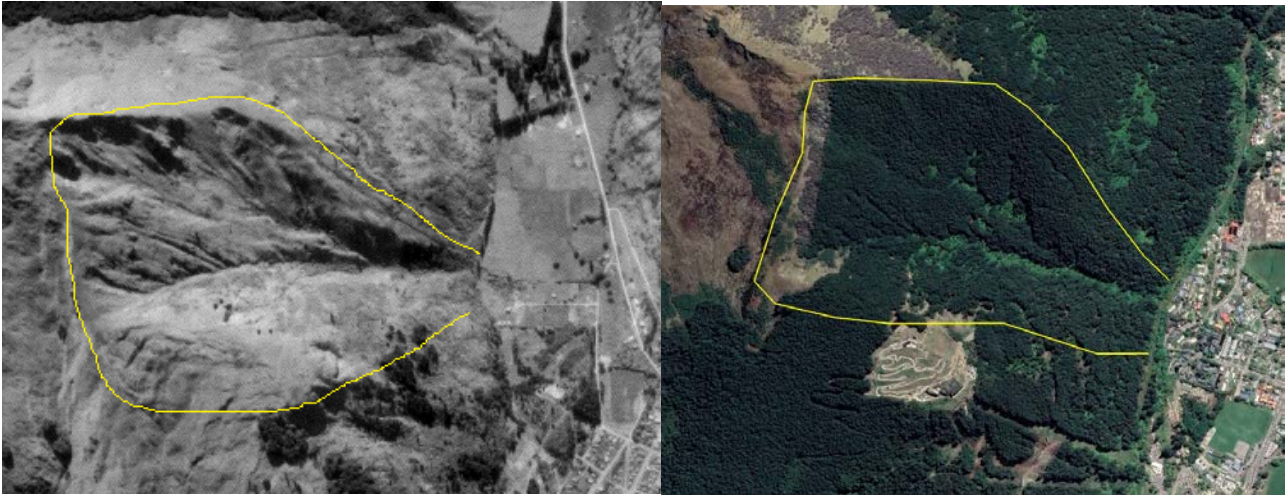
Figure C 3 - Approximate perimeter of the Reavers Catchment, from historical aerial photo (1954, left) and Google Earth images (2019, right). Note vegetation changes over this time

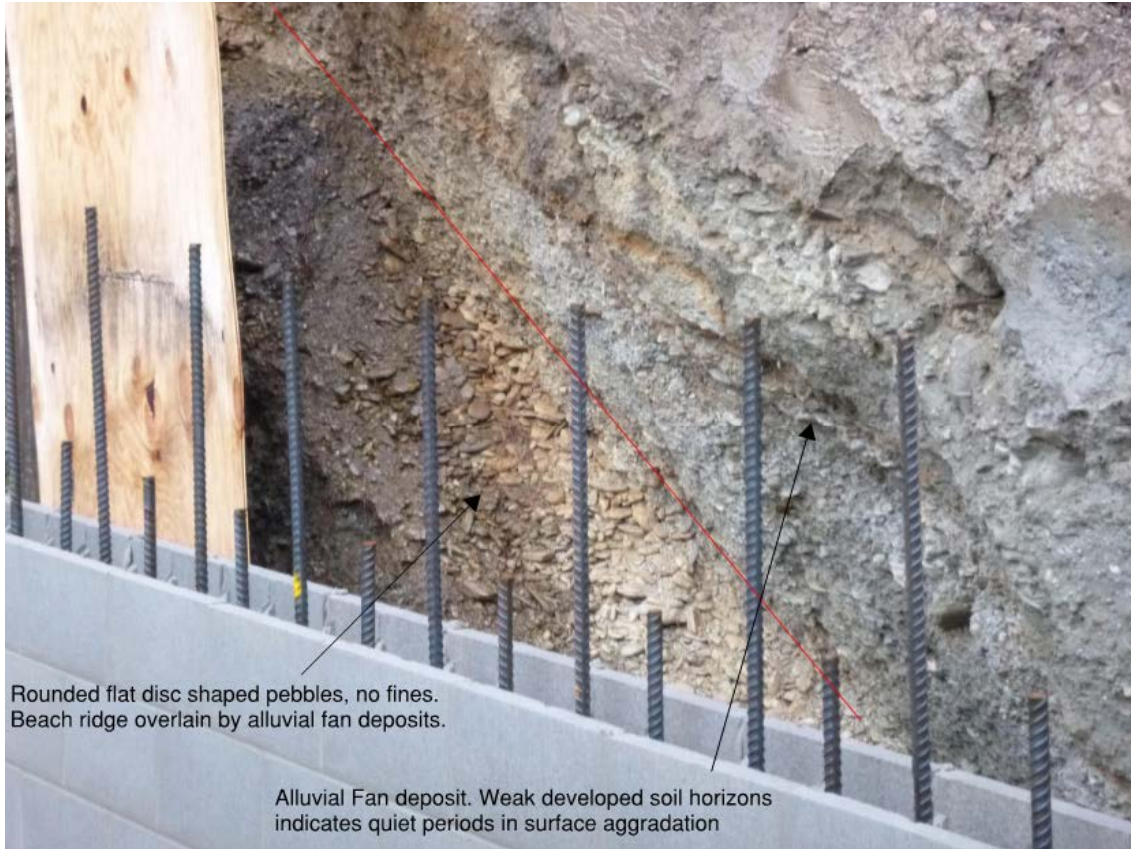
Figure C 4 - Exposure of interfingering sediments within the Reavers Fan at 62 Fryer Street (October 2018).

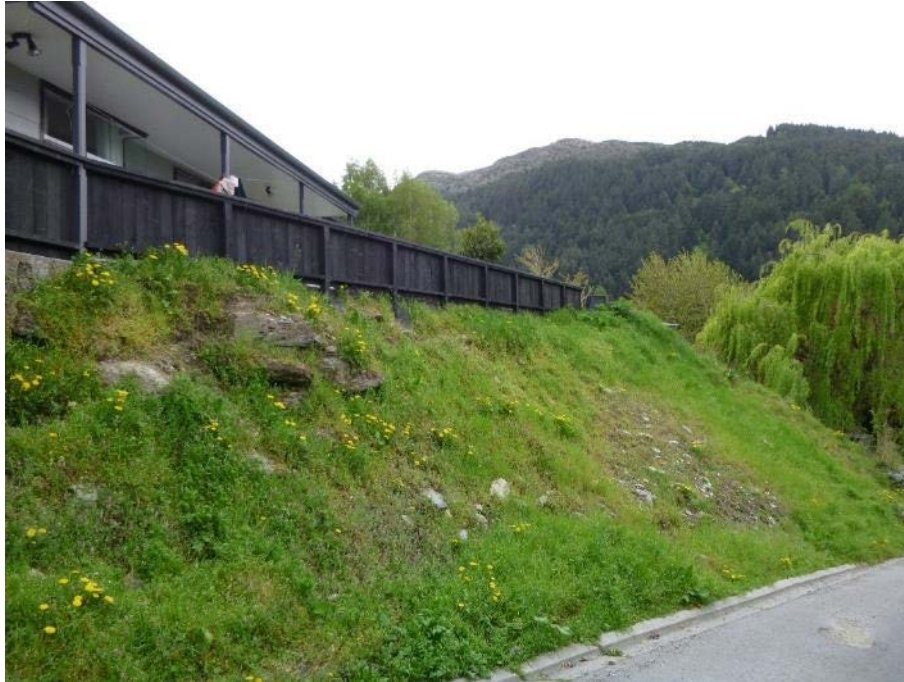
Figure E 1 - Alluvial fan deposits in the upper fan adjacent to 45 Boydtown Way, with boulders visible (2018).

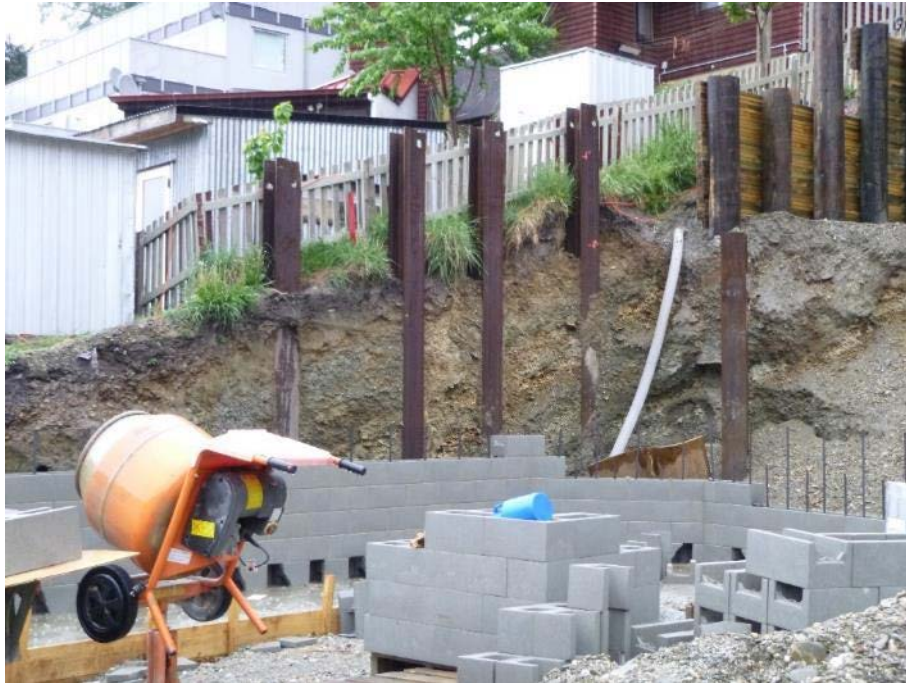
Figure E 2 - Alluvial fan and beach deposits at 62 Fryer Street (under development, 2018).

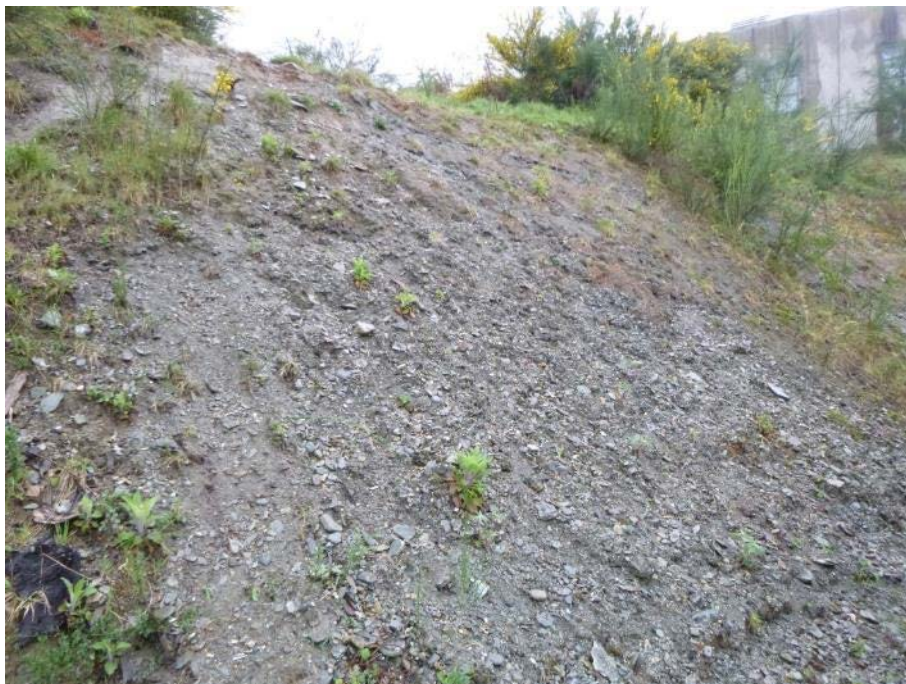
Figure E 3 - Alluvial fan deposits in the mid-reaches of the fan at 1 Bowen Street (2018).

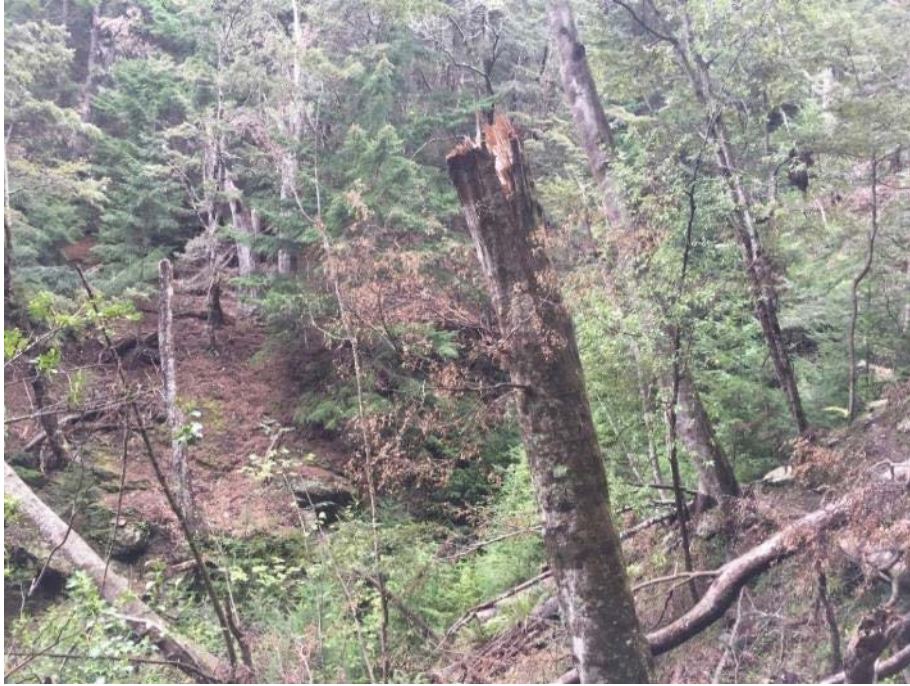
Figure E 4 - Photograph showing forest and ground cover on the true left of Brewery Creek taken looking towards the true right bank (-45.142699°; 168.392485°; 470m asl).

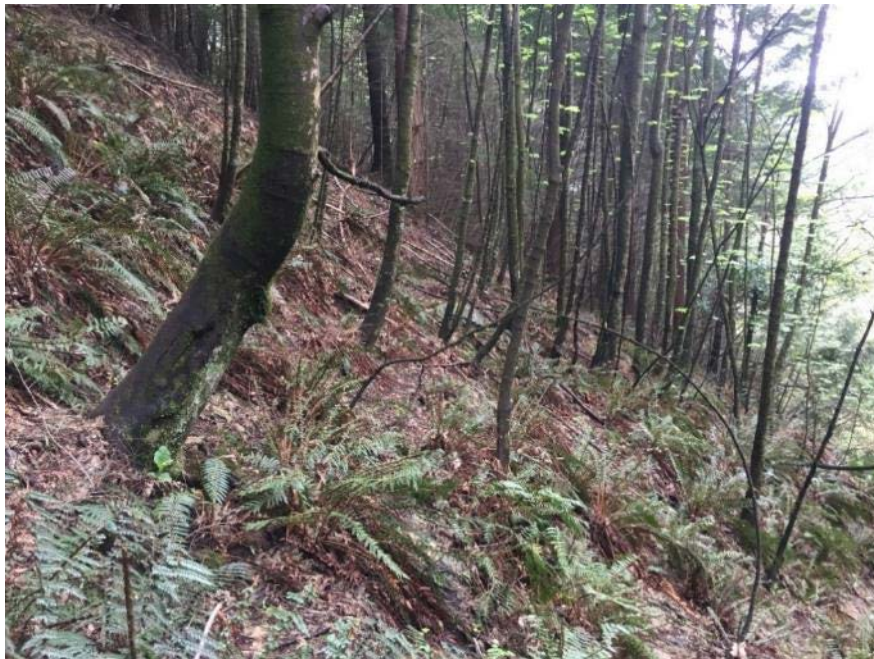
Figure E 5 - Photograph showing deformed young trees present on the true left of Brewery Creek taken looking north (45.149800°; 168.393140°; 442m asl).

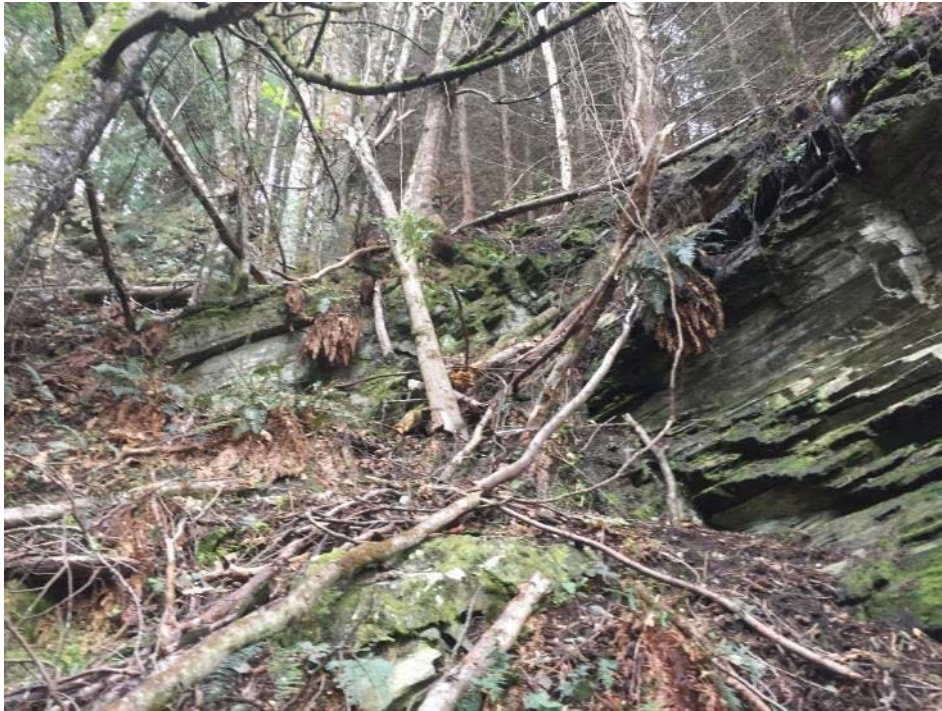
Figure E 6 - Photograph of localised schist outcrop observed to the true left of Brewery Creek. Outcrop approximately 3m high and 10m in length. Photograph taken facing west (45.112099; 168.391194; 570m asl).

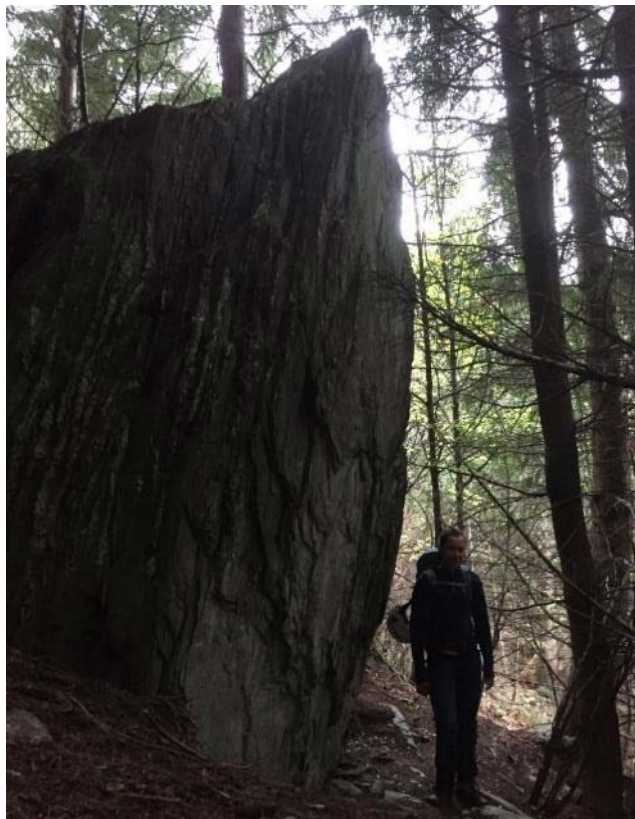
Figure E 7 - Photograph taken on the true left of Brewery Creek looking south and showing large boulder encountered on slope (45.056130; 168.391518; 630m asl).

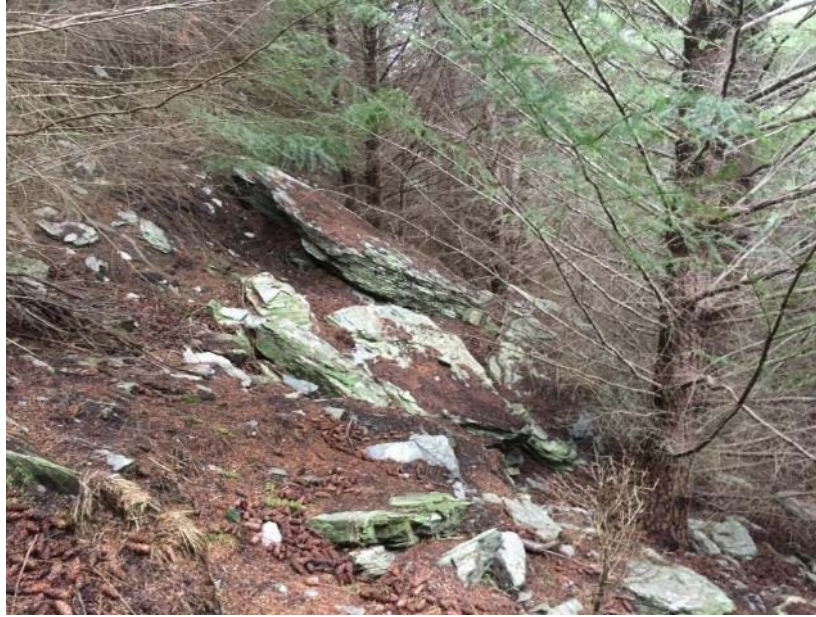
Figure E 8 - Photograph of boulders beneath schist outcrop on the true left of Brewery Creek. Taken looking north (45.112739; 168.392168; 790m asl).

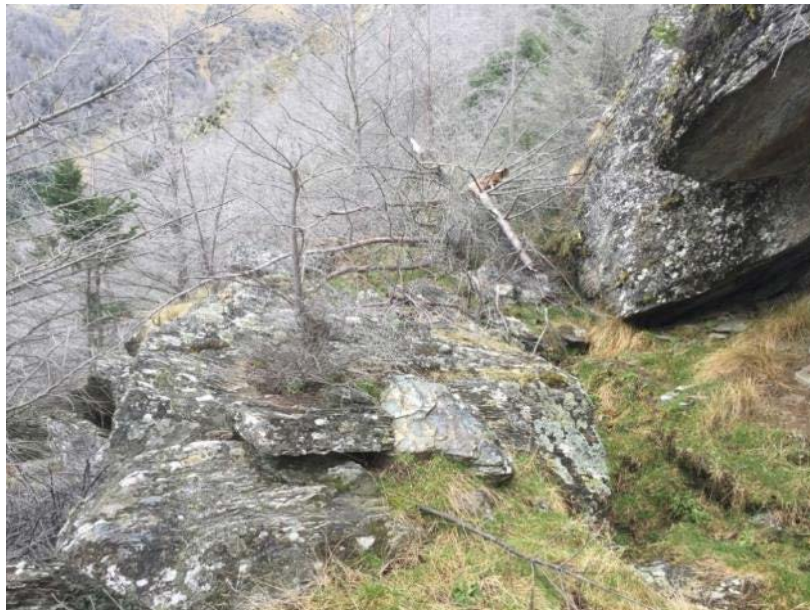
A high concentration of randomly orientated boulders ranging from 200mm x 100mm x 20mm up to 4000mm x 3000mm x 1000mm were observed between 980m and 1100m asl (Figure E 9). Outcrops were not present immediately above the boulders. Foliation within the larger boulders appeared to be consistent with the regional trend suggesting that the boulders represent in-situ fracturing of outcrops.

Figure E 9 - Boulders present on the true left of Brewery Creek. Foliations within larger boulders are consistent with the regional trend suggesting they were sourced from in situ fracturing of outcrop. Photograph taken looking south (45.046299; 168.391134; 870m).

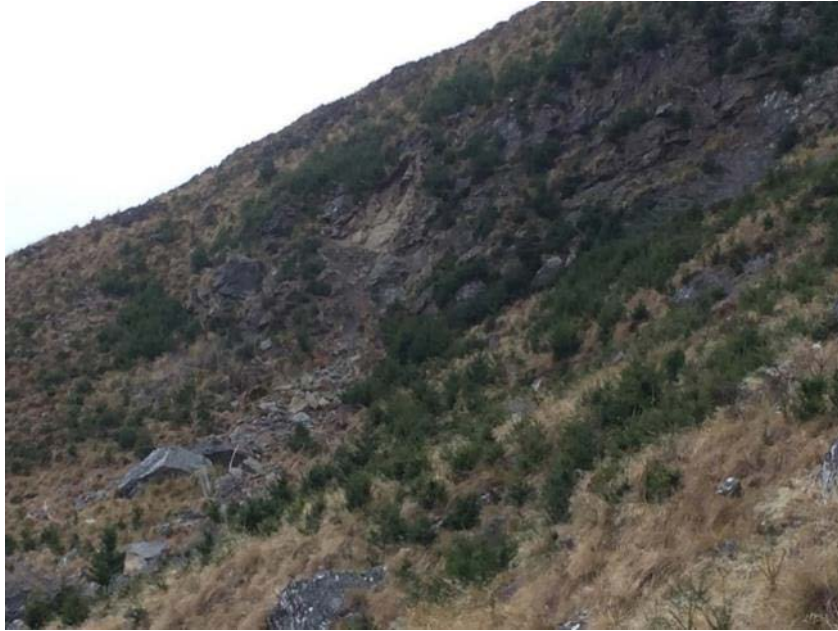
Ridgelines present between 1000m and 1100m asl on the true left side of Brewery Creek exhibit localised outcrops of schist (Figure E 10). The outcrops appeared highly fractured and contain loose boulders ranging from 100mm x 50mm x 10mm up to 1000mm x 500mm x 100mm. Scree slopes with evidence of recently deposited boulders to cobbles were observed beneath these outcrops (Figure E 11). The ridgeline at the northern-most extent of the catchment comprised an approximately 10m to 15m tall outcrop spanning 80m along the cliff (Figure E 12). Loose boulders up to 3000mm x 1000mm x 500mm were observed at the intersection of joints (Figure E 13). Boulders of similar dimensions were observed immediately beneath the cliff and in the area approximately 300m downslope (Figure E 13).

Figure E 10 - Photograph taken at base of ridgeline looking west and showing fractured outcrop with scree slope below (45.04169 168.39476; 960m asl)

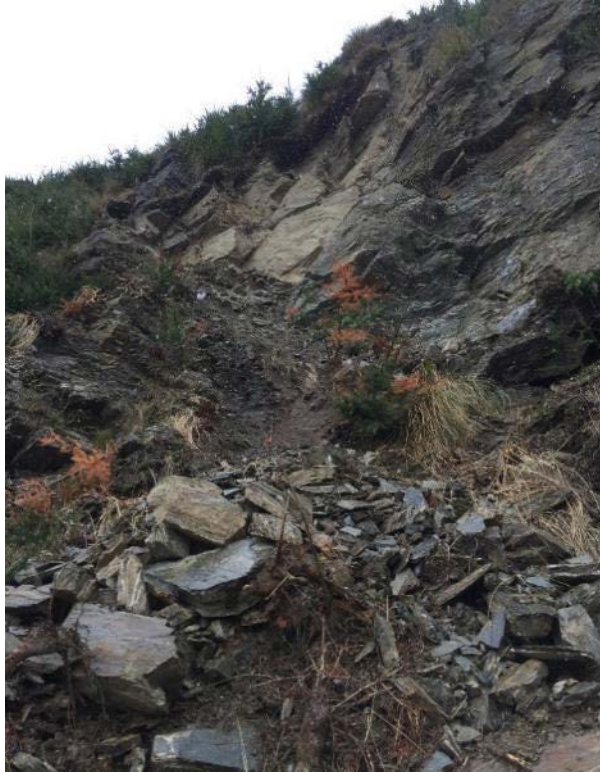
Figure E 11 - Close-up photograph of recent scarp and rockfall debris on outcrop present on ridgeline looking west and shown in Figure E10 (45.042570 168.385761; 985m asl).

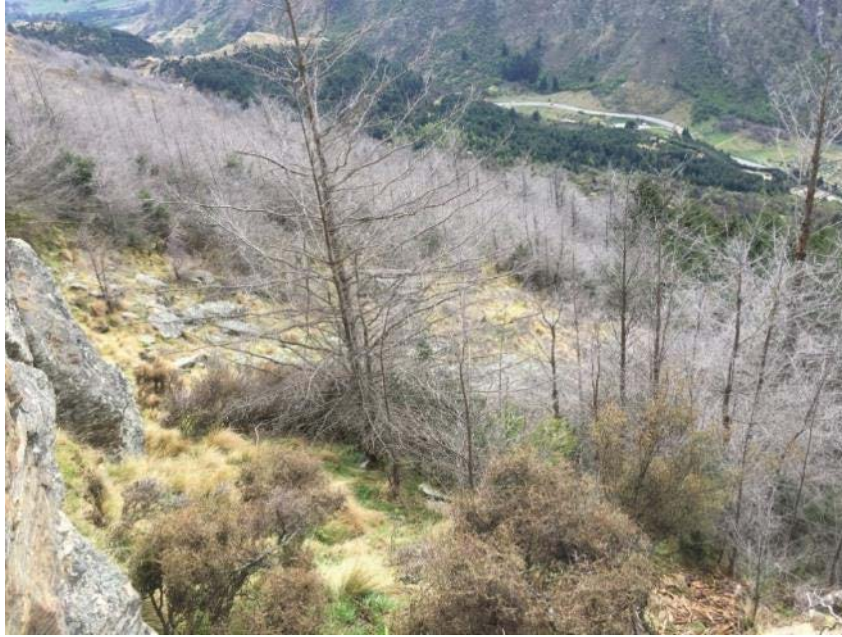
Figure E 13 - Photograph looking downslope (north-east) showing rockfall debris below the cliff shown in Figure E 12 (45.045369; 168.3912449; 825m asl).

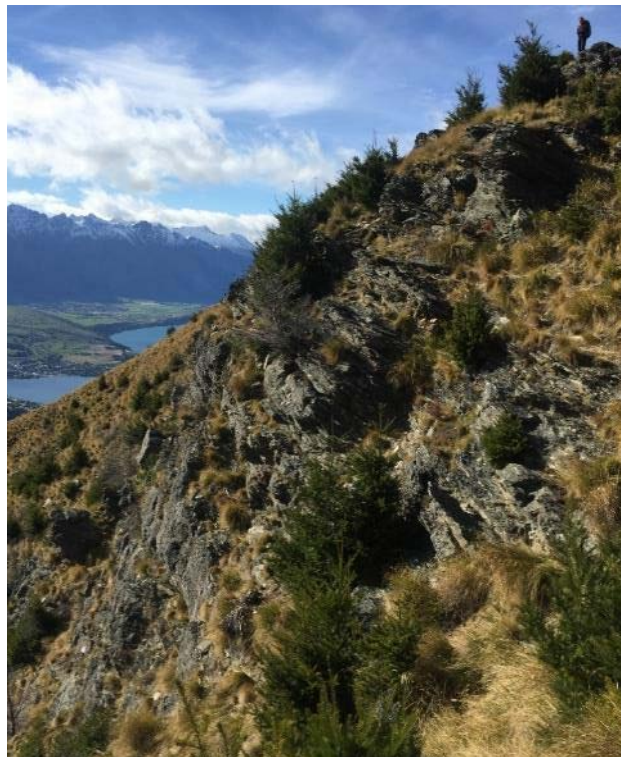
The true right slope of Brewery Creek contains cliffs with localised linear outcrops of schist (Figure E 14). Loose boulders up to 2000mm x 800mm x 500mm were present at the intersection of joints within the schist. Boulders of similar dimensions were observed downslope of the cliffs and appeared to be sourced from the upslope outcrops.

Figure E 14 - Photograph taken from top of the true right slope of Brewery Creek looking east and showing schist outcrops (45.051459; 168.381927; 1110m asl).

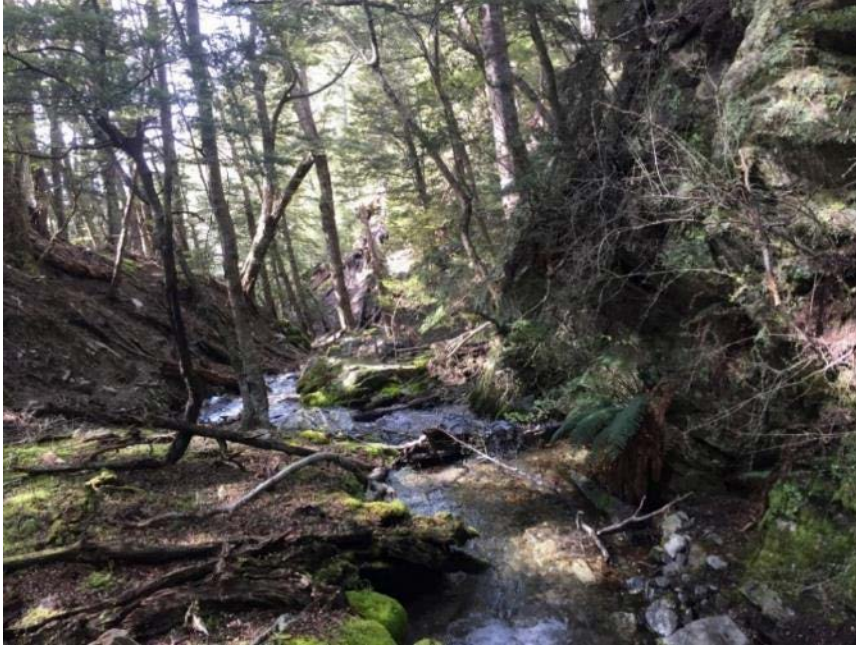
Figure E 15 - Photograph taken in Brewery Creek looking downstream (east). True left bank contains colluvial deposits while true right bank comprises schist outcrop (45.005100; 168.381773; 950m asl).

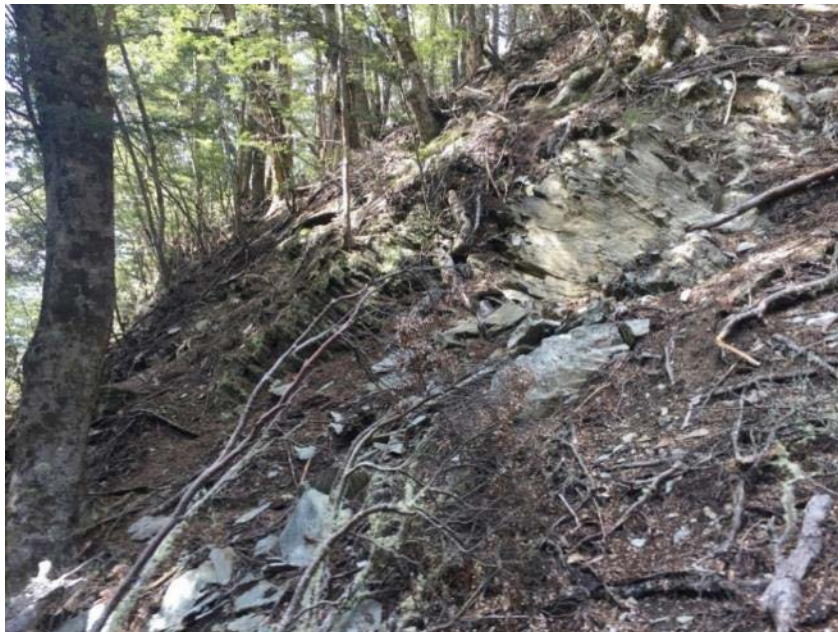
The channel of Brewery Creek generally exhibited slumping of colluvial deposits along the true left bank and outcrops of schist along the true right bank (Figure E 15). Loose rocks ranging from 200mm x 100mm x 50mm up to 3000mm x 2000mm x 500mm were present on the outcrops (Figure E 16). In some areas scarps up to 2000mm x 1000mm were observed on the outcrops and indicated recent dislodging of material (Figure E 17). The corresponding boulders were not observed in the channel suggesting downstream transport. Localised colluvium deposits were observed on the true right bank where outcrops were not present adjacent to the stream.

Figure E 16 - Photograph of schist outcrop surrounded by colluvial deposits on true right bank of Brewery Creek. Photograph taken facing south-west (45.042829; 168.382238; 920m asl).

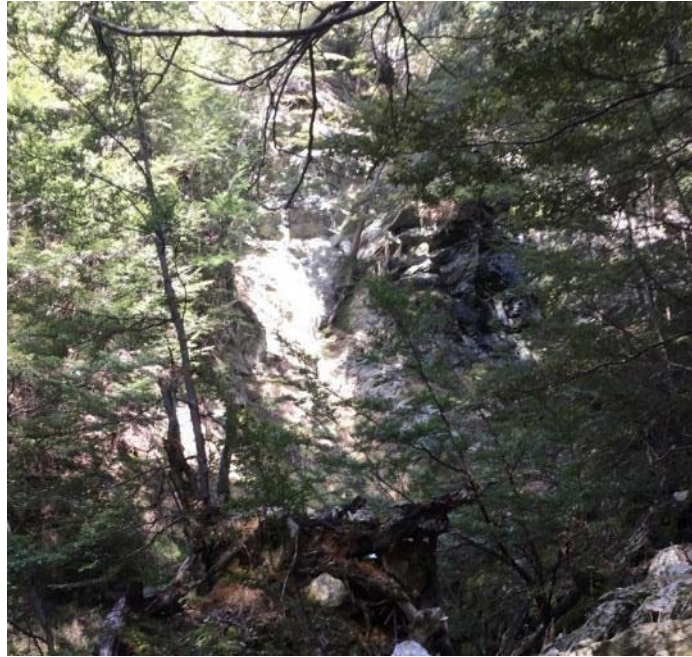
Figure E 17 - Photograph of outcrop on true right bank of Brewery Creek. Lighter area is scarp of recent rockfall. Photograph taken facing south (45.046170; 168.382772; 885m asl).

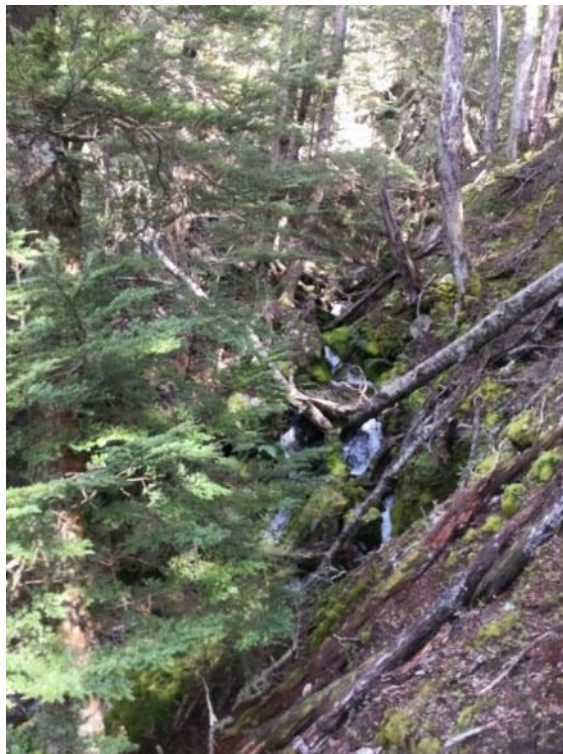
Dead trees that appear to have fallen into the channel were observed where the channel was relatively steep and narrow (Figure E 18). Accumulations of dead trees within, and adjacent to, the channel were present where the channel widened (Figure E 19). The logs are a source of debris that could be transported to form log jams and other small dams in the watercourses. Failure of these dams would generate larger pulses within debris flow and/or debris flood events.

Figure E 18 - Photograph looking upstream along Brewery Creek (looking west) showing accumulation of dead trees in narrow section of the channel (45.040700; 168.381806; 965m asl).

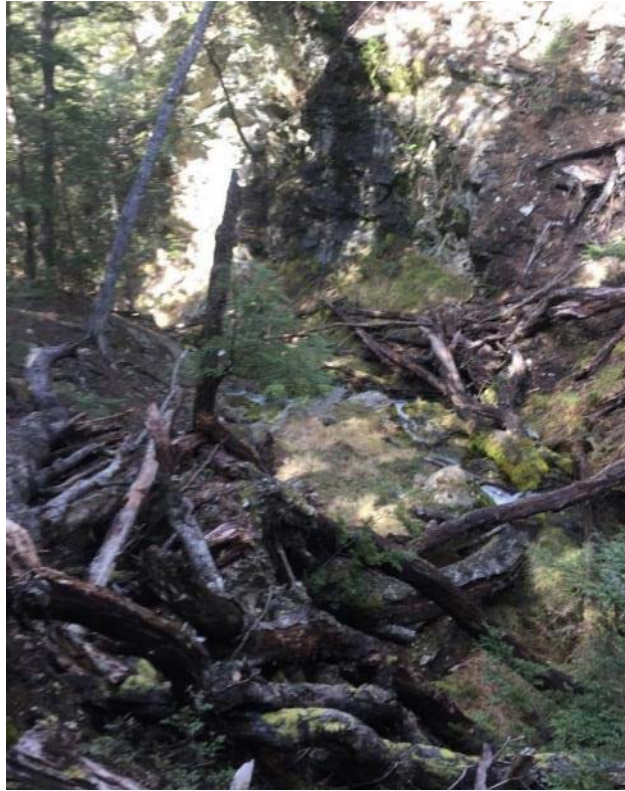
Figure E 19 - Photograph looking downstream (west) in Brewery Creek showing accumulation of logs within a wider section of the creek bed (45.043989; 168.382652; 900m asl).

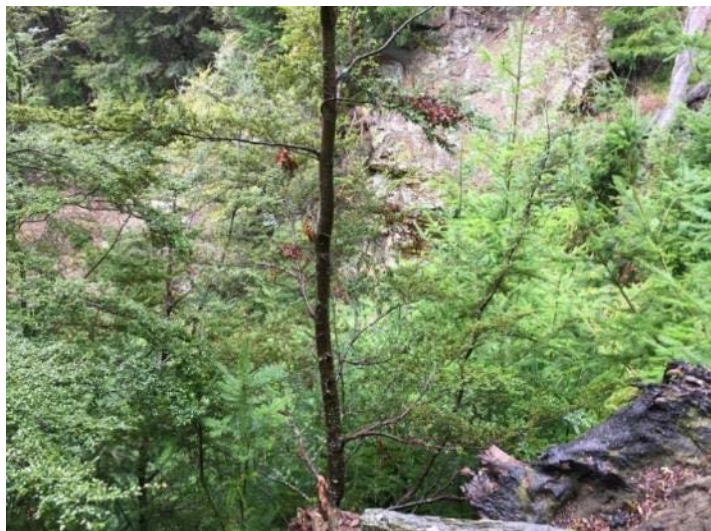
The stream channel contains dense pine saplings below approximately 550m asl. Observations below this point were limited to the top of the river bank, however suggest that the stream channel continues to comprise colluvium on the true left bank, outcrops with loose boulders on the true right bank, and an abundance of logs within the creek bed (Figure E 20). The saplings were all approximately 3m to 4m tall suggesting a period of vegetation clearance followed by regrowth along the channel. No relationship between sapling age and height has been documented for the Queenstown region therefore the age of the saplings is uncertain.

Figure E 20 - Photograph taken from slope above true left bank of Brewery Creek looking south and showing the density of pine saplings within the channel (45.059519; 168.396410; 630m asl).

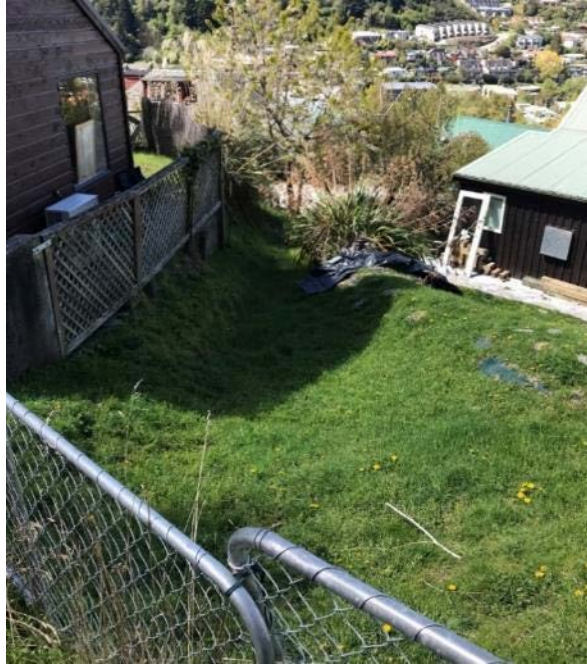
Figure E 22 - Photograph of small channel through residential properties directly above culvert intake. Taken looking east (45.126229; 168.391439; 365m asl).

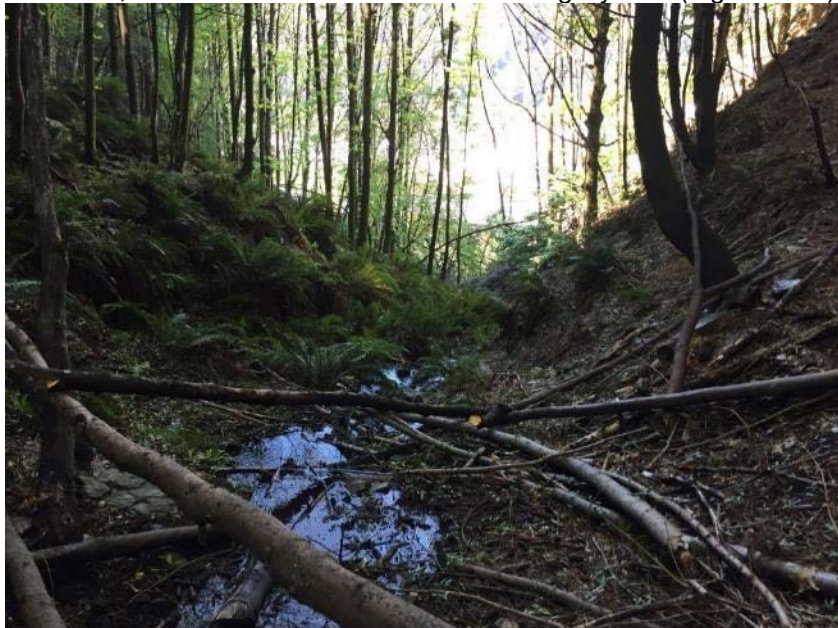
At the time of field mapping the creek was flowing from approximately 430m asl to around 370m asl where it drained underground approximately 20m upstream of the stream culvert. The gully immediately upstream from the fan apex is moderately-to-steeply sloping and varies in width from 10m to 30m. Colluvium was observed on the true left bank of the creek while outcrops of schist and localised colluvium were observed on the true right bank (Figure E 23). Localised boulders up to 500mm x 200mm x 100mm in size, broken tree branches, and leaf litter were observed on the gully floor (Figure E 23).

Figure E 23 - Photograph looking downstream along Reavers Creek towards the culvert and showing the vegetation cover within the gully (45.129700; 168.393897; 380m asl).

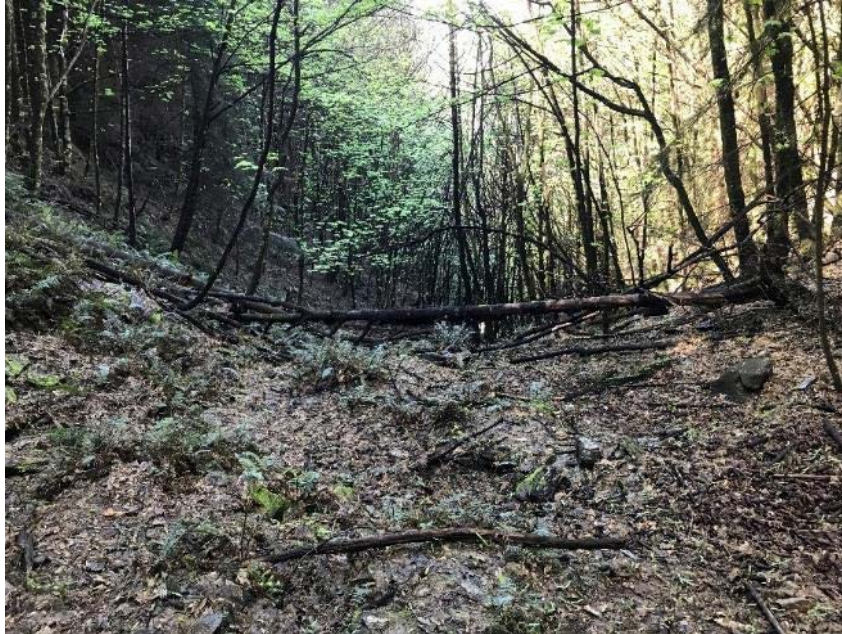
deposits generally observed on the true left bank, and outcrops of schist and colluvial deposits on the true right bank (Figure E 24). The gully margins and floor contain trees of varying sizes, leaf litter, and vegetation debris (Figure E 24). No evidence for recent water flow was observed however some trees within the channel exhibit deformation/warping suggesting localised creep (Figure E 25). Localised moss-covered cobbles to boulders up to 1000mm x 500mm x 200mm were additionally observed on the channel floor, and in some cases were up to 4500mm x 3000mm x 2000mm (Figure E 26).

Figure E 24 - Photograph looking upstream along Reavers Creek showing the vegetation present within open sections of the channel and state of the gully floor (45.126670; 168.391179; 430m asl).

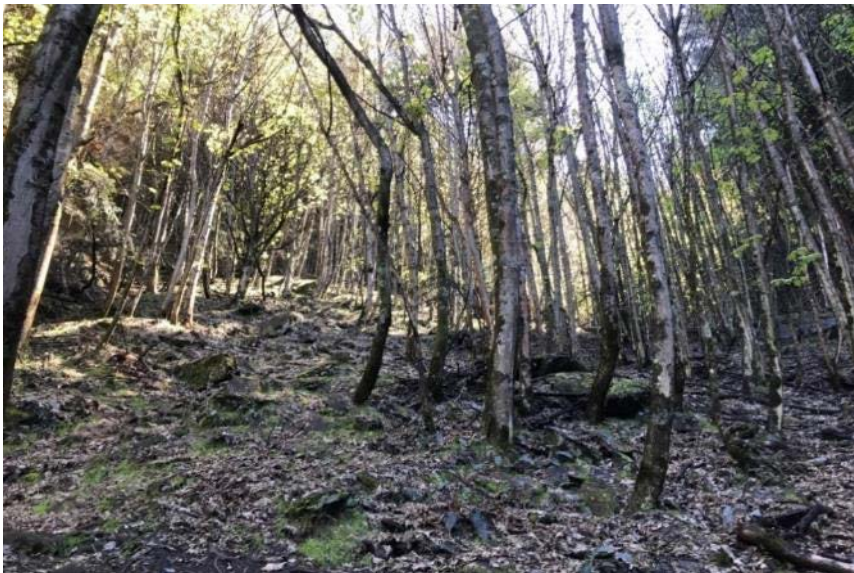
Figure E 25 - Photograph looking upstream along Reavers Creek showing localised warping and deformation of trees within an open section of the channel (45.124980; 168.394920; 560m asl).

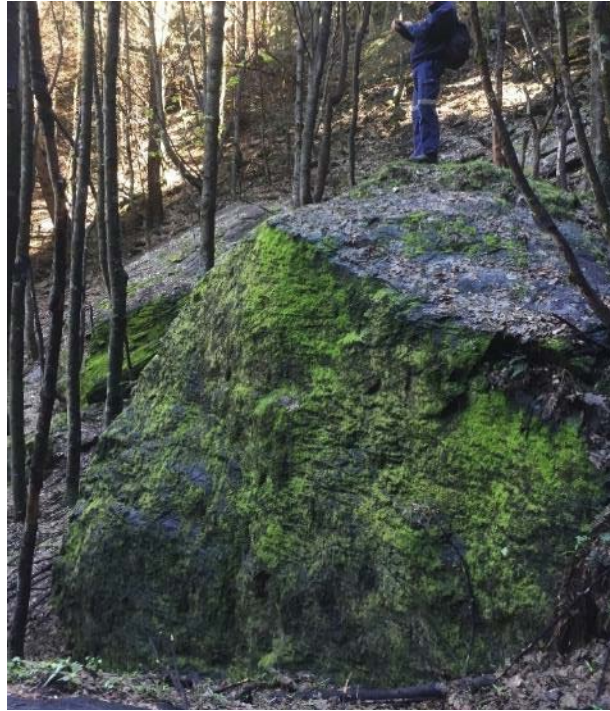
Figure E 26 - Photograph showing large boulder present within wide section of the channel (45.122959; 168.385986; 665m asl).

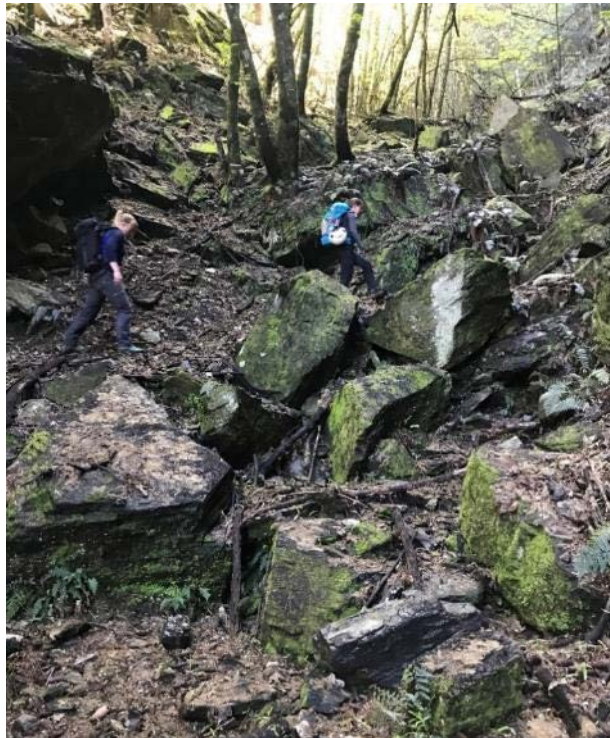
Localised accumulations of boulders were observed where outcrops intersect the channel (Figure E 27). Boulders range in size from 200mm x 100mm x 50mm up to 1000mm x 800mm x 500mm and are covered in moss with no evidence for recent water-flow observed (Figure E 27).

Figure E 27 - Photograph looking upstream along Reavers Creek showing accumulations of boulders within the channel. Boulders are covered in moss and leaf litter with no evidence for recent water flow (45.126220; 168.391400; 440m asl).

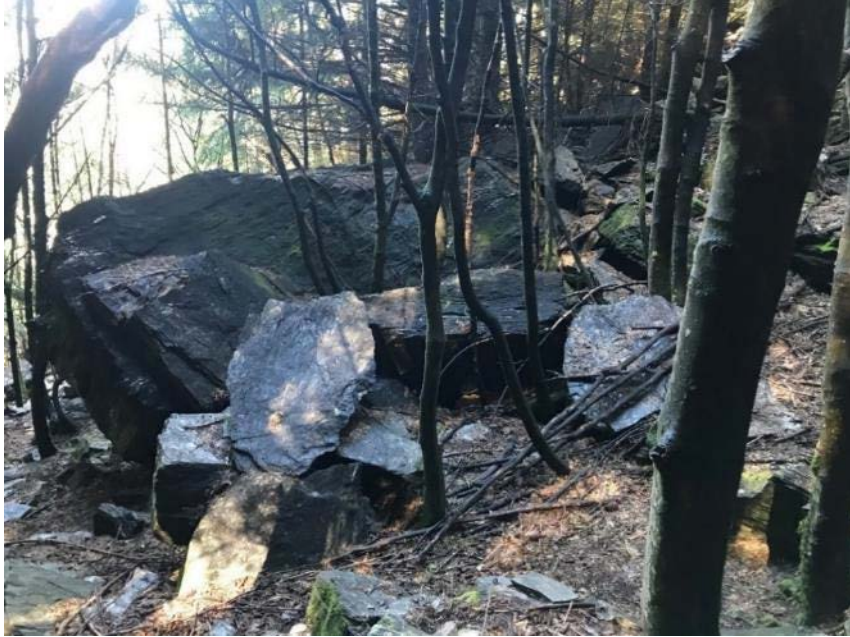
5000mm x 2000mm x 1000mm and possibly larger (Figure E 28). The boulders exhibited varying states of weathering and appeared to be sourced from the overhead bluff outcrop at 730m asl (Figure E 29).

Figure E 28 - Photograph of boulders observed near true right bank of Reavers Creek channel and located beneath cliff at 735 m asl. Rocks appear to be randomly orientated and exhibit varying degrees of weathering (45.124950 168.385328; 680m asl).

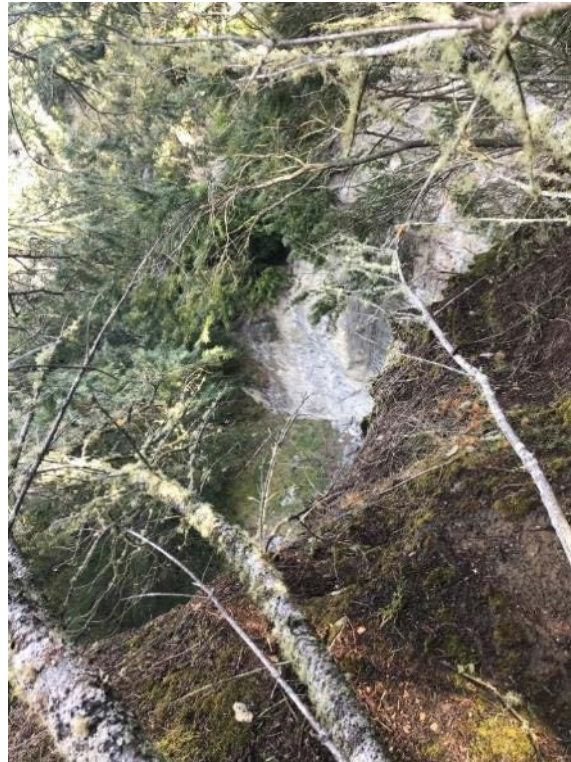
Figure E 29 - Photograph looking towards cliff above boulder the field in the channel. Cliff outcrops along ridgeline next to the Skyline Gondola and is approximately 20-50m high (45.124640; 168.385355; 735m asl).
