Natural Hazards Affecting Gorge Road, Queenstown

Prepared for Queenstown Lakes District Council

Prepared by Beca Limited

12 November 2020

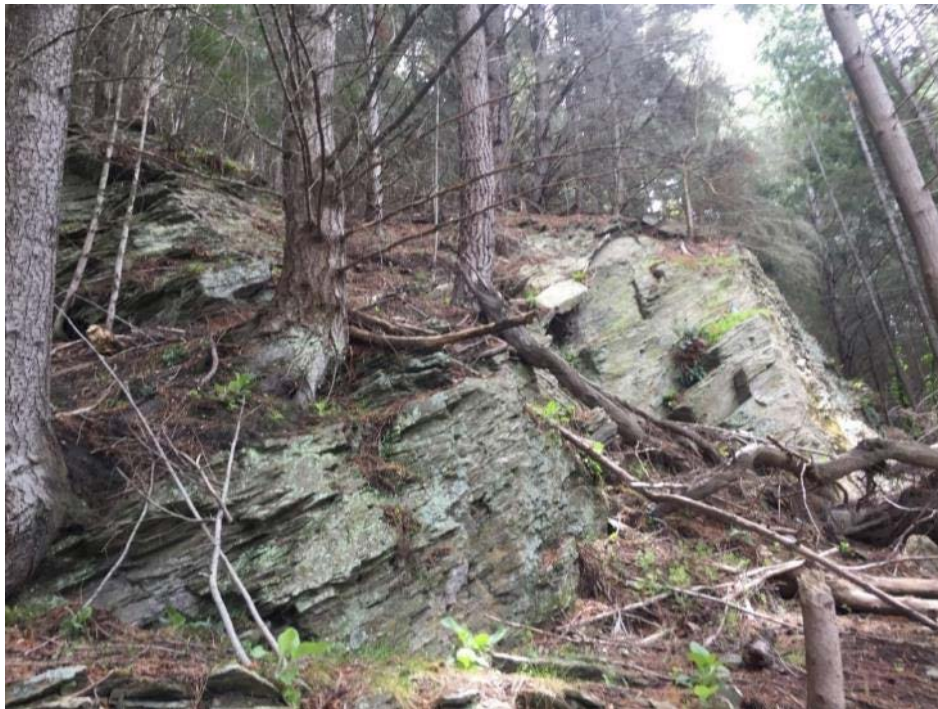
Figure E 30 - Photograph showing outcrop present immediately above the transmission line. Taken looking north (45.119400; 168.393881; 340m asl).

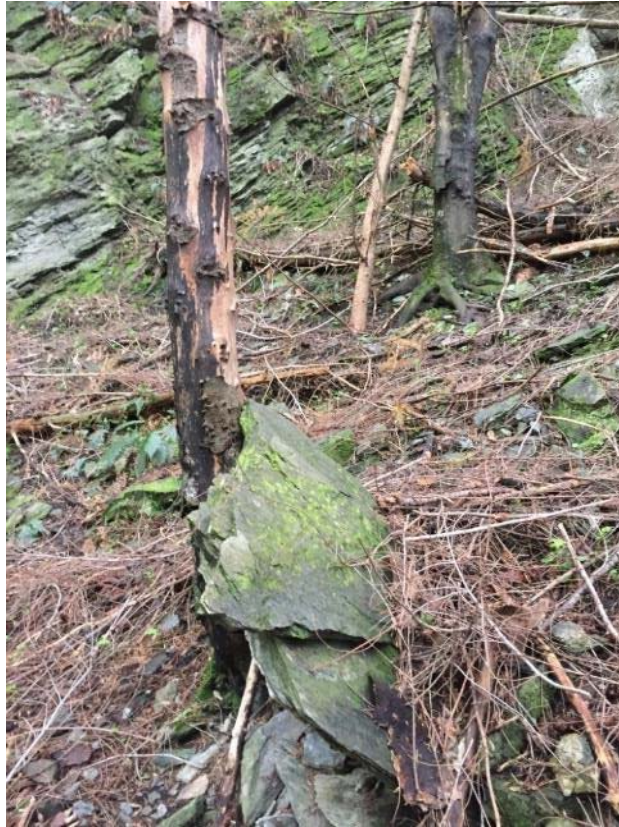
Figure E 31 - Photograph of rocks stacked adjacent to small (10cm diameter) tree indicating recent shedding of material of the above cliff (45.124570; 168.391300; 530m asl). Damage to bark suggests repeated impact damage from shredded material, albeit the tree is still alive.

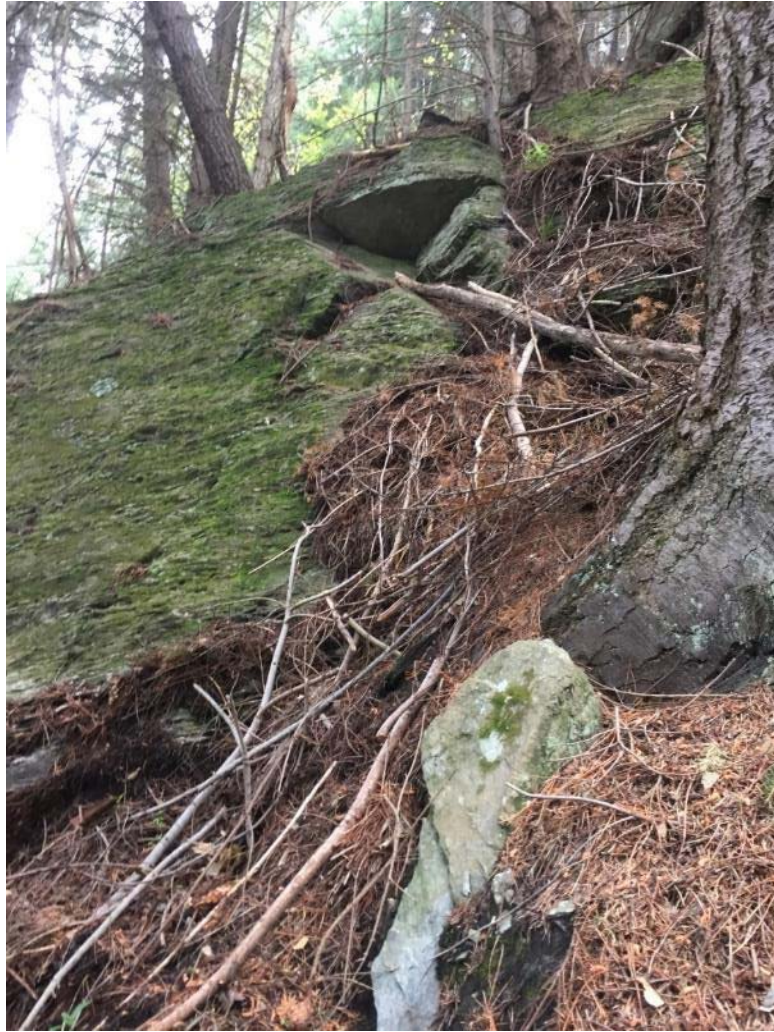
Figure E 32 - Photograph taken from base of cliff looking upslope and showing block fallen from cliff onto slope blow (45.114299; 168.392974; 540m asl).

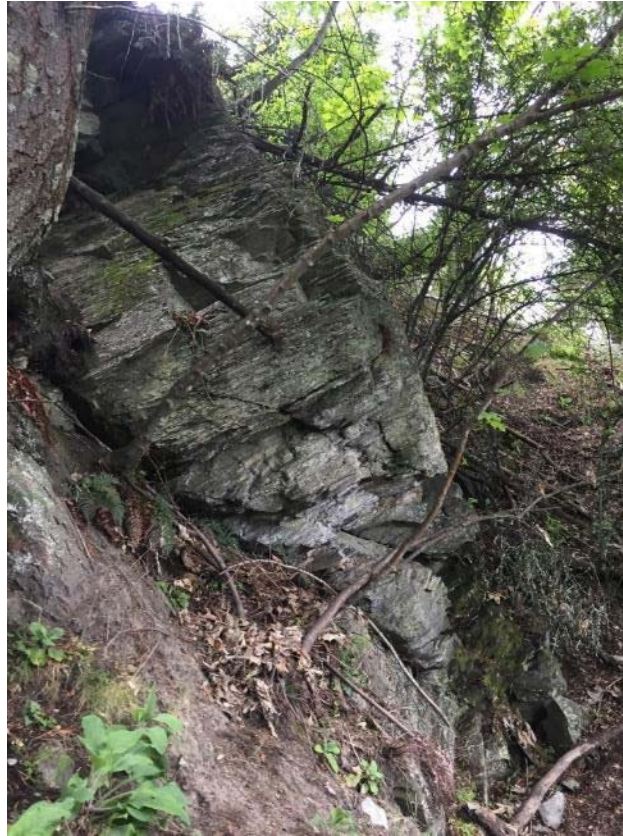
Figure E 33 - Photograph showing large loose block present on outcrop immediately behind the Kiwi Birdlife Park. Taken looking towards the north with properties behind the trees in the background (45.136690; 168.392309; 380m asl).

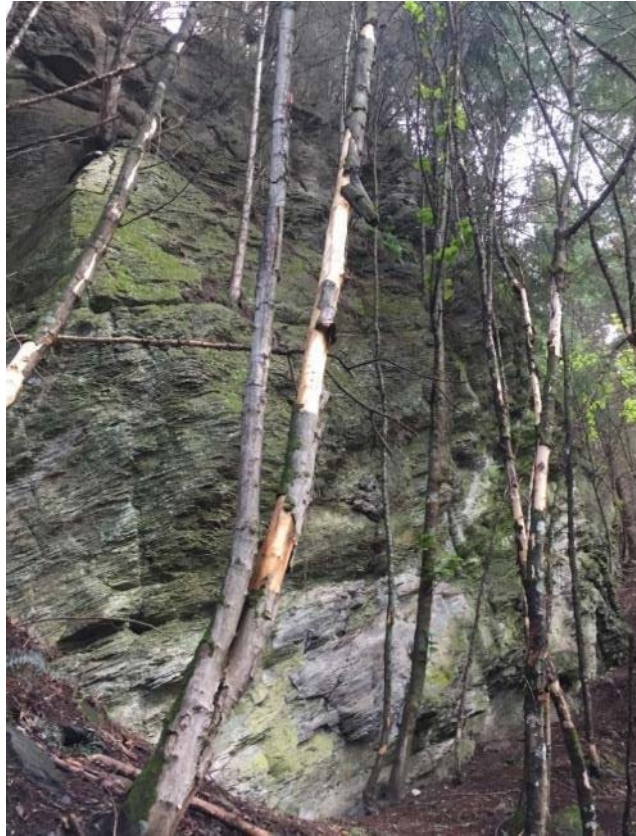
The slope immediately behind the Kiwi Birdlife Park on the true right bank of Reavers Creek contains outcrops of similar dimensions and states to those observed behind the transmission line. The outcrops were found to range from 20m to 80m in length to 4m to 20m in height (Figure E 34). Loose rocks approximately 70mm x 50mm x 20mm to 500mm x 500mm x 100mm were present on the outcrops, and rocks of similar dimensions were observed on the underlying slopes. Localised larger blocks up to 2000mm x 800mm x 500mm were identified at the intersection of joint sets on some outcrops. Localised blocks of similar dimensions were observed beneath some outcrops. In one case a boulder appeared to have fallen off relatively recently due to a lack of weathering on the outcrop scar and fresh faces present on the boulder below (Figure E 35).

Figure E 34 - Photograph of outcrop observed mid-slope in the area behind the Kiwi Birdlife Park and south of Reavers Creek (45.132709; 168.391859; 450m asl).

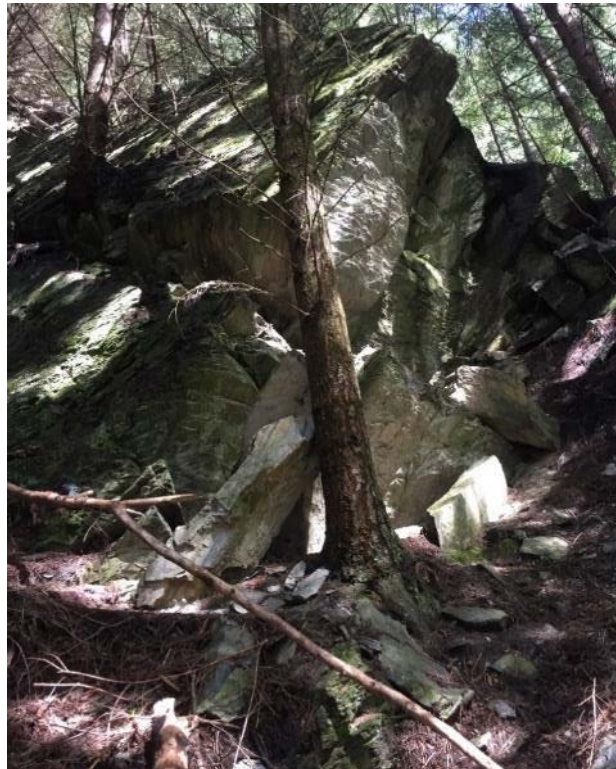
Figure E 35 - Recent scar on outcrop (white colouration) with fresh boulders below suggesting recent rockfall (45.127630; 168.391316; 515m asl).

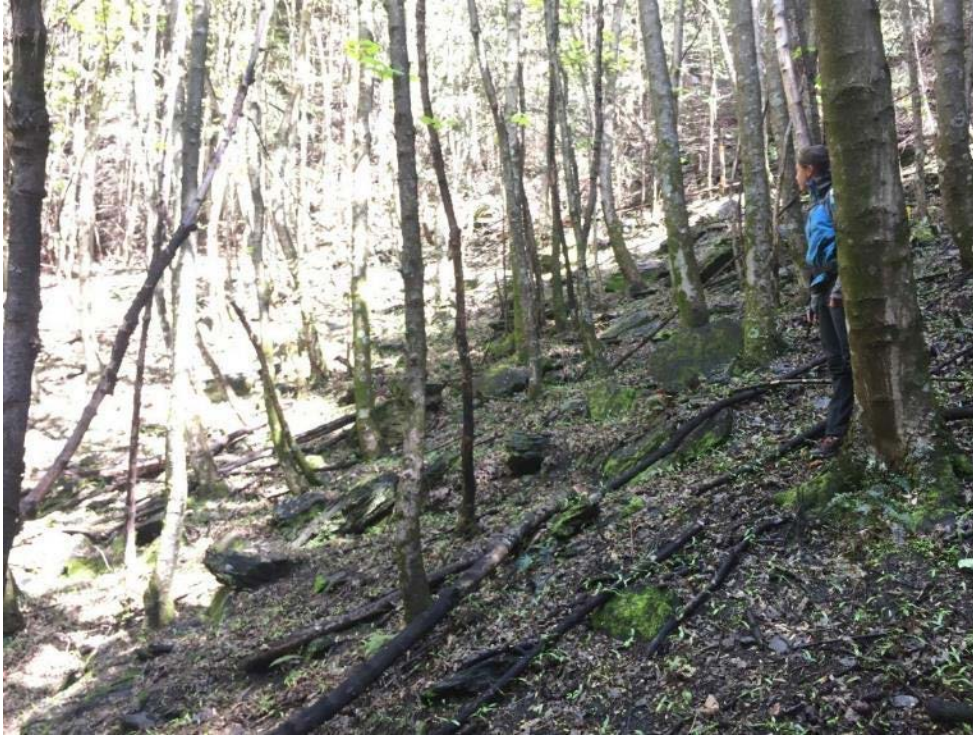
Figure E 36 - Photograph showing accumulation of boulders and younger trees in a topographic depression on the slope between Brewery and Reavers Creeks (45.18950 168.3918599; 540m asl).

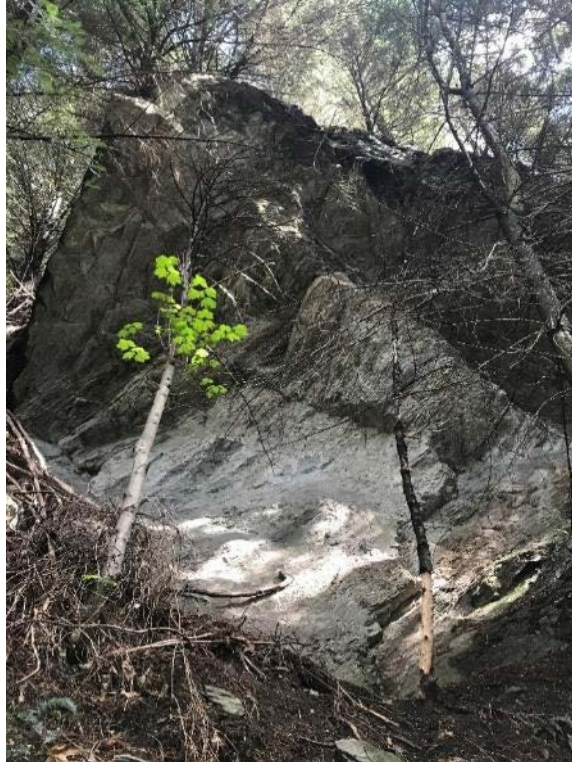
A continuous cliff ranging in height from 10m to 30m was identified on the slope between Brewery and Reavers Creek and extending from 540m to approximately 630m asl. Loose cobbles to boulders were observed on the surface of the outcrop and range in size from 100mm x 80mm x 50mm up to 2500mm x 1000mm x 500mm. Larger blocks were observed at the intersection of joints (Figure E 37). Cobbles to boulders of similar dimensions were observed on the slope immediately beneath the cliff and extending downslope to approximately 490 m asl. The cliff appeared to be the source of the accumulation of boulders shown in Figure E 36. Boulders leaning on young trees and scars on the trees likely due to flying rocks were observed beneath the cliff and suggest that the outcrop is actively shedding material (Figure E 39 and Figure E 40).

Figure E 37 - Photograph looking up at cliff present between Brewery and Reavers Creek. A loose block is present at the intersection of two joint sets. Photograph taken looking upslope towards the west (45.11414; 168.391672; 580m asl).

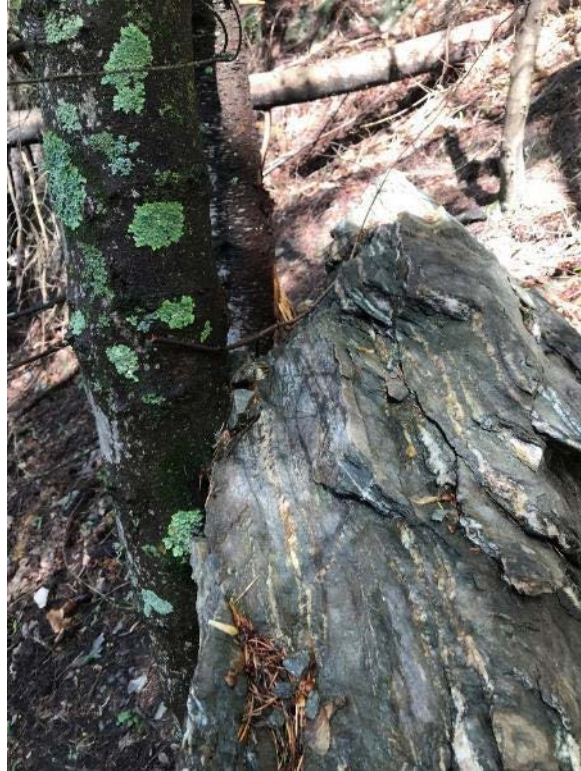
Figure E 39 - Photograph showing rock leaning against young tree. The rock appears to have caused recent damage to the tree suggesting recent movement (45.117179; 168.391492; 600m asl).

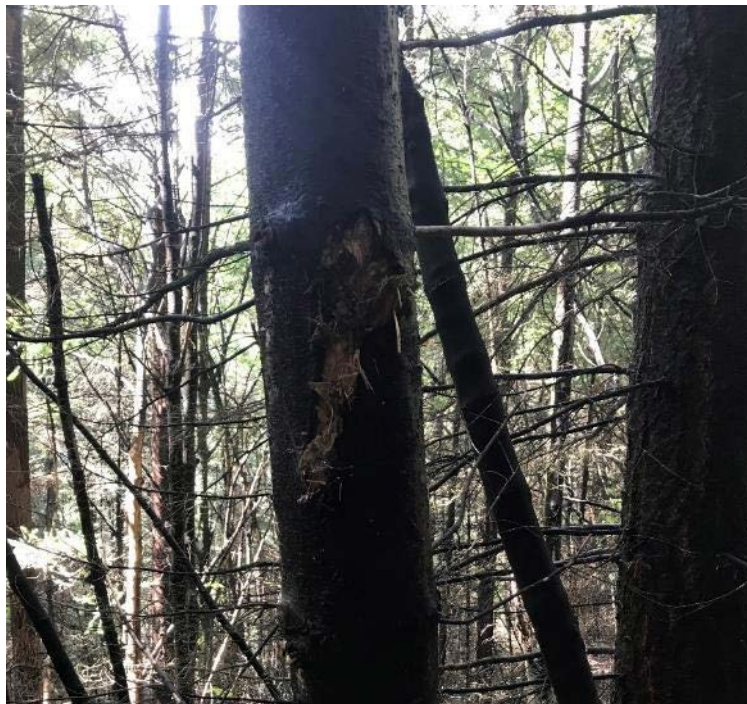
Figure E 40 - Photograph of damage to tree trunk believed to have been caused by flying rockfall debris. Taken looking downslope towards the east (45.127089; 168.391267; 545m asl).

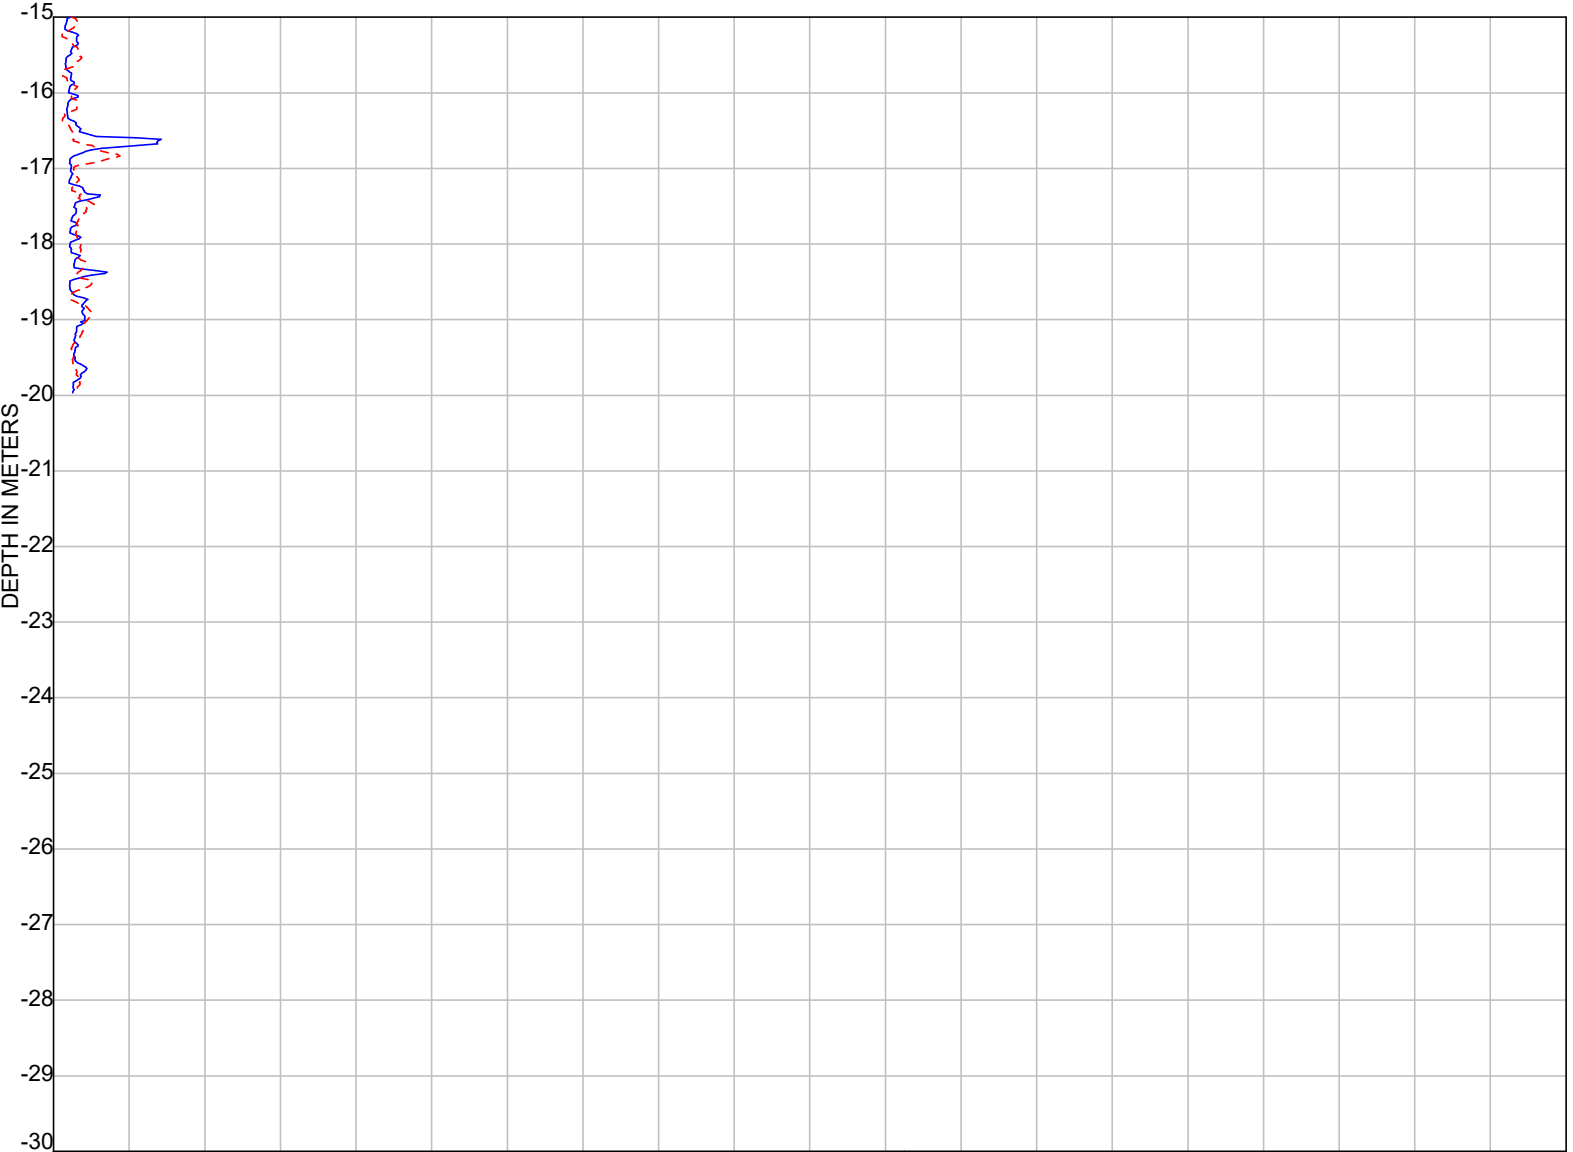
Tip resistance (MPa) → 0 5 10 15 20 25 30 35 40 45 50 55 60 65 70 75 80 85 90 95 100
 Local friction (MPa) → 0 0.25 0.50 0.75 1.00 1.25 1.50 1.75 2.00 2.25 2.50

Pore pressure (kPa) → -100 0 100 200 300 400 500
 Inc [deg] 3.64 4.21

Operator : JC	Cone : I-CFYYP20-15	Test in accordance with ASTM D5778
Date : 18-1-2017	Cone Serial No : 160610	Cone type cylindrical electrical 1510 mm ²
Time : 10:35	Remark :	Easting [m] 1258109
		Northing [m] 5005219

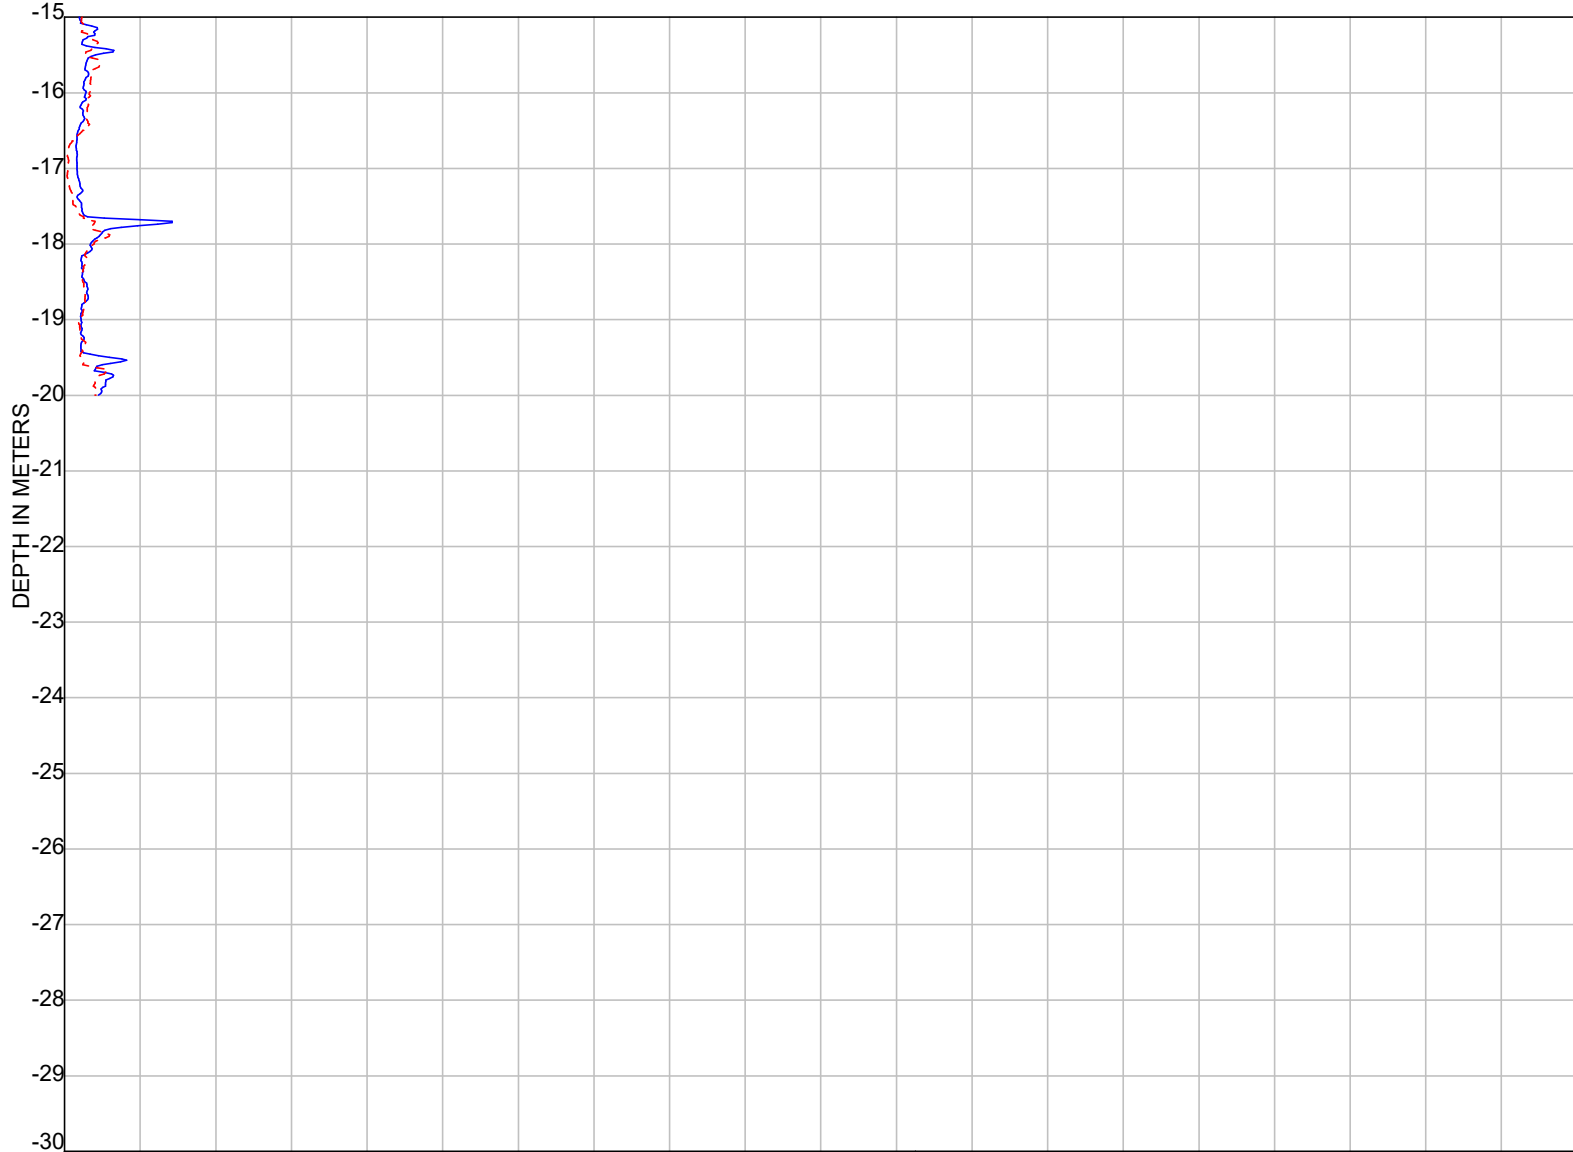
Tip resistance (MPa) → 0 5 10 15 20 25 30 35 40 45 50 55 60 65 70 75 80 85 90 95 100
 Local friction (MPa) → 0 0.25 0.50 0.75 1.00 1.25 1.50 1.75 2.00 2.25 2.50

Pore pressure (kPa) → -100 0 100 200 300 400 500
 Inc [deg]

Operator : JC	Cone : I-CFYYP20-15	Test in accordance with ASTM D5778
Date : 18-1-2017	Cone Serial No : 160610	Cone type cylindrical electrical 1510 mm ²
Time : 11:19	Remark :	Easting [m] 1258157
		Northing [m] 5005280

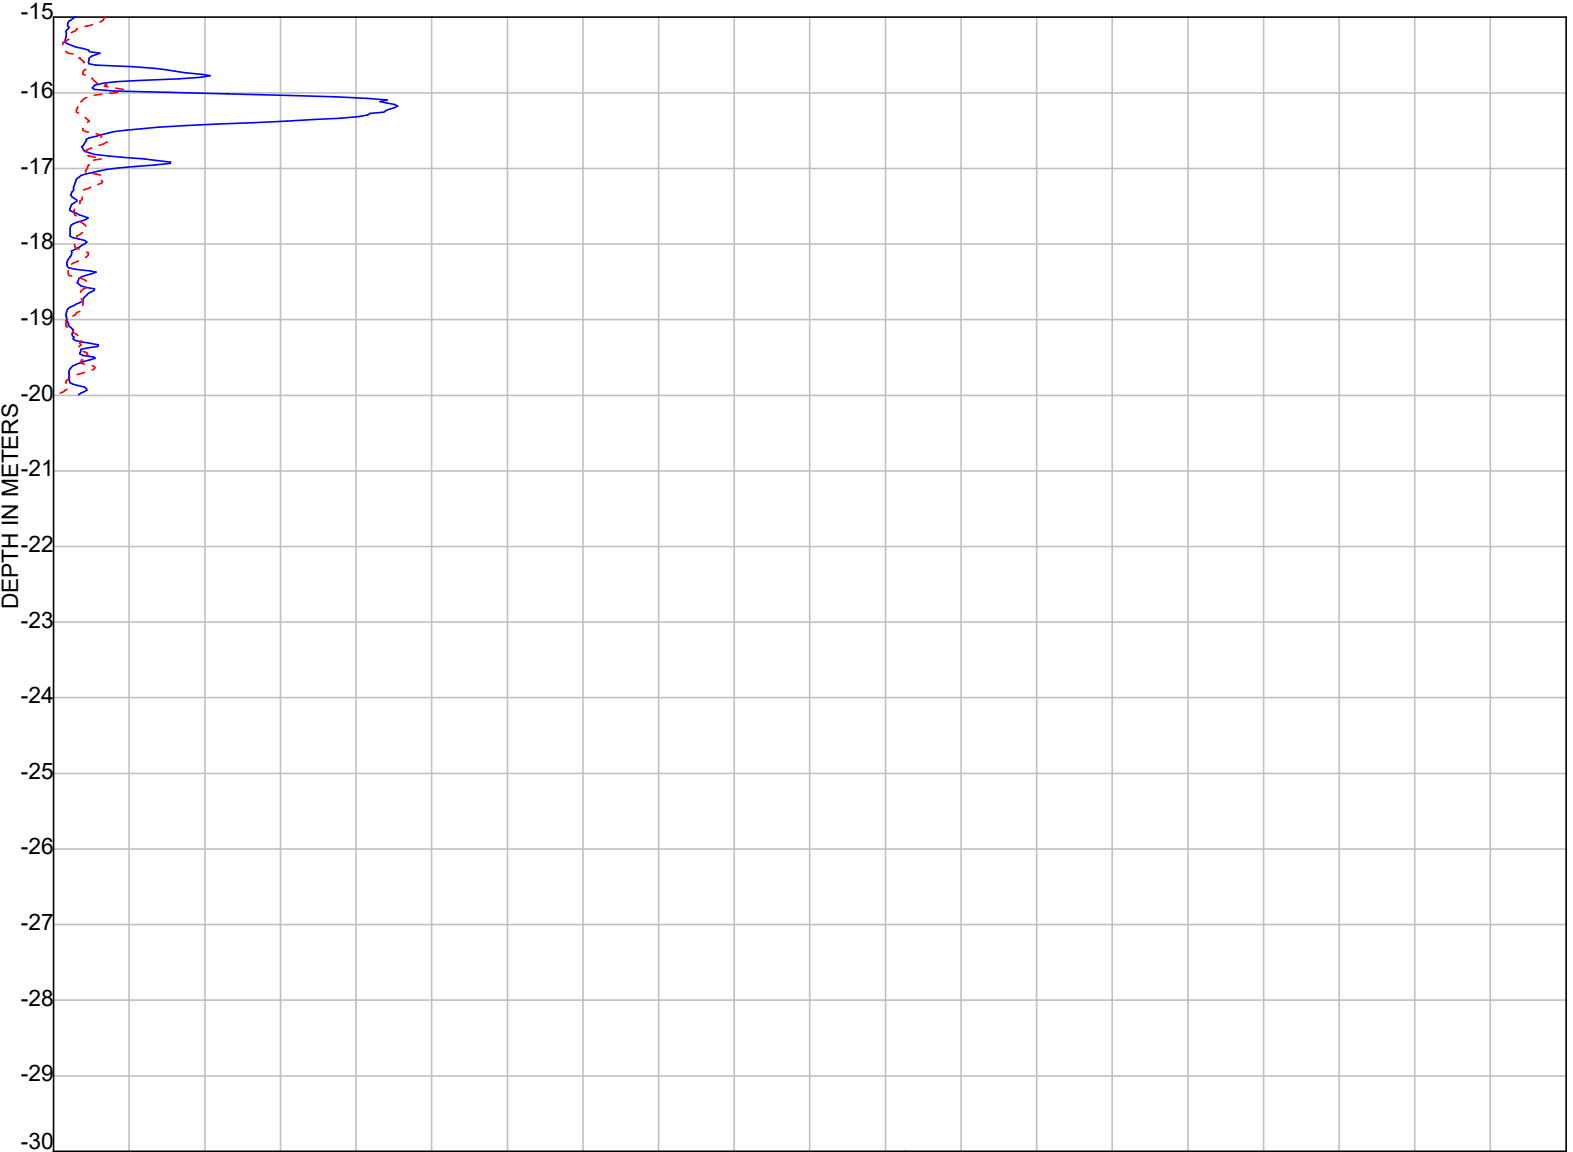
Tip resistance (MPa) → 0 5 10 15 20 25 30 35 40 45 50 55 60 65 70 75 80 85 90 95 100
 Local friction (MPa) → 0 0.25 0.50 0.75 1.00 1.25 1.50 1.75 2.00 2.25 2.50

Pore pressure (kPa) → -100 0 100 200 300 400 500
 Inc [deg]

Operator : JC	Cone : I-CFYYP20-15	Test in accordance with ASTM D5778
Date : 18-1-2017	Cone Serial No : 160610	Cone type cylindrical electrical 1510 mm ²
Time : 12:42	Remark :	Easting [m] 1258216
		Northing [m] 5005285

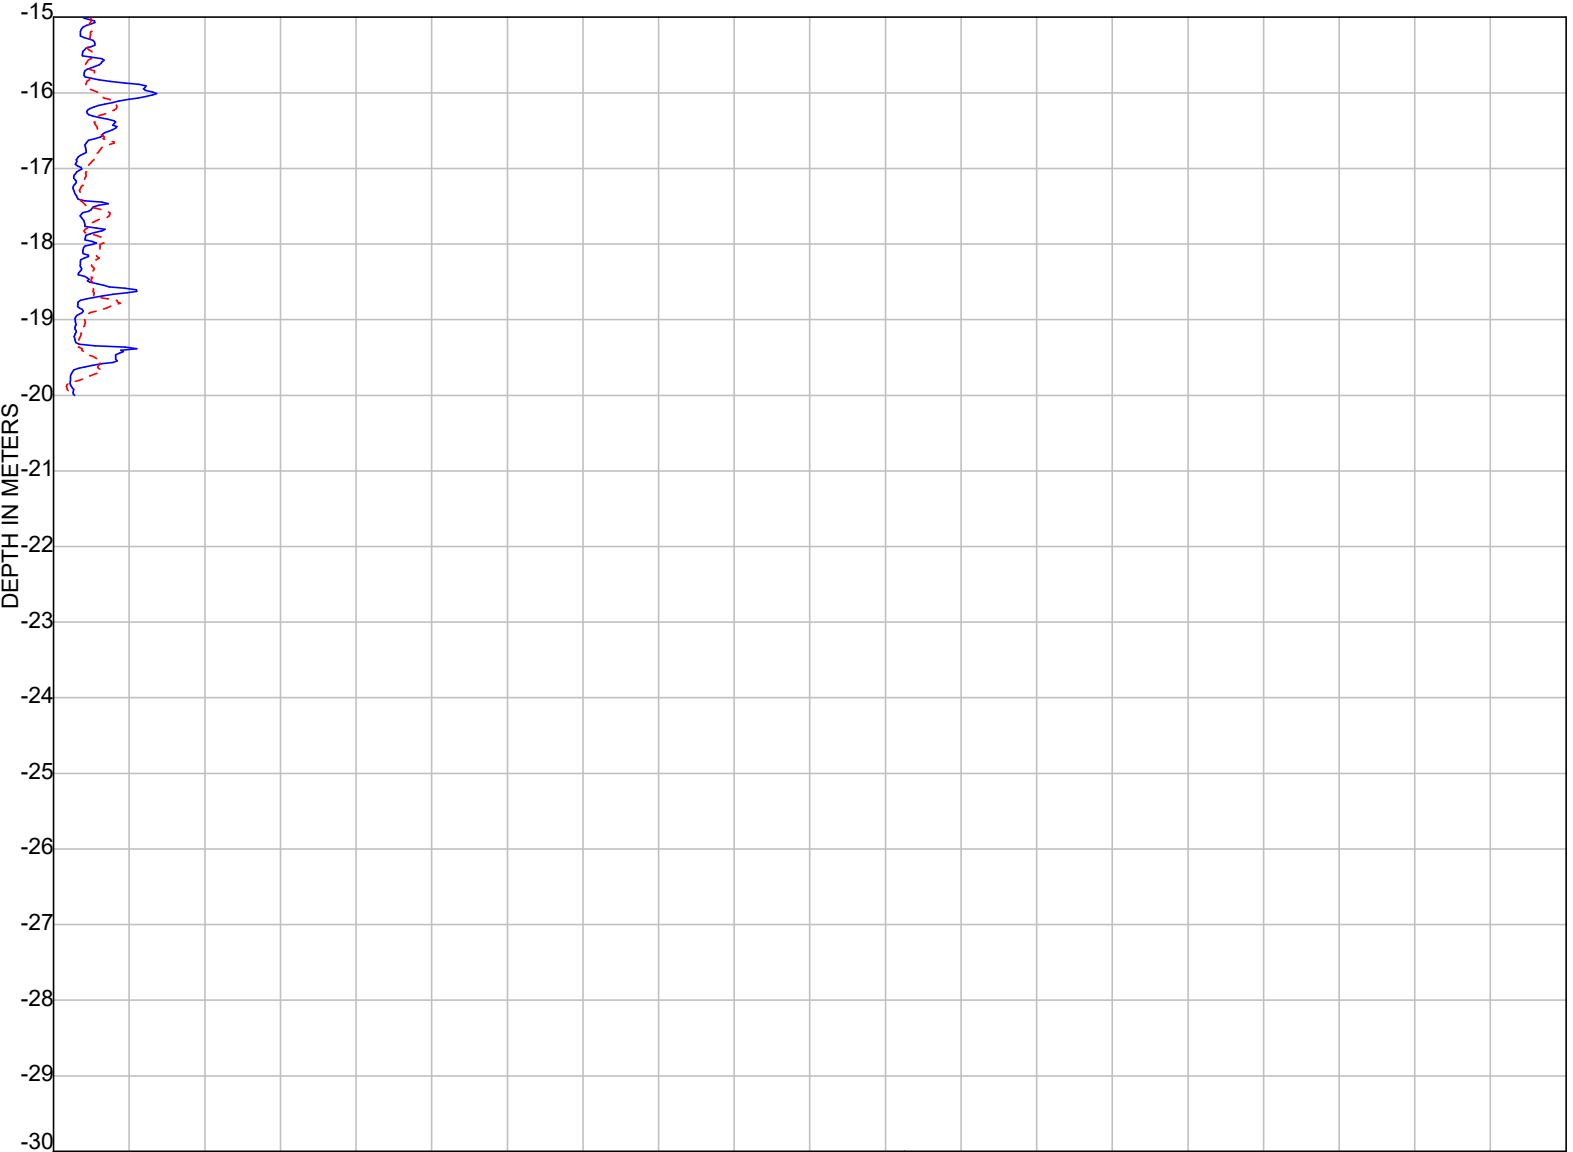
-100 0 100 200 300 400 500
 Inc [deg] 2.84 2.92

Operator : JC	Cone : I-CFYYP20-15	Test in accordance with ASTM D5778
Date : 18-1-2017	Cone Serial No : 160610	Cone type cylindrical electrical 1510 mm ²
Time : 14:48	Remark :	Easting [m] 1258123
		Northing [m] 5005331

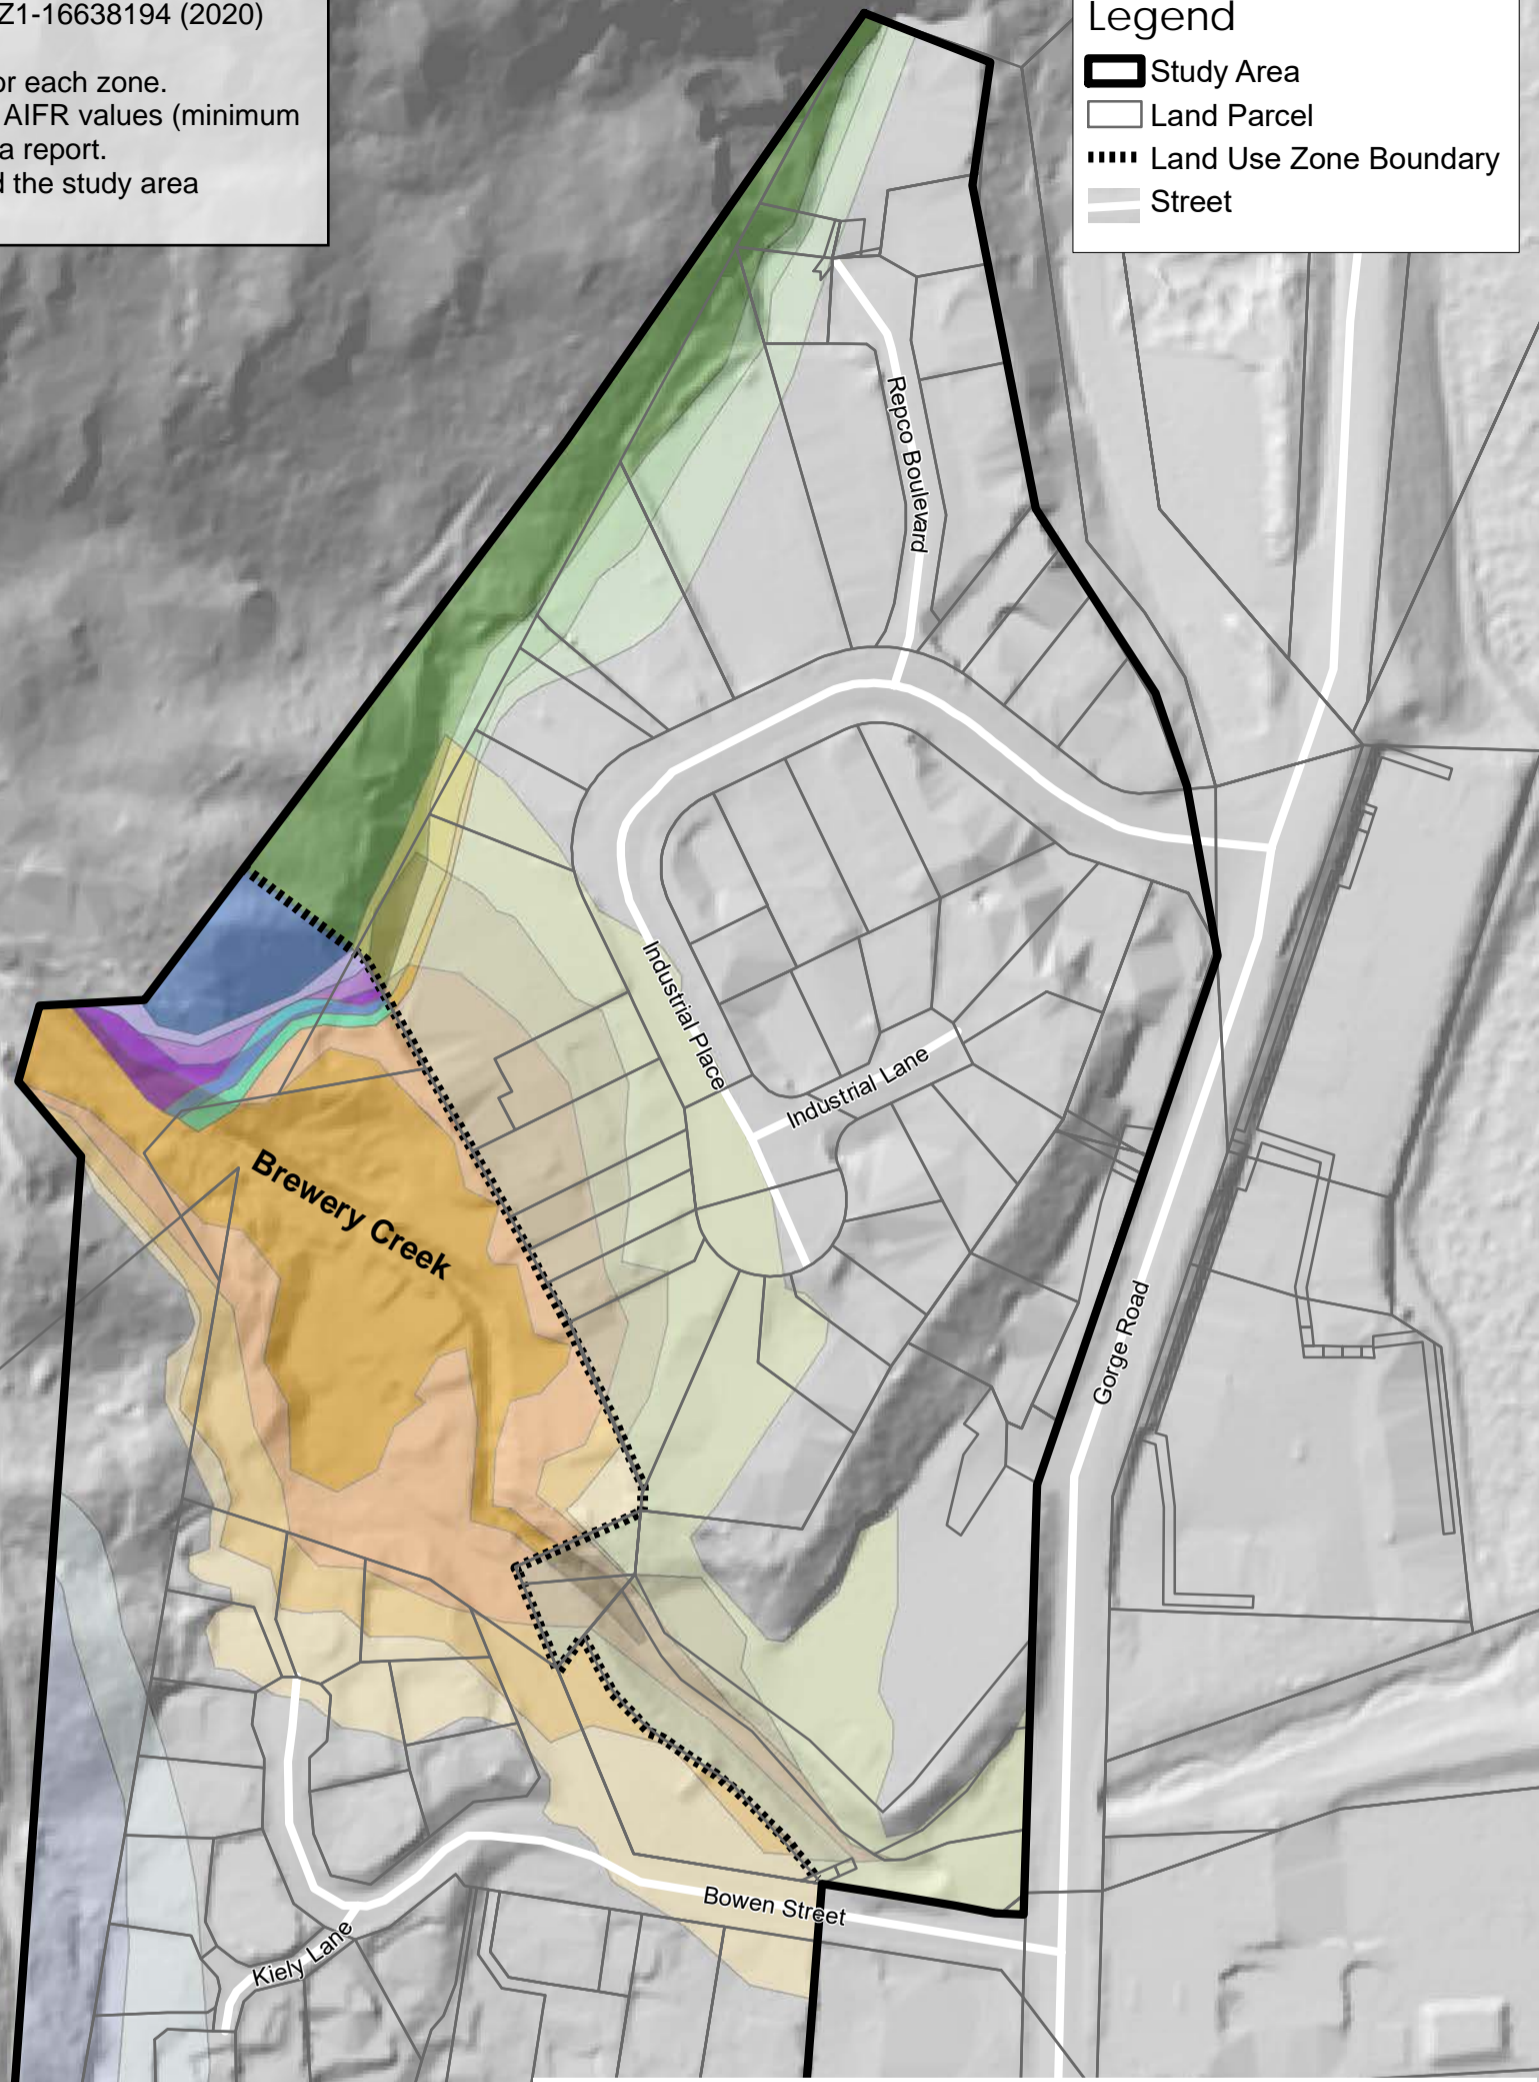
Combined Slope Stability Annual Individual Fatality Risk by zone

Debris Flow			
		Zone 1	Zone 2	Zone 3	Zone 4
Rockfall	Residential	3.1×10^{-3}	9.1×10^{-4}	9.6×10^{-5}	4.8×10^{-6}
	Zone 1	7.4×10^{-4}	3.8×10^{-3}	1.6×10^{-3}	8.3×10^{-4}
	Zone 2	2.3×10^{-4}	3.3×10^{-3}	1.1×10^{-3}	3.2×10^{-4}
	Zone 3	1.7×10^{-5}	3.1×10^{-3}	9.3×10^{-4}	1.1×10^{-4}

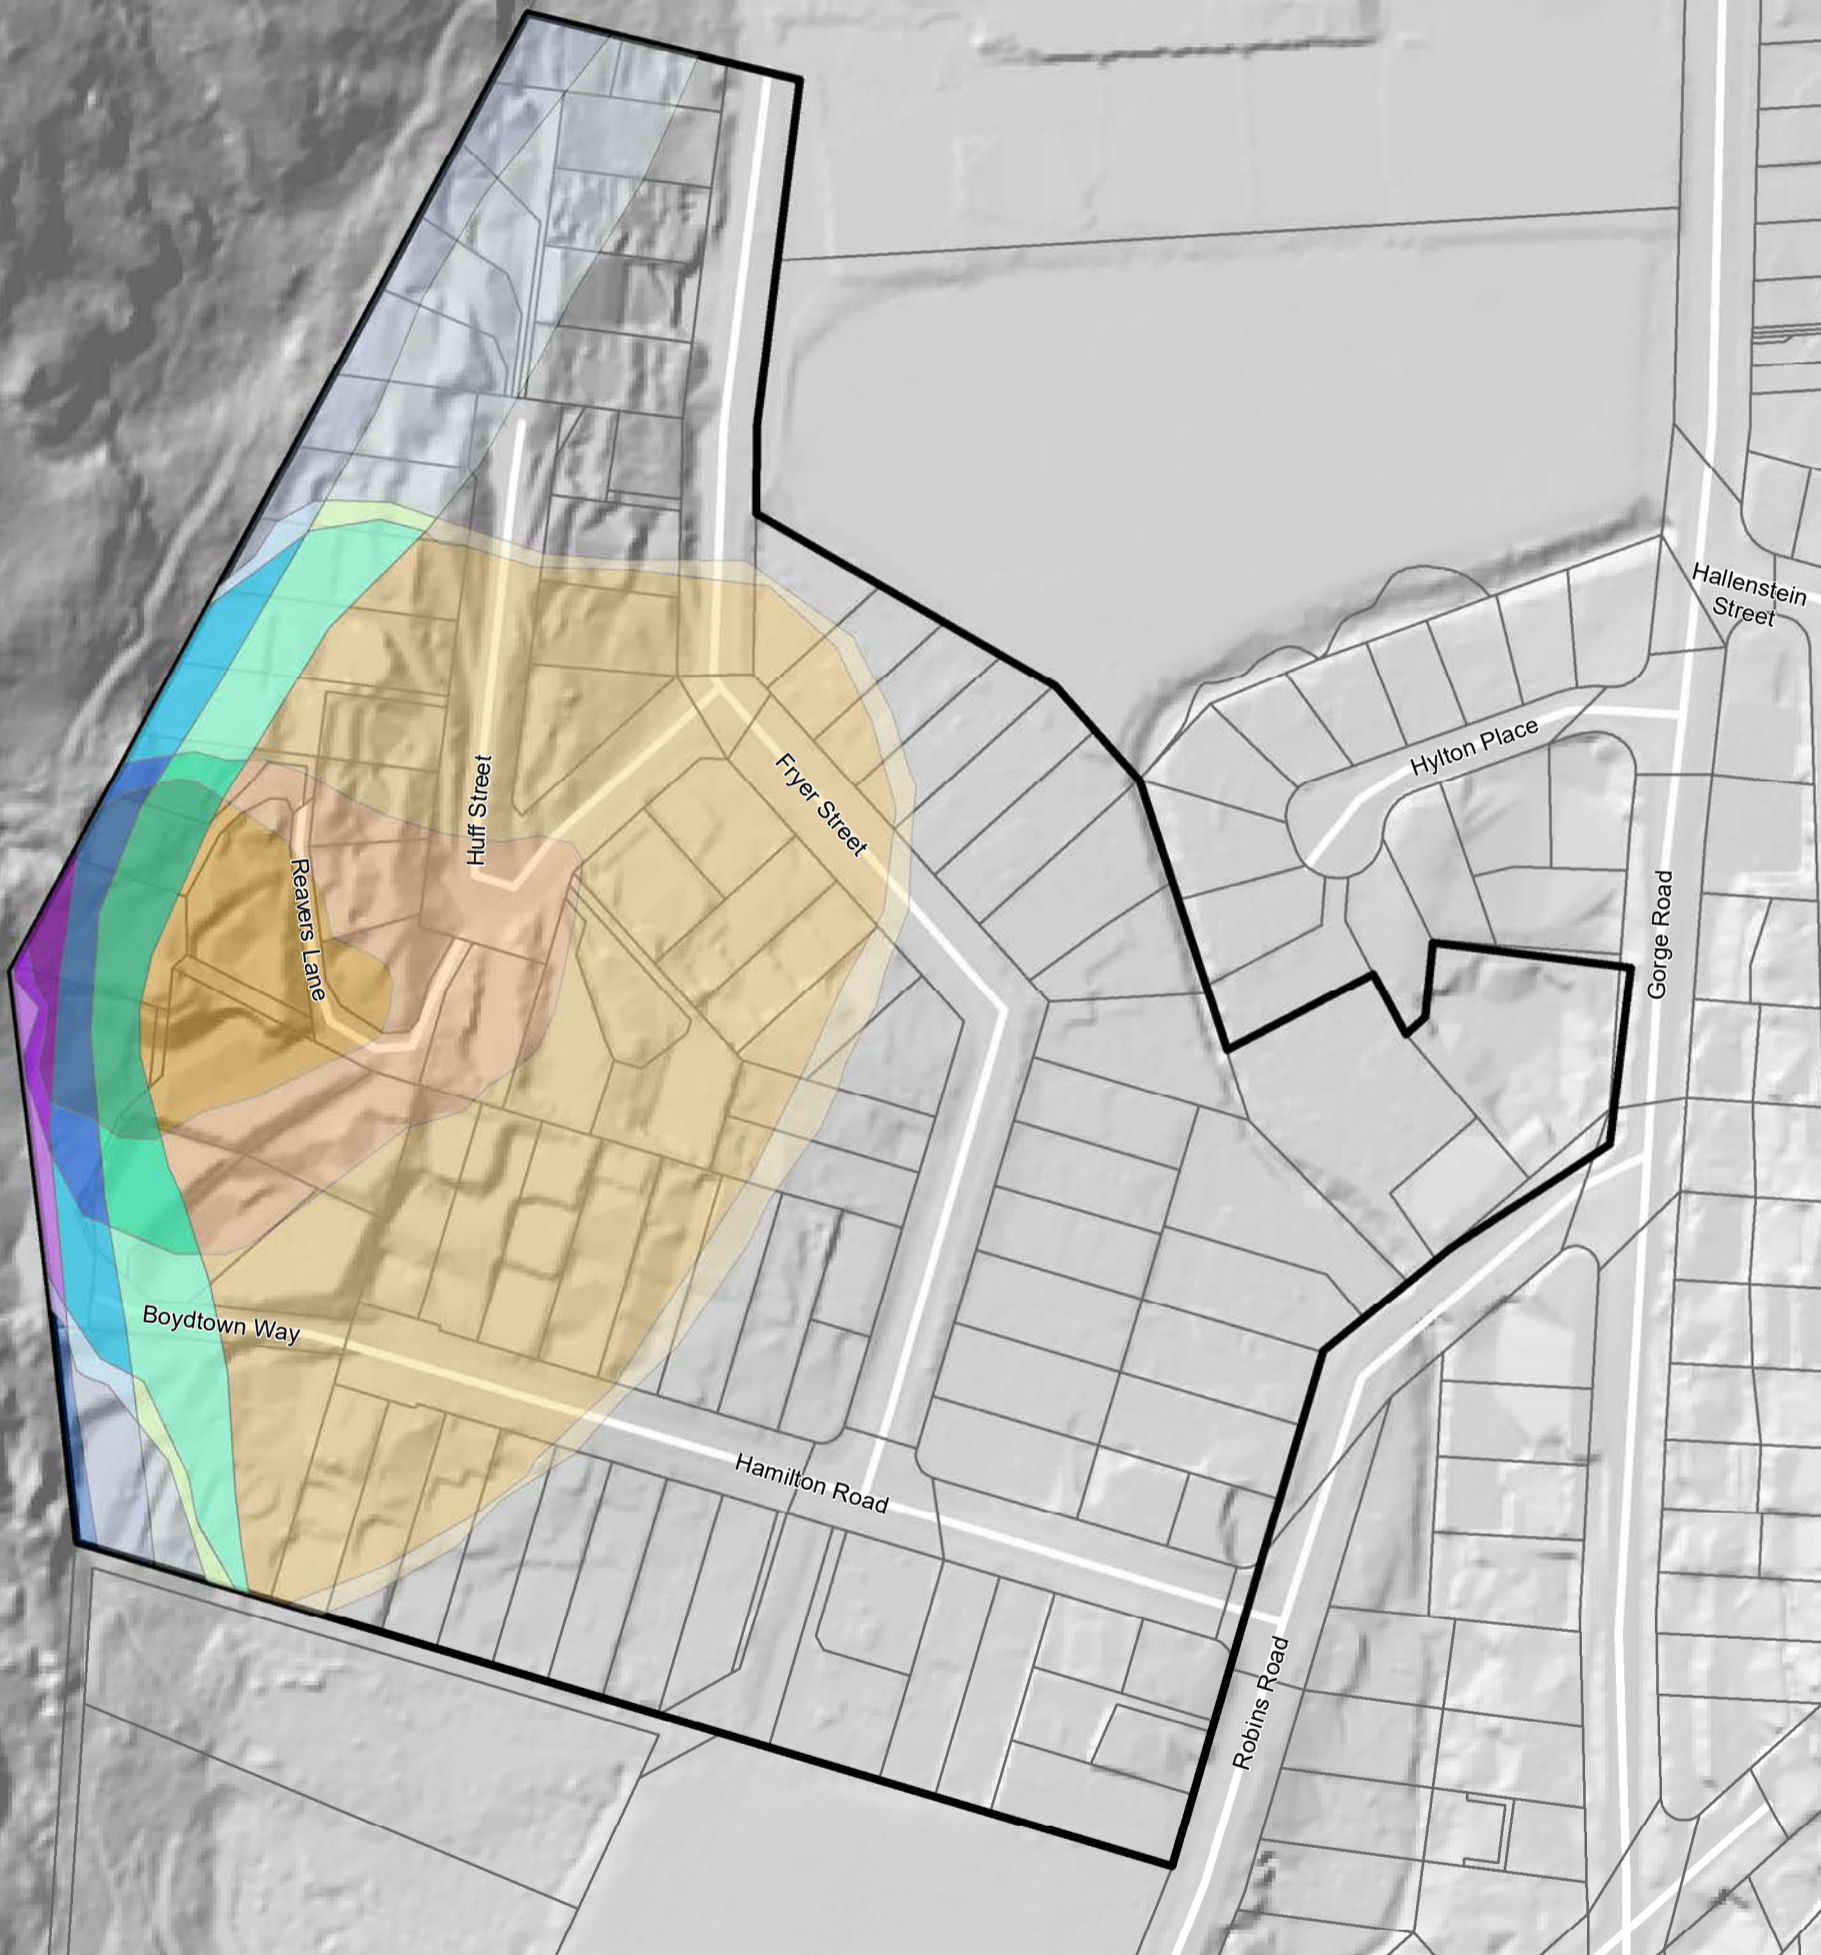
Combined Slope Stability Annual Individual Fatality Risk by zone

Debris Flow			
		Zone 1	Zone 2	Zone 3	Zone 4
Rockfall	Residential	1.0×10^{-3}	1.4×10^{-4}	4.3×10^{-5}	2.2×10^{-6}
	Zone 1	7.4×10^{-4}	1.8×10^{-3}	8.8×10^{-4}	7.8×10^{-4}
	Zone 2	2.3×10^{-4}	1.2×10^{-3}	3.7×10^{-4}	2.7×10^{-4}
	Zone 3	1.7×10^{-5}	1.0×10^{-3}	1.6×10^{-4}	6.1×10^{-5}
	Zone 4				1.9×10^{-5}
