Natural Hazards Affecting Gorge Road, Queenstown

Prepared for Queenstown Lakes District Council

Prepared by Beca Limited

12 November 2020

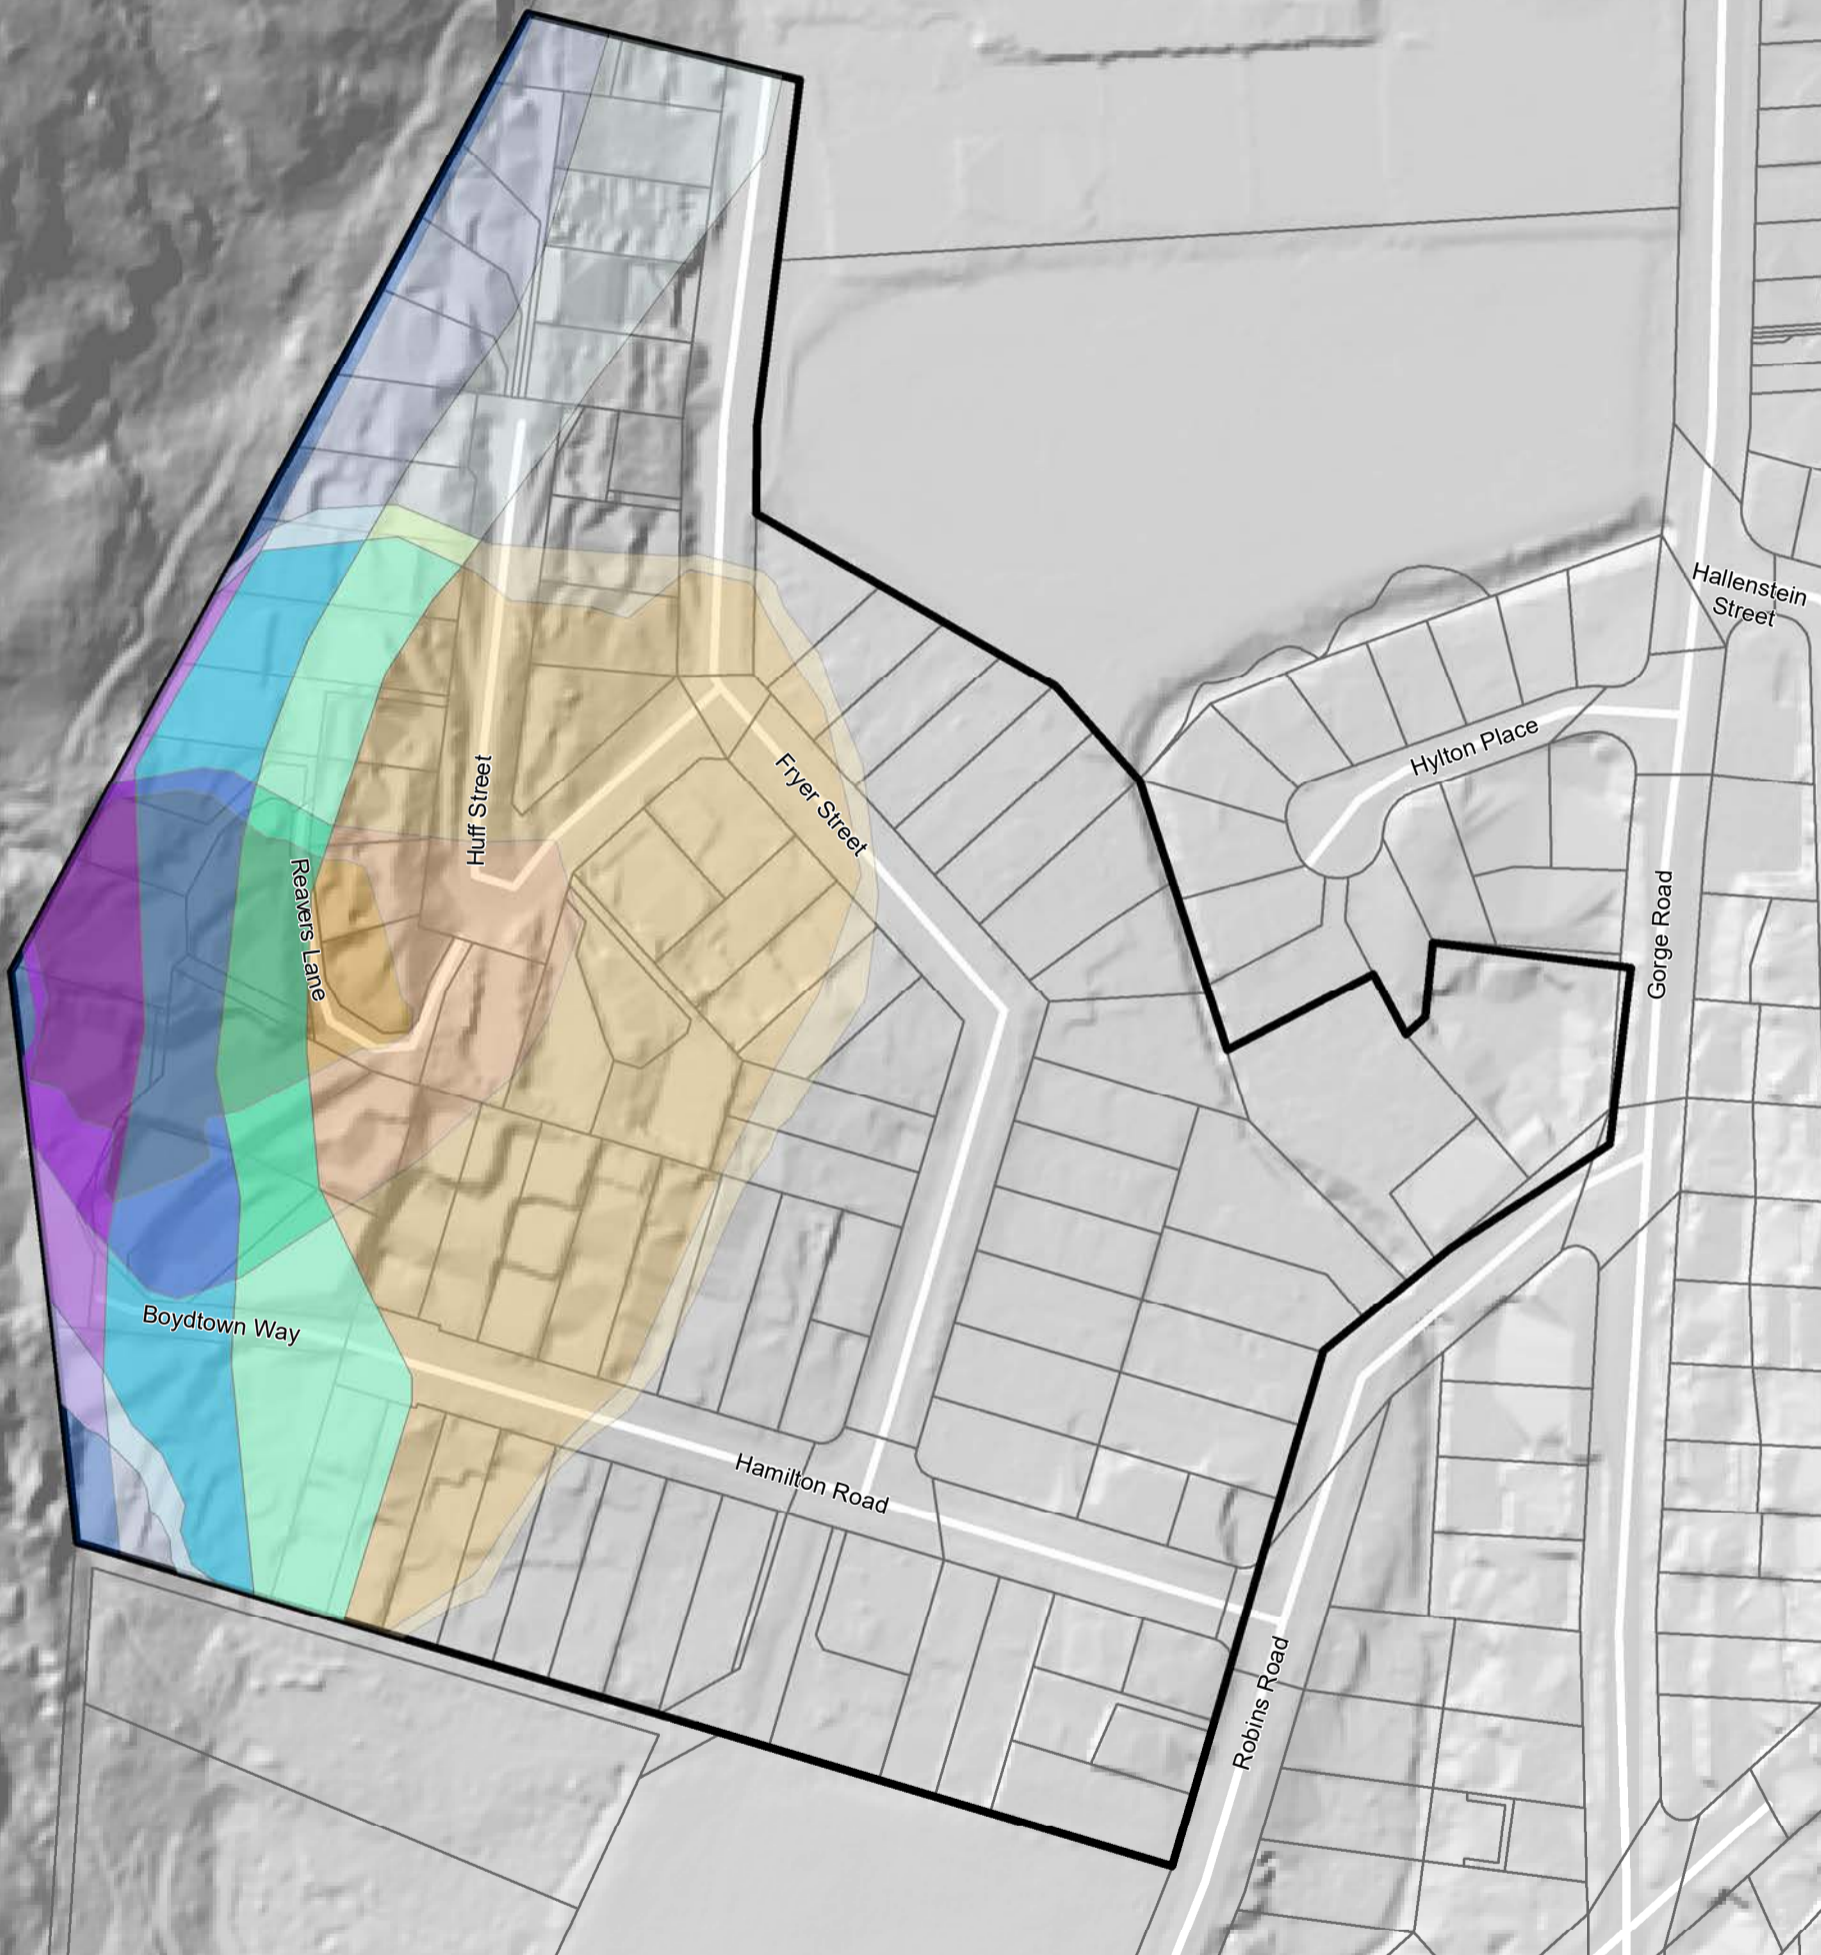
Combined Slope Stability Annual Individual Fatality Risk by zone

Debris Flow			
		Zone 1	Zone 2	Zone 3	Zone 4
Rockfall	Residential	1.0×10^{-3}	1.4×10^{-4}	4.3×10^{-5}	2.2×10^{-6}
	Zone 1	7.4×10^{-4}	1.8×10^{-3}	8.8×10^{-4}	7.8×10^{-4}
	Zone 2	2.3×10^{-4}	1.2×10^{-3}	3.7×10^{-4}	2.7×10^{-4}
	Zone 3	1.7×10^{-5}	1.0×10^{-3}	1.6×10^{-4}	6.1×10^{-5}
	Zone 4				1.9×10^{-5}

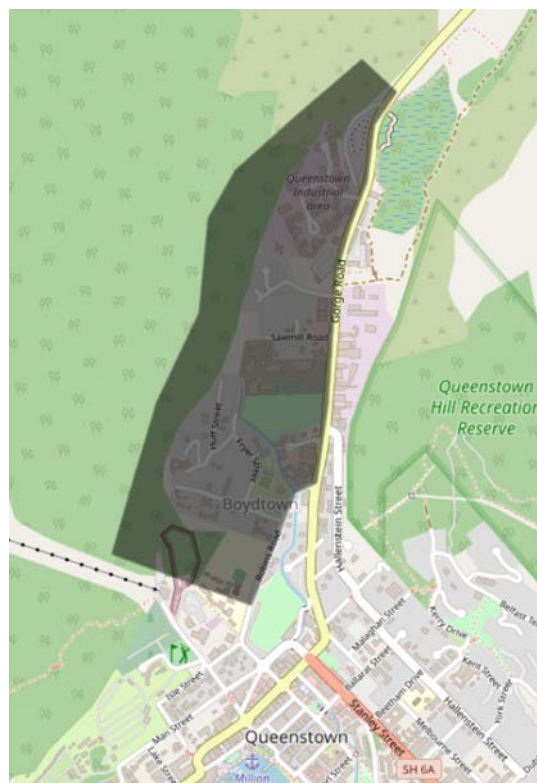
Figure 1. Map showing the area covered by the 1 m x 1 m grid in dark grey.

1. Create a 1 m x 1 m grid across the area comprising the two alluvial fans as shown in Figure 1.
2. Select a hazard layer (either rock fall or debris flow) provided by BECA;
3. For each 1 m x 1 m grid cell extract the hazard value for this grid cell from the hazard layer provided by BECA.
4. Using the vulnerability models for rockfall and debris flow in Massey et al 2019 calculate the loss ratio for each grid cell given the hazard value from Step 3.
5. Repeat Steps 2-5 for each hazard layer.
6. The output is a 1 m x 1 m grid of loss ratios (0-1) for each hazard layer.
