**BEFORE THE HEARINGS PANEL FOR THE QUEENSTOWN LAKES  
PROPOSED DISTRICT PLAN**

**IN THE MATTER** of Stage 3 of the Proposed District Plan, Chapter 30  
Variation

**EVIDENCE OF BEN MACKEY ON BEHALF OF OTAGO REGIONAL COUNCIL**

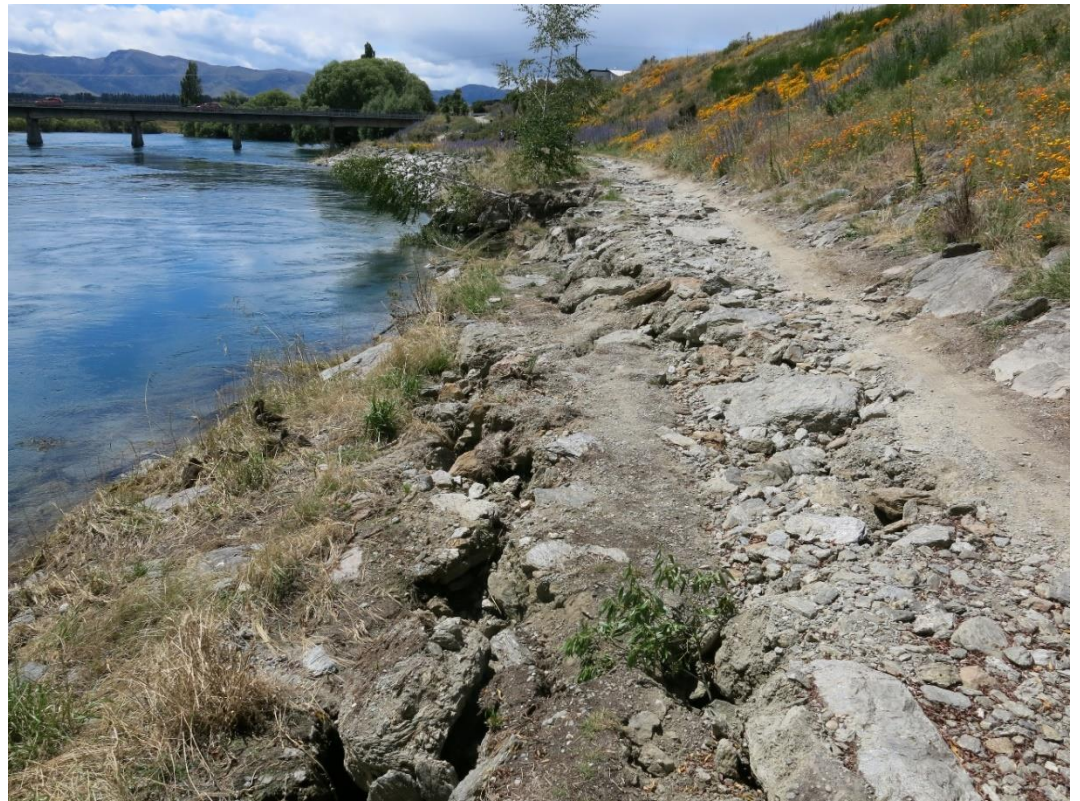
**Figure 3.** Slumping of rockwork protecting the right bank of the Clutha River at Albert Town. Damage occurred due to scour of the channel bank and bed during high flows in December 2019. SH6 bridge visible in top of image.

15. A slump at the upstream end of the rockwork occurred in 2014, and has been monitored for the ORC.
16. During flooding in December 2019 (highest flow since 1999) a 40m section of the rockwork was damaged (Figure 3), and the 2014 upstream slump was reactivated due to significant scour along the channel wall. The rockwork requires repair and modification to re-establish the pre-existing level of bank protection. This will likely

involve the importation of a significant quantity of rock and fill, and potentially modification of the river edge and terrace face.

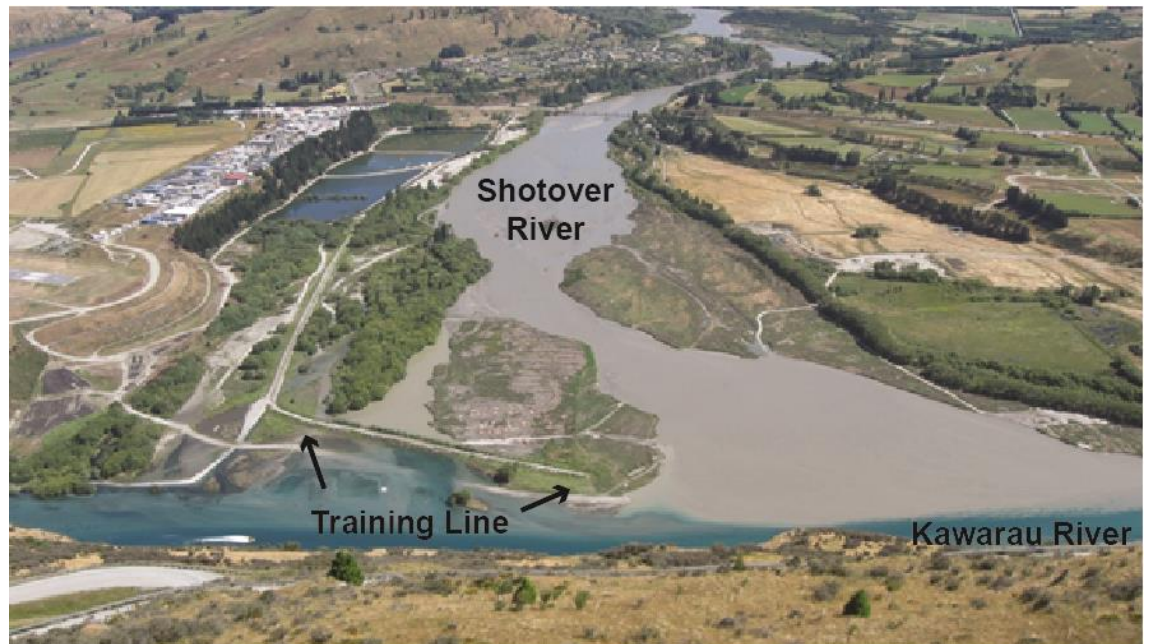
**Figure 4.** View up the Shotover Delta during high flows in 2013. The training line visible on lower left of image directs the turbid water of the Shotover River to the right to meet the clear water of the Kawarau River at an oblique angle. Kawarau River flows left to right.

19. The ORC constructed a rock revetment and 400m long training line on the Shotover River delta in 2011. Much of the Shotover River Delta, including the training line, is classified as ONL.
20. The training line structure is designed to 'train' the Shotover River to join the Kawarau River at an oblique angle, rather than at right angles as governed by the geometry of the Shotover/Kawarau confluence (Fig. 4). In training the Shotover

River to occupy the left hand (east) side of the delta, it is intended to minimise the potential for the Shotover River to constrict the flow of the Kawarau River, the only outlet from Lake Wakatipu. In previous floods, the Shotover River has met the Kawarau River orthogonally. Water and sediment from the Shotover River obstructs the flow of the Kawarau River, causing water to back up into Lake Wakatipu, directly increasing both the level of the lake and the potential of flooding in Queenstown.

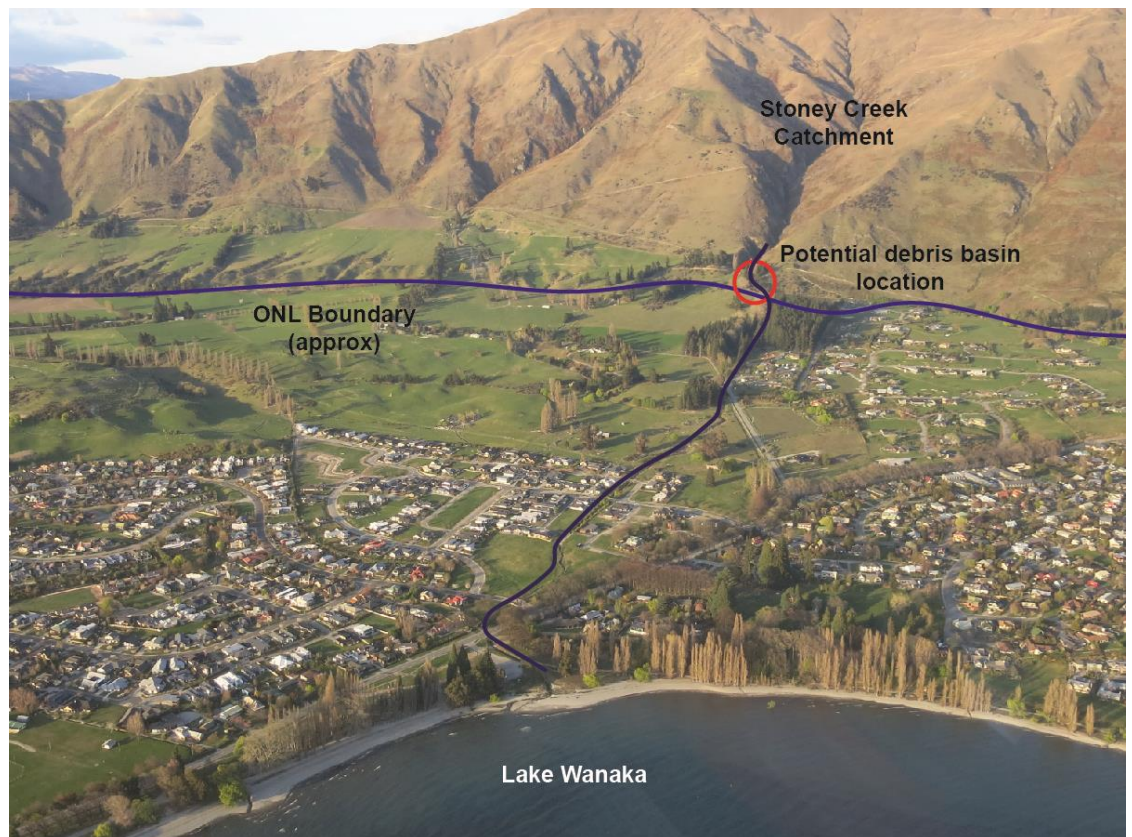
**Figure 5.** Oblique view of the Stoney Creek alluvial fan, Wanaka. The approximate ONL boundary is shown in blue, with the ONL extent continuing upslope. A proposed site of a debris retention basin is shown in red. Photo taken in 2015.

23. Stoney Creek is one of a series of creeks emanating from hills south of Wanaka Township (Fig. 5). These catchments have alluvial fans at their base, and have generated debris flows and sediment laden floods in the past which can endanger

24. Original plans included the creation of an upper debris trap basin at the head of the alluvial fan, a site which is partly covered by the ONL layer (Fig. 5). With increased urban development on the lower slopes of the Stoney Creek alluvial fan, additional protection from debris flows, such as creation of a debris trap structure, may be considered in the future. This would require significant earthworks and potentially the installation of rock or concrete elements.

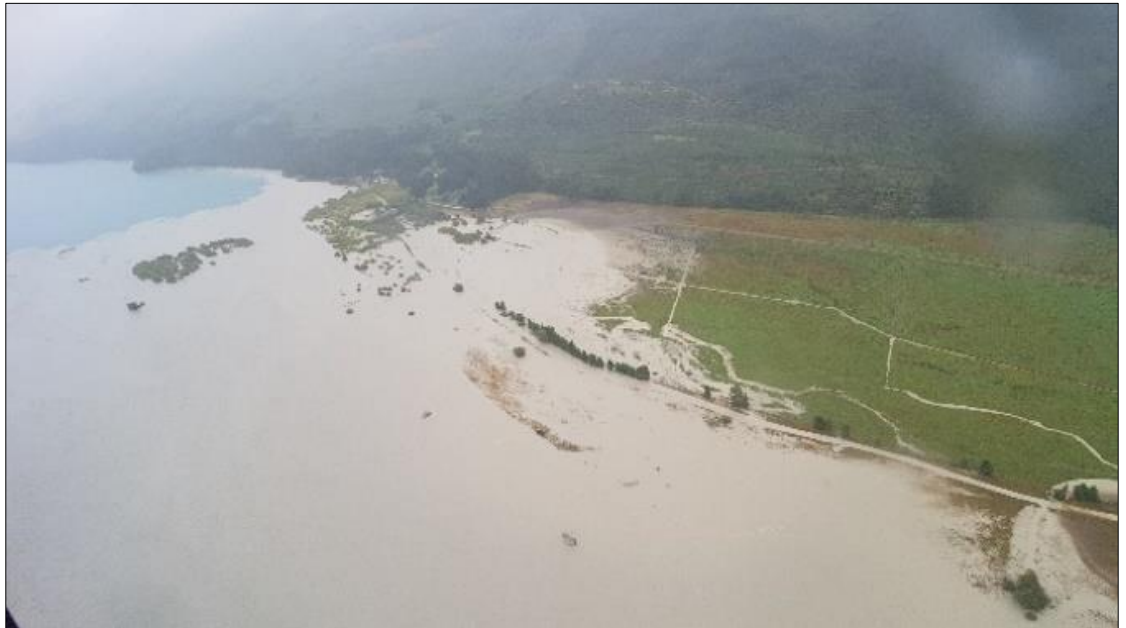
**Figure 6.** View southwest across the Dart River delta towards Kinloch during  $>1700 \text{ m}^3\text{s}^{-1}$  flood in March 2019. Clear water in top left is Lake Wakatipu. The inundated Kinloch Road follows the tree line in centre-right of view.

recent years the rivers have changed course during high flows, and damaged roads and property (Figs. 6-7). Future river avulsions could pose a hazard to the settlements of Kinloch and Glenorchy.

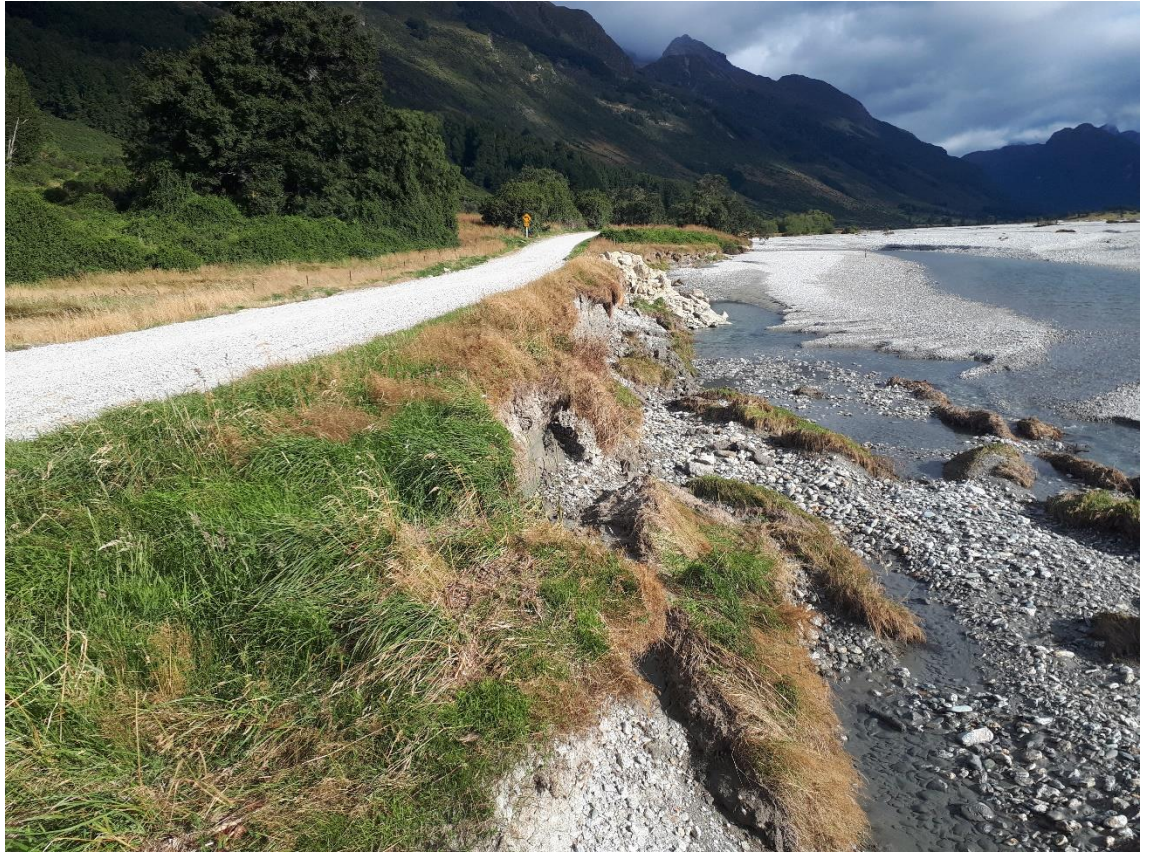
**Figure 7.** Dart River erosion causing damage to Kinloch Road (Feb 2020).

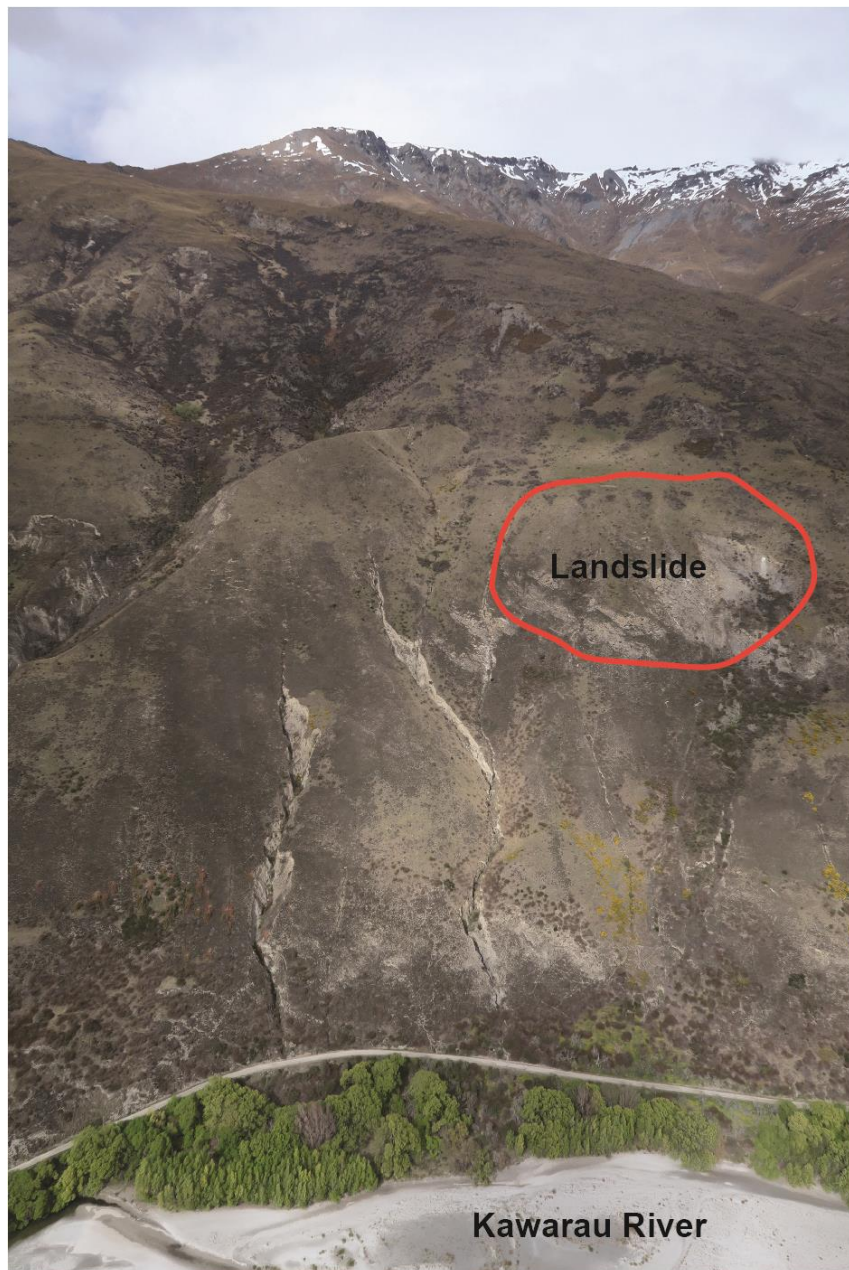
**Figure 8.** Incipient bedrock landslide above the Kawarau River approximately 1.6km upstream of the Arrow River confluence. This landslide has sufficient volume to dam the river if it failed as one mass. The landslide is monitored by ORC.

28. The Kawarau River which drains Lake Wakatipu has a relatively low gradient, until approximately the bungy bridge where it steepens through the Kawarau Gorge. This reach is within the ONL layer (Figure 1). A longstanding concern has been the potential for landslides to deposit rock and debris into the river and potentially form a landslide dam (Fig. 8). By impeding flow down the Kawarau River in this section, a landslide dam could decrease the efficiency of outflow from Lake Wakatipu, or in an adverse scenario, block and back up the river and cause lake level to rise. This could cause flooding issues in Queenstown and other lakeside communities.

29. Were a landslide identified with potential to block the Kawarau River it may require preventative measures, including extensive earthworks, to stabilise it. If this scenario eventuated and the river was partially or fully blocked by landslide debris, then it may be necessary to modify or excavate the landslide deposit to re-establish efficient flow down the Kawarau River.
