**STATEMENT OF EVIDENCE OF ROBERT BOND ON BEHALF OF REMARKABLES  
PARK LIMITED AND QUEENSTOWN PARK LIMITED**

**(GEOTECHNICAL ENGINEERING – NATURAL HAZARDS)**

**STREAM 13 REZONING HEARINGS**

# **Geotechnical Hazard Appraisal**

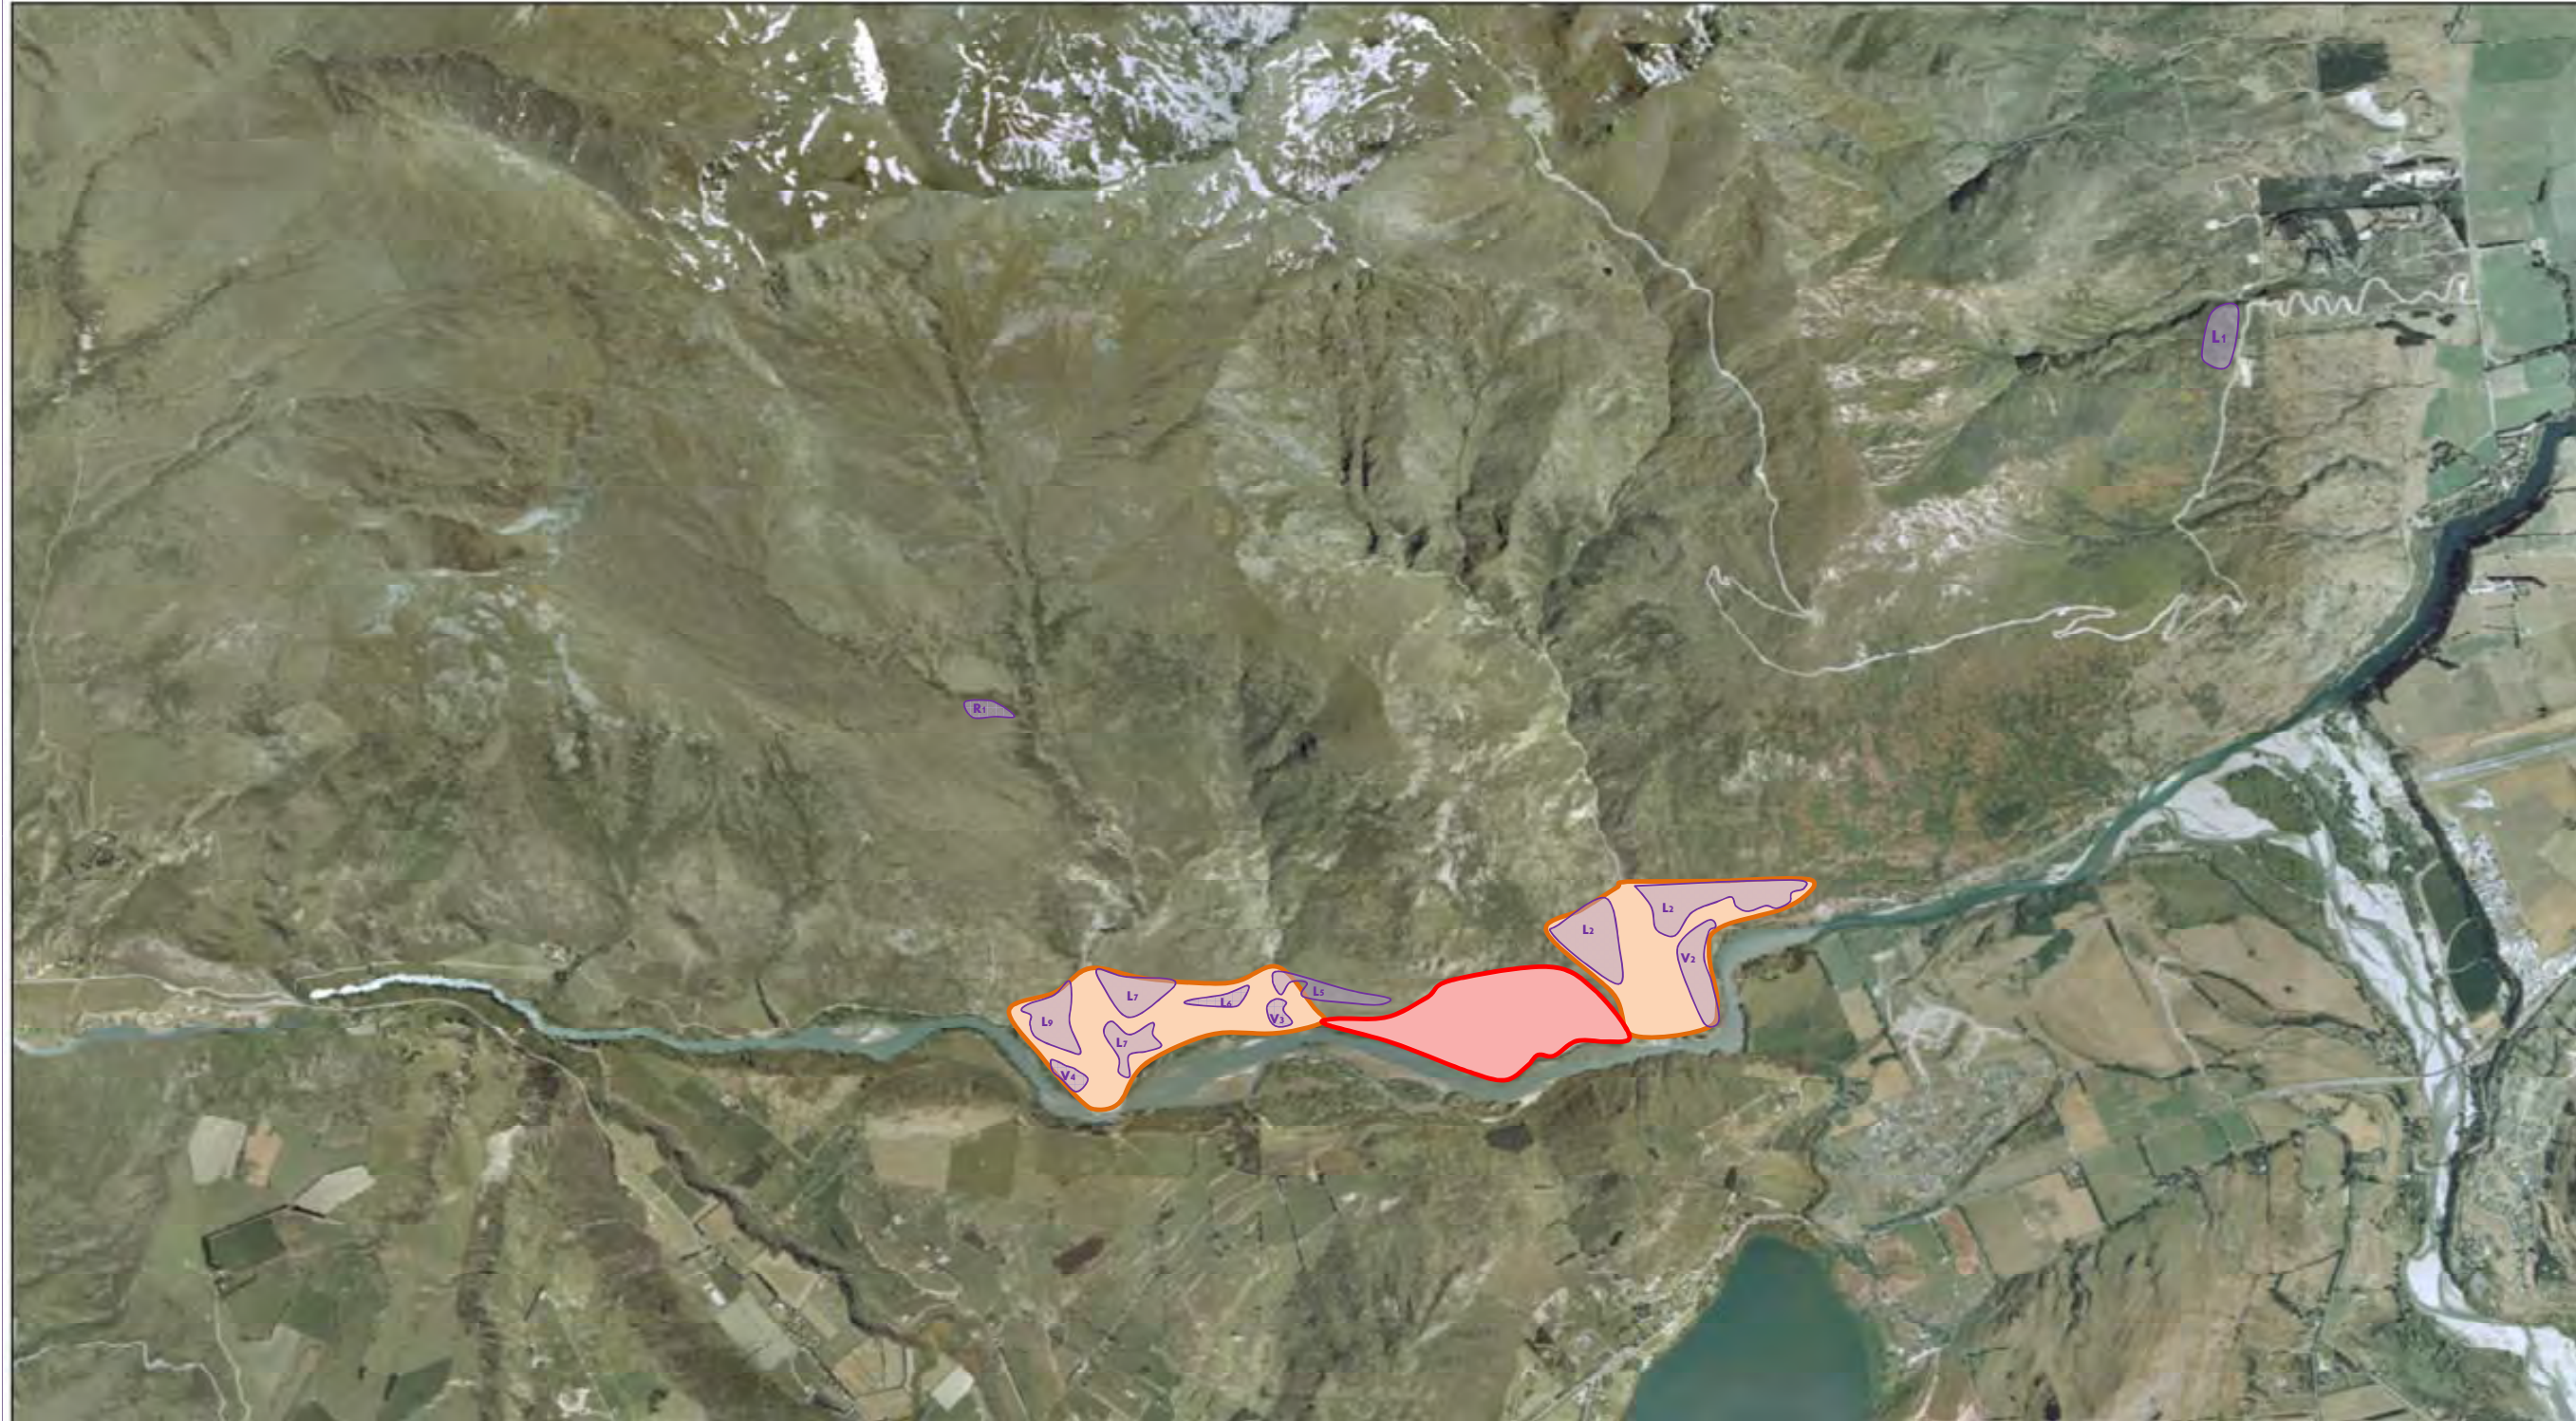
**Map 6: Liquefaction & Lateral Spread Hazard**

Site investigations are recommended during the details design stage to confirm the degree of the Liquefaction risk across the Station, which is currently broadly classified as 'Possibly Susceptible' according to the Opus 2002 Natural Hazards Study.

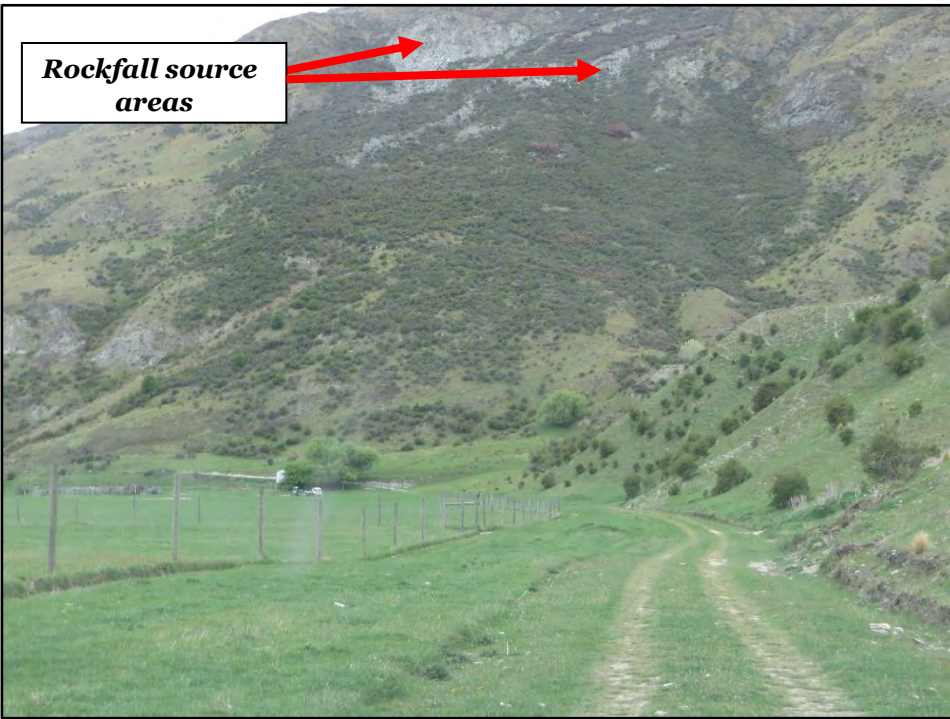
**Photograph 7 (Left):** Example of a bedrock outcrop /bluff above the access road that could release rockfall to road level  
**Photograph 8 (Bottom Left):** Example of rockfall source areas high above The Park, which could release rockfall. In this case, The Park is reasonably well protected by vegetation on the slope inbetween.
