Preliminary Geotechnical Assessment

Ladies Mile Masterplan Area,
Queenstown

December 2020

GeoSolve Ref: 200353

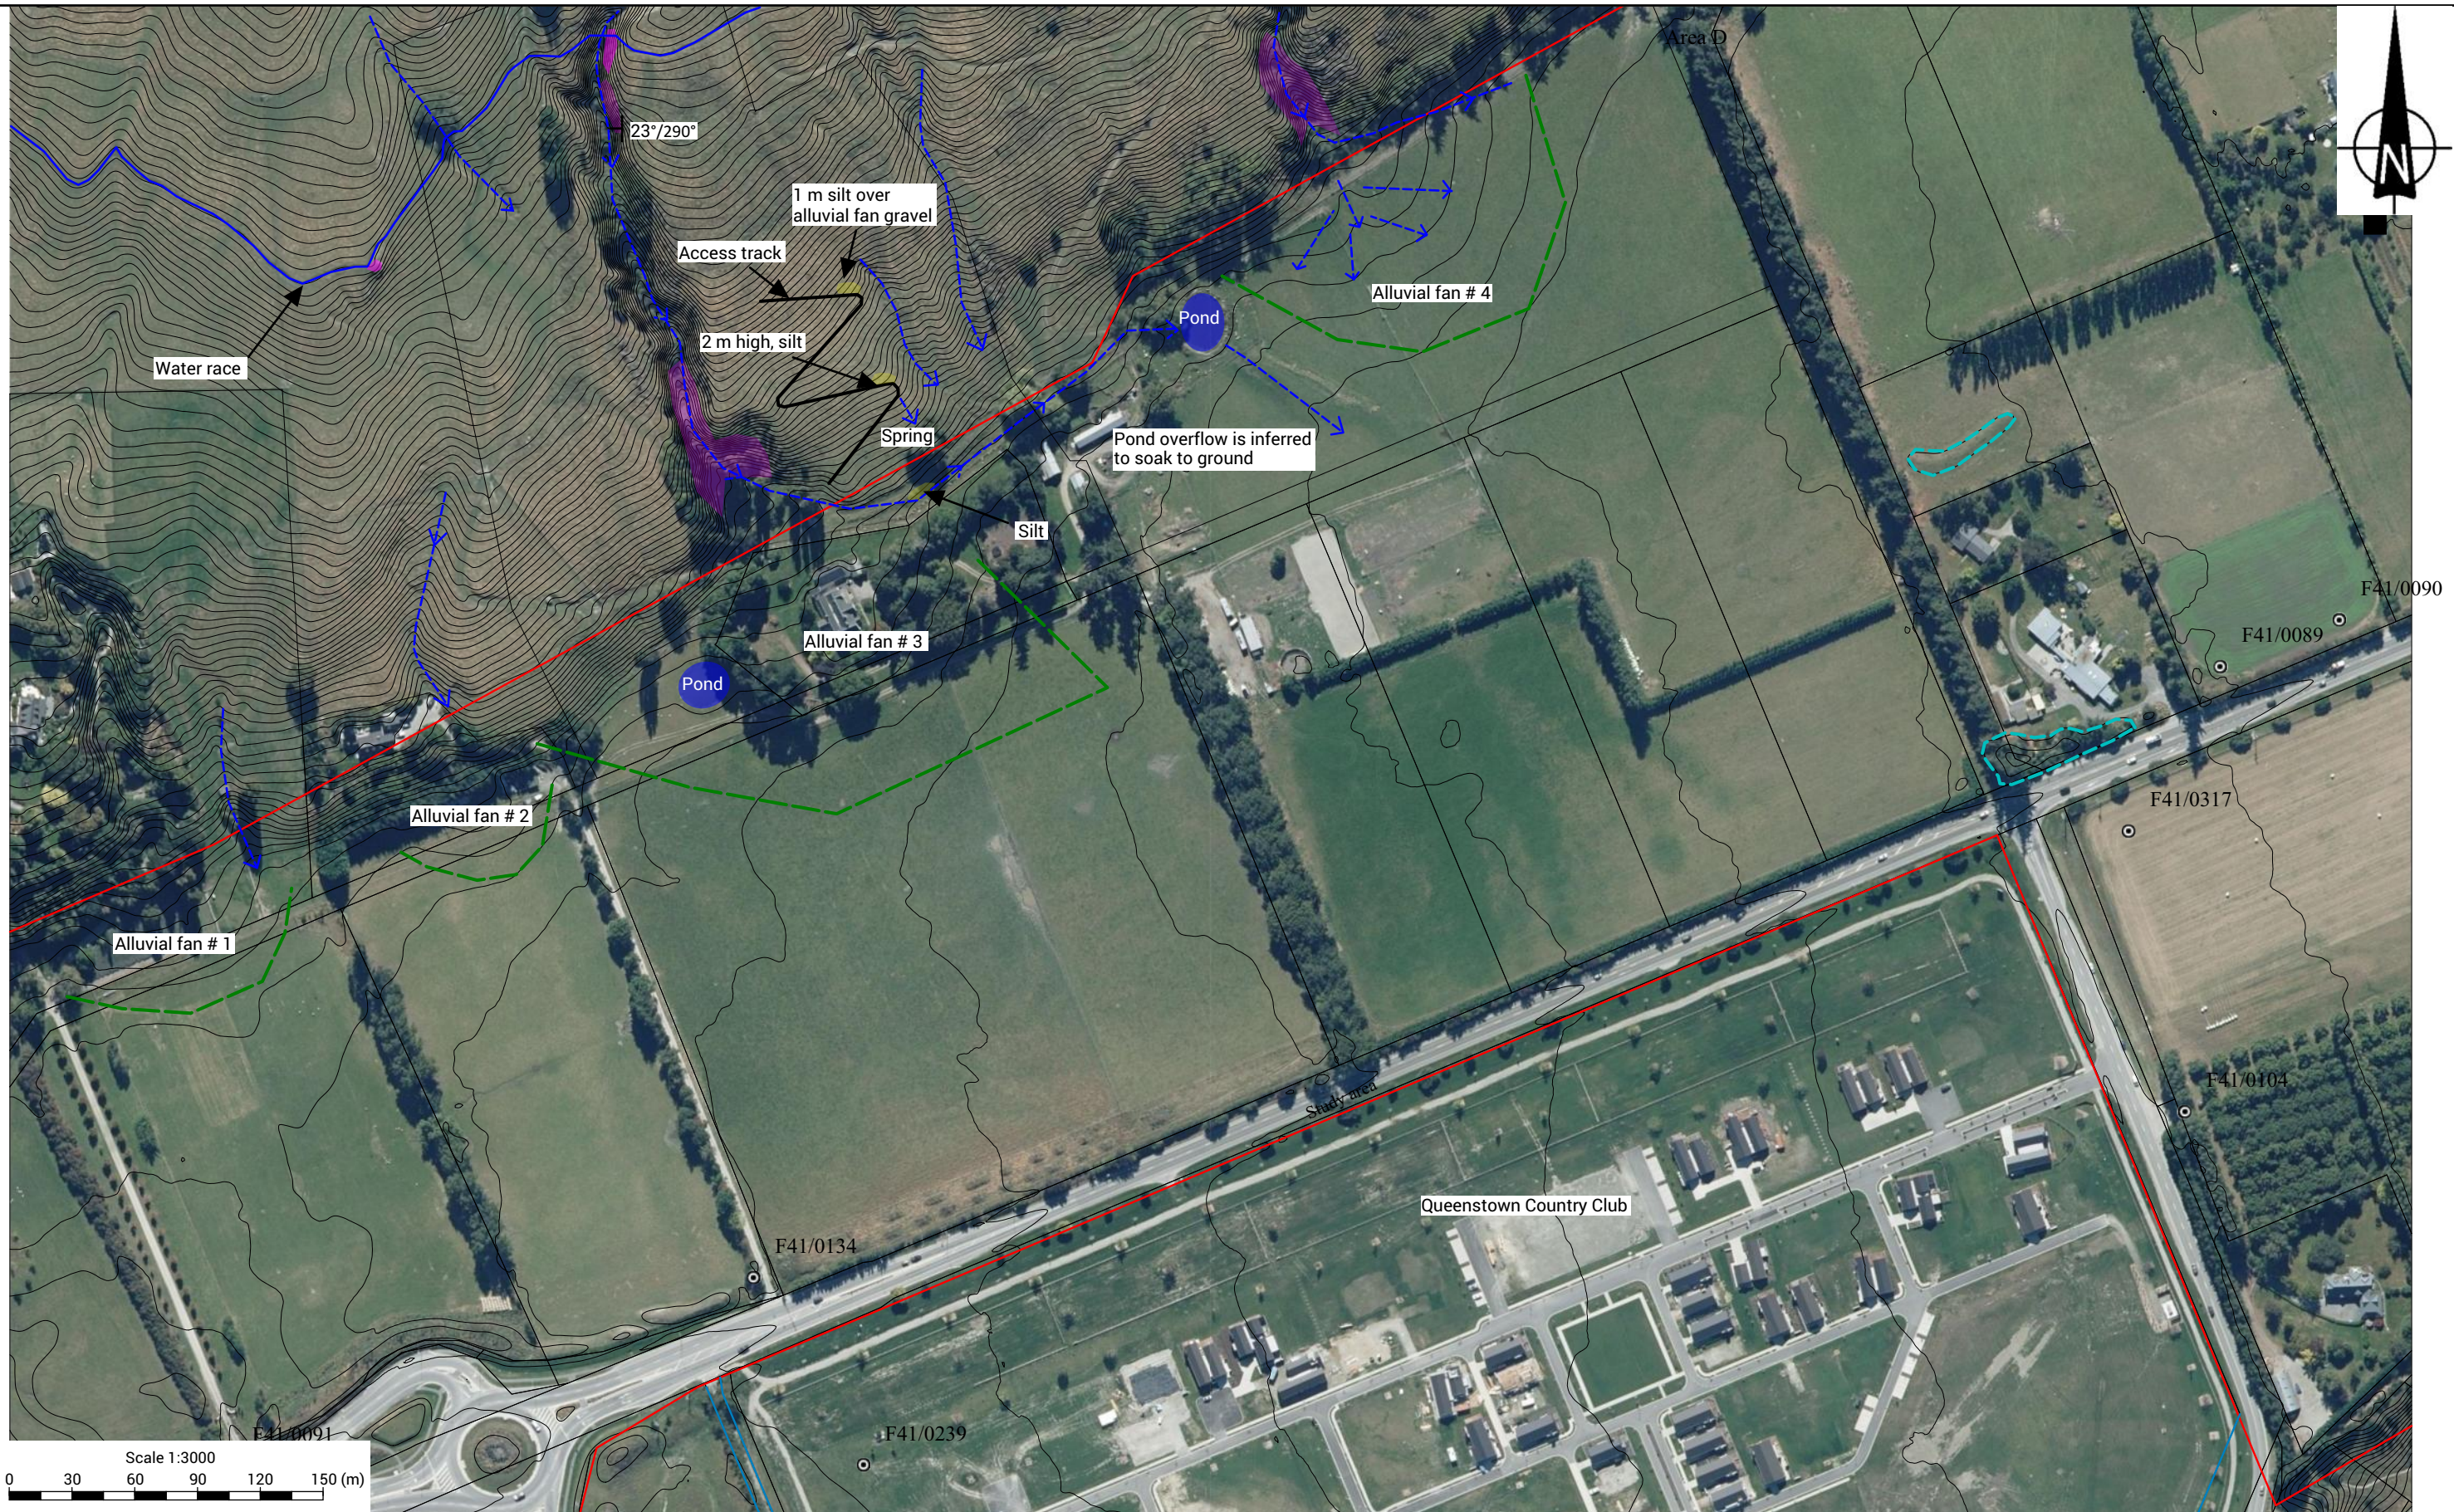
FIG No: **FIGURE 3**

Well-incised gullies are formed in the hillslopes north of the site. Surface drainage generally flows in a southerly direction. Cut-off drains are present at the toe of the northern hillslopes, which divert water to retention ponds present in the locations shown on the attached Figures 3 & 5, Appendix A. From the retention ponds water generally drains to more permeable subsoil layers, and groundwater flows are expected to track towards Lake Hayes. Overland flows beyond base of the slopes were generally not observed.

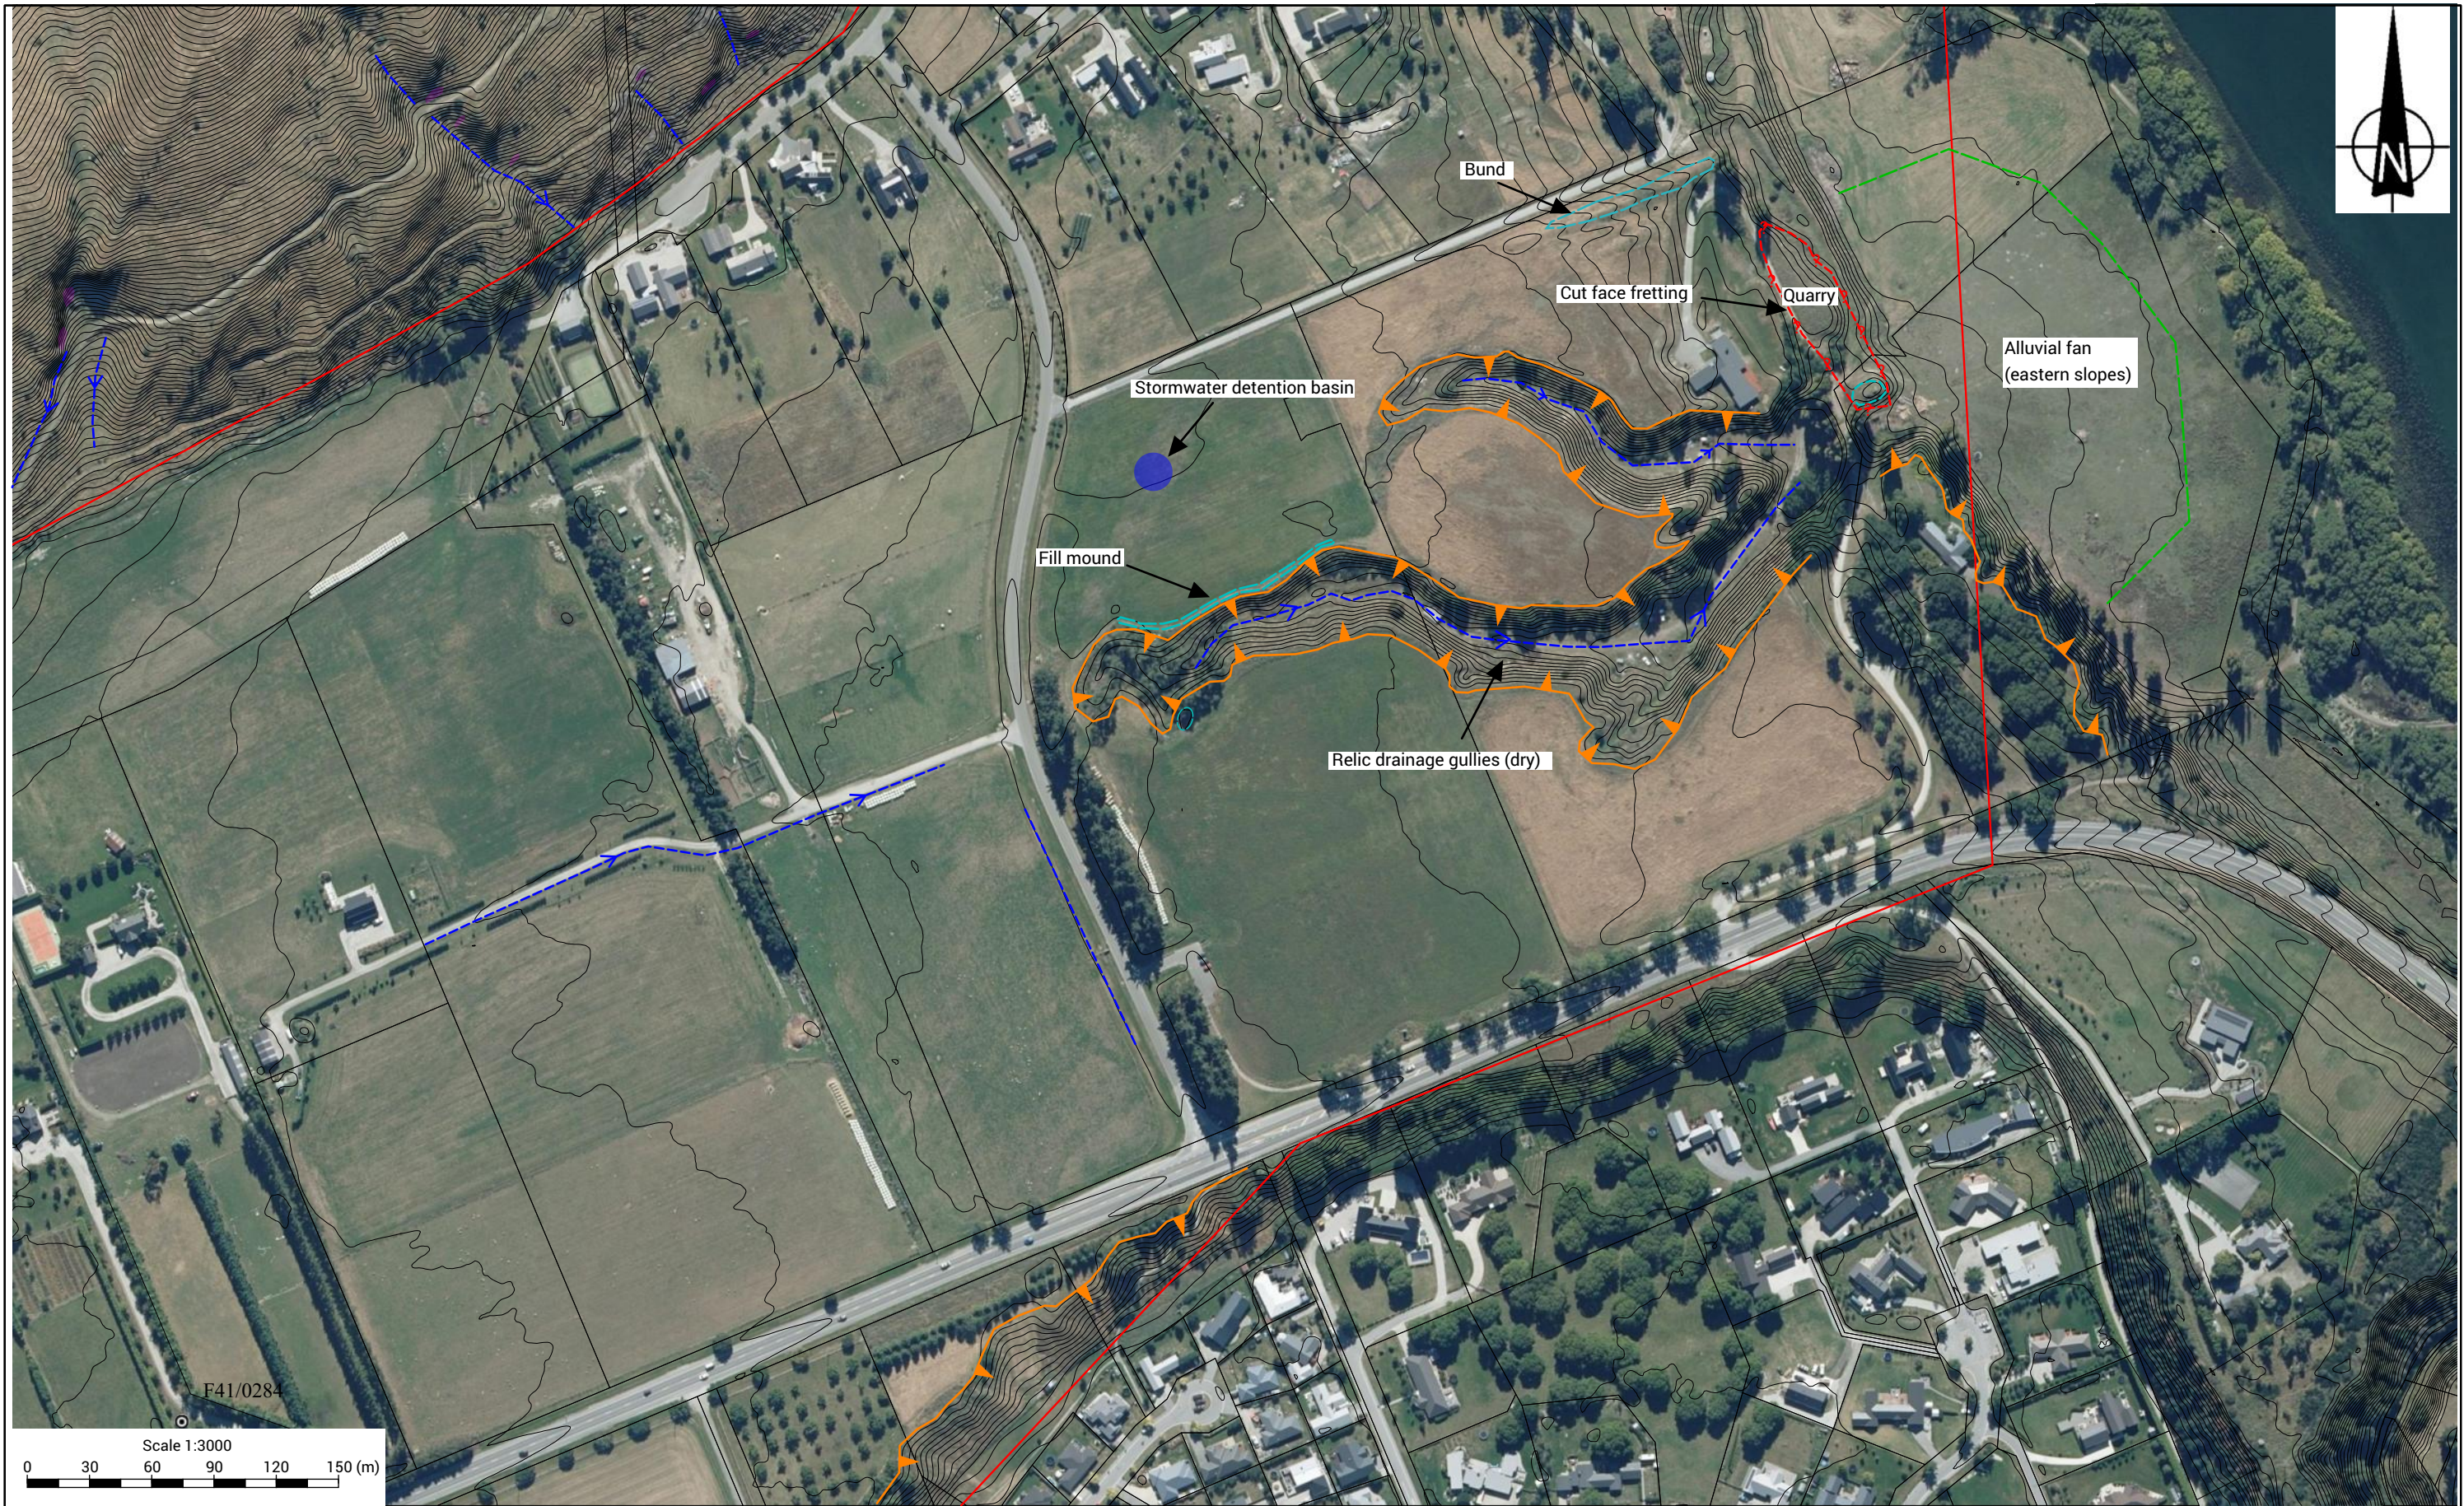
FIG No: **FIGURE 7**

An area of encapsulated **contaminated fill** is present within the eastern part of the masterplan area, in the location shown in Figure 7, Appendix A. The contaminated fill is approximately 3.0 m deep was placed in 2015 as part of the Threeewood residential development. Further comment is provided in Section 6.5 below.

A small historic landslide feature was observed above the north-eastern end of the hillslopes, in the location shown in Figure 7, Appendix A. Subvertical schist bedrock forms the scarps. This schist debris landslide is inferred to be slowly creeping in response to heavy rainfall and seismic events.

An anecdotal area of historic lime quarrying is present within the eastern slopes of the subject site, as shown in Figure 7. This area is localised however, any fill material associated with this activity could be subject to settlement following a major regional earthquake event. Any foundations proposed within this area will require specific engineering design and assessment at detailed design stage.

An isolated existing schist debris landslide is located in the northern eastern corner of the masterplan area, as shown in Figure 7, and is inferred to be slowly creeping in response to high rainfall and seismic events.

As discussed in Section 4.2 above, approximately 3.0 m of contaminated fill is present within the eastern part of the masterplan area, see Figure 7, Appendix A.
