Skyline Enterprises Ltd
 Skyline Upgrade
 Stormwater Discharge - Detailed Hazard Assessment
 Aerial Summary Plan

Skyline Enterprises Ltd
 Skyline Upgrade
 Stormwater Discharge - Detailed Hazard Assessment
 Geomorphology Summary Plan

Skyline Enterprises Ltd	
Skyline Upgrade	
Stormwater Discharge - Detailed Hazard Assessment	
Detailed Geomorphology below DL1, northern/upper zone	
FIG No:	Figure 1d
REV.	1

Skyline Enterprises Ltd	
Skyline Upgrade	
Stormwater Discharge - Detailed Hazard Assessment	
DL1 Southern Flow Path Longsection	
FIG No:	Figure 2a
REV.	1

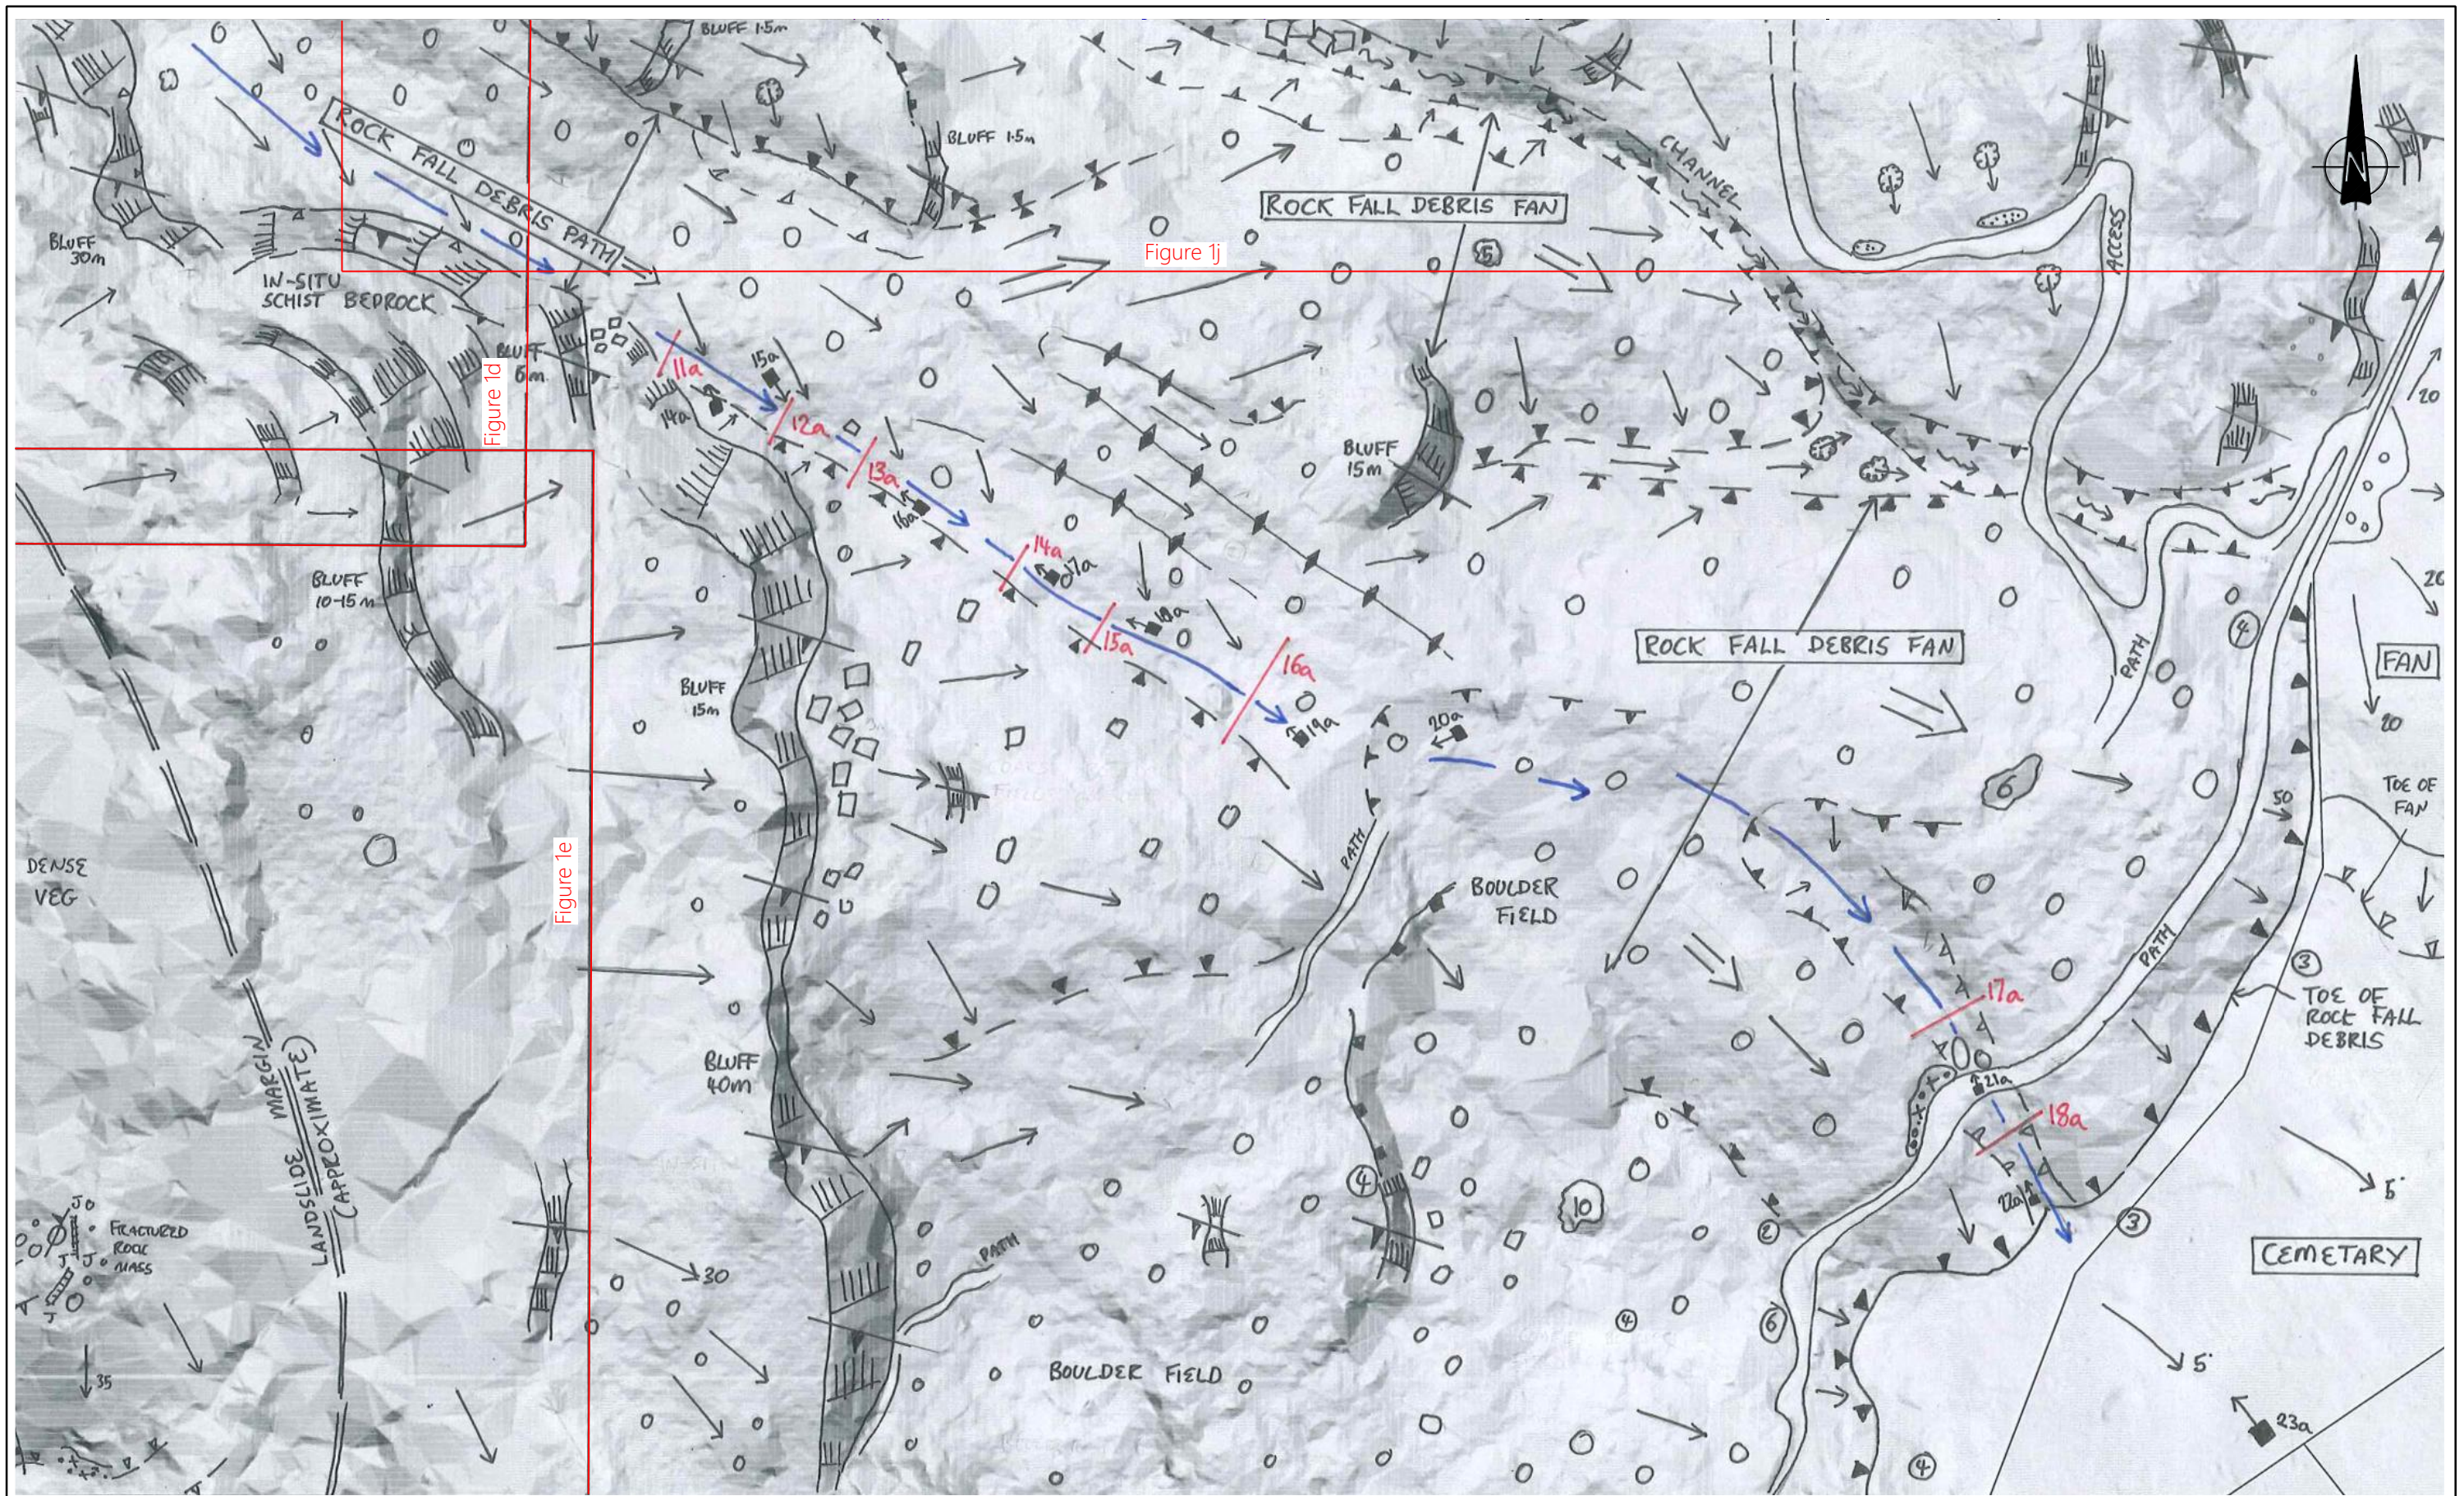
FIG No:
Figure 1f

Skyline Enterprises Ltd
 Skyline Upgrade
 Stormwater Discharge - Detailed Hazard Assessment
 Detailed Geomorphology below DL1, south eastern zone

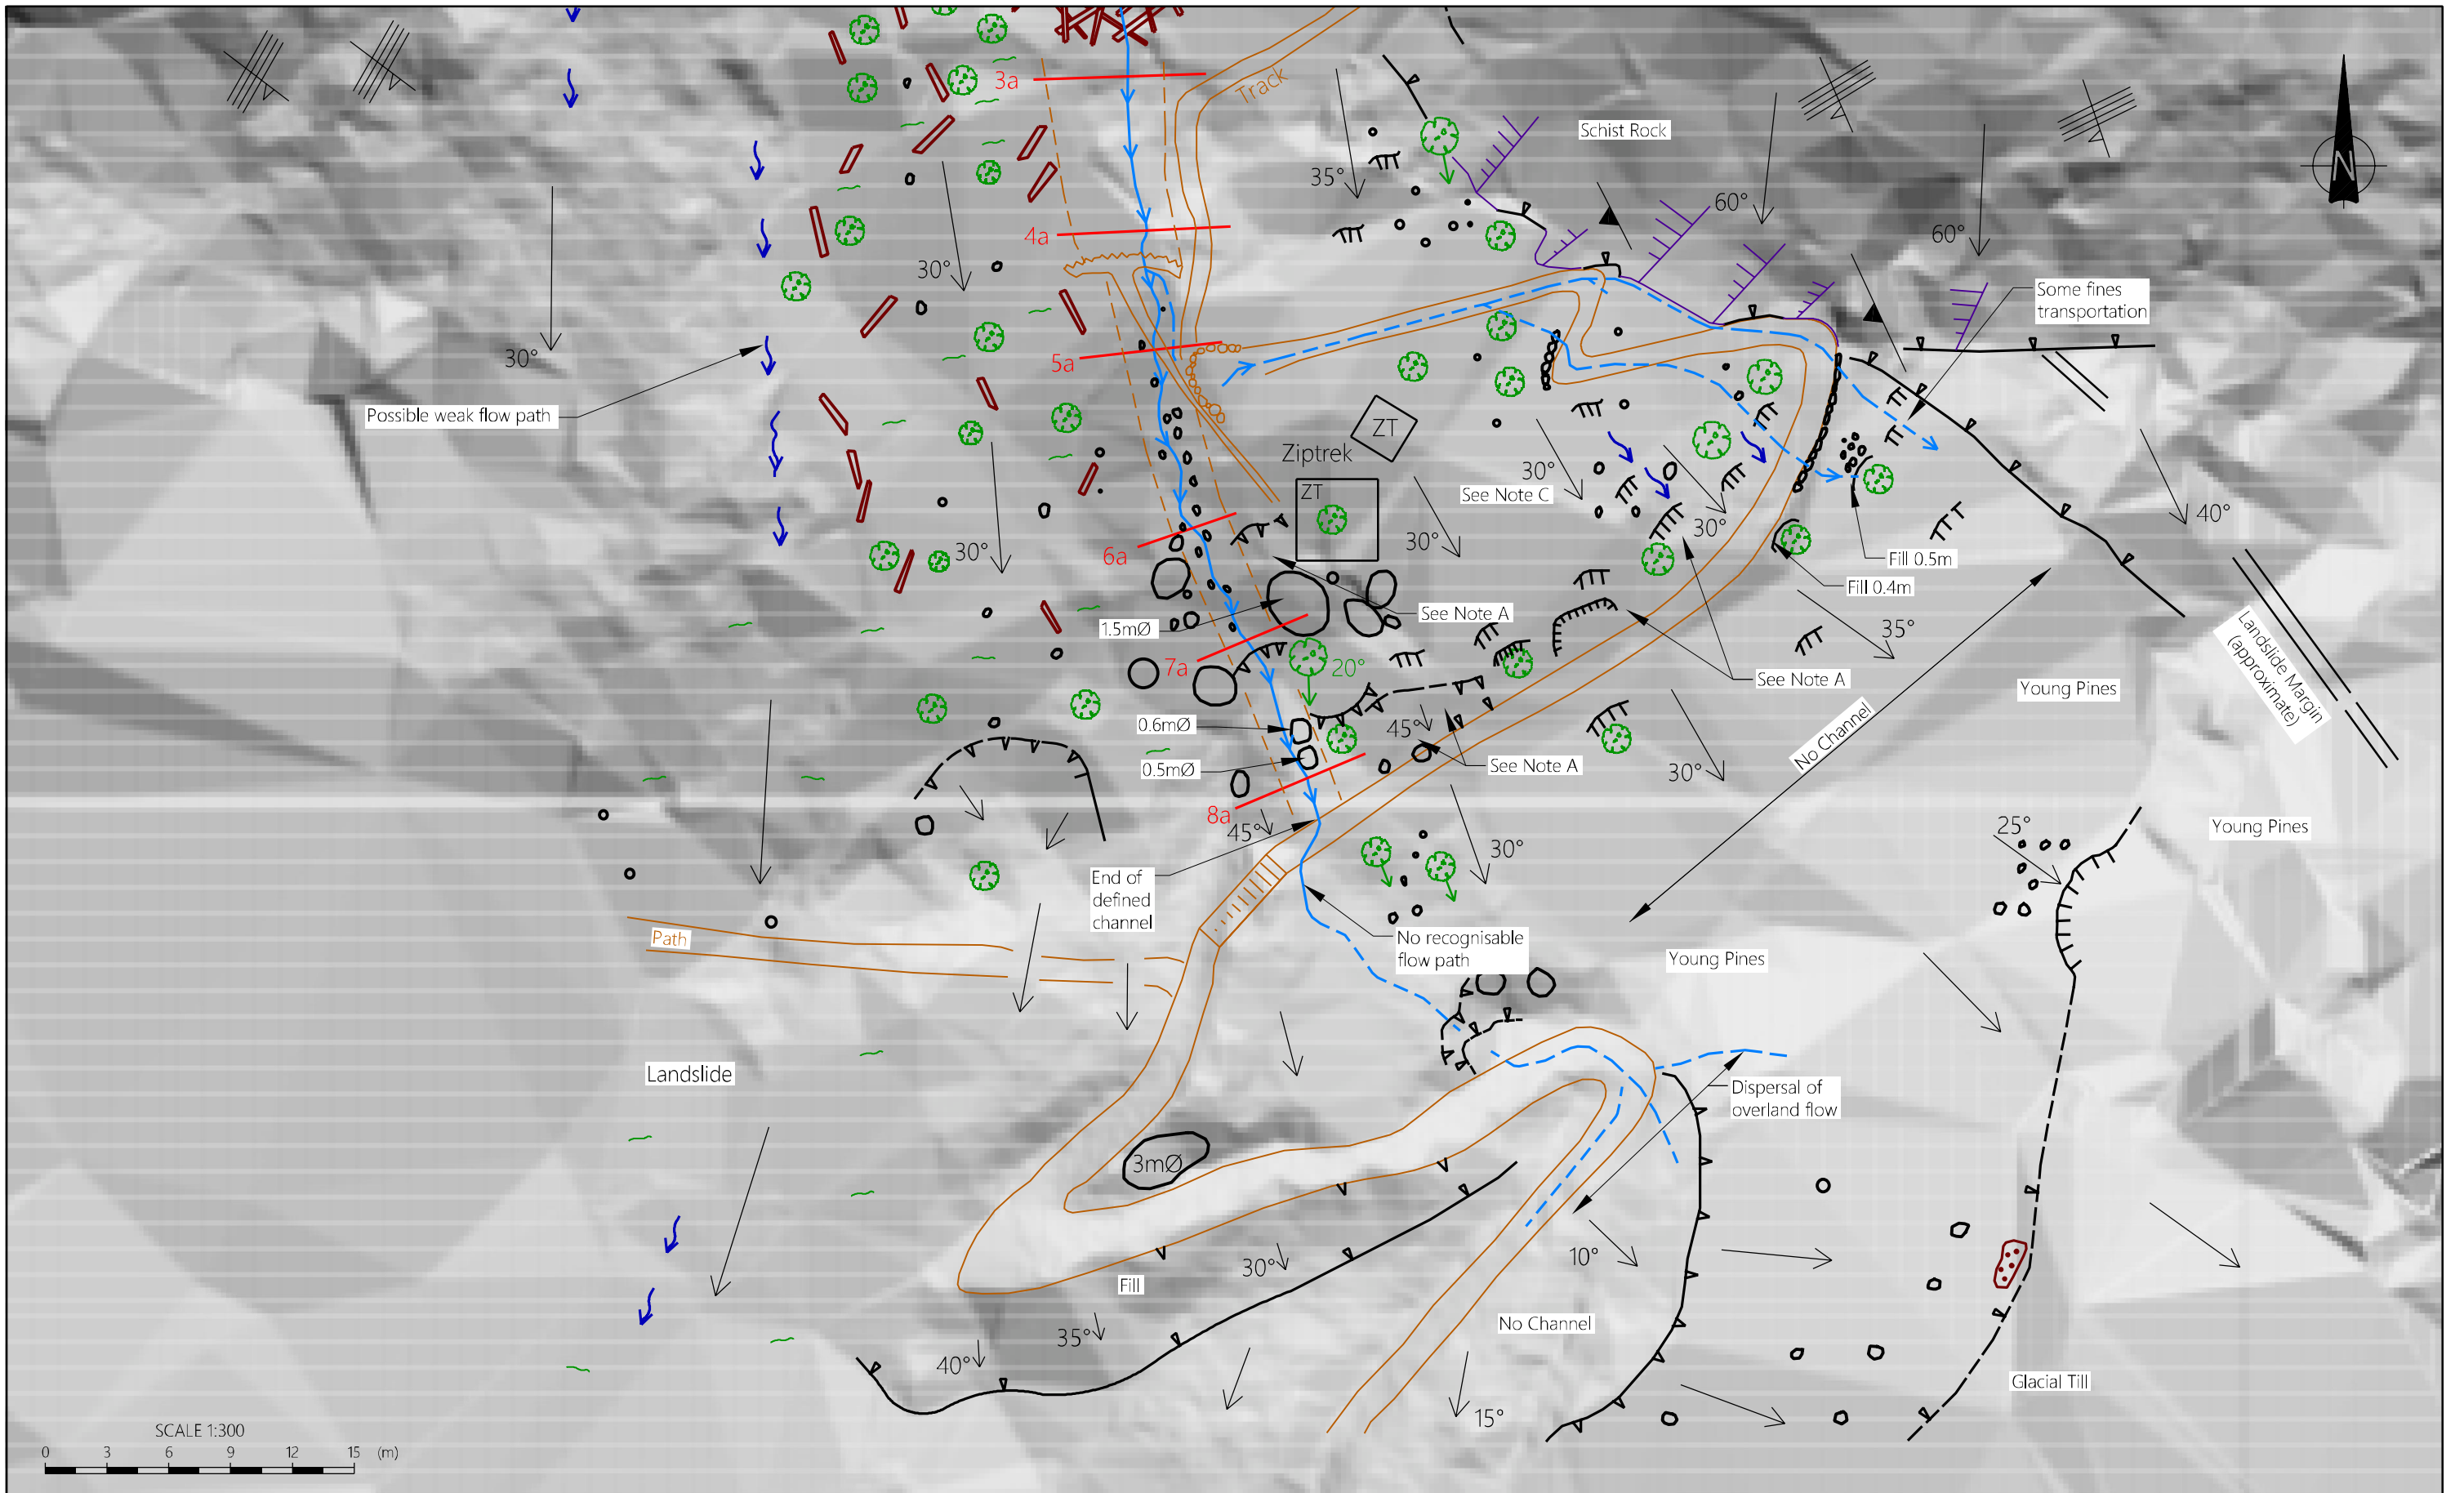
File No:
Figure 1h

- A. Angular chaotic cobble and boulder deposit to 0.4m diameter. Silty sandy gravel matrix.
- B. Angular cobble and boulder deposit, downslope imbrication.
- C. 0.1-0.2m topsoil in most areas, some surface creep. Underlying materials are gravel, cobble, and boulders.

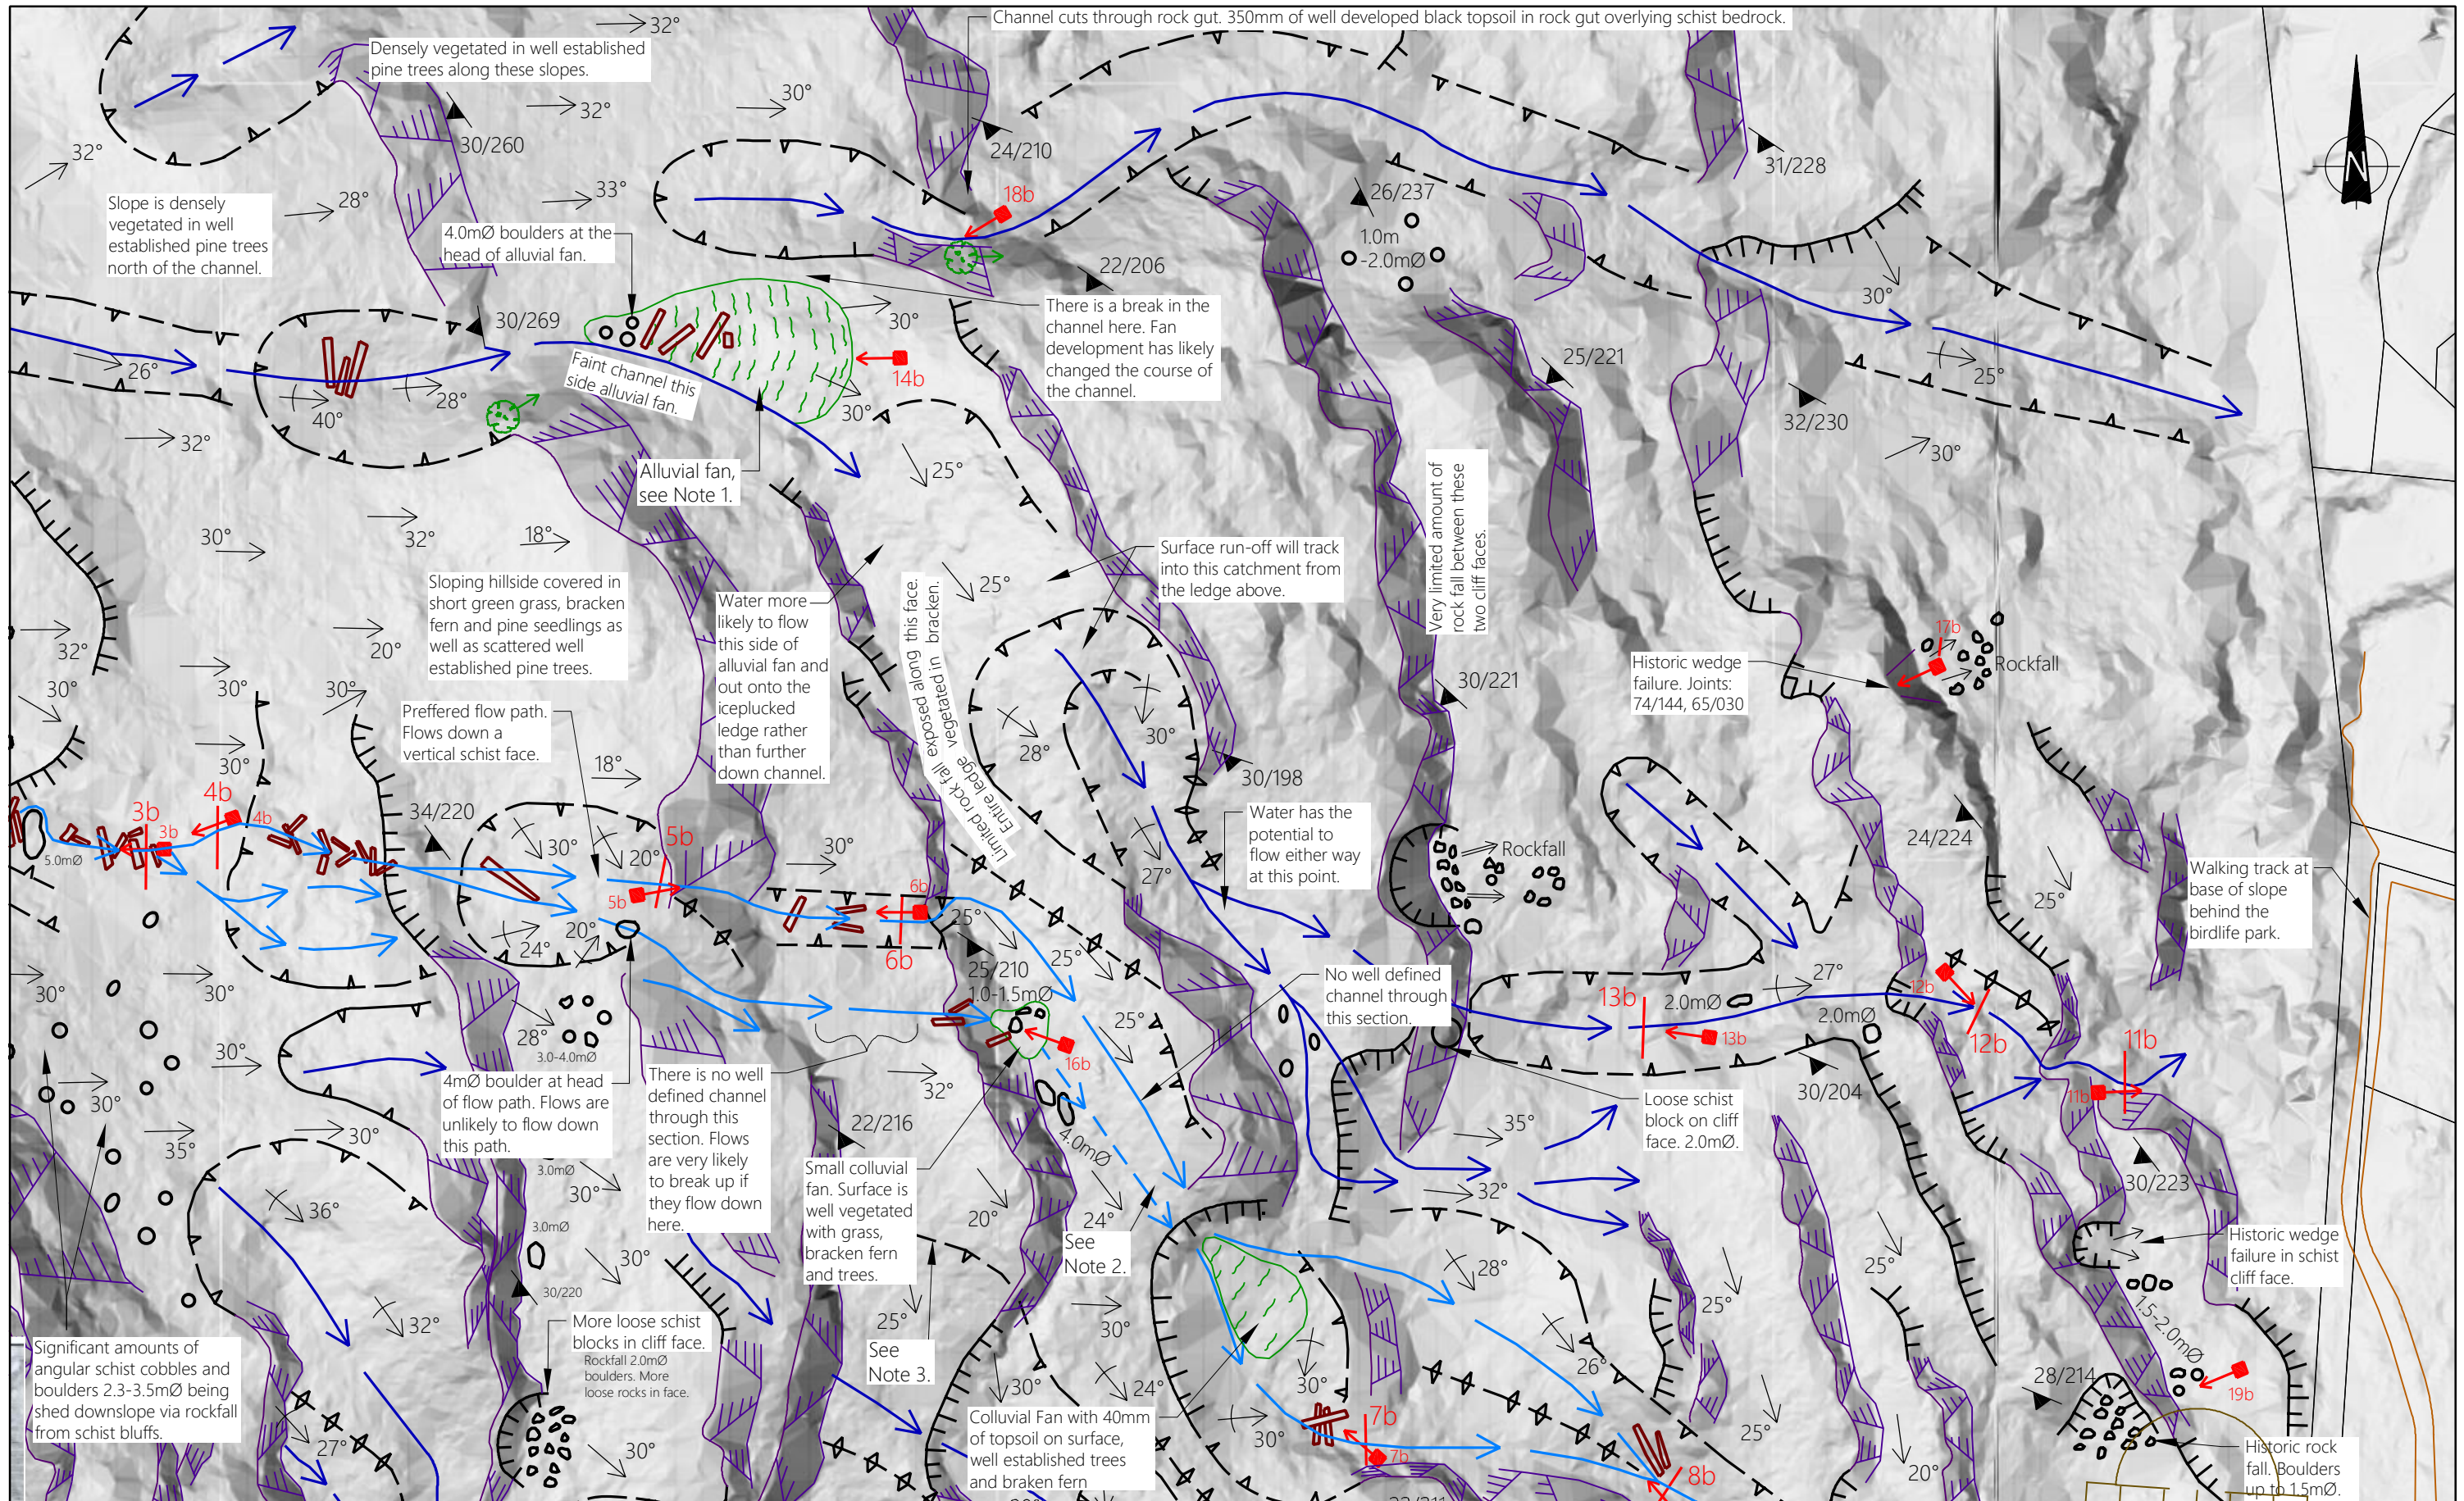
FIG No: Figure 1k

1. The entire fan surface is curved and lobate-historic debris flows. Fan surface is vegetated in well established trees and bracken fern. No evidence of scour erosion. 50mm of black topsoil overlying black gravelly organic SILT with trace cobbles and boulders.
2. Very faint line of channel above the cliffs. Flows are most likely to disperse across the slope upon reaching the colluvial fan, then dissipate through the bluffs.
3. 60mm of black topsoil overlying black gravelly organic SILT with some cobbles and boulders and some fine roots (Colluvial Fan).

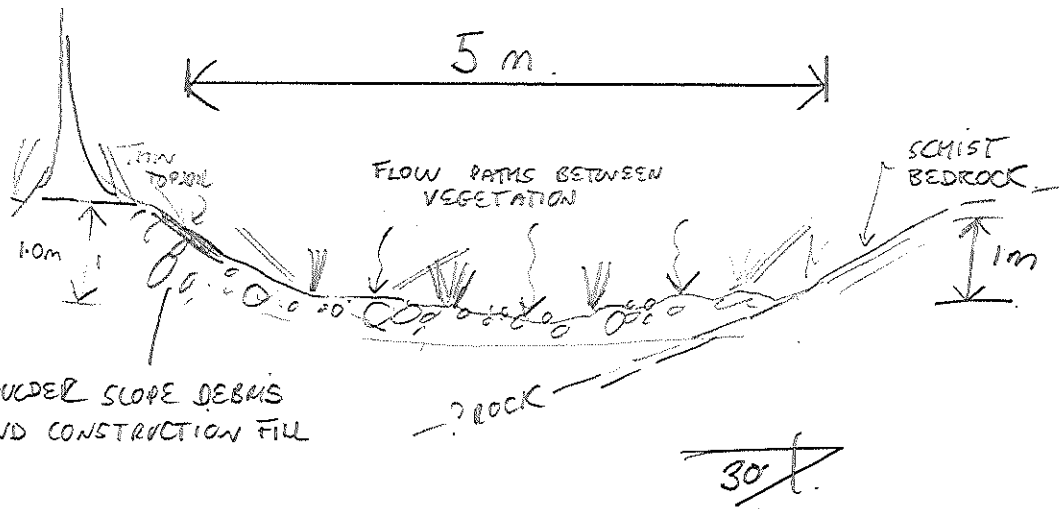
Section Number: 3a.

angularity		
Depth of soil	1m	
Average size	50 - 100 mm	
Max size	0.3 m.	
Tightly interlocked or loose	loose materials on surface.	
Scour erosion	Some scour, transportation of gravel.	
Vegetation	Sporadic grass and fern growth	
Depth of Topsoil:	Sporadic cover < 50mm.

Some fallen tree debris.

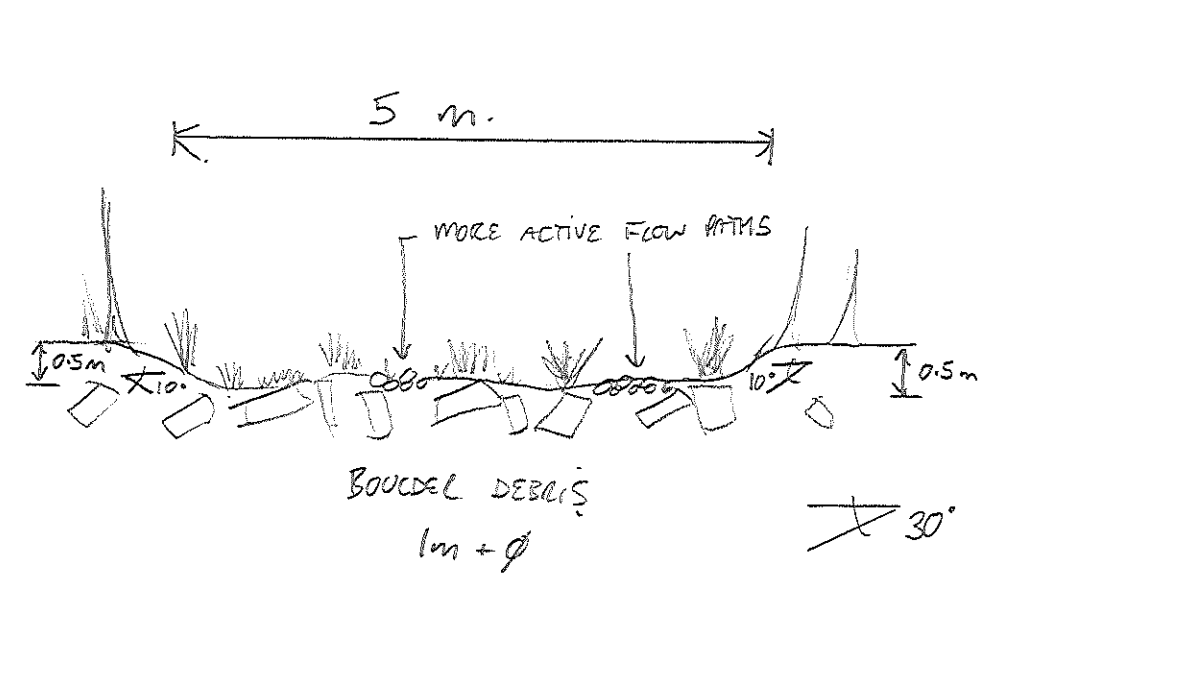
Section Number: 4a

Angularity	Angular.		
Depth of soil	Unknown, estimated 2-4 m.		
Average size	50 - 100 mm		
Max size	0.3 m.		
Tightly interlocked or loose	Loose gravel on surface, interlocked boulders beneath.		
Scour erosion	Some minor scour, transportation of gravel.		
Vegetation	Well established grass, ferns, shrubs.		
Depth of Topsoil	50 - 100 mm.

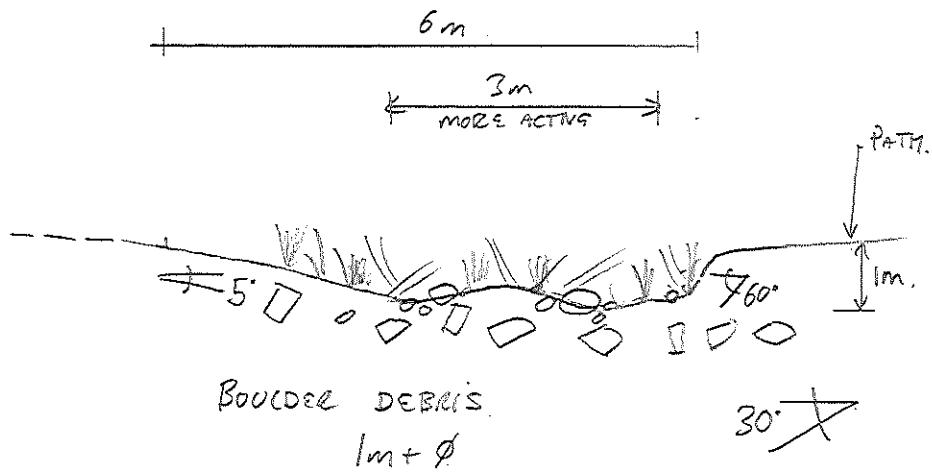
Section Number: 5a.

Angularity	Angular.		
Depth of soil	Unknown, estimated 3-6m		
Average size	50 - 100mm.		
Max size	0.3m.		
Tightly interlocked or loose	Some loose surface material, interlocked boulders beneath.		
Scour erosion	Very minor, possible transportation of gravel.		
Vegetation	Well established grass, fern, bushes.		
Depth of Topsoil	50-100mm.

Significant fallen and felled tree debris.

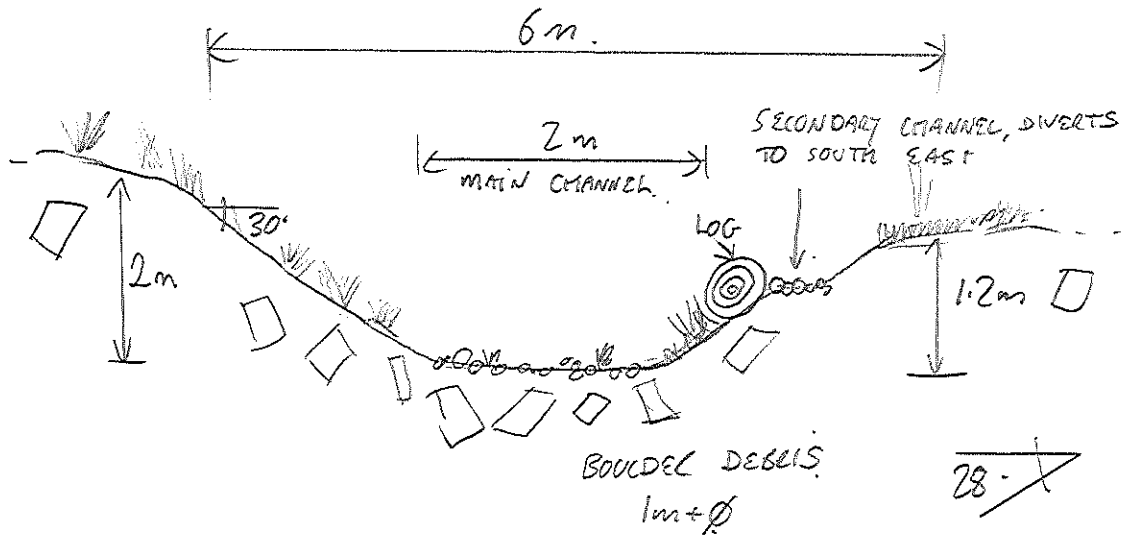
Section Number: 6a.

Angularity	Angular.		
Depth of soil	Unknown, several metres		
Average size	50-100mm.		
Max size	0.35 m.		
Tightly interlocked or loose	Some loose material on surface, interlocked beneath		
Scour erosion	Very minor, some transportation of gravel.		
Vegetation	Sporadic grass, ferns		
Depth of Topsoil	pockets ~ 450mm.

Large fallen tree in channel.

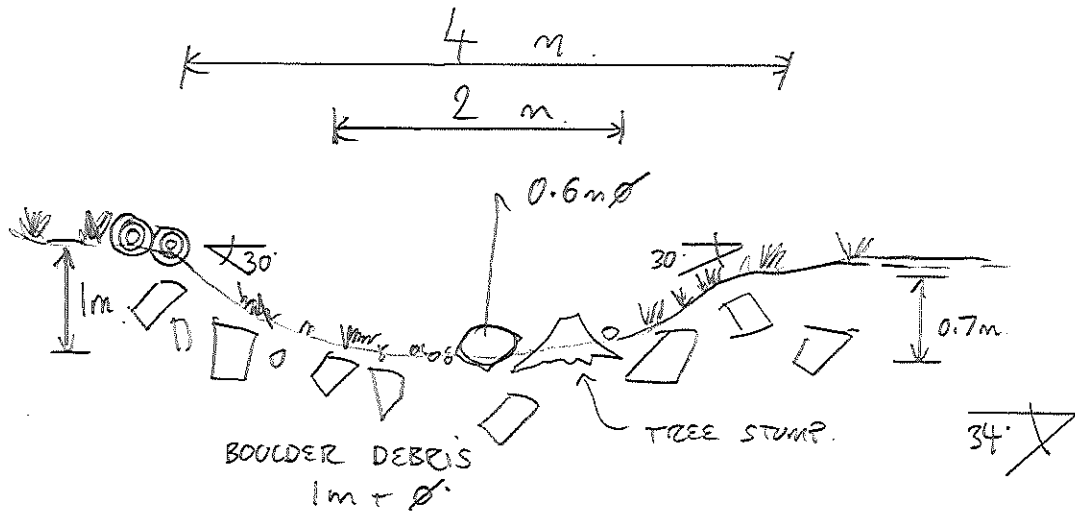
Section Number: *Ta.*

Angularity	Angular		
Depth of soil	Unknown, several metres		
Average size	50-100mm. on surface. large boulders	beneath	
Max size	0.6m. (in channel)		
Tightly interlocked or loose	Loose surface, interlocked boulders	beneath	
Scour erosion	Very minor		
Vegetation	Pockets of grass, ferns in channel		
Depth of Topsoil	Sporadic < 50mm - 100mm.

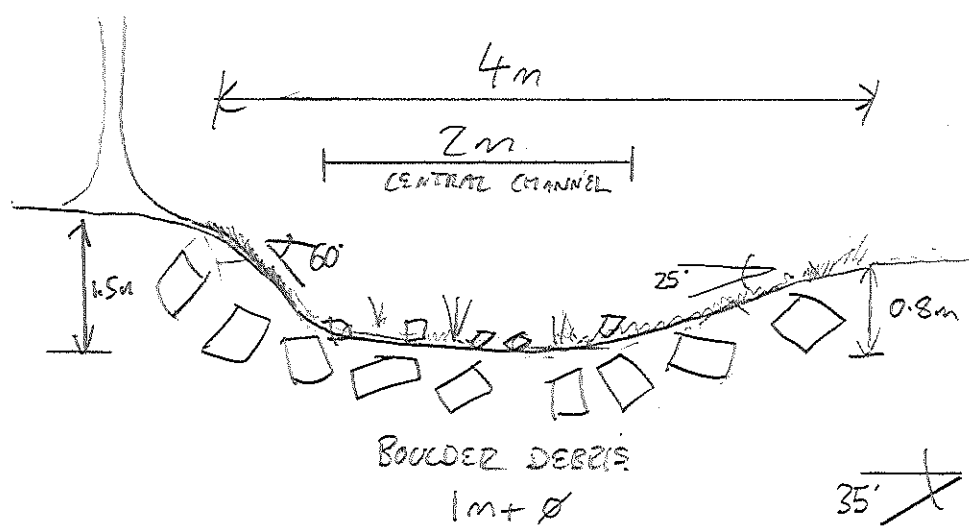
Section Number: 8a

Angularity	<i>Angular</i>		
Depth of soil	<i>Unknown, Several metres.</i>		
Average size	<i>50-100 mm.</i>		
Max size	<i>250mm in channel</i>		
Tightly interlocked or loose	<i>Thin loose surface, interlocked boulders beneath.</i>		
Scour erosion	<i>Very minor, some transportation</i>		
Vegetation	<i>Späadic pockets, grass shrubs.</i>		
Depth of Topsoil	<i>Variable. coverage 250mm - 100mm.</i>

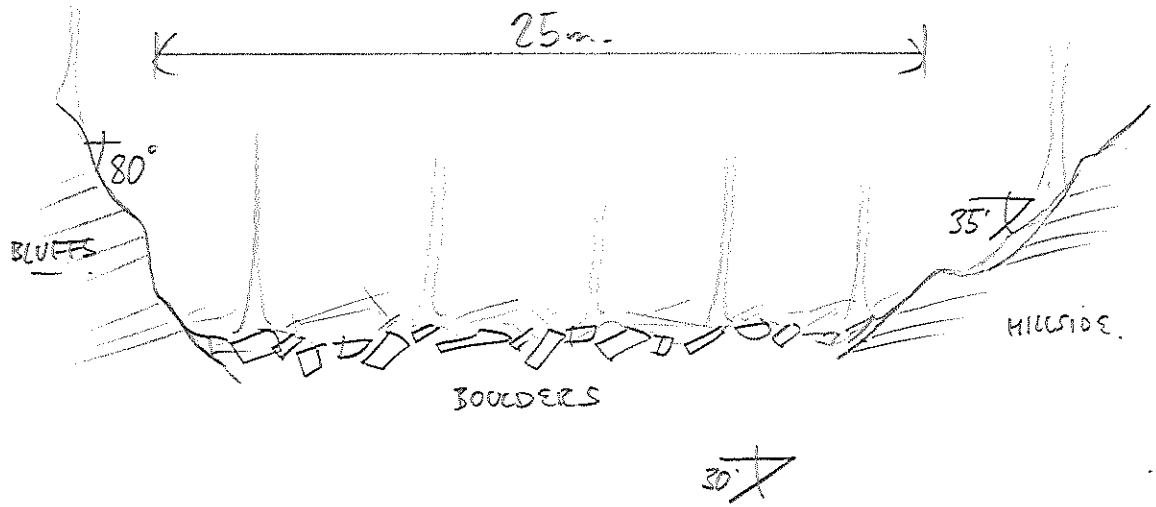
Section Number: 11a.

Angularity	Angular.		
Depth of soil	Unknown, several metres.		
Average size	0.5 m +.		
Max size	3m.		
Tightly interlocked or loose	Interlocked.		
Scour erosion	None, no evidence of overland flow.		
Vegetation	Mature trees, ferns		
Depth of Topsoil	Established between boulders 50-100mm

fallen tree debris.

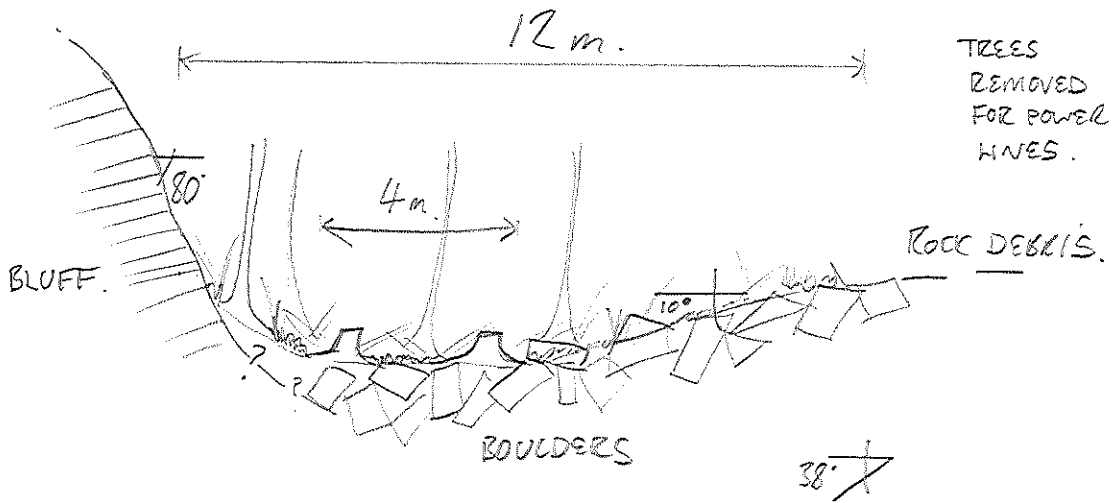
Section Number: *12a.*

Angularity	Angular.		
Depth of soil	Unknown, estimated 1-3 m.		
Average size	0.5 m +		
Max size	1.5 m.		
Tightly interlocked or loose	Interlocked		
Scour erosion	None, no evidence of overland flow.		
Vegetation	Well established mature trees, moss, ferns		
Depth of Topsoil	Established between boulders 50-100 mm.

Significant fallen tree debris, tree trunks from felled mature trees in channel.

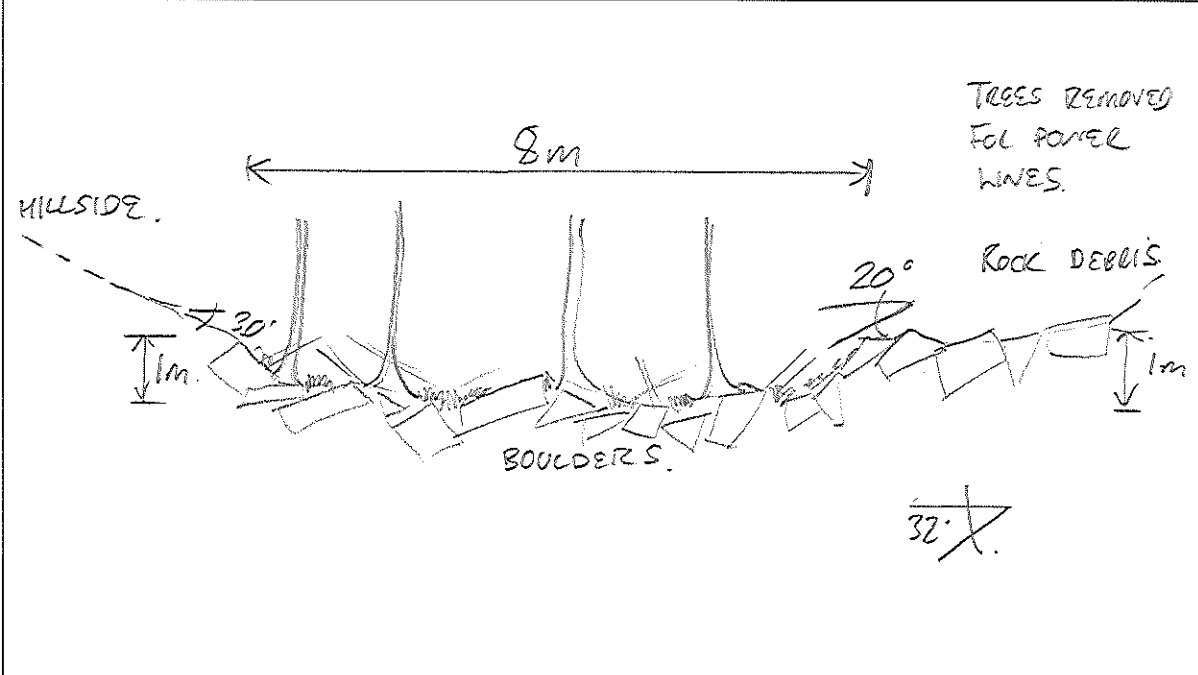
Section Number: 13a

Angularity	<i>Angular.</i>		
Depth of soil	<i>Unknown, estimated</i>	<i>2-4m</i>	
Average size	<i>0.3m +.</i>		
Max size	<i>1.5m.</i>		
Tightly interlocked or loose	<i>Interlocked.</i>		
Scour erosion	<i>None, no evidence of overland flow.</i>		
Vegetation	<i>Mature and young trees, moss.</i>		
Depth of Topsoil	<i>Variable, established between boulders</i>	<i>50-100 mm.</i>

Fallen tree debris.

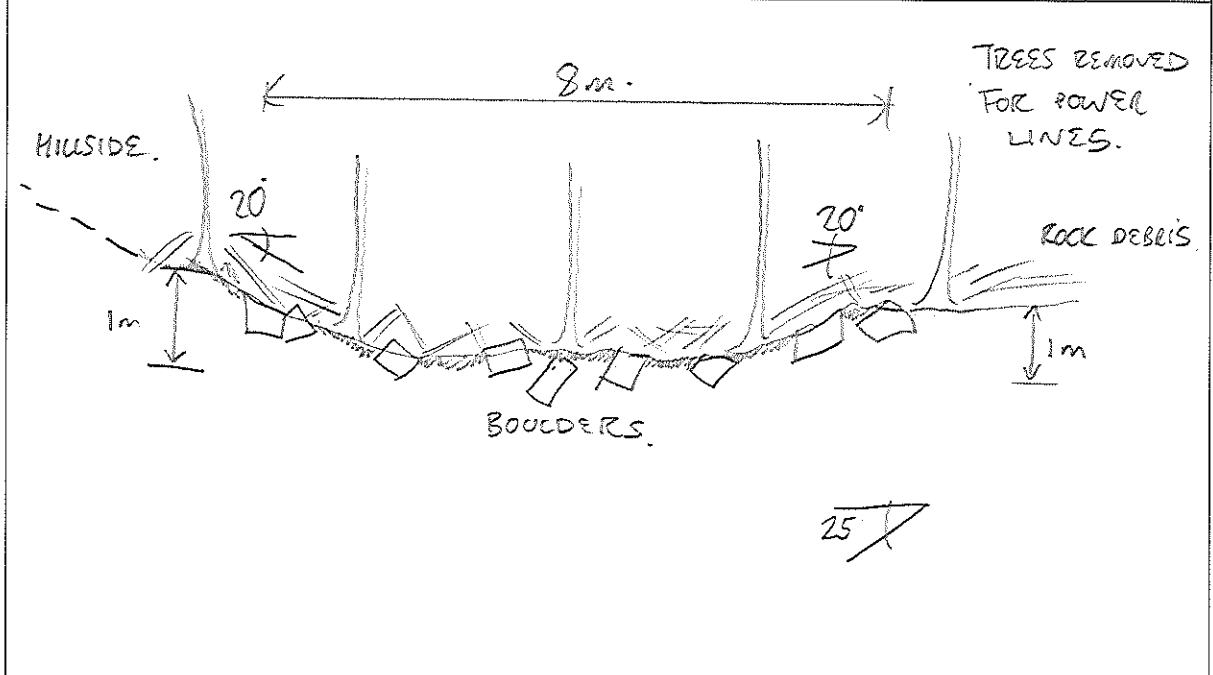
Section Number: 14a

Angularity	Angular.		
Depth of soil	Unknown, several metres.		
Average size	0.5m ±		
Max size	1.5 m.		
Tightly interlocked or loose	Interlocked		
Scour erosion	None, no indications of overland flow.		
Vegetation	Mature trees.		
Depth of Topsoil	Established between boulders 50-100mm.

Significant fallen tree debris/ felled trees.

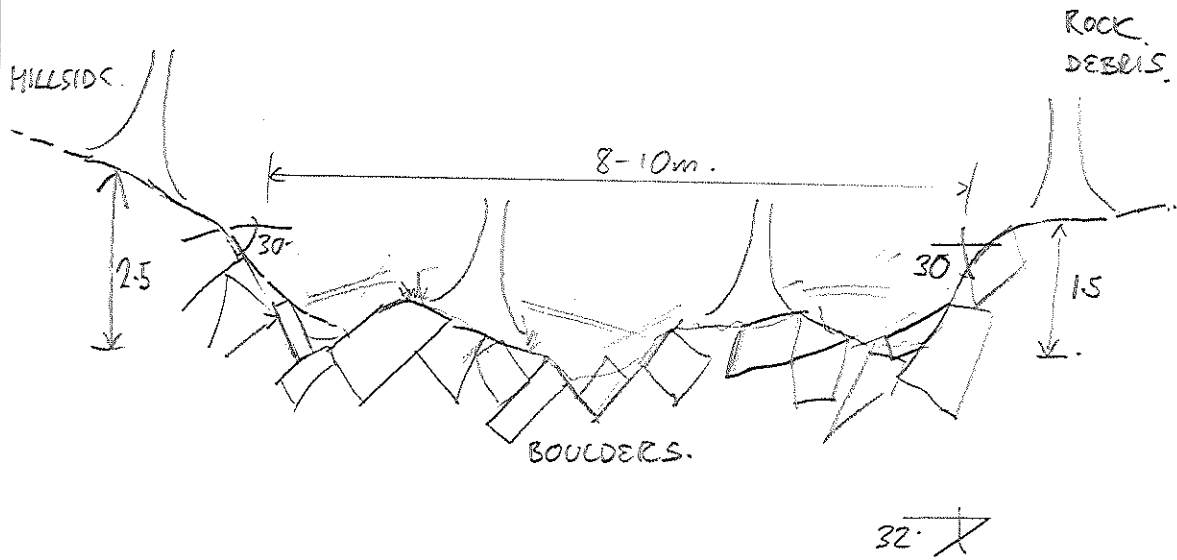
Section Number: 16a.

Angularity	Angular		
Depth of soil	Unknown, expected to be several metres.		
Average size	0.5m +		
Max size	2m		
Tightly interlocked or loose	Interlocked.		
Scour erosion	None, no indications of overland flow.		
Vegetation	Mature trees.		
Depth of Topsoil	Established between boulders	50-100mm

Fallen tree debris.

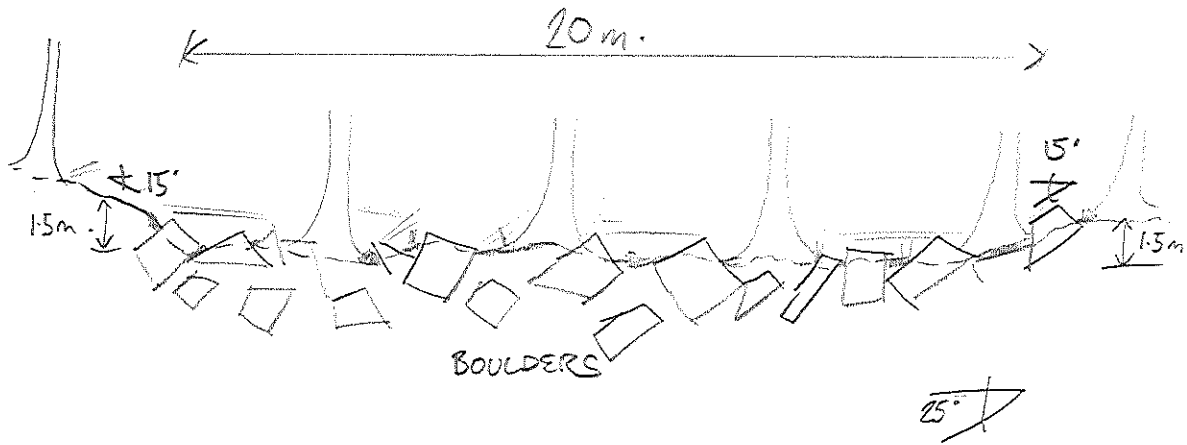
Angularity	Angular		
Depth of soil	Unknown, expected to be several metres.		
Average size	0.5m ⁺		
Max size	4m.		
Tightly interlocked or loose	Interlocked, high void space.		
Scour erosion	None, no indications of overland flow		
Vegetation	Mature trees		
Depth of Topsoil	Established between boulders 50-100mm.

Channel is very vague, lots of bifurcation and dispersal around boulders and trees.
 Very coarse boulder field, with fallen tree debris

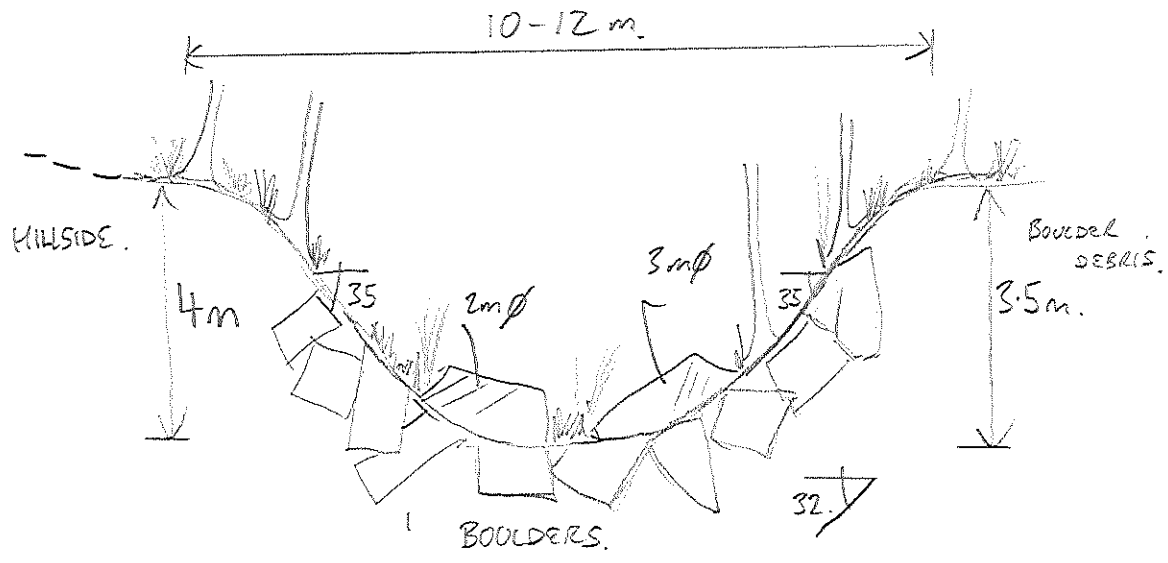
Section Number: 17a

Angularity	Angular.		
Depth of soil	Unknown, expected to be several metres.		
Average size	0.3m +.		
Max size	3 m.		
Tightly interlocked or loose	Interlocked.		
Scour erosion	None, no indications of any overland flow.		
Vegetation	Well established, mature trees ferns, bushes		
Depth of Topsoil	100 mm good coverage.

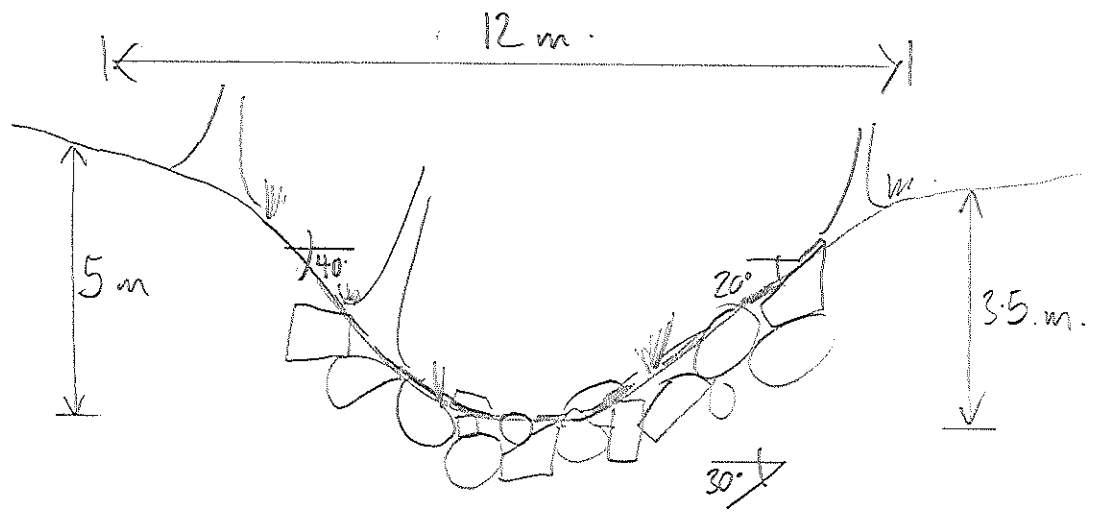
Section Number: 18a

Angularity	Angular		
Depth of soil	Unknown, expected to be several metres.		
Average size	Coarse boulders 300mm +.		
Max size	1.5m.		
Tightly interlocked or loose	Interlocked		
Scour erosion	None, no indications of any overland flow.		
Vegetation	Well established, mature trees, ferns, bushes		
Depth of Topsoil	100mm, good coverage.

MTB track above, possibly diverting flow.

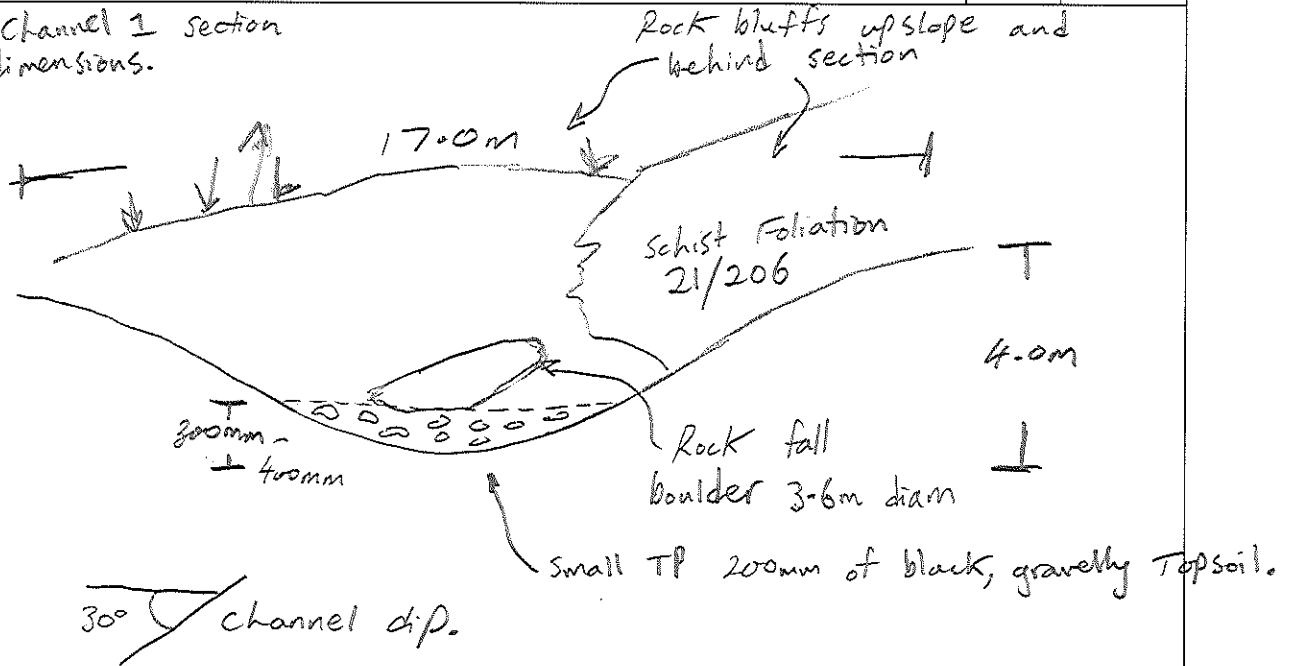
Section Number: 1b

Channel 1 section dimensions.

angularity Angular Schist clasts

Depth of soil 300mm-400mm of erodible bedload

Tightly interlocked or loose Bedload Soil is loose, levee material is tightly interlocked

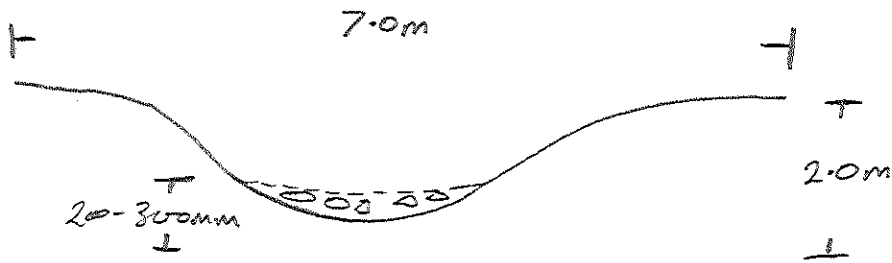
Section Number: 2b

Channel ② section dimensions

34° channel dip

Little evidence of gravels, cobbles etc.

Tightly interlocked or loose Bedload soil is loose/soft - levee material; is tightly interlocked.
