Skyline Enterprises Ltd
 Skyline Upgrade
 Stormwater Discharge - Detailed Hazard Assessment
 Aerial Summary Plan

Skyline Enterprises Ltd
 Skyline Upgrade
 Stormwater Discharge - Detailed Hazard Assessment
 Geomorphology Summary Plan

Skyline Enterprises Ltd	
Skyline Upgrade	
Stormwater Discharge - Detailed Hazard Assessment	
Detailed Geomorphology below DL1, northern/upper zone	
FIG No:	Figure 1d
REV.	1

Skyline Enterprises Ltd	
Skyline Upgrade	
Stormwater Discharge - Detailed Hazard Assessment	
DL1 Southern Flow Path Longsection	
FIG No:	Figure 2a
REV.	1

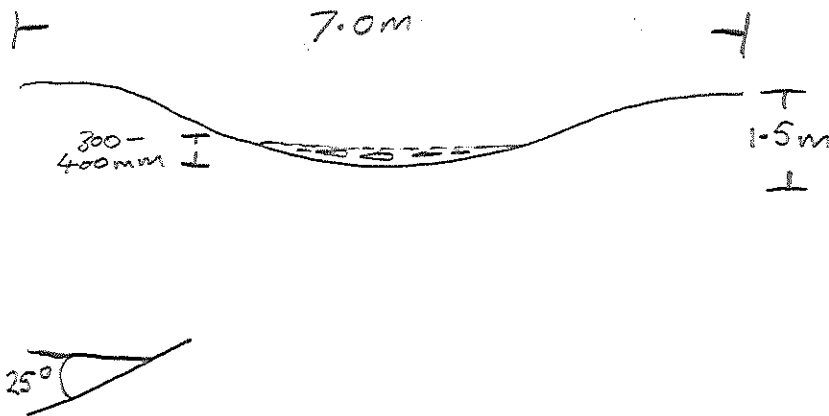
Channel section ③

Section through bend in channel.

angularity Angular schist clasts (very rarely visible)

Depth of soil 300-400mm

Tightly interlocked or loose Loos/soft organic debris bedload - Tightly interlocked levee's

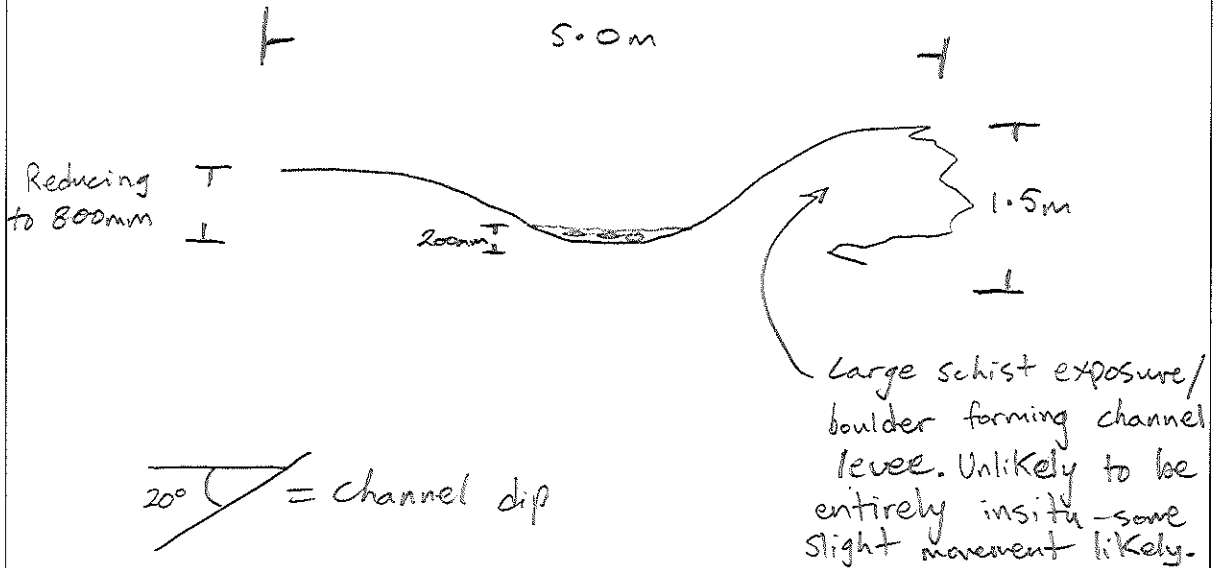
Section Number: 4b

Section through bend in channel,

angularity Angular schist clasts

Depth of soil 200mm

Tightly interlocked or loose Loose/soft organic debris in channel bedload

Note: TP dug with hammer in channel bed. 200mm of black Topsoil and decaying organic material (pine needles etc) with some fine roots. An angular schist cobble was struck at 200mm bgl.

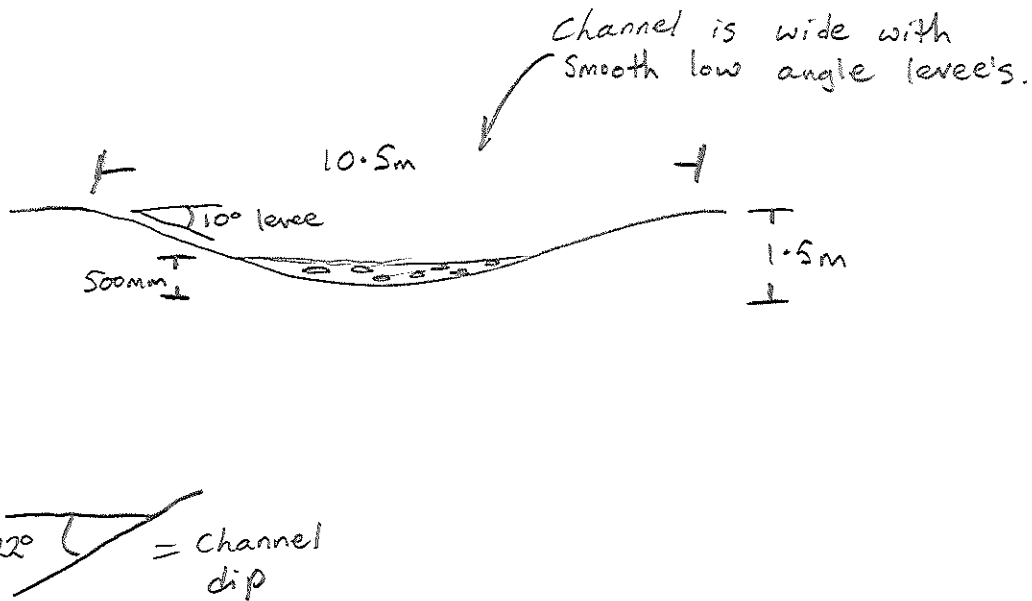
Section Number: 5b

Immediately above schist bluff

angularity Angular schist clasts

Depth of soil 500mm

Tightly interlocked or loose Tightly interlocked levees - Loose/soft organic bed load.

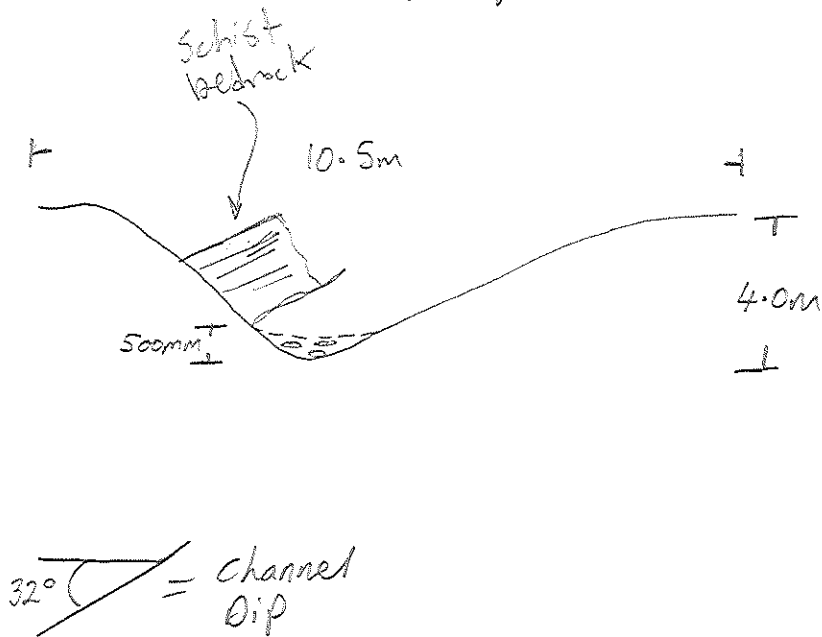
Section Number: 7b

Below catchment at beginning of channel

angularity Angular

Depth of soil Approx 500mm

Tightly interlocked or loose Soft/loose channel bed - levees are schist bedrock

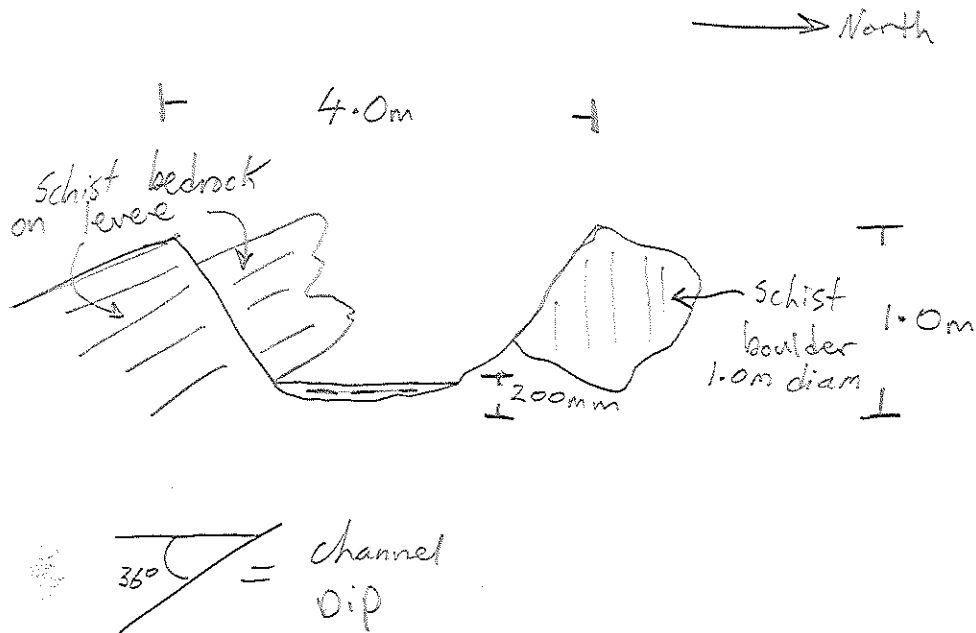
Section Number **9b**

angularity	Angular schist clasts		
Depth of soil	200mm - mostly topsoil overlying Schist bedrock		
Average size	50mm		
Max size	500mm angular Schist boulder		
Tightly interlocked or loose	Soft/loose bedload - Schist bedrock levees		
Scour erosion	None		
Vegetation	Short green grass, bracken Fern, well established trees on banks of channel - organic debris dead trees, branches.

Comments: Schist bedrock is exposed on the channel sides and in the base of the channel immediately upslope of this section. A thin veneer of organic SILT and organic debris covers the schist bedrock.

Note: TP dug with hammer. Black, gravelly organic SILT w minor cobbles & boulders observed to 400mm depth. G=f-c, g=angular.

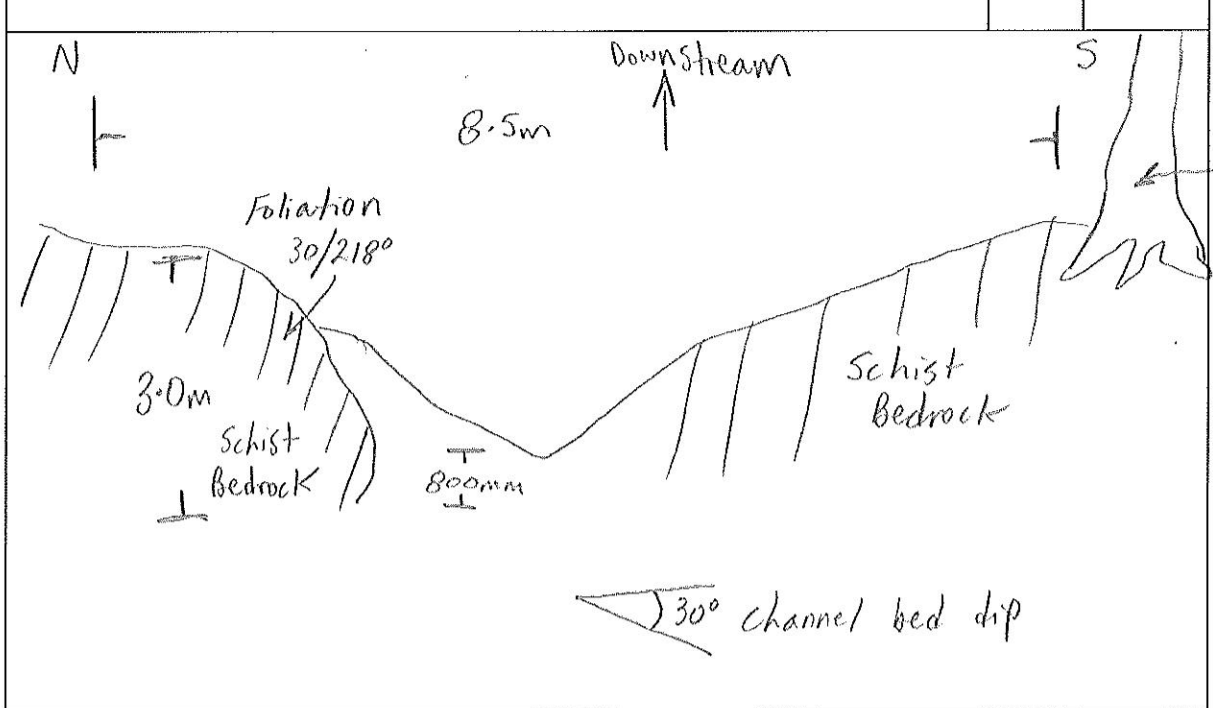
Section Number: 11b

Angularity	Angular		
Depth of soil	800mm + overlying schist bedrock		
Average size	40mm		
Max size	200mm		
Tightly interlocked or loose	loose soil in bed / schist bedrock on levees		
Scour erosion	None		
Vegetation	Dead organic debris - leaves and sticks / trees		
Depth of Topsoil	60mm of poorly developed topsoil

Hand dug test pit: 60mm, black poorly developed topsoil
 400mm, light brown organic SILT and organic debris - wood fragments, rootlets, Fibrous organic material
 100mm, grey/brown gravelly organic SILT angular schist clasts

Note: No loose blocks with the potential to move.

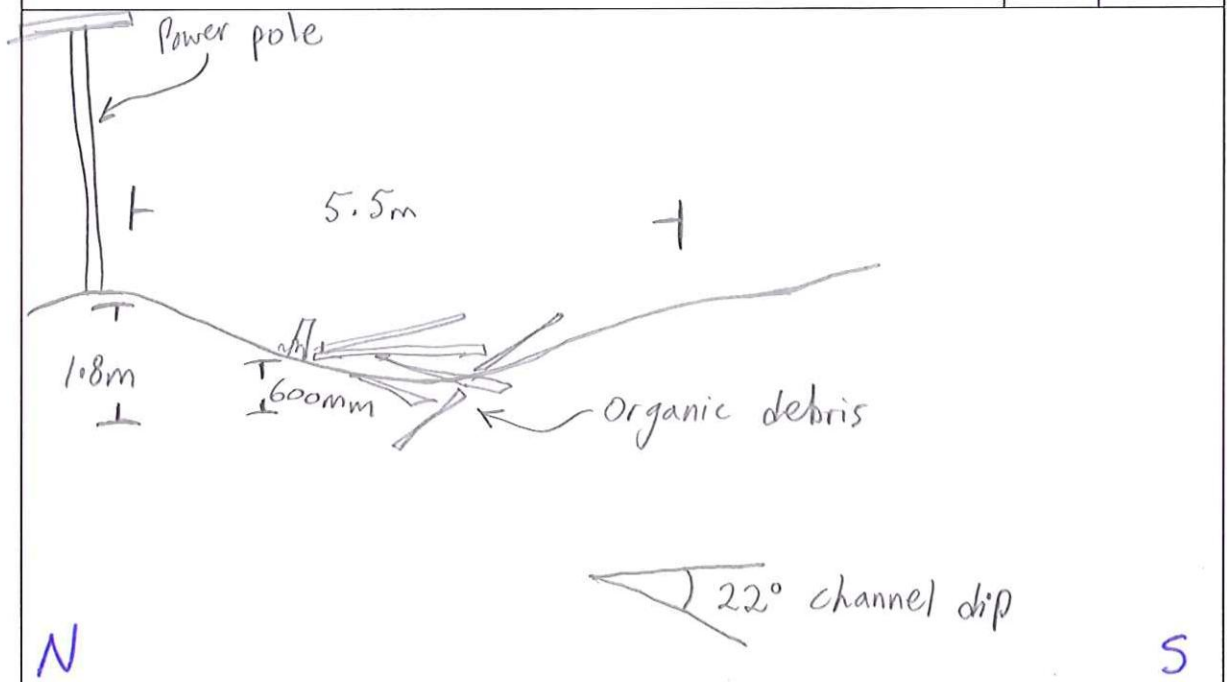
Section Number: 12b

Angularity	No clasts exposed on the surface		
Depth of soil	600mm - potentially mobile		
Average size	40mm		
Max size	No clasts exposed		
Tightly interlocked or loose	Loose in channel bed		
Scour erosion	None		
Vegetation	Bracken Fern, long green grass, broom, dead	organic debris	
Depth of Topsoil	300mm poorly developed black topsoil

The channel bed is choked with organic debris which include dead trees and branches & tree stumps.

- Hand dug TP: 300mm poorly developed black topsoil
- ↳ organic SILT & fibrous organic material
 - Overlying gravelly organic SILT w some cobbles
 - ↳ cobbles angular to sub-rounded
 - ↳ max size 100mm

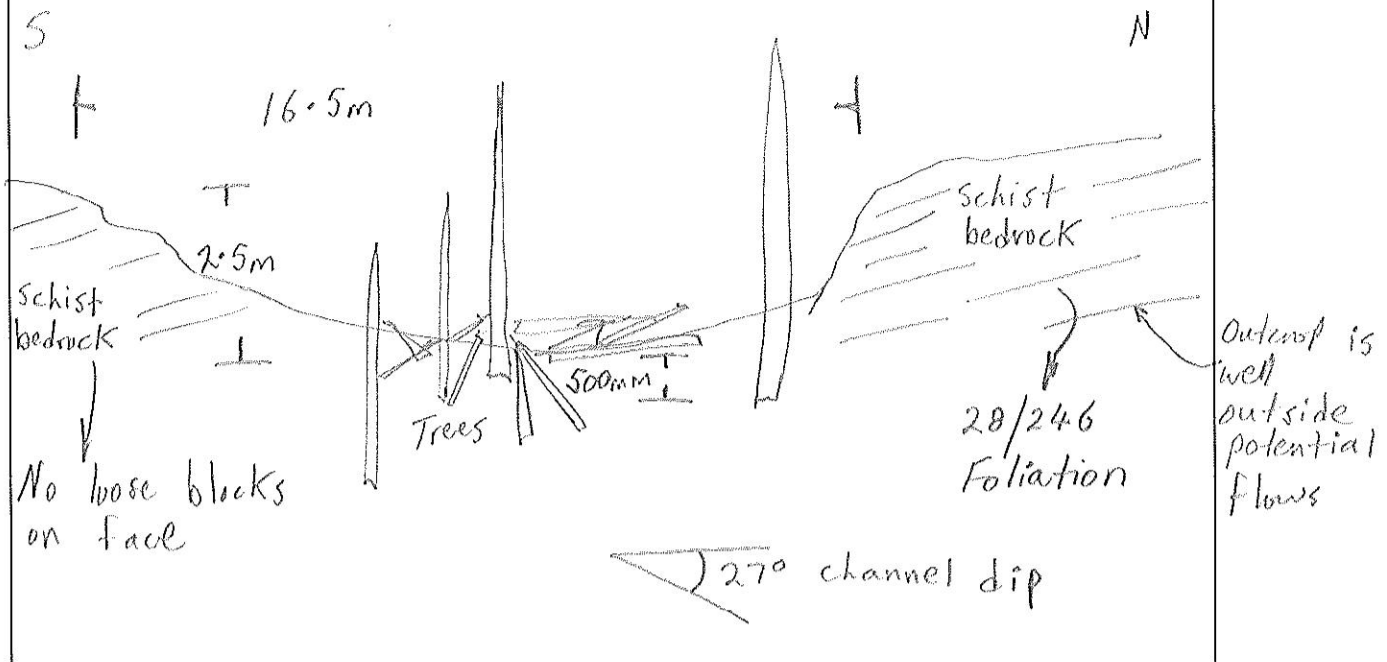
Section Number: 13b

Angularity	Angular schist clasts		
Depth of soil	500mm potentially mobile		
Average size	50mm		
Max size	1.8m - angular		
Tightly interlocked or loose	Loose/soft in channel bed		
Scour erosion	None - organic debris appears to be kept around trees.		
Vegetation	Bracken Fern & well established trees / Dead organic debris		
Depth of Topsoil	60mm well developed black topsoil

Hand dug TP: 60mm well developed black topsoil
 overlying 400mm+ of black
 gravelly organic SILT
 g=angular, g=f-c
 to sub-angular

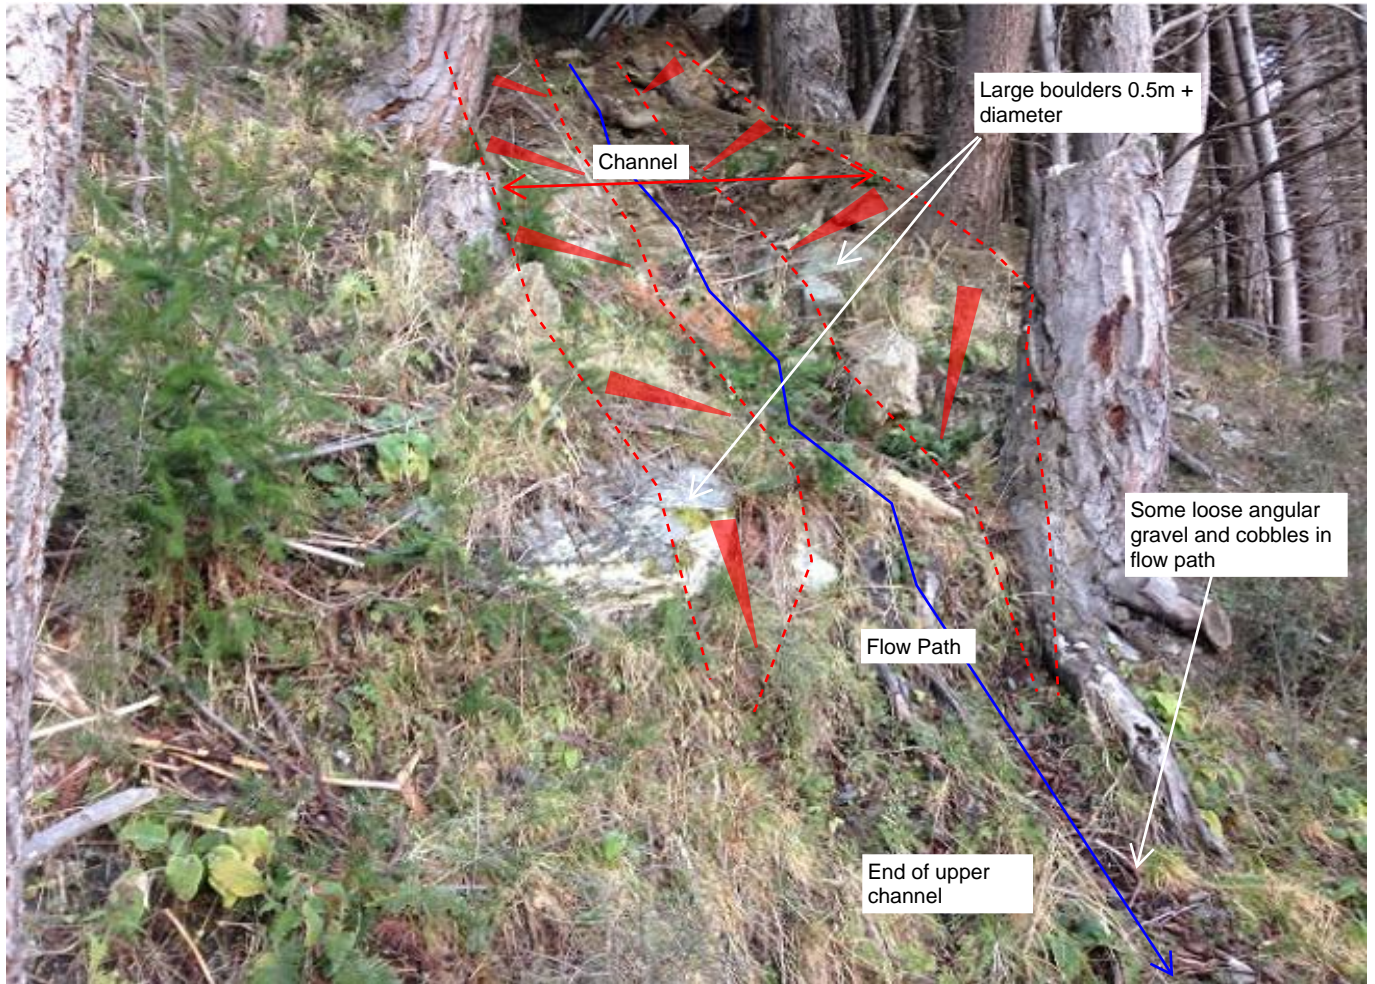
Photograph 9a. End of the defined DL1 channel directly above a Ziptrek access track

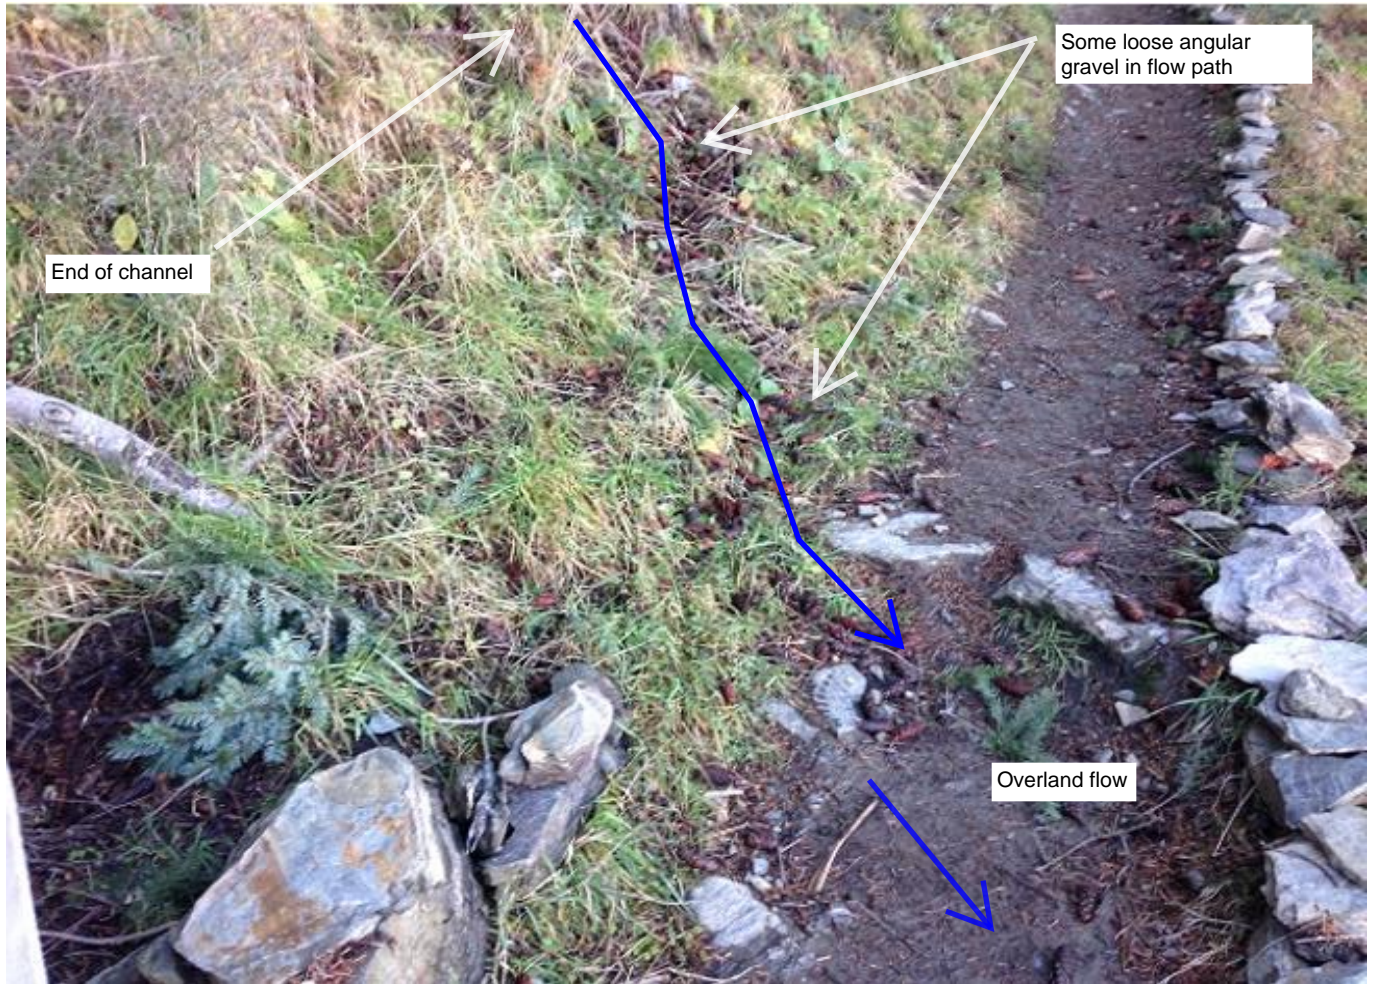
Photograph 10a. Area below DL1 defined Channel, no clear flow path, dispersal/bifurcation of overland flows expected. No existing or active channel indicating current flows don't significantly influence this area.

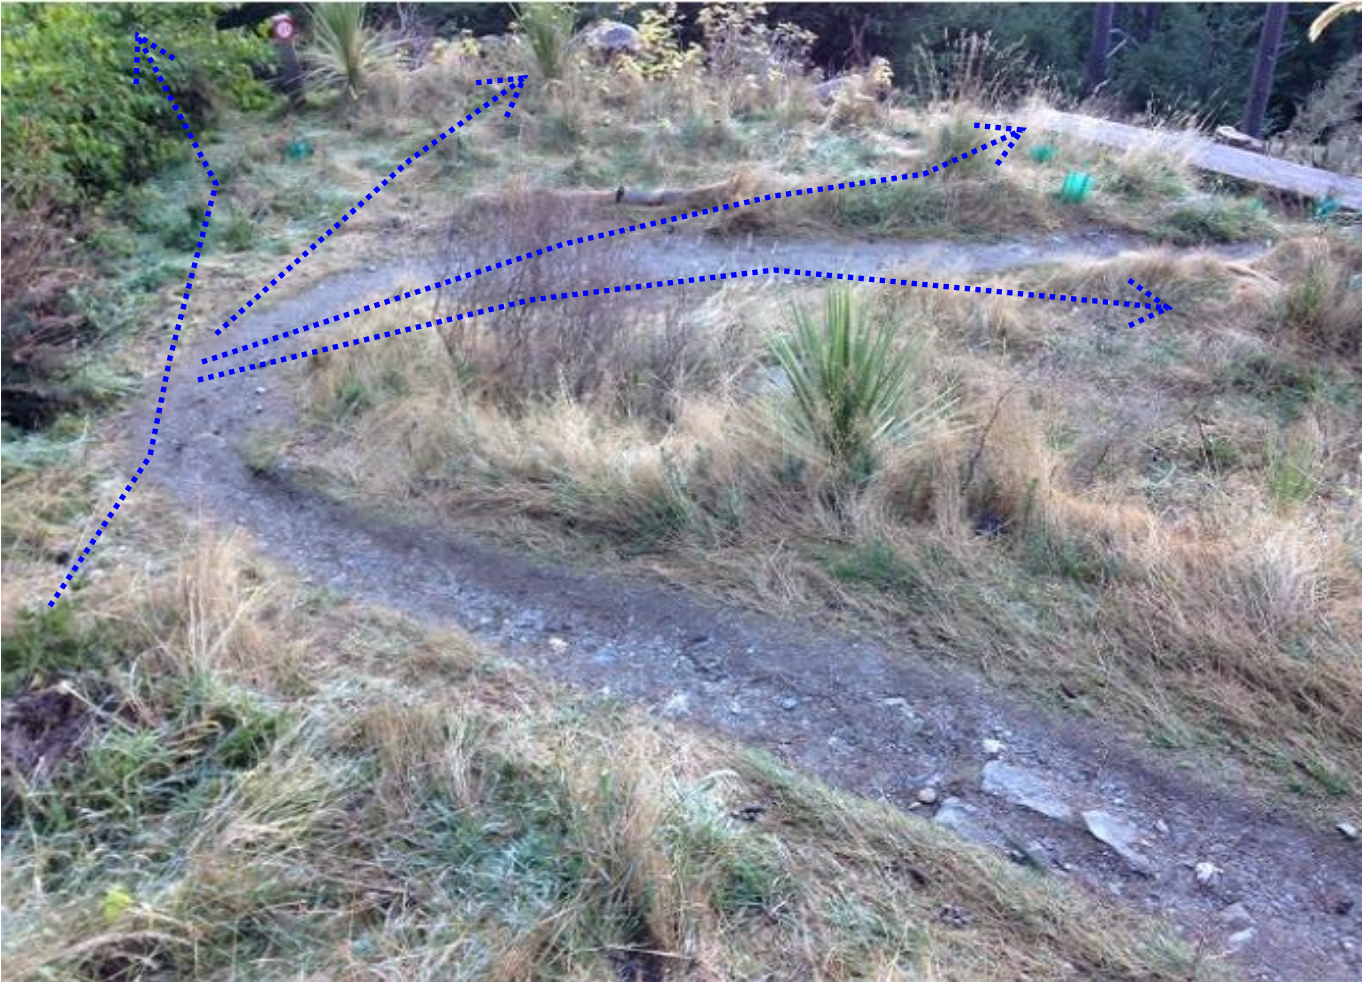
Photograph 11a. Slope area immediately below the defined DL1 channel. Vegetated slopes no clear scour/erosion or active down slope movement of materials. Very dense vegetation comprising young pines on the left of the photograph.

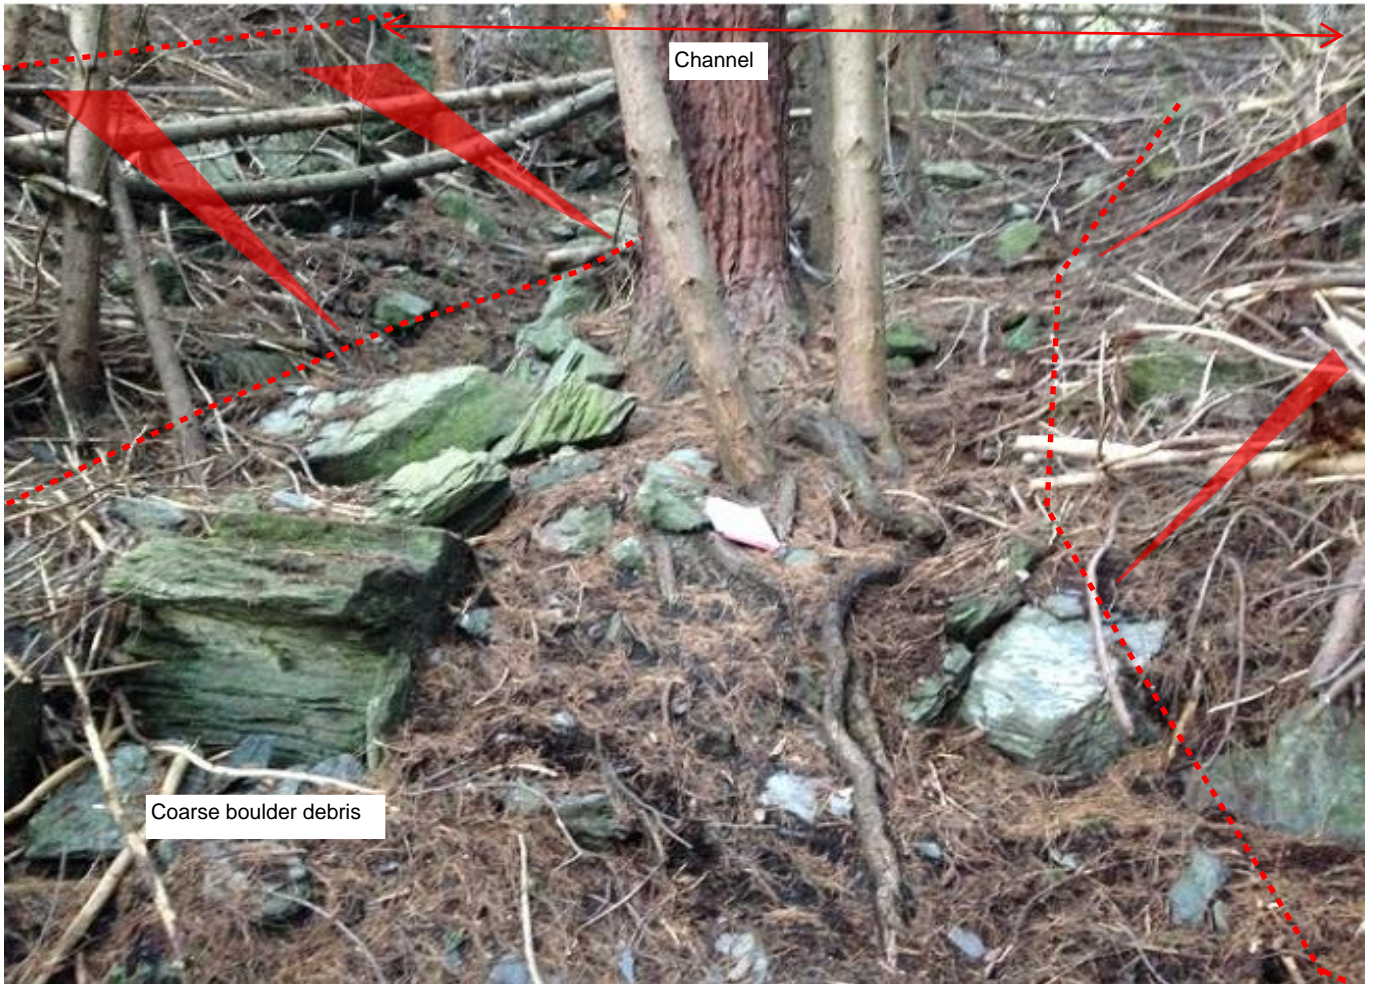
Wide channel, coarse
boulders, mature
trees, tree debris

Photograph 19a. Flow channel Section 16a.

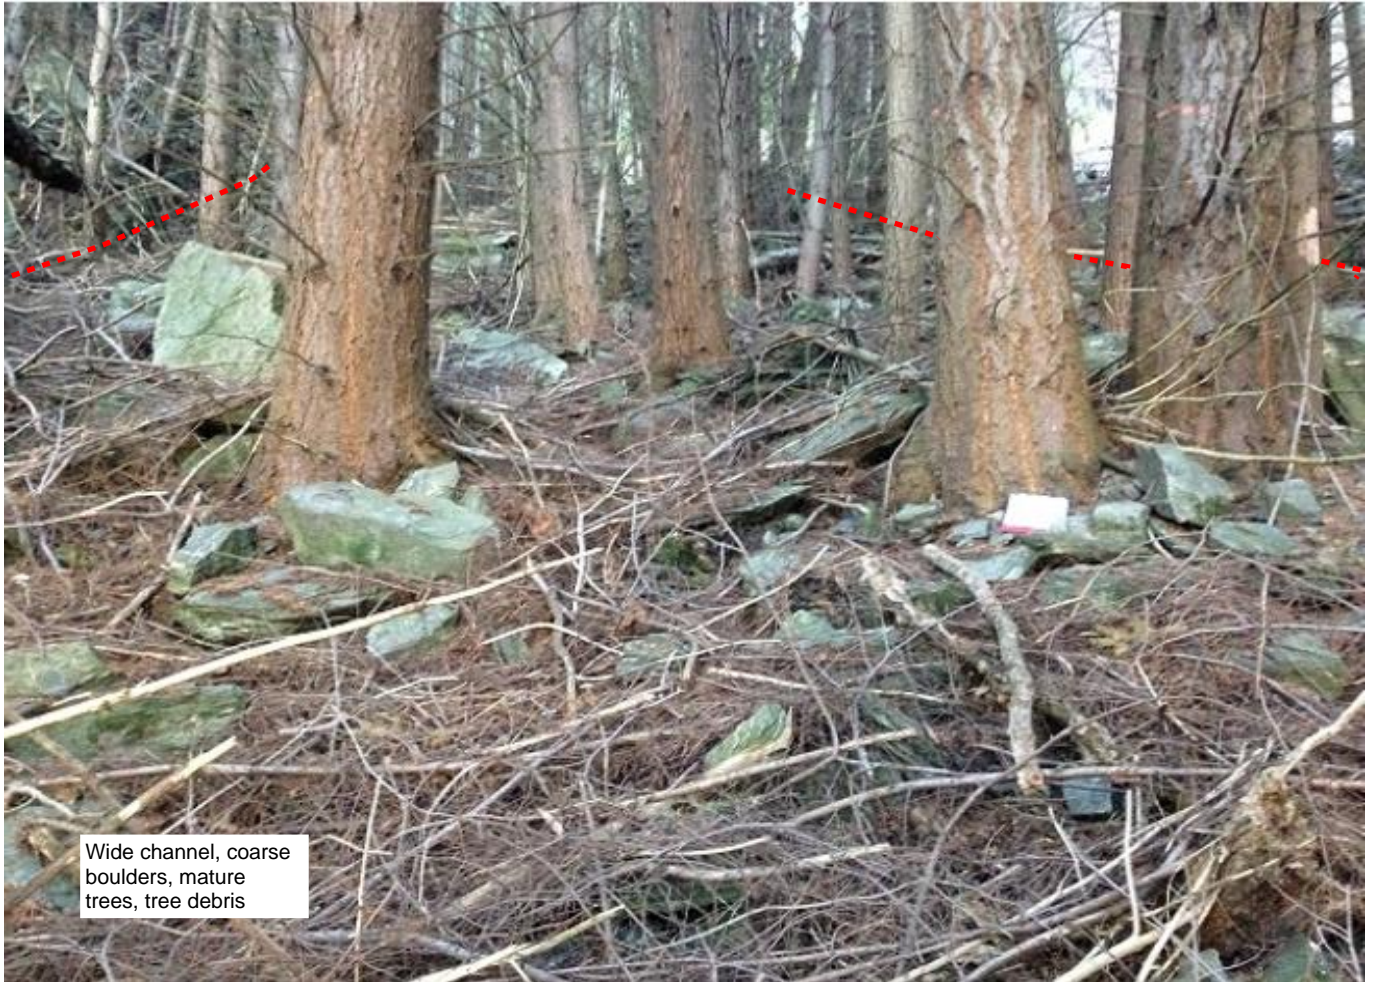
Photograph 20a. Area with no clear channel. Very rough, coarse boulder surface with dispersal and bifurcation of overland flows expected.

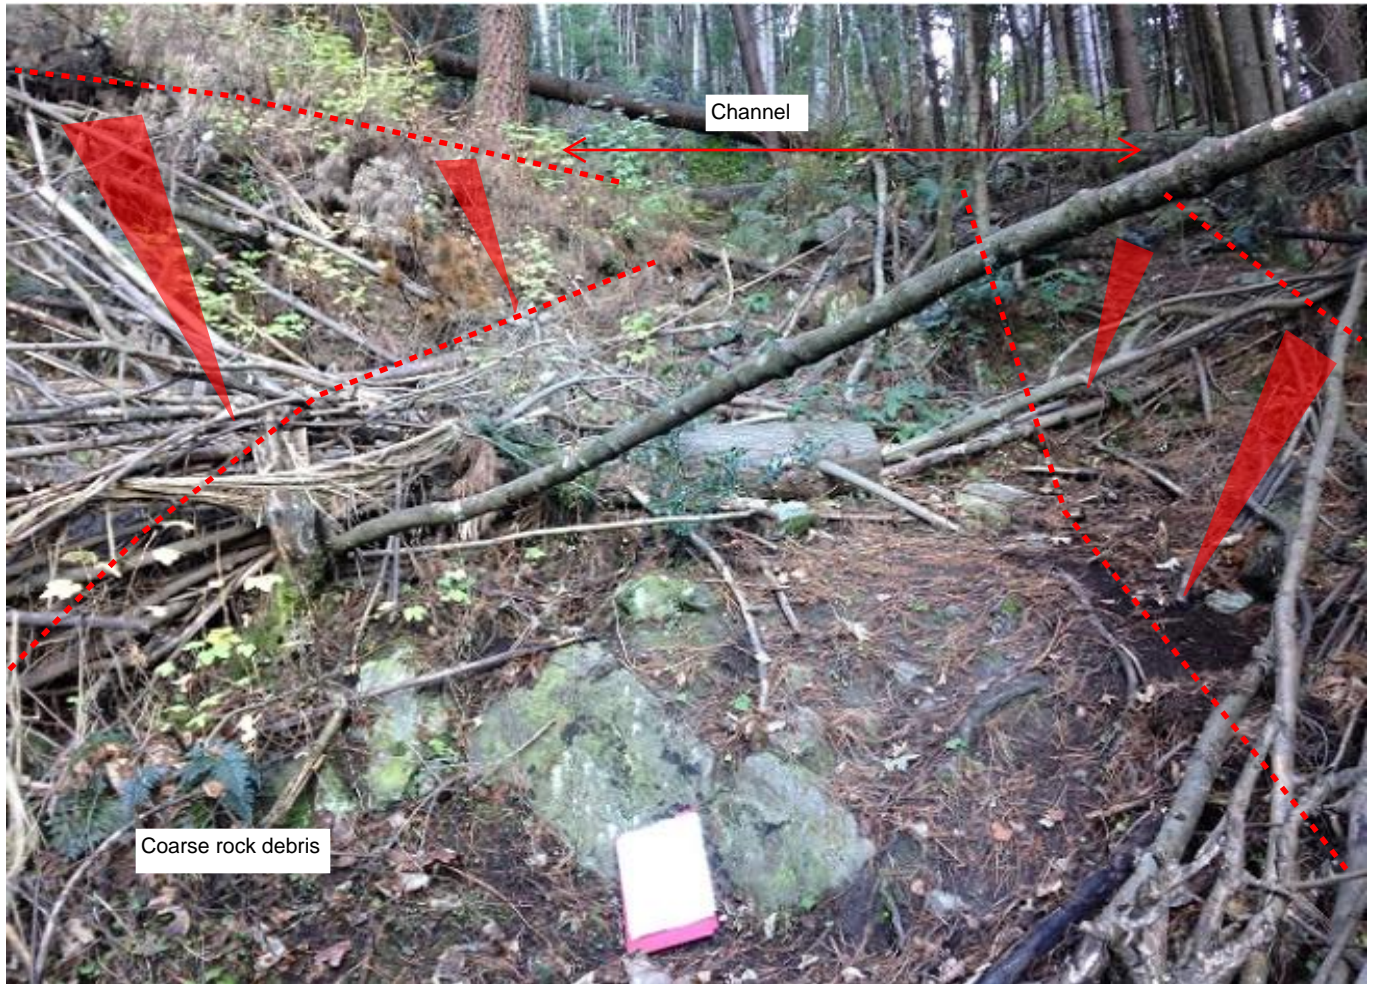
Photograph 23a. Base of the channel, slope toe area in Queenstown Cemetery

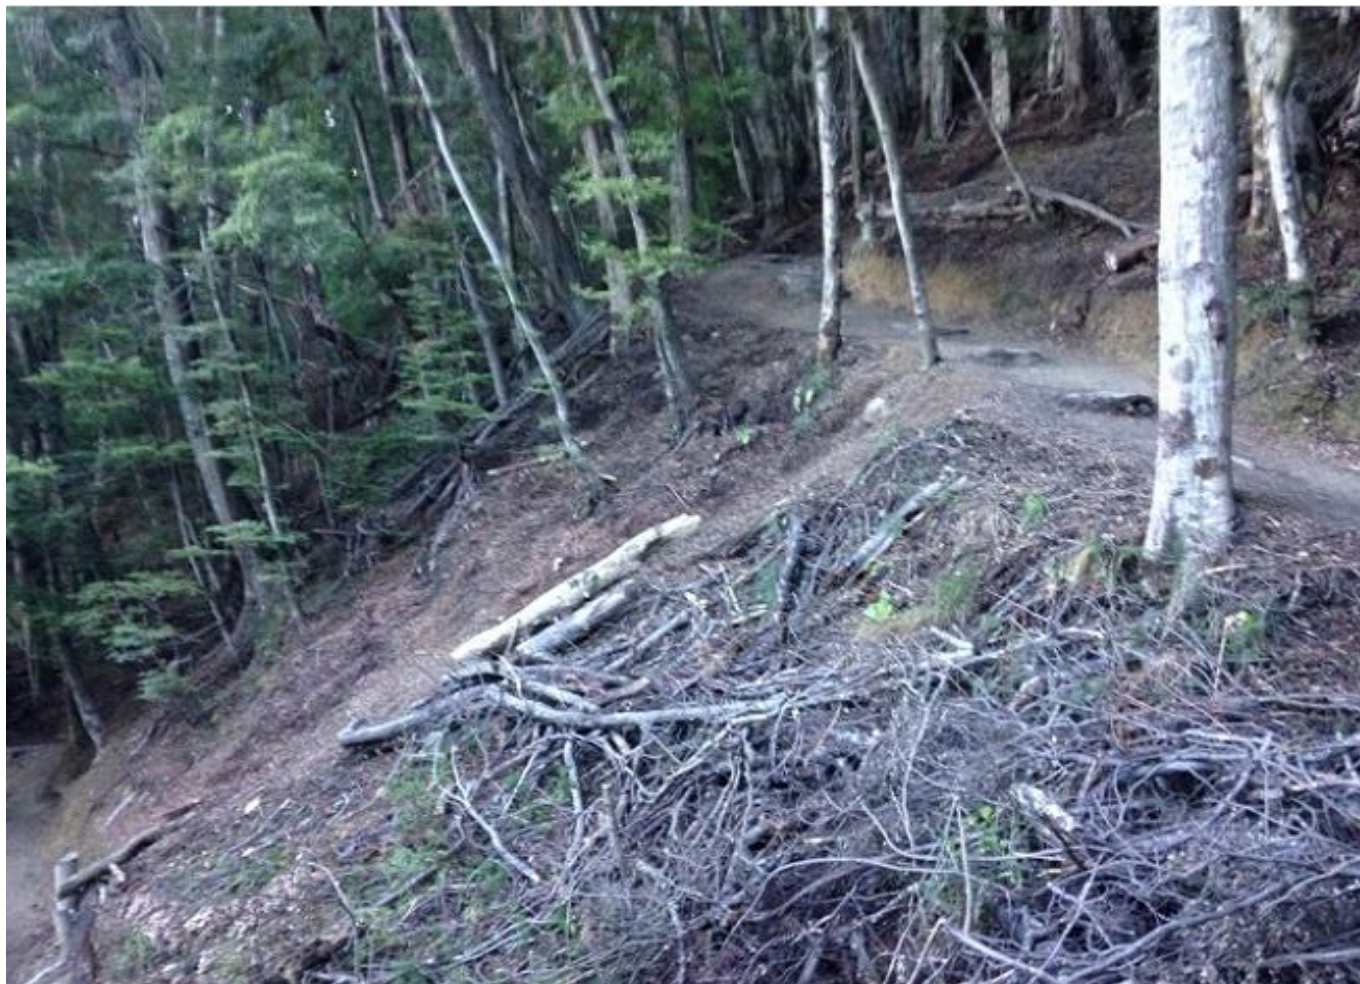
Photograph 25a. Large schist exposure typical of the landslide below DL1, southern areas. Consistent foliation orientation indicating translational movement of large schist blocks.

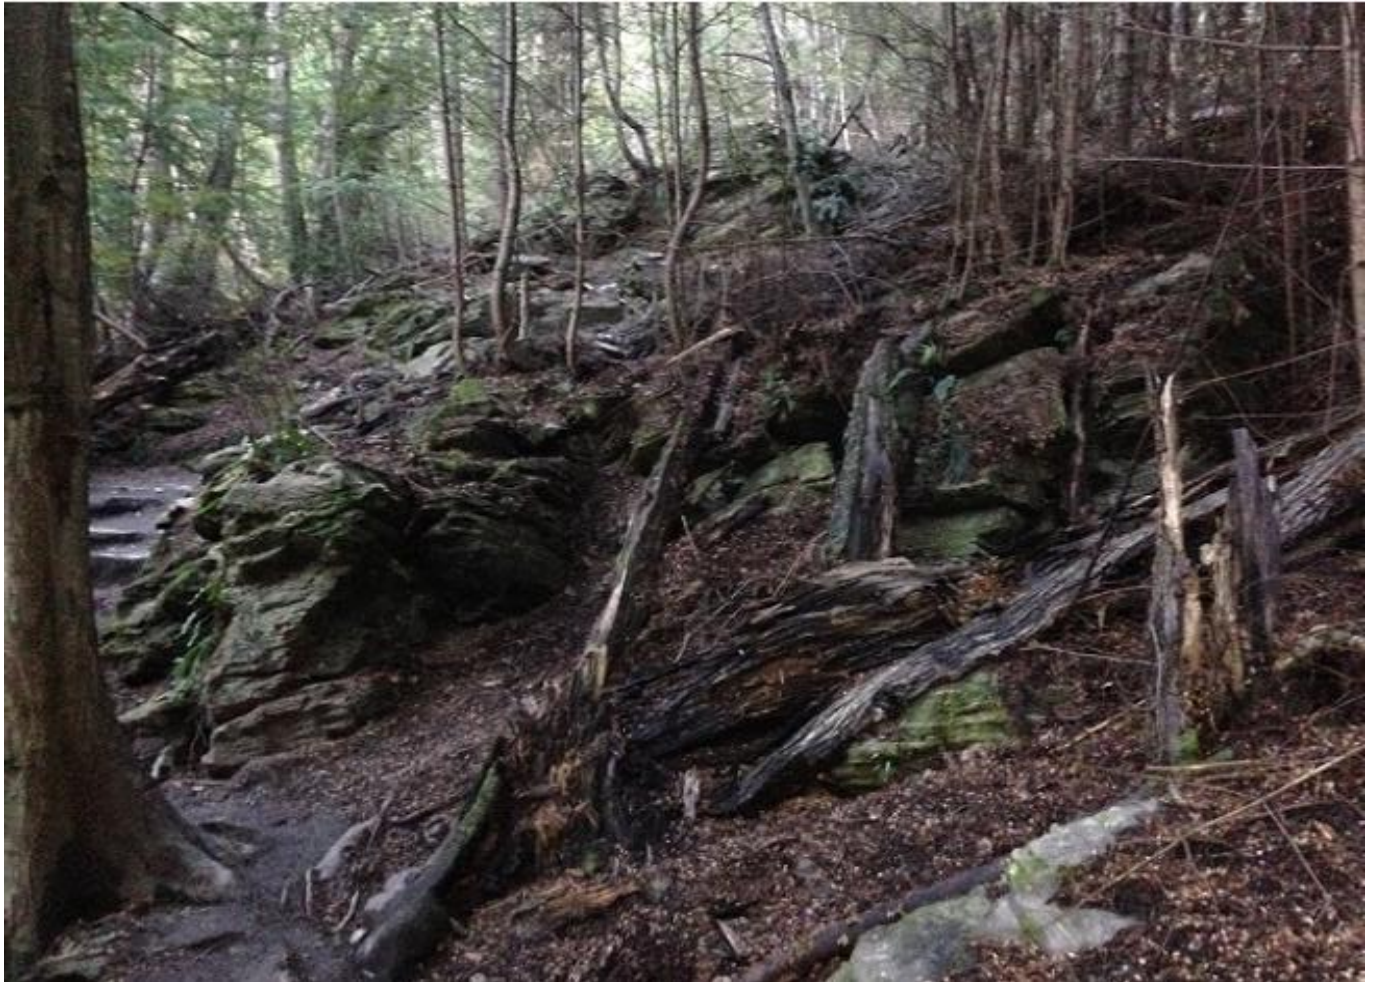
Photograph 26a. Debris behind trees a short distance below the skyline complex.

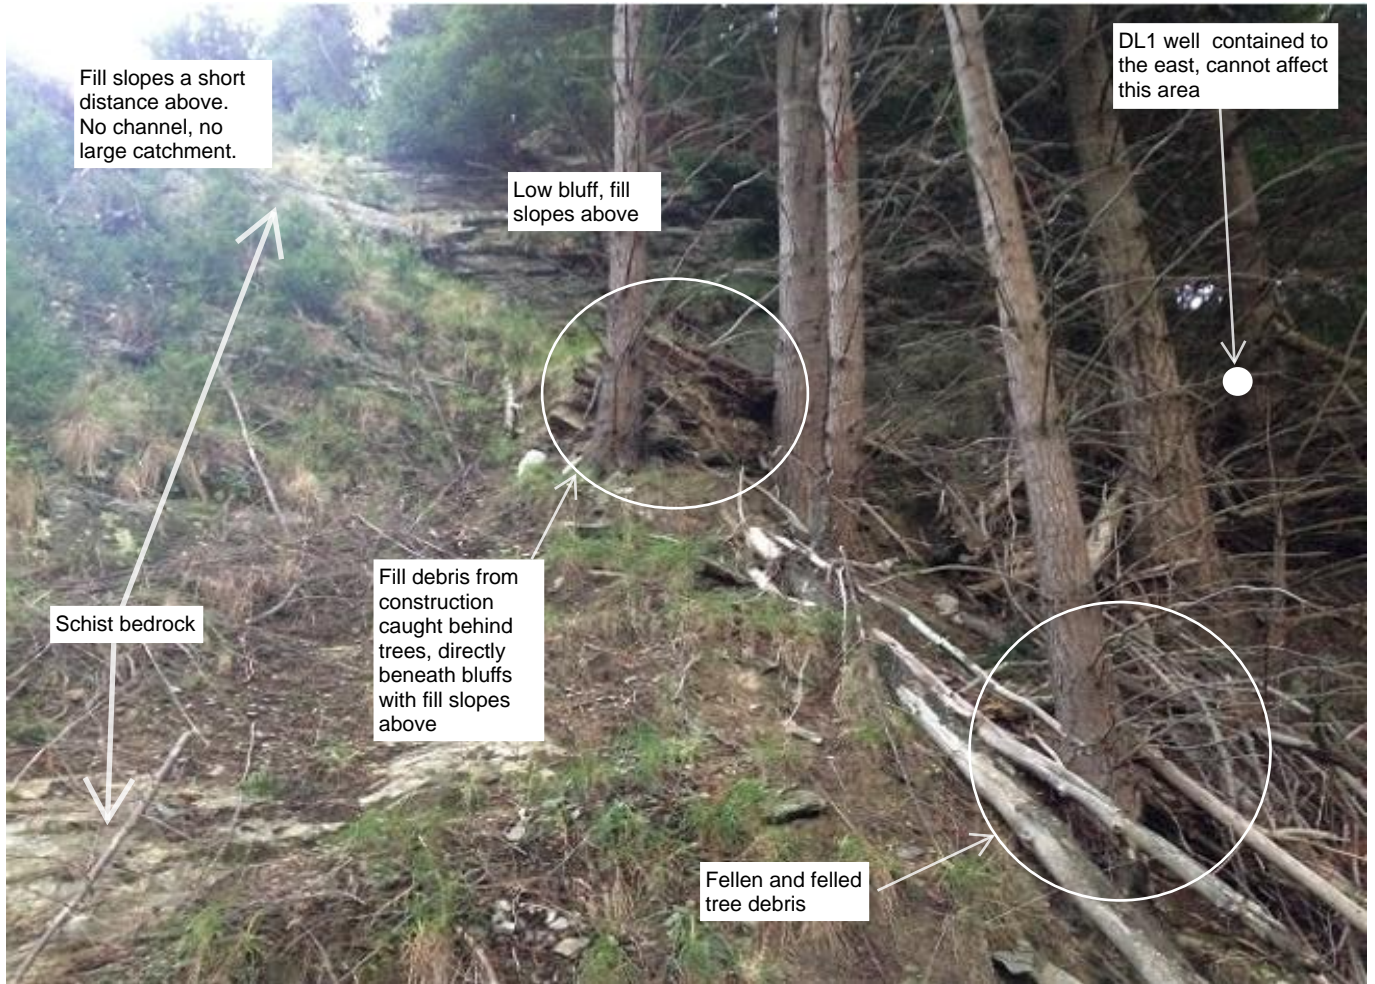
Photograph 27a. Soil and vegetation debris behind trees a short distance below the Skyline complex.

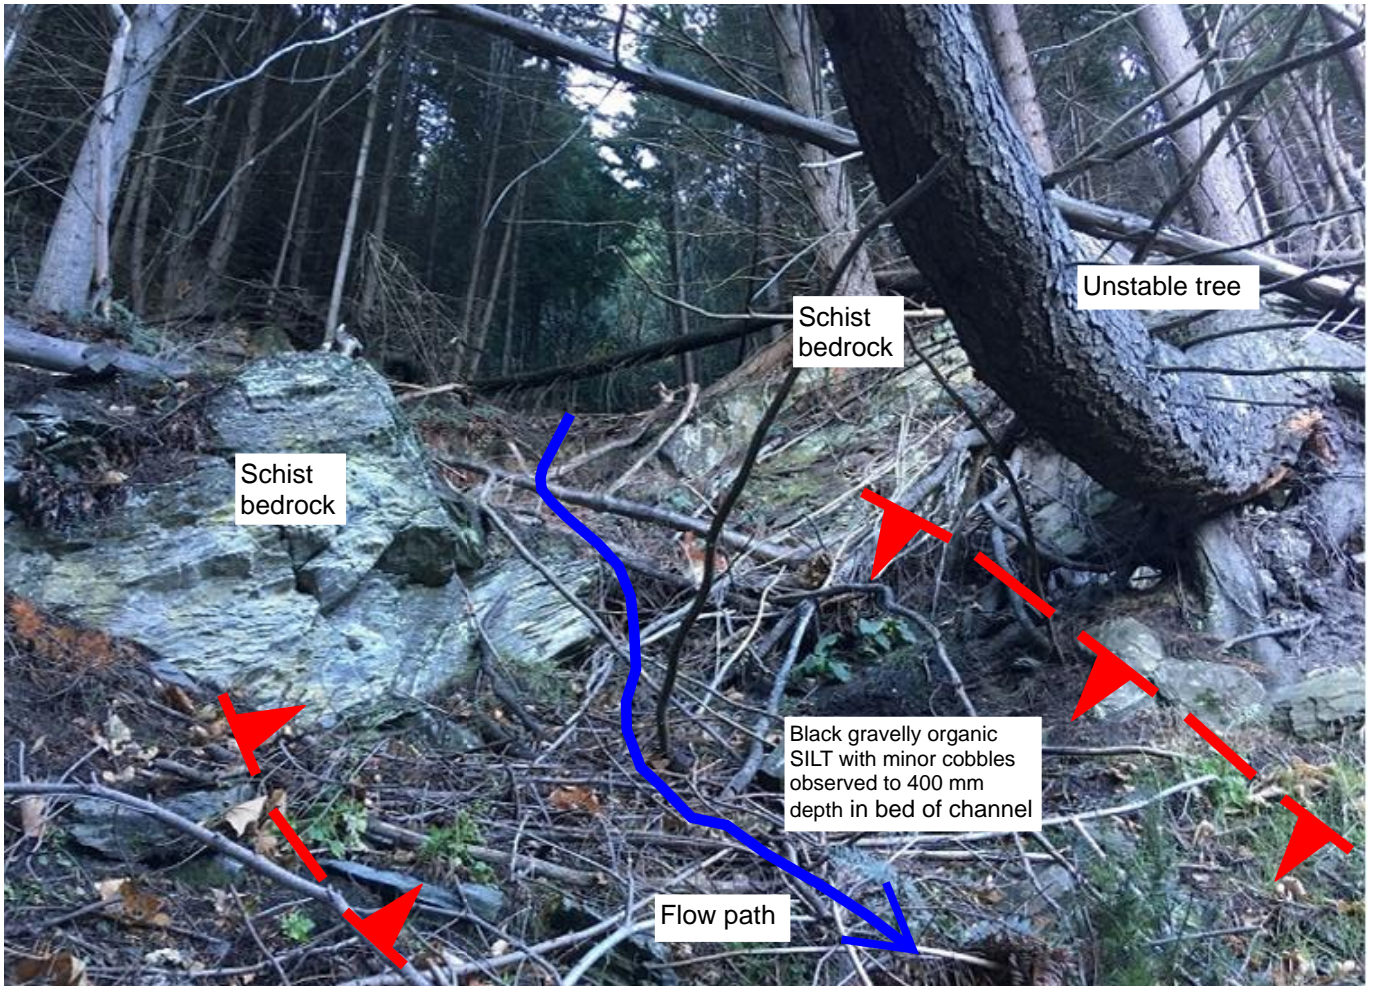
Photograph 9b. DL2 flow channel Section 9b.

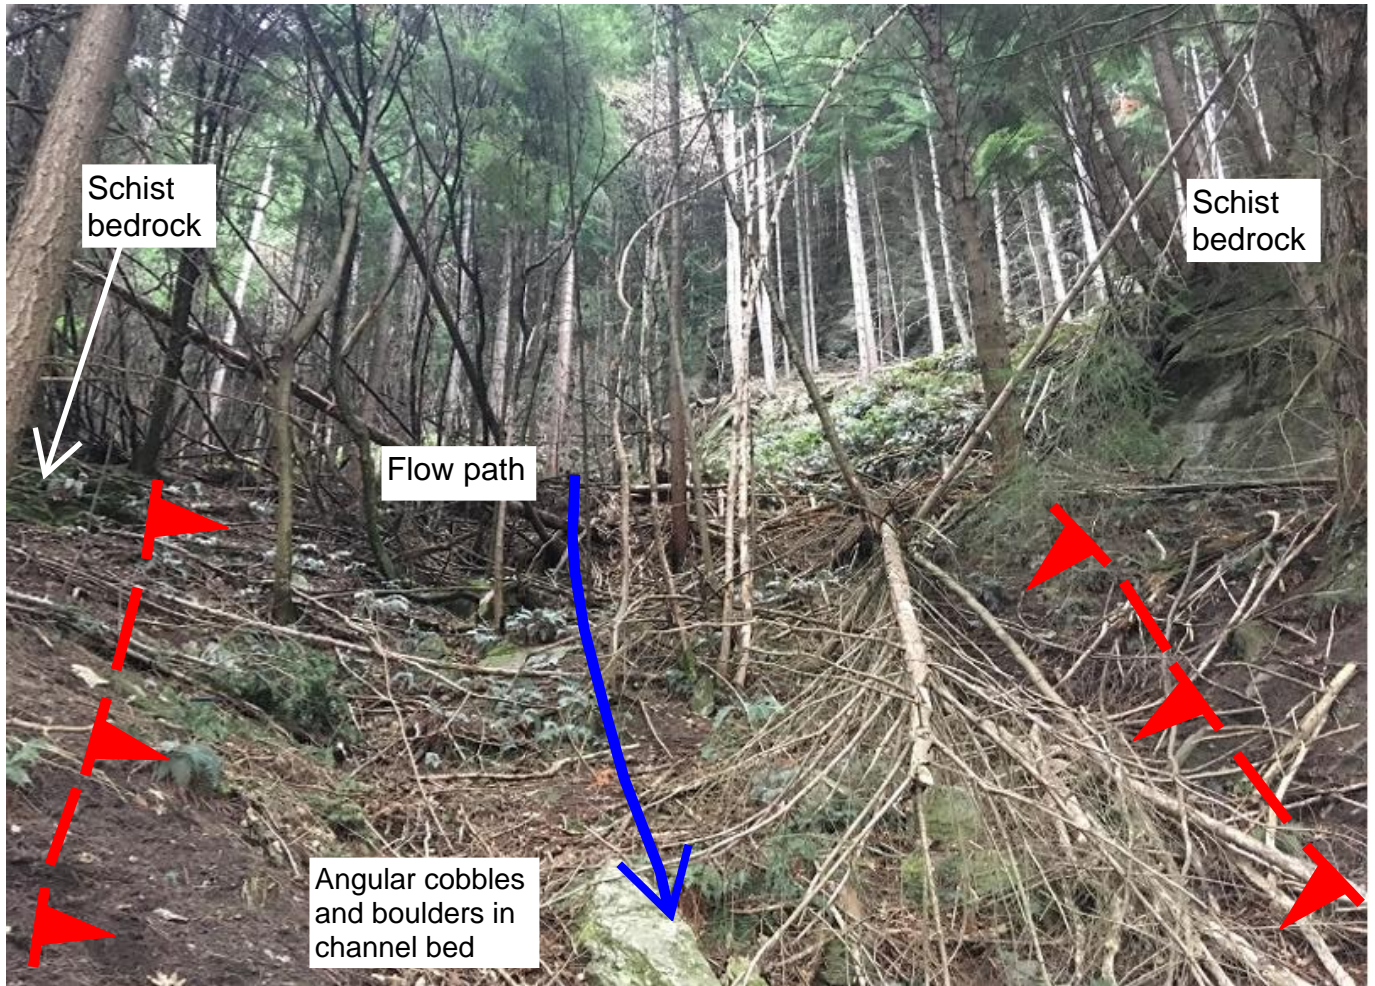
Photograph 13b. DL2 flow channel Section 13b.

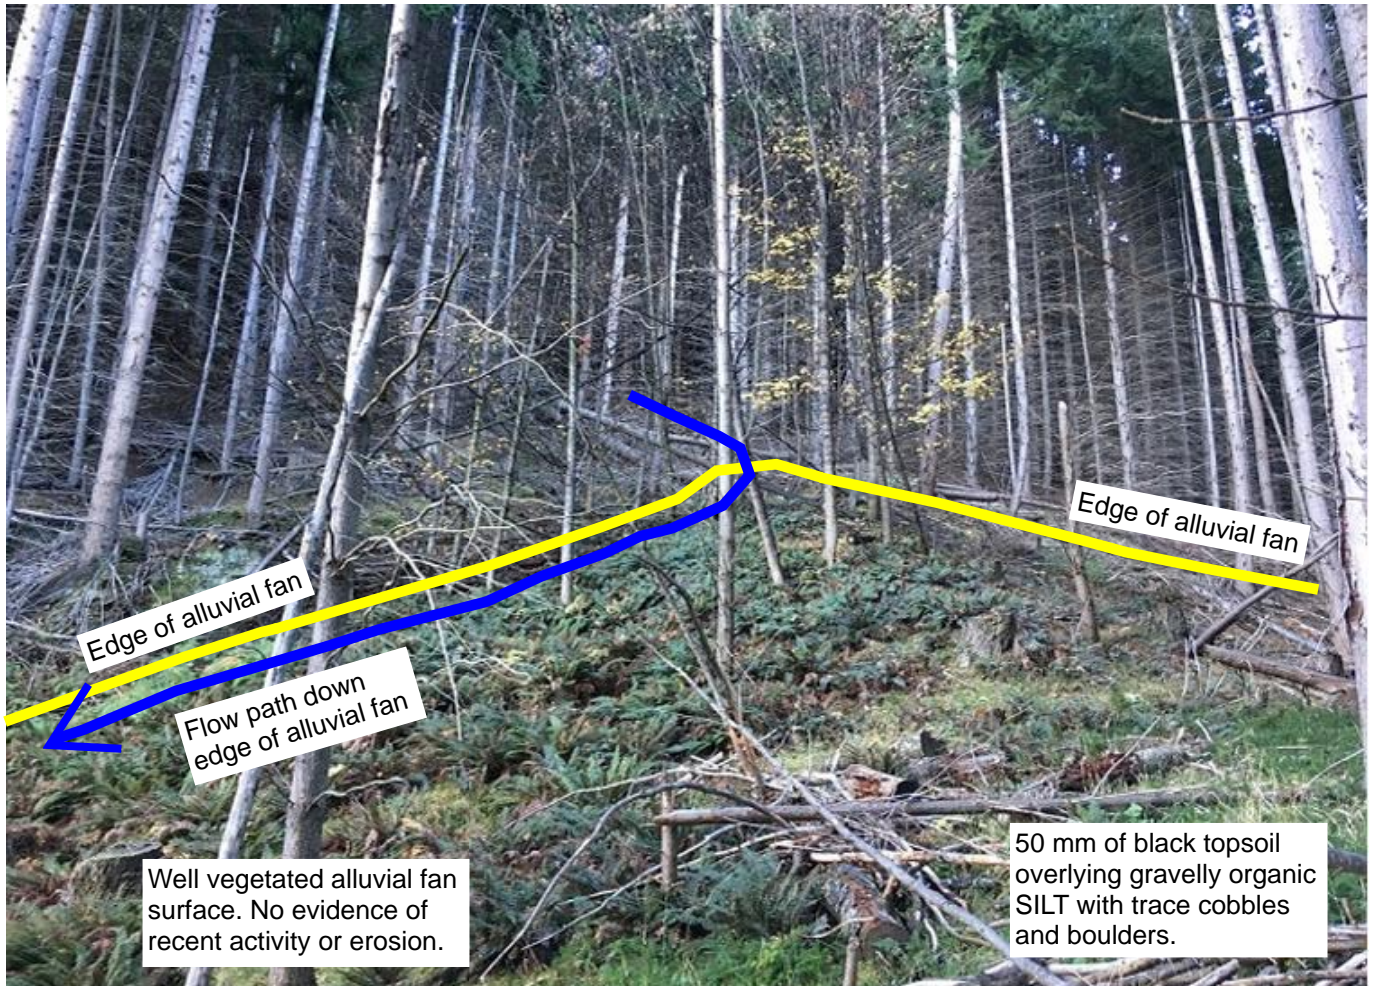
Edge of alluvial fan

Flow path down edge of alluvial fan

50 mm of black topsoil overlying gravelly organic SILT with trace cobbles and boulders.

Photograph 14b. DL2 map area general photograph. Alluvial fan at the base of a schist bluff on the northern edge of the DL2 map area. The entire fan surface is curved and lobate indicating possible historic debris flows. Stormwater discharge from Skyline will not be fed into this flow path nor does it have the potential to make it into this catchment area.
