Skyline Enterprises Ltd
 Skyline Upgrade
 Stormwater Discharge - Detailed Hazard Assessment
 Aerial Summary Plan

Skyline Enterprises Ltd
 Skyline Upgrade
 Stormwater Discharge - Detailed Hazard Assessment
 Geomorphology Summary Plan

Skyline Enterprises Ltd	
Skyline Upgrade	
Stormwater Discharge - Detailed Hazard Assessment	
Detailed Geomorphology below DL1, northern/upper zone	
FIG No:	Figure 1d
REV.	1

Skyline Enterprises Ltd	
Skyline Upgrade	
Stormwater Discharge - Detailed Hazard Assessment	
DL1 Southern Flow Path Longsection	
FIG No:	Figure 2a
REV.	1

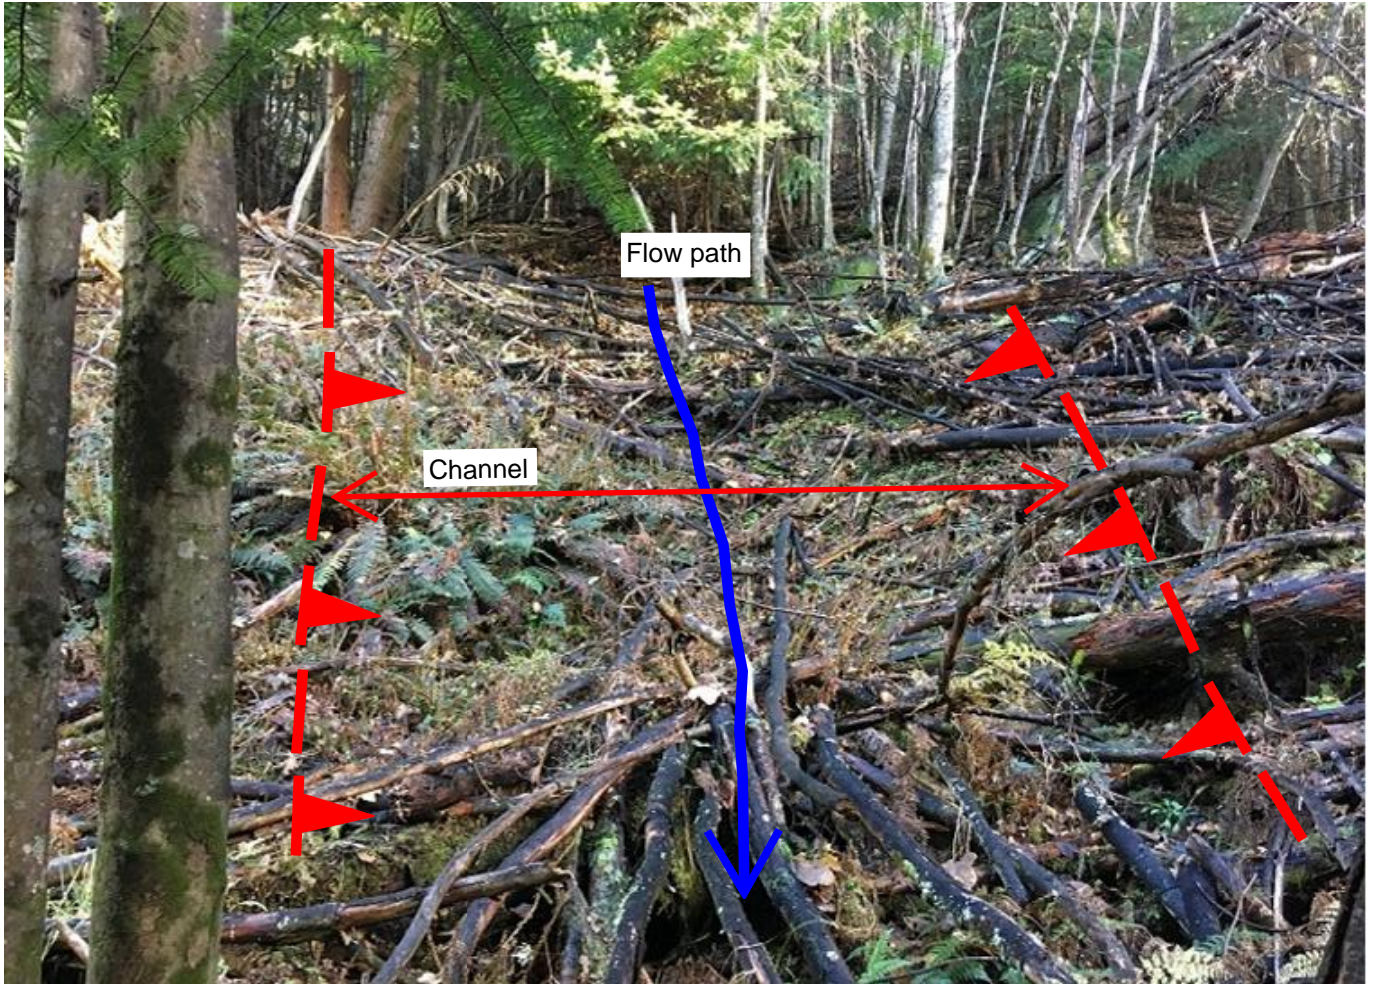
Photograph 15b. DL2 map area general photograph. Channel bed choked full of dead organic debris downslope of channel Section 4b.

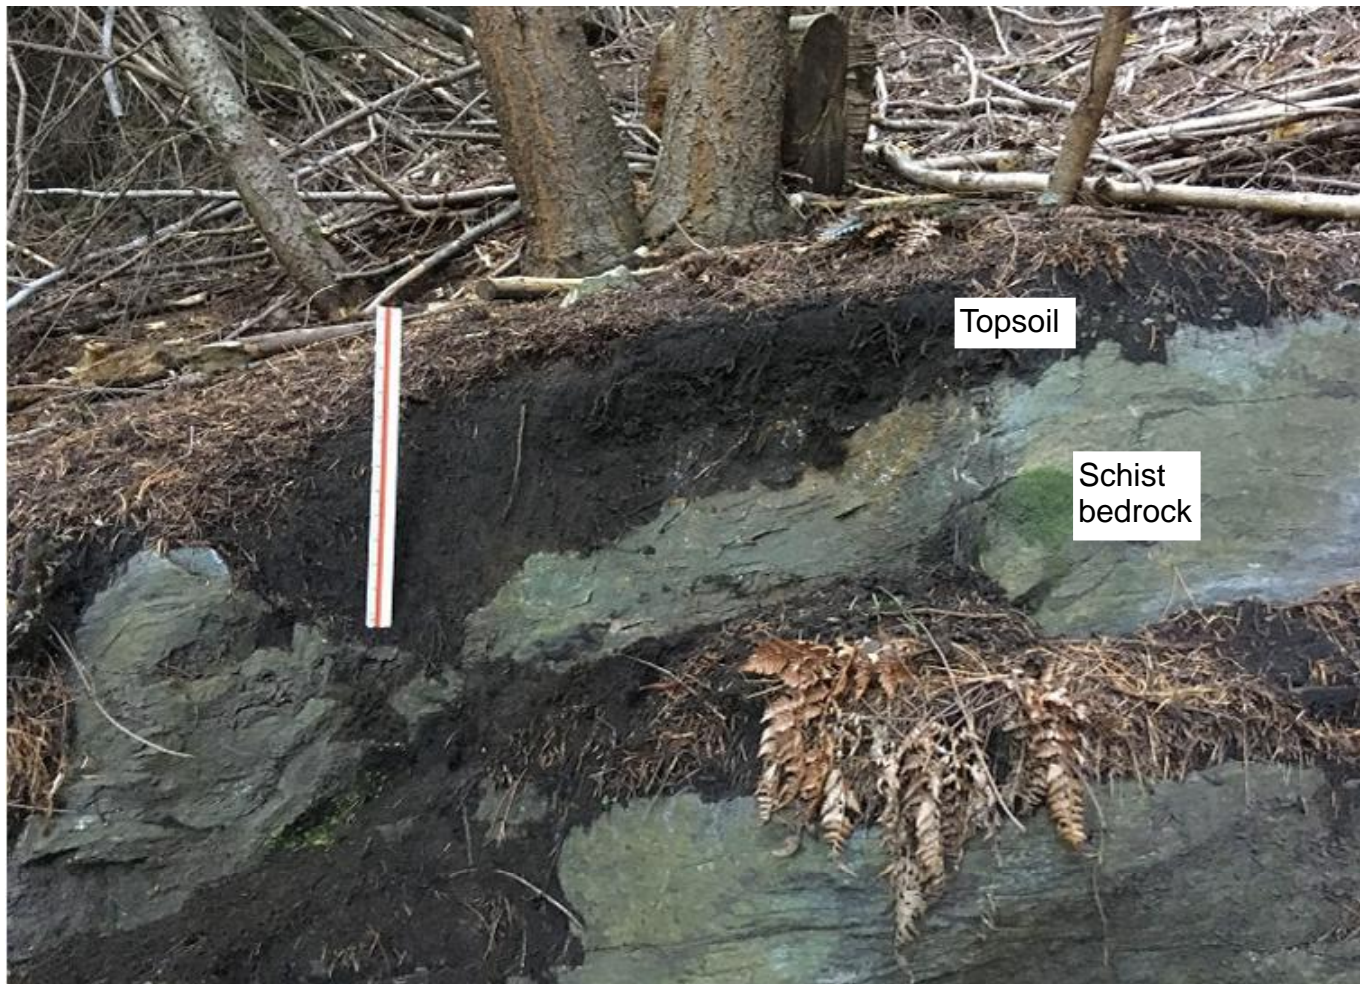
Topsoil

Schist
bedrock

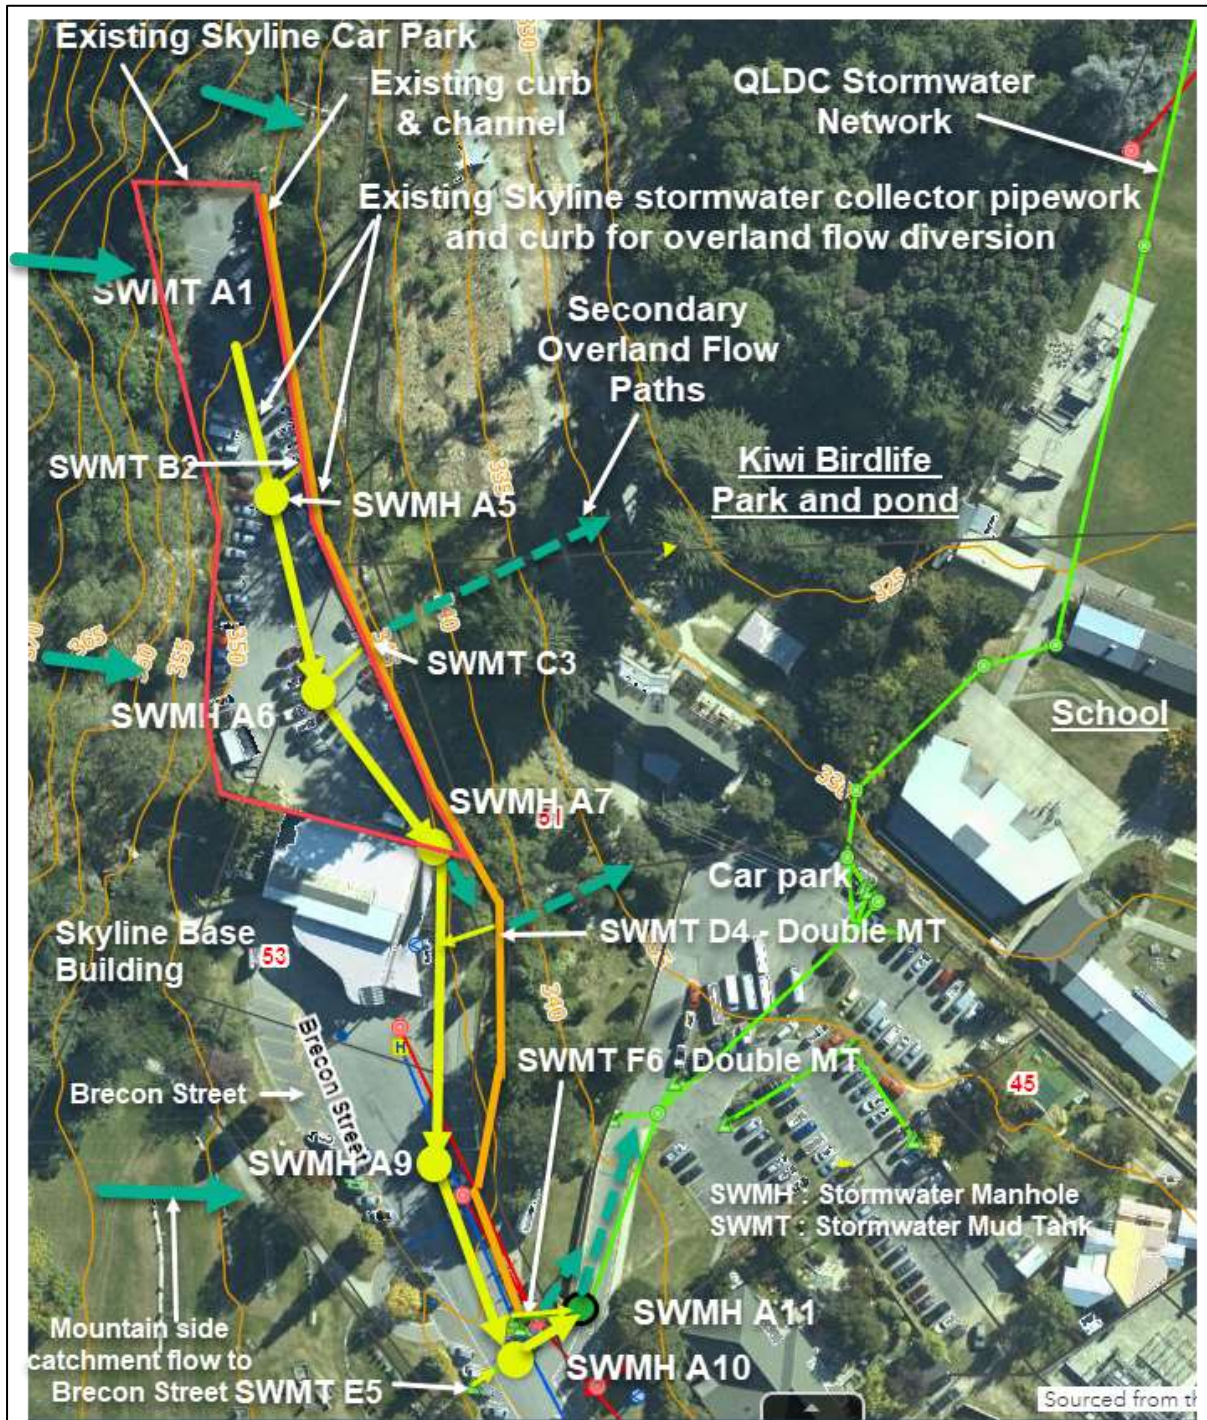
Figure 4.1: Existing Skyline / Brecon Street Stormwater Infrastructure Plan

As described above, the existing piped stormwater system collects stormwater from the existing Gondola Base building carpark and discharges it into the QLDC stormwater network in Brecon Street. Refer to Figure 4.1 below.

Note that stormwater manholes and mud tanks, as illustrated in Figure 4.1 below, are given the abbreviations SWMH and SWMT respectively with a reference, for example A10 is referenced as SWMH A10.

The existing Skyline carpark stormwater system was constructed between 2012 and 2014. The manhole positions, lid levels, and pipe invert levels in Brecon Street and through the school were resurveyed to check the as-built levels. The updated survey data has been used to estimate the capacity of the existing 300mm diameter (dia.) stormwater system to discharge from the car park building and bus park area to the stormwater network in Brecon Street.

The pre-development discharge capacity of the existing stormwater system upstream of SWMH A10 was estimated using a hydraulic model as well as a supplementary hand calculation check. It was found that when the stormwater pipe network upstream of SWMH A10 is operating at capacity it subsequently starts to overflow at SWMH A7 and SWMT D4 and results in overland flows into the KBP.
