Memorandum

To	Ben Greenwood
Copy	Rob Bond
From	Paul Jaquin
Office	Queenstown
Date	23 January 2020
File	
Subject	Meads Road

Damage has occurred to Meads Road around the 17th December 2019, to east of the Bee Burn stream and alluvial fan, below Peak AA9B, and to the west of the Terrace Stream Fan.

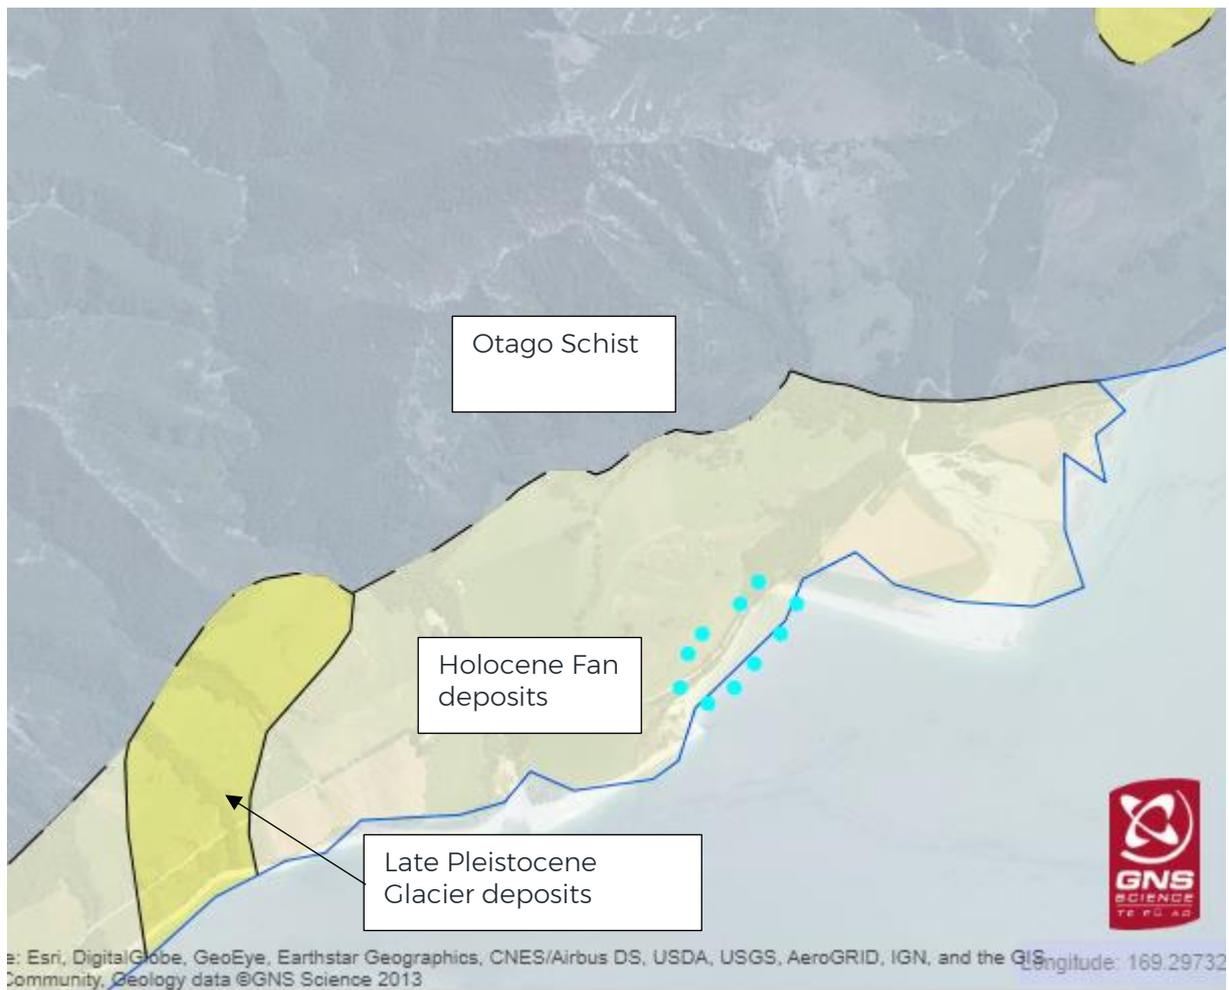
Figure 2 Site Geology. GNS Webmaps

The site is underlain by Otago schist, and Meads road in this area runs along a large Holocene river fan deposits from the areas of the Bee Burn, which comprise angular mixed boulder, gravels, sands and silts. Peak AA9B is considered to be a harder schist outcrop, which has been filled around by the Holocene Fan Deposits. The road cutting and the slope of Peak AA9B in this area are consistent with this expected geology, comprising angular gravels in a sandy silty matrix. Figure 2

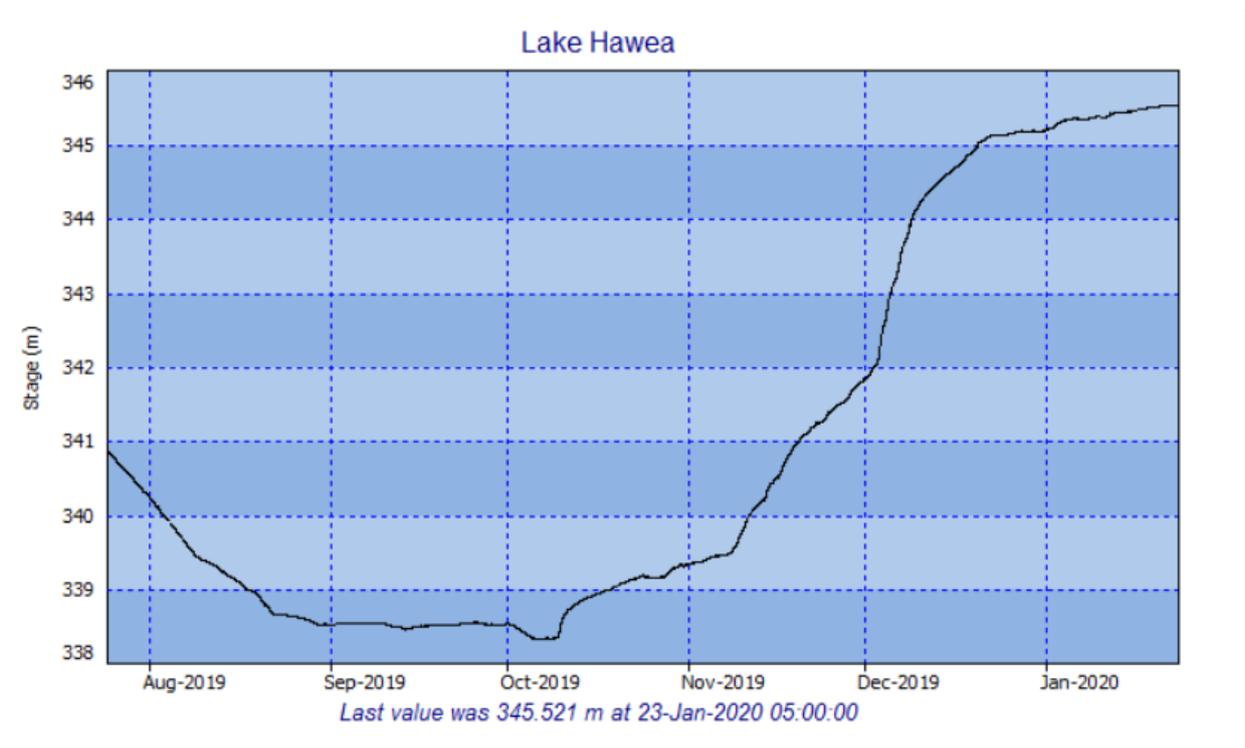
Figure 3 Lake Hawea Lake levels

At the time of the slips, then lake levels was around 345.2m, increased from 338.5m in October 2019, (an increase of 6.7m).

The cause of the slip is considered to be a reduction of the strength of the material and increase in mass at the base of the slope, caused by increased saturation as a result of the increase in lake level.

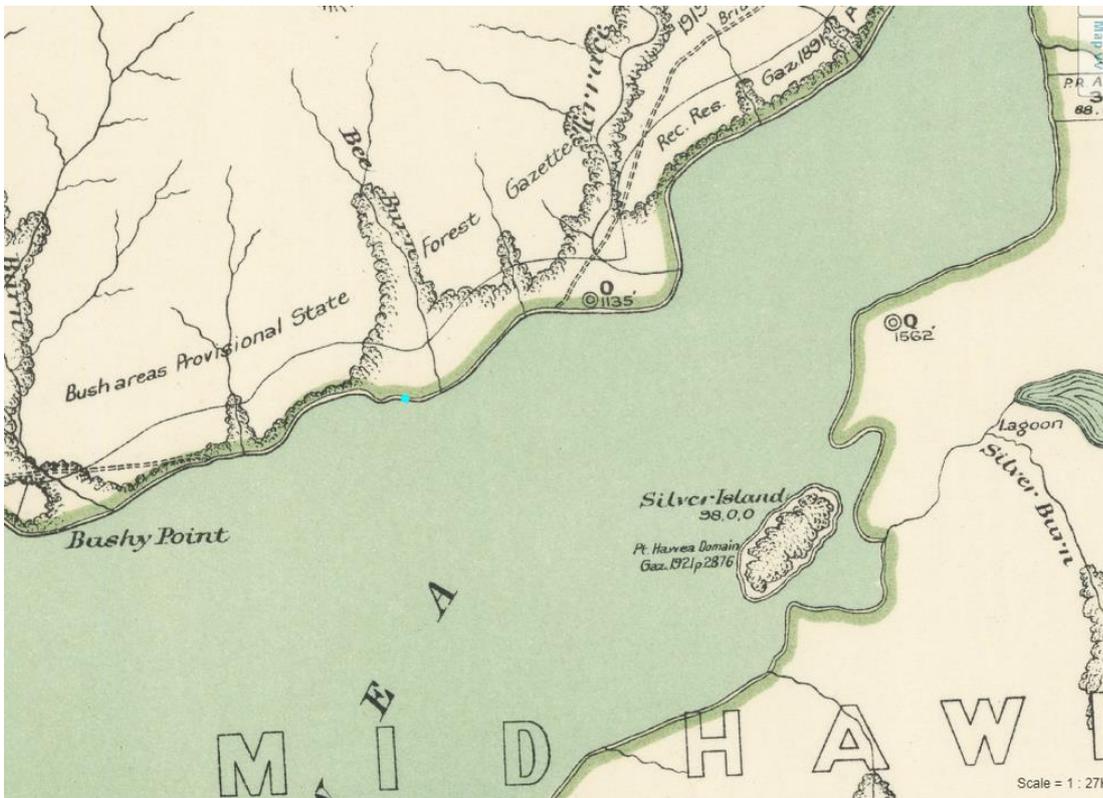
Figure 5 Historic mapping 1923, showing the site. The road shown to only extent to Kidds Bush campsite.

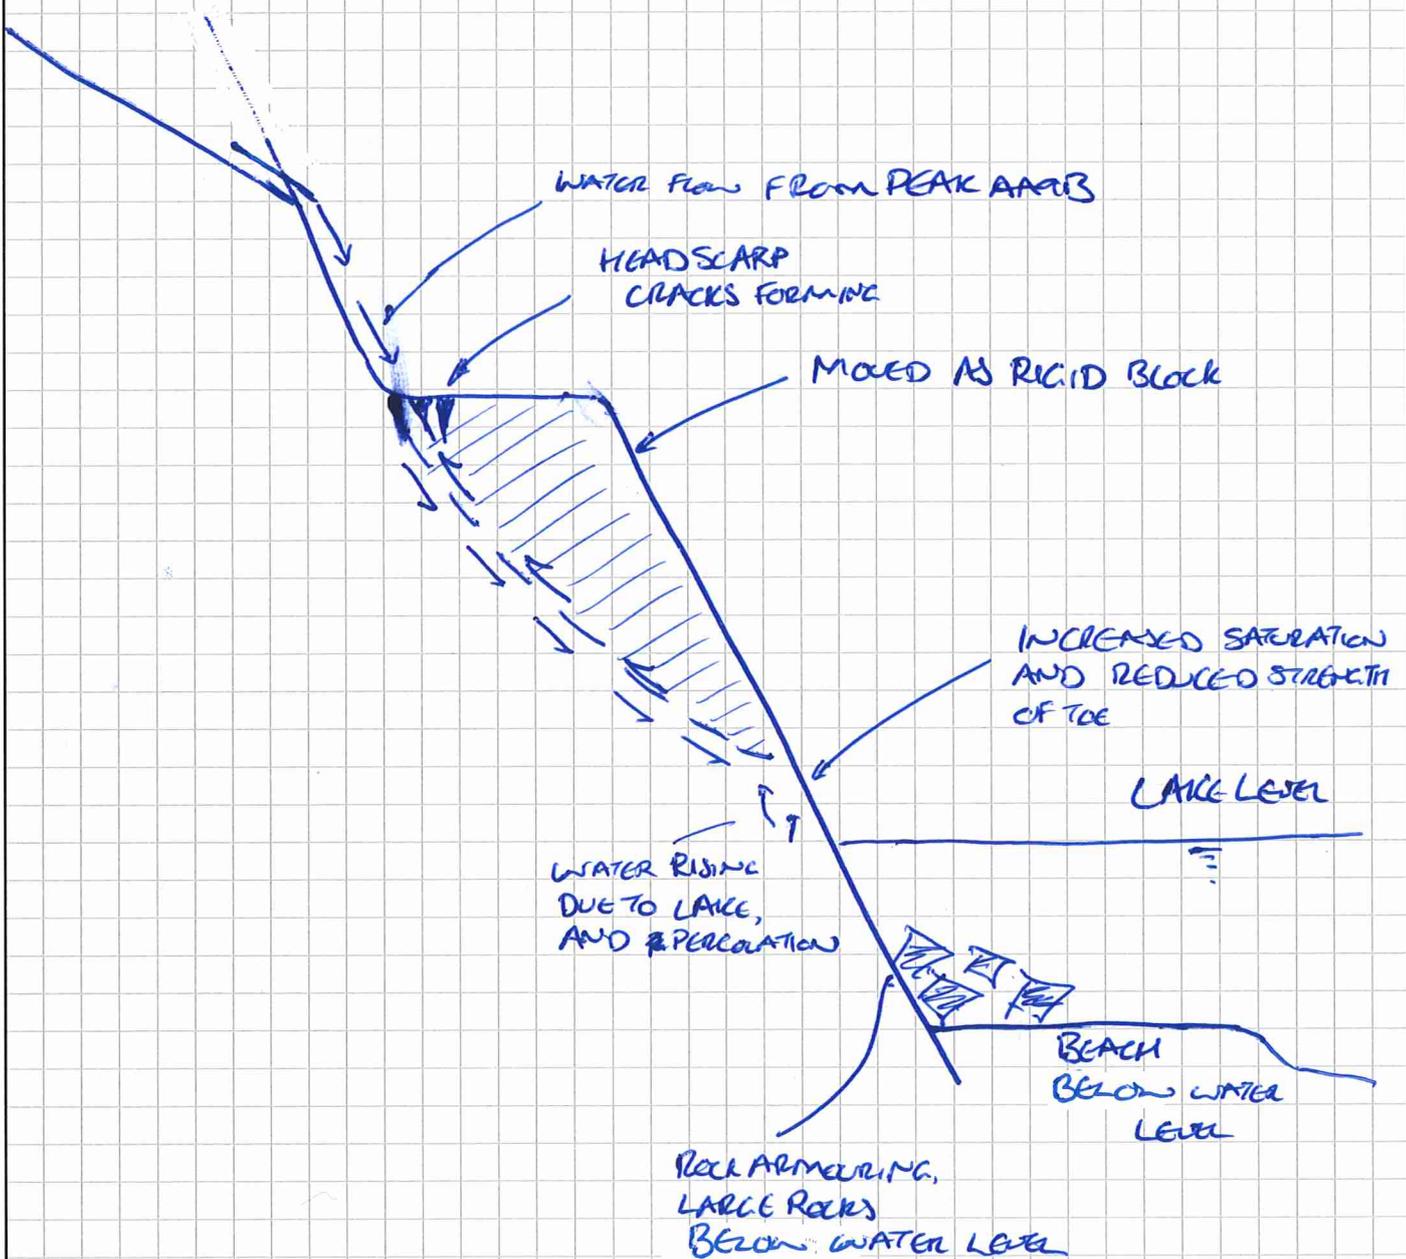
Situation

The cracking appears to be in the form of a slip circle headscarp, with the cracking across the whole width of the road, and some movement into the up slope area.

The slip appears to be a deep seated rotational failure through the Holocene Fan deposits. A number of slip surfaces may have formed, meaning a rigid scallop shaped block of soil has rotated. This has manifested itself as a series of headscarp cracks at road level.
