**BEFORE THE INDEPENDENT HEARING PANEL APPOINTED BY THE
QUEENSTOWN LAKES DISTRICT COUNCIL**

UNDER the Resource Management Act 1991 (RMA)
IN THE MATTER of the Te Pūtahi Ladies Mile Plan Variation in accordance
with section 80B and 80C, and Part 5 of Schedule 1 of the
Resource Management Act 1991.

**STATEMENT OF EVIDENCE OF SIMON DAVID BEARDMORE
29 September 2023**

Attachment 1: Identified HAIL Areas within the TPLM Zone

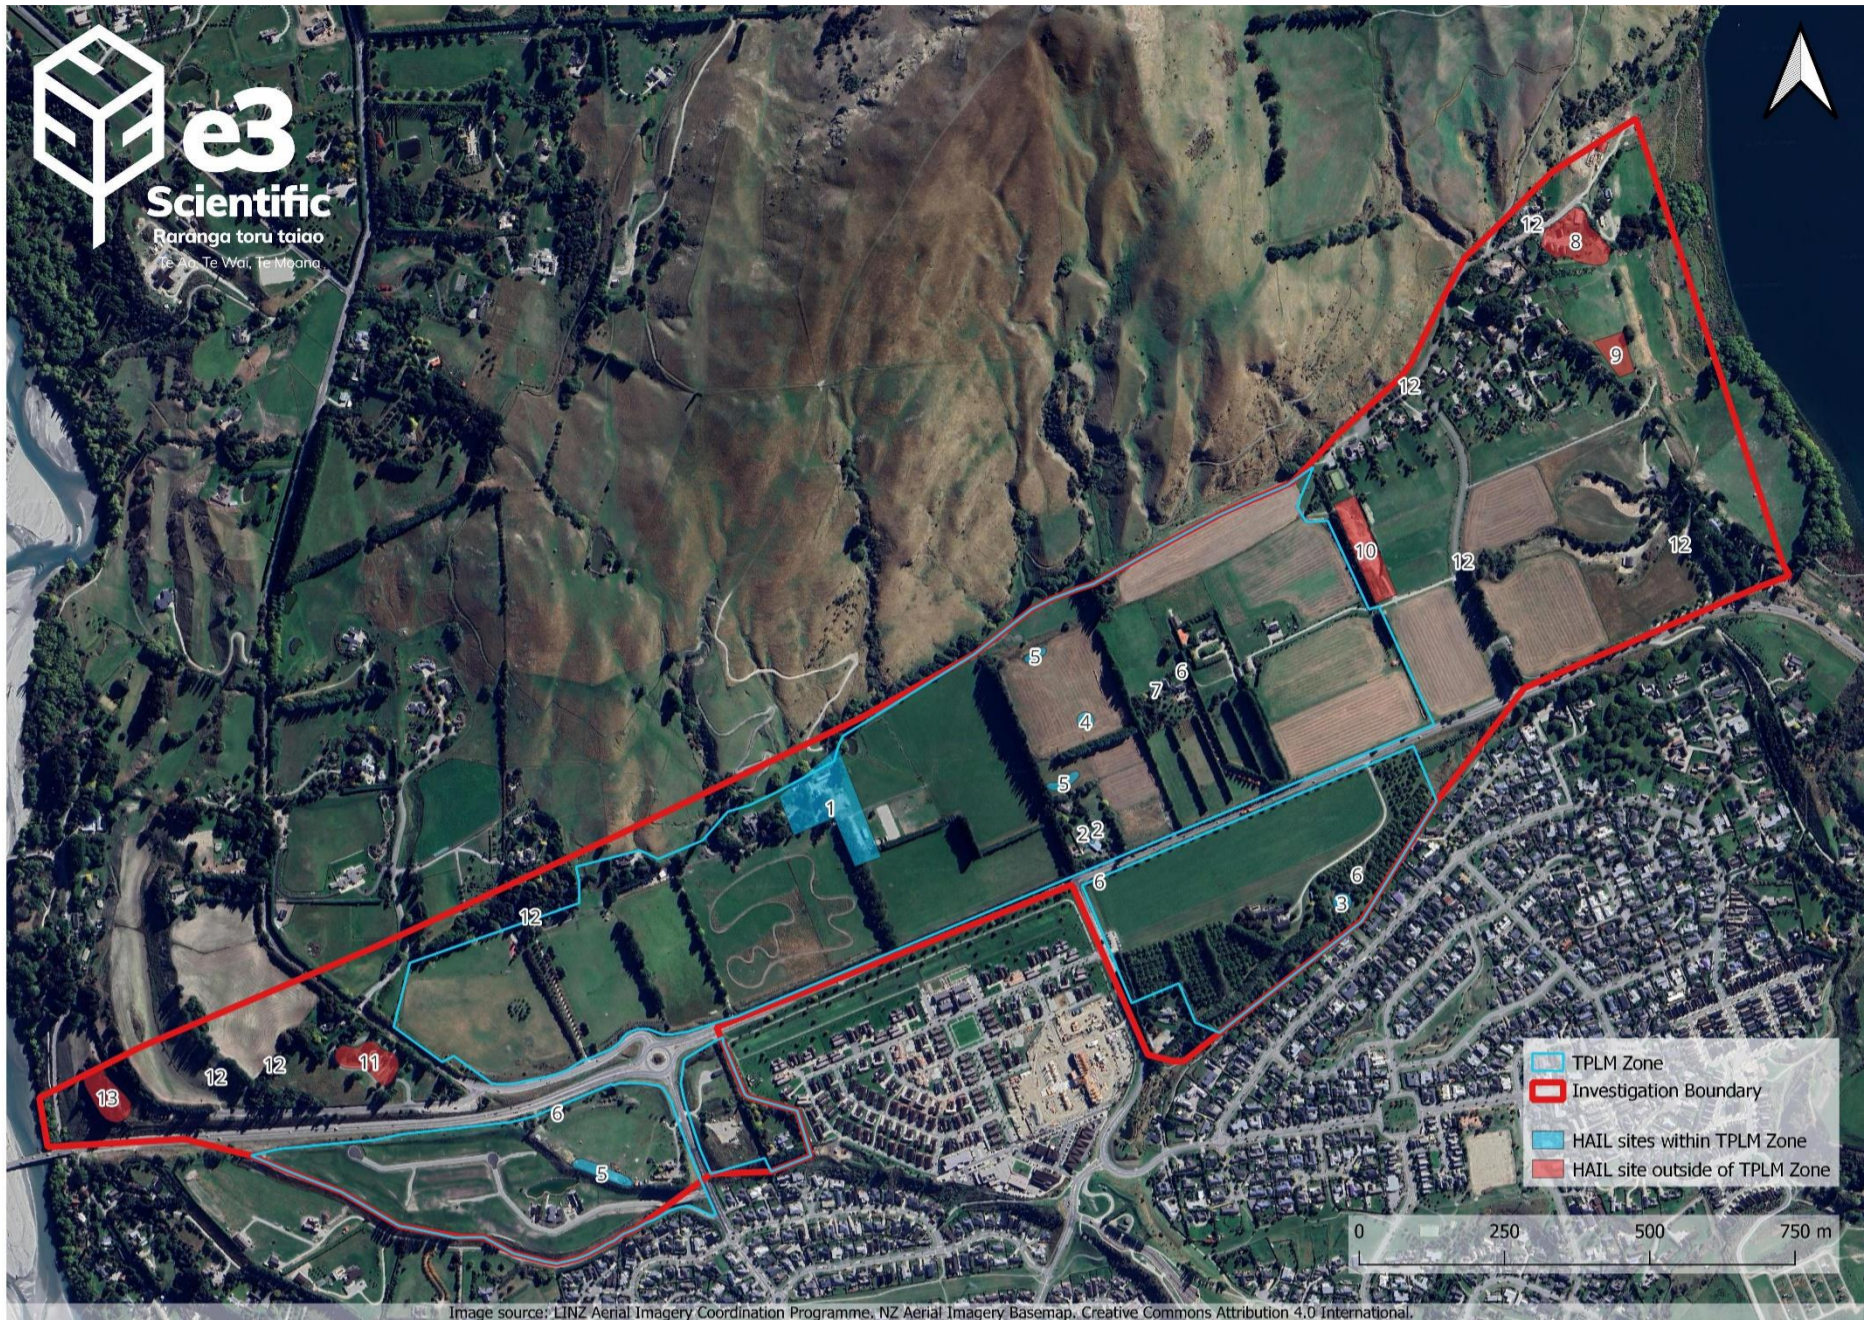
Identified HAIL Sites inside the TPLM Zone		
1	Glenpanel farm hub	A8. Livestock dip or spray race operations
2	Ladies Mile Pet Lodge	A17. Storage tanks or drums for fuel, chemicals or liquid waste
3	Chestnut Farm	A17. Storage tanks or drums for fuel, chemicals or liquid waste
4	Farm Landfill	G3. Landfill sites
5	Uncontrolled Fill	G3. Landfill sites
6	Transformers	B2. Electrical transformers
7	Small Scale Fuel Storage	A17. Storage tanks or drums for fuel, chemicals or liquid waste
Identified HAIL Sites outside the TPLM Zone		
8	Historic Threepwood Farm Hub	A8. Livestock dip or spray race operations
9	Threepwood Encapsulation Cell	G3. Landfill sites
10	Current Threepwood Farm Hub	A6. Fertiliser manufacture or bulk storage A17. Storage tanks or drums for fuel, chemicals or liquid waste F4. Motor vehicle workshops
11	Lower Shotover Cemetery	G1. Cemeteries
12	Transformers (Outside of TPLM Zone)	B2. Electrical transformers

13	Uncontrolled Fill	G3. Landfill sites

- 13 While the investigation for the PSI Report involved an assessment of the Ladies Mile study area (shown in Attachment 1), the notified TPLM Zone area is only a subset of the study area. Accordingly, my evidence only addresses the findings of the PSI Report that relate to the TPLM Zone.

- 14 The PSI identified 13 discrete pieces of land in the TPLM Zone where it is considered more likely than not that activities described in the HAIL have taken place, and therefore potential soil contamination may be present (see Attachment 1).

- 23 Of the identified activities, Glen Panel Farm sheep dip and the farm landfill on Pt Sec 46 Blk III Shotover SD have the greatest likelihood of causing soil contamination (shown as HAIL sites number 1 and 4 respectively in Attachment 1).
