**STATEMENT OF EVIDENCE OF PAUL GEORGE FAULKNER ON BEHALF OF  
REMARKABLES PARK LIMITED AND QUEENSTOWN PARK LIMITED**

**(GEOTECHNICAL/ENGINEERING GEOLOGY)**

**STREAM 13 REZONING HEARINGS**

Queenstown Park Limited  
Stream 13 Rezoning Hearings  
Natural Hazard Summary Plan - Proposed Gondola Corridor  
River Section

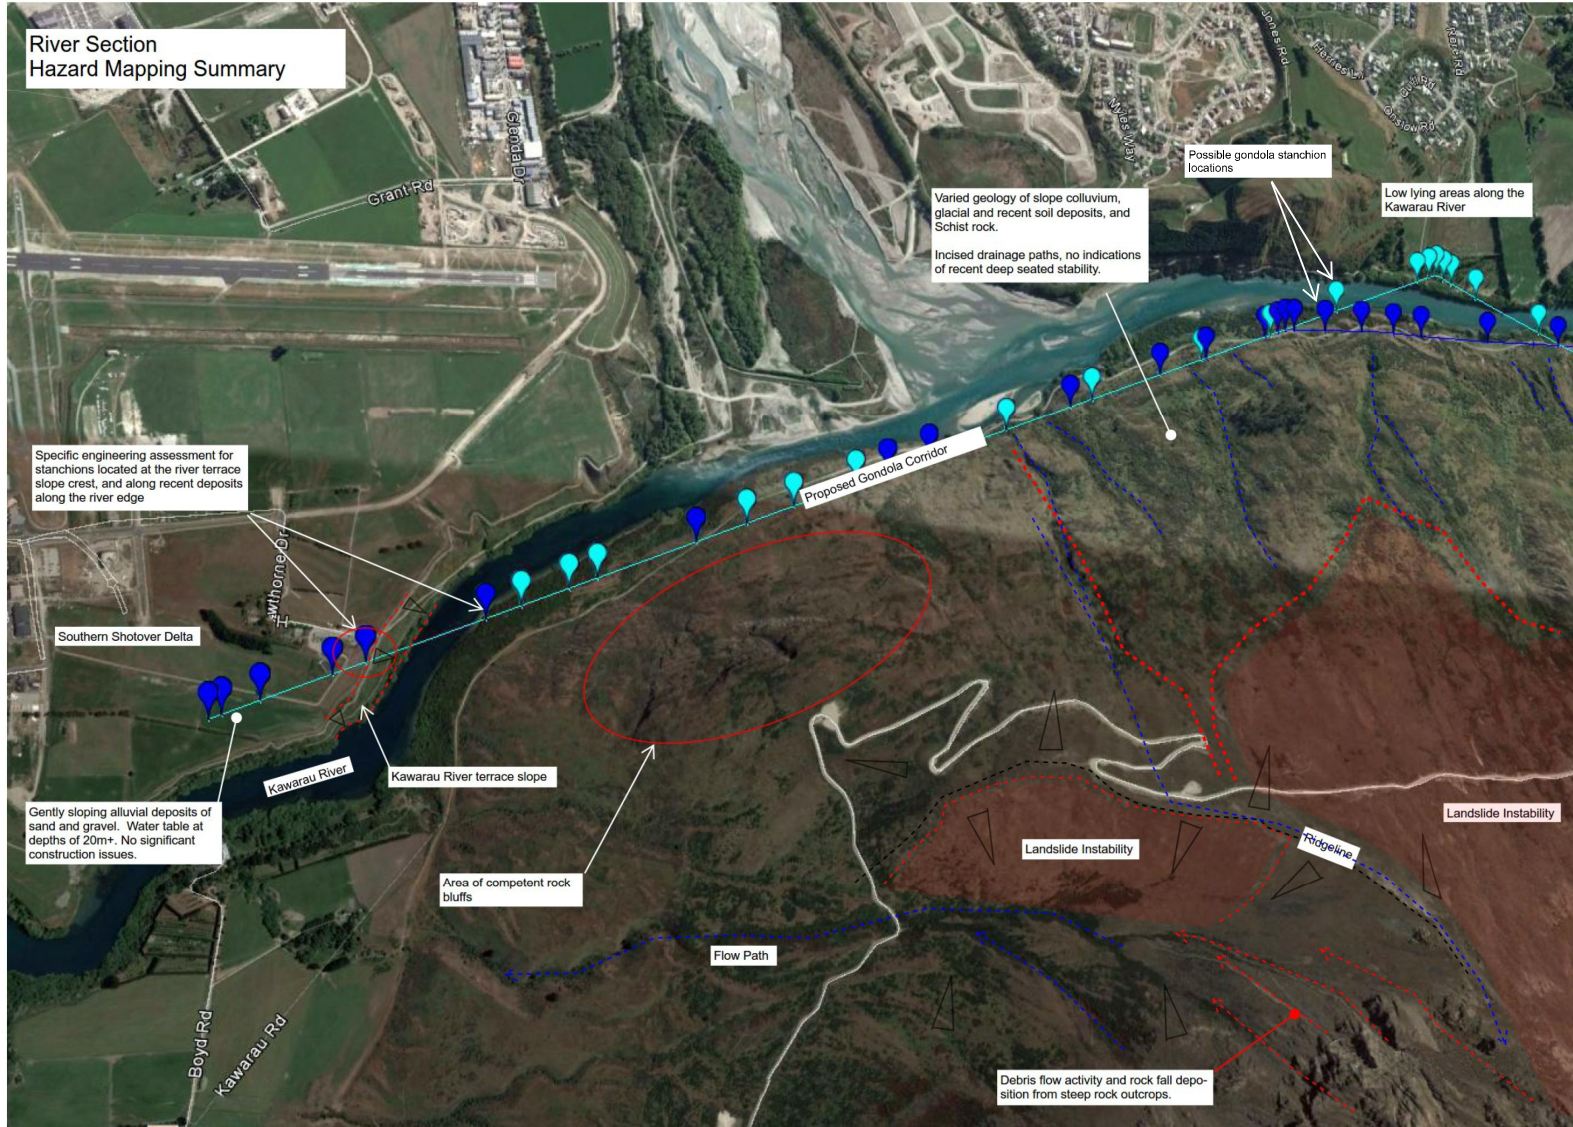
FIG No:  
Figure 1a

**River Section  
Hazard Mapping Summary**

Specific engineering assessment for stanchions located at the river terrace slope crest, and along recent deposits along the river edge

Gently sloping alluvial deposits of sand and gravel. Water table at depths of 20m+. No significant construction issues.

Area of competent rock bluffs

Varied geology of slope colluvium, glacial and recent soil deposits, and Schist rock.  
Incised drainage paths, no indications of recent deep seated stability.

Debris flow activity and rock fall deposition from steep rock outcrops.

6.1 The main hazard locations are shown on the **attached** site plan, Figures 1a, 1b and 1c and are summarised in the sections below.

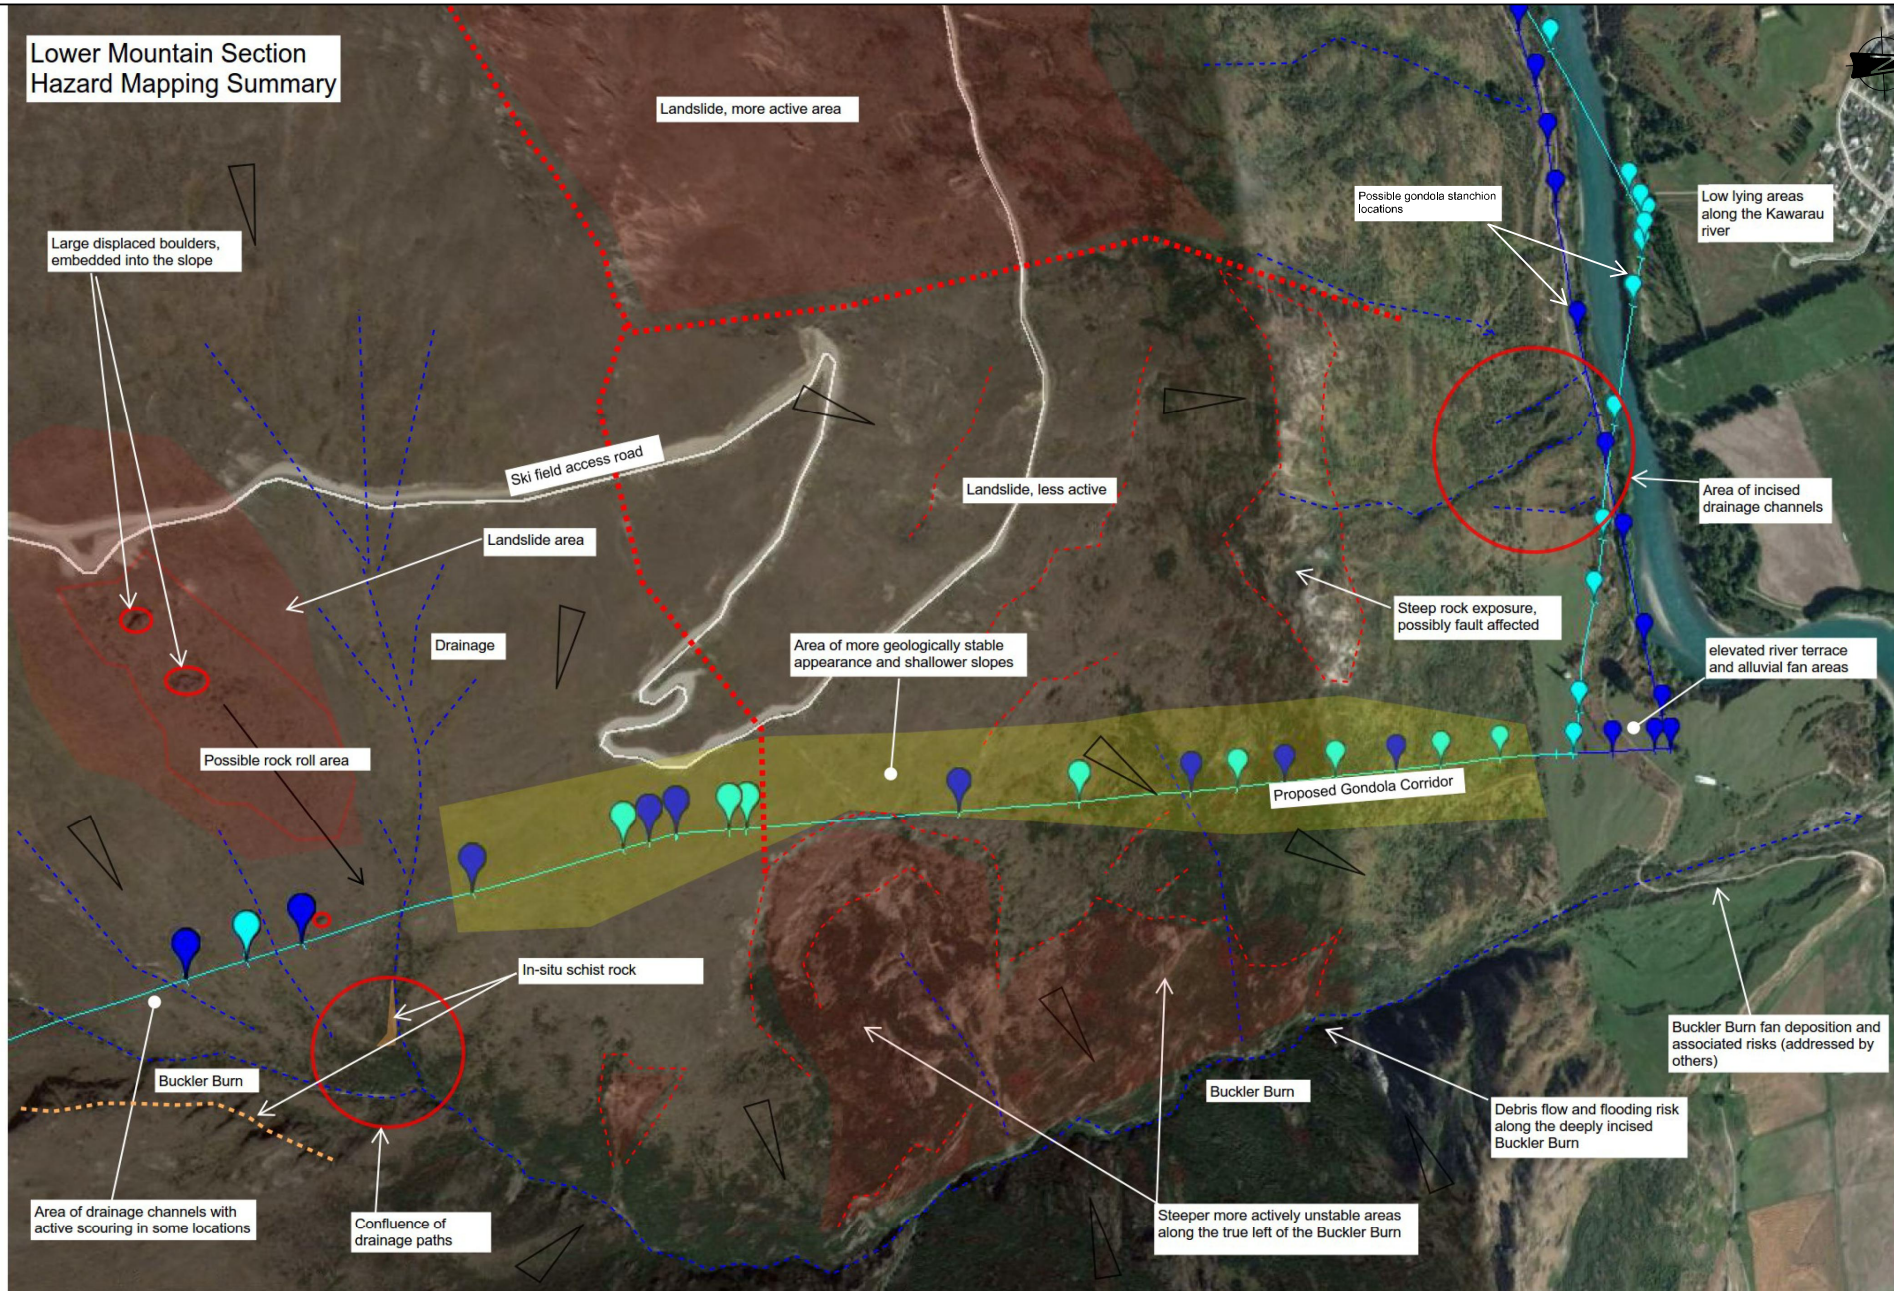
FIG No:  
Figure 1b

# Lower Mountain Section Hazard Mapping Summary

Natural Hazard Summary Plan - Proposed Gondola Corridor

Lower Mountain Section

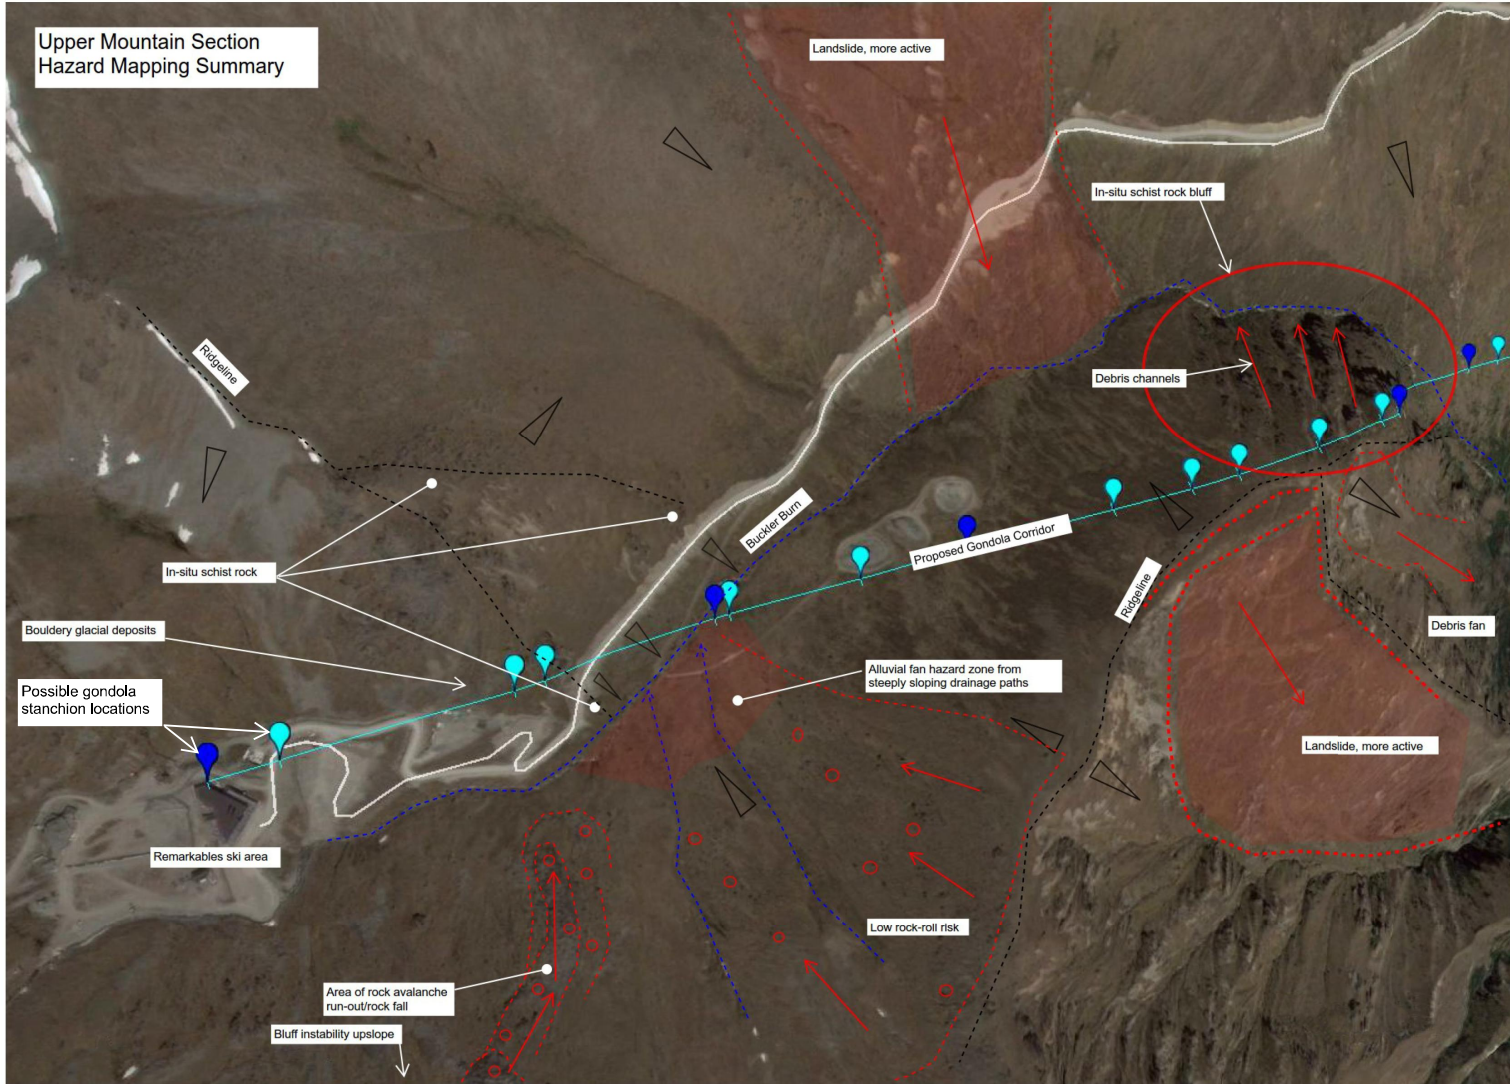
FIG No:  
Figure 1c

Queenstown Park Limited  
Stream 13 Rezoning Hearings  
Natural Hazard Summary Plan - Proposed Gondola Corridor  
Upper Mountain Section
